***CENTENNIAL COAL
CLARENCE COLLIERY
ANNUAL REVIEW
January 2020 to December 2020***

March 2021

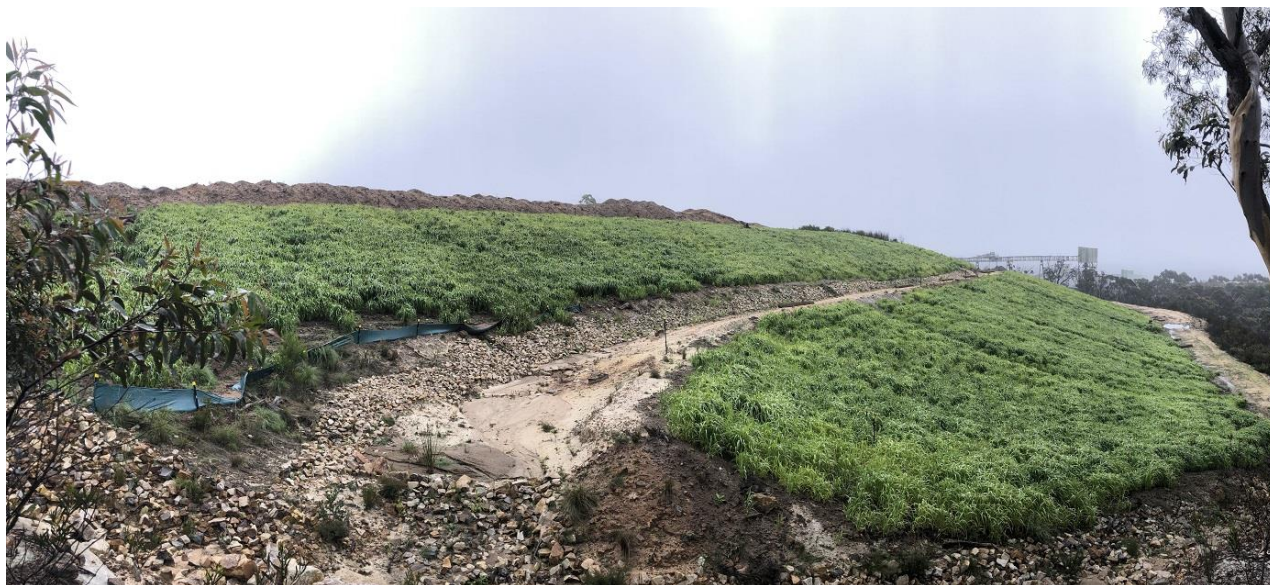
Figure 58. REA IV Rehabilitation Trial Area April 2020 showing cover crop growth

Overall Site H (straw mulch without cover crop) performed poorly with lower scores for most EFA variables (landscape organisation index, infiltration index, nutrient cycling, habitat complexity). The groundcover protection and native floristic diversity were also lower than other sites. Without the cover crop protection, the site also experienced a significant amount of erosion with rills present across the bottom portion of the slope. Site H was the only site with considerable erosion, which indicates that the cover crop is essential in controlling erosion during the establishment period.

Results of the surveys suggest that Site K (vital polykelp with cover crop) is currently performing the best, and Site H (straw mulch without cover crop) is performing the worst. As can be expected at year one of a recently rehabilitated area, the EFA data has returned results that are low, and all components are below the values required to meet MOP completion criteria. Notwithstanding this, the trial plots are generally stable and there are currently minimal remediation actions recommended (eg. repair of silt fence). The next annual monitoring survey will be required in November-December 2021.

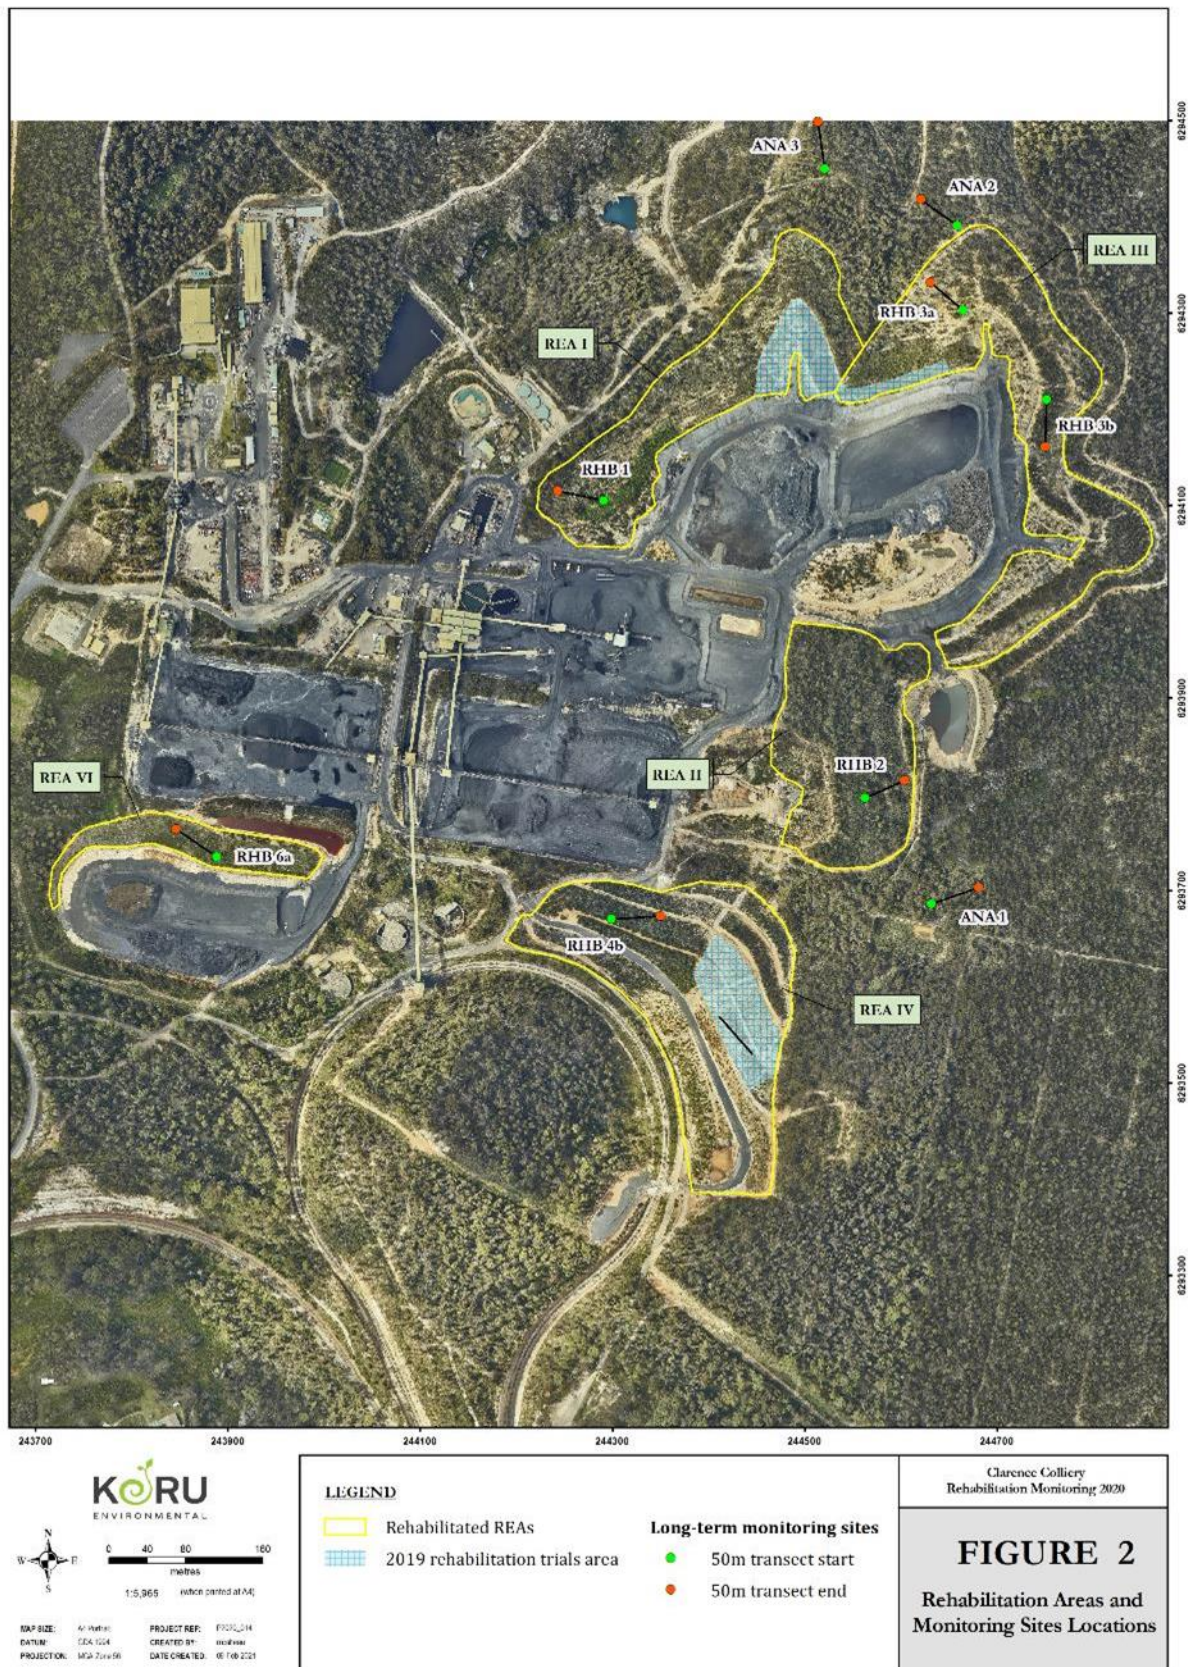
Figure 59. Clarence Colliery Rehabilitation Areas and Monitoring Site Locations

Each monitoring site consists of a standardised 50m long transect, with a nested 10m x 30m plot and 1m x 1m quadrats. To facilitate repeated measurements over time, all sites were permanently located with metal star pickets at the start and end points of the 50m line, and their geographical coordinates recorded using a GPS ($\pm 3\text{m}$ accuracy).

An overview of the monitoring program is presented in Table 33 and
