KOOLAN IRON ORE PTY LTD

KOOLAN ISLAND IRON ORE MINE AND PORT FACILITY

MINE CLOSURE PLAN

DOCUMENT ID: MGI-KIO-MCP

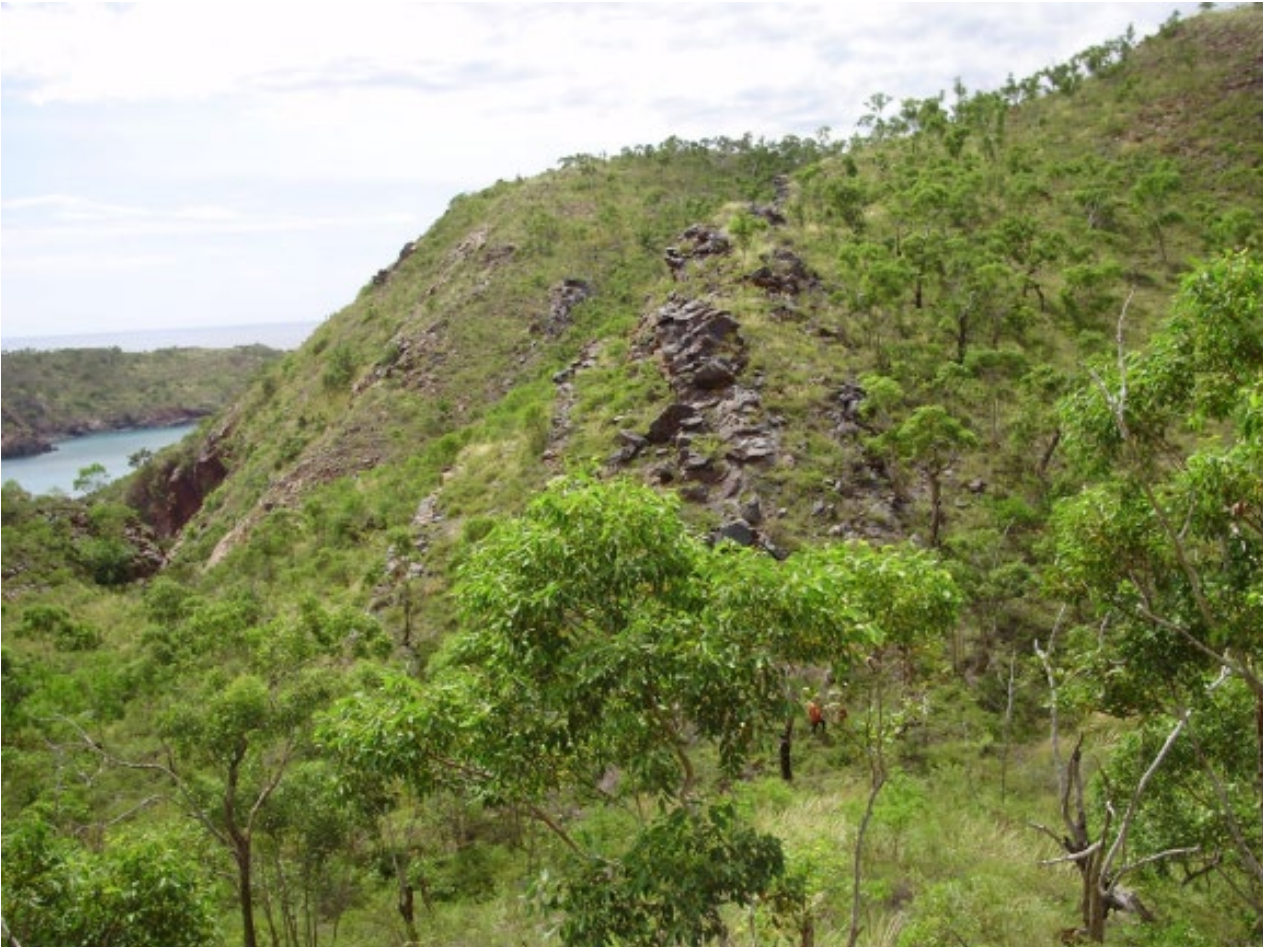
Plate 7-1: Steep gully feature typical of Koolan Island topography

The rugged topography of the Island coupled with tropical rainfall events prohibits the formation of deep soil profiles. The prevalence of steep slopes (Plate 7-1) over much of the Island and the extensive rock outcrop makes stripping of the fine skeletal topsoil challenging from an operational and safety viewpoint. Koolan Island was already a highly disturbed environment due to former mining and human occupation. Presently, these factors have acted to severely limit the available stockpiled topsoil / growth medium resource available for land rehabilitation. Additionally, the rugged topography may impose additional controls on the practicable alignments of abandonment bunds.

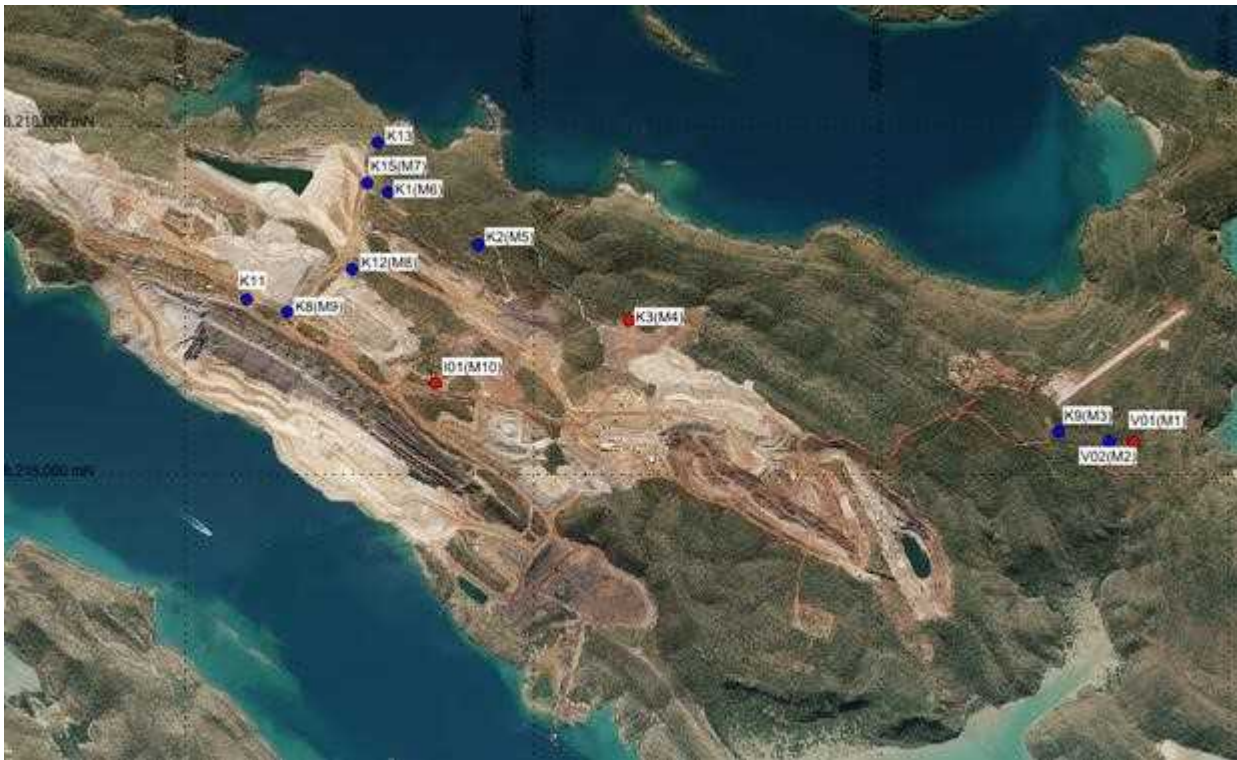
Figure 7-5: Location of Production Bores (red) and Monitoring Bores (blue).

KIOP abstracted water for industrial and domestic purposes from production bores I01 (South Syncline Aquifer), V01 (North Syncline Aquifer) and K3 (Central Anticline) during the 2018-2019 monitoring period. Total Abstraction from production bores was 91,289kL during 2018. Table 7-5 presents water usage data from 2014 to 2018. Changes in standing water levels from the base year to 2018 are shown Table 7-6.

The monitoring regime was adjusted in March 2016 to reflect the low risk of groundwater from site abstraction and operations on groundwater quality once the site entered C&M. Water quality monitoring is undertaken annually. Additional monitoring of production bores was undertaken in accordance with Groundwater Operating Strategy commitments approved by the DWER EPA Services. Licence L8148/20016/4 groundwater monitoring requirements are listed in Table 7-4 and bore locations are shown in Figure 7-5.

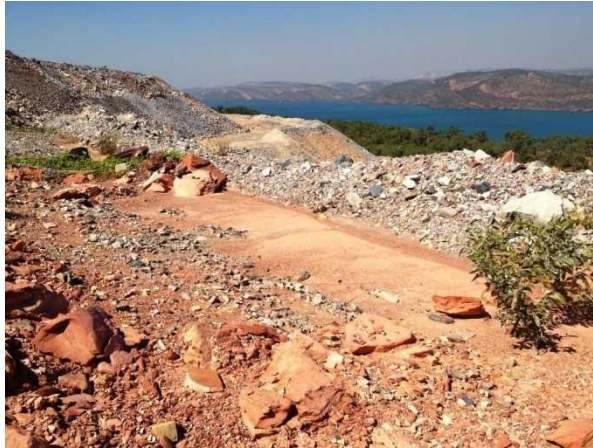
Plate 7-2: Accumulation of sediment in catchment berm (2015)

Some erosion was visually evident in 2015. A catchment berm proved effective at retaining sediment eroded from the trial plots (Plate 7-2). Encouragingly, the erosion did not significantly advance by 2019, indicating that the rate of erosion reduced over time as vegetation established.

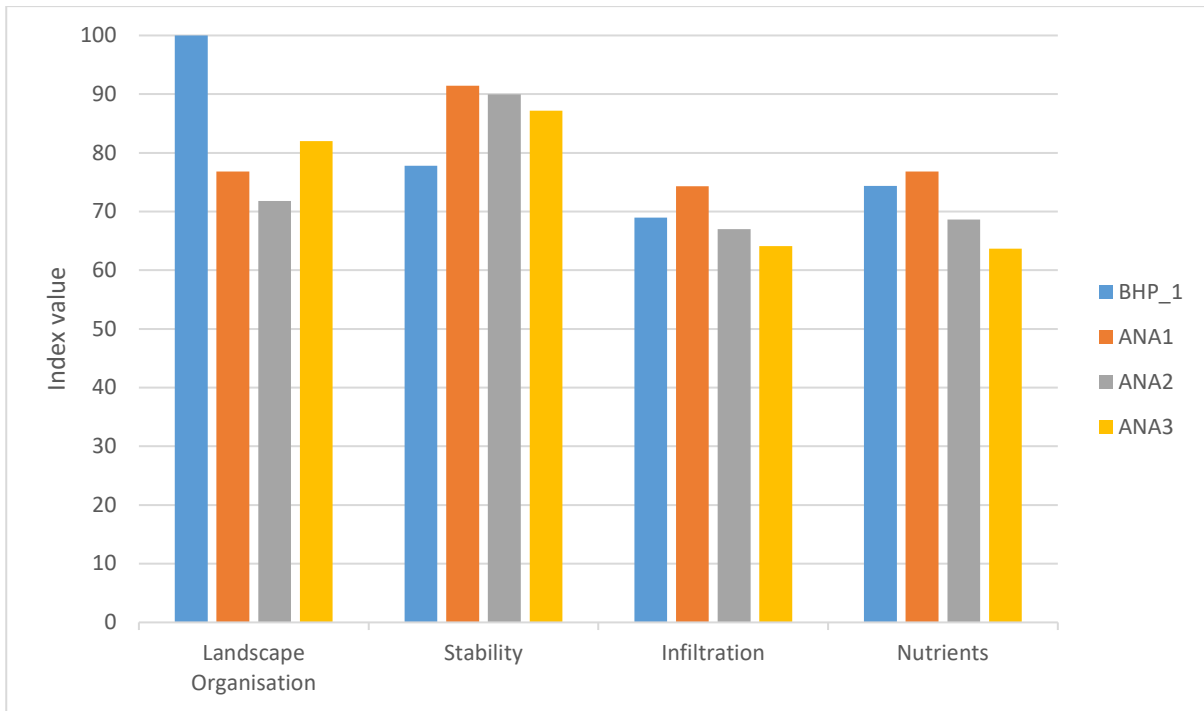
Figure 7-15: Landscape Organisation, Stability, Infiltration and Nutrient Index values of the BHP Moonscaping transects compared to the Analogue transects

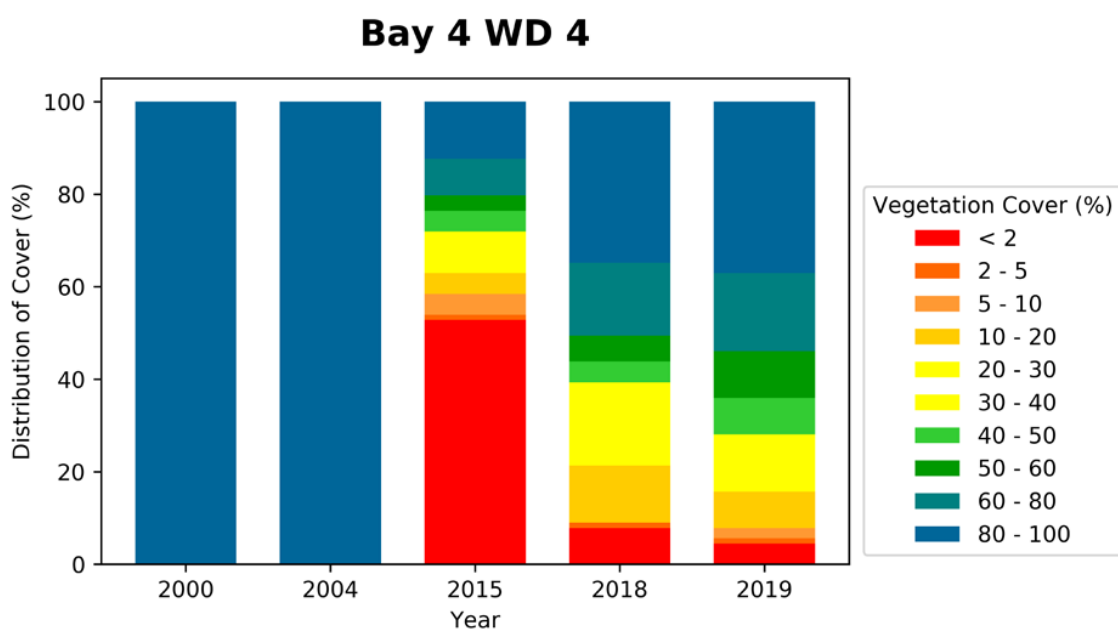
Figure 7-21: Distribution of vegetation cover for Pindan Drainage rehabilitation site

The work of eMapper (2019) shows vegetation cover in the Bay 4 area adjacent the re-instated Pindan Drainage (Figure 7-23). The area has shown good recovery between 2015 and 2018. There is also evidence of further recovery between 2018 and 2019, with decreases in areas of sparser vegetation cover.

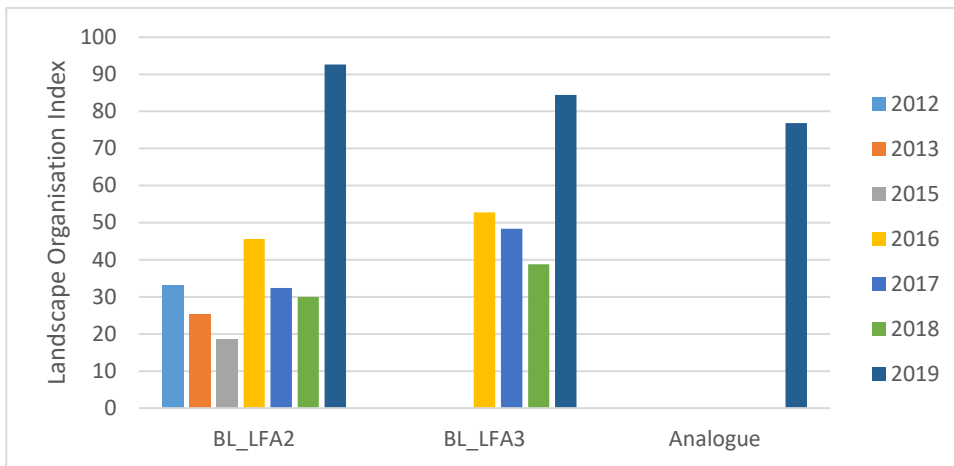
Figure 7-23: Landscape Organisation Index at the Barra Limb Transects compared to the mean of the Analogue transects

The area has been monitored on up to 7 occasions between 2012 and 2019 (Figure 7-25).

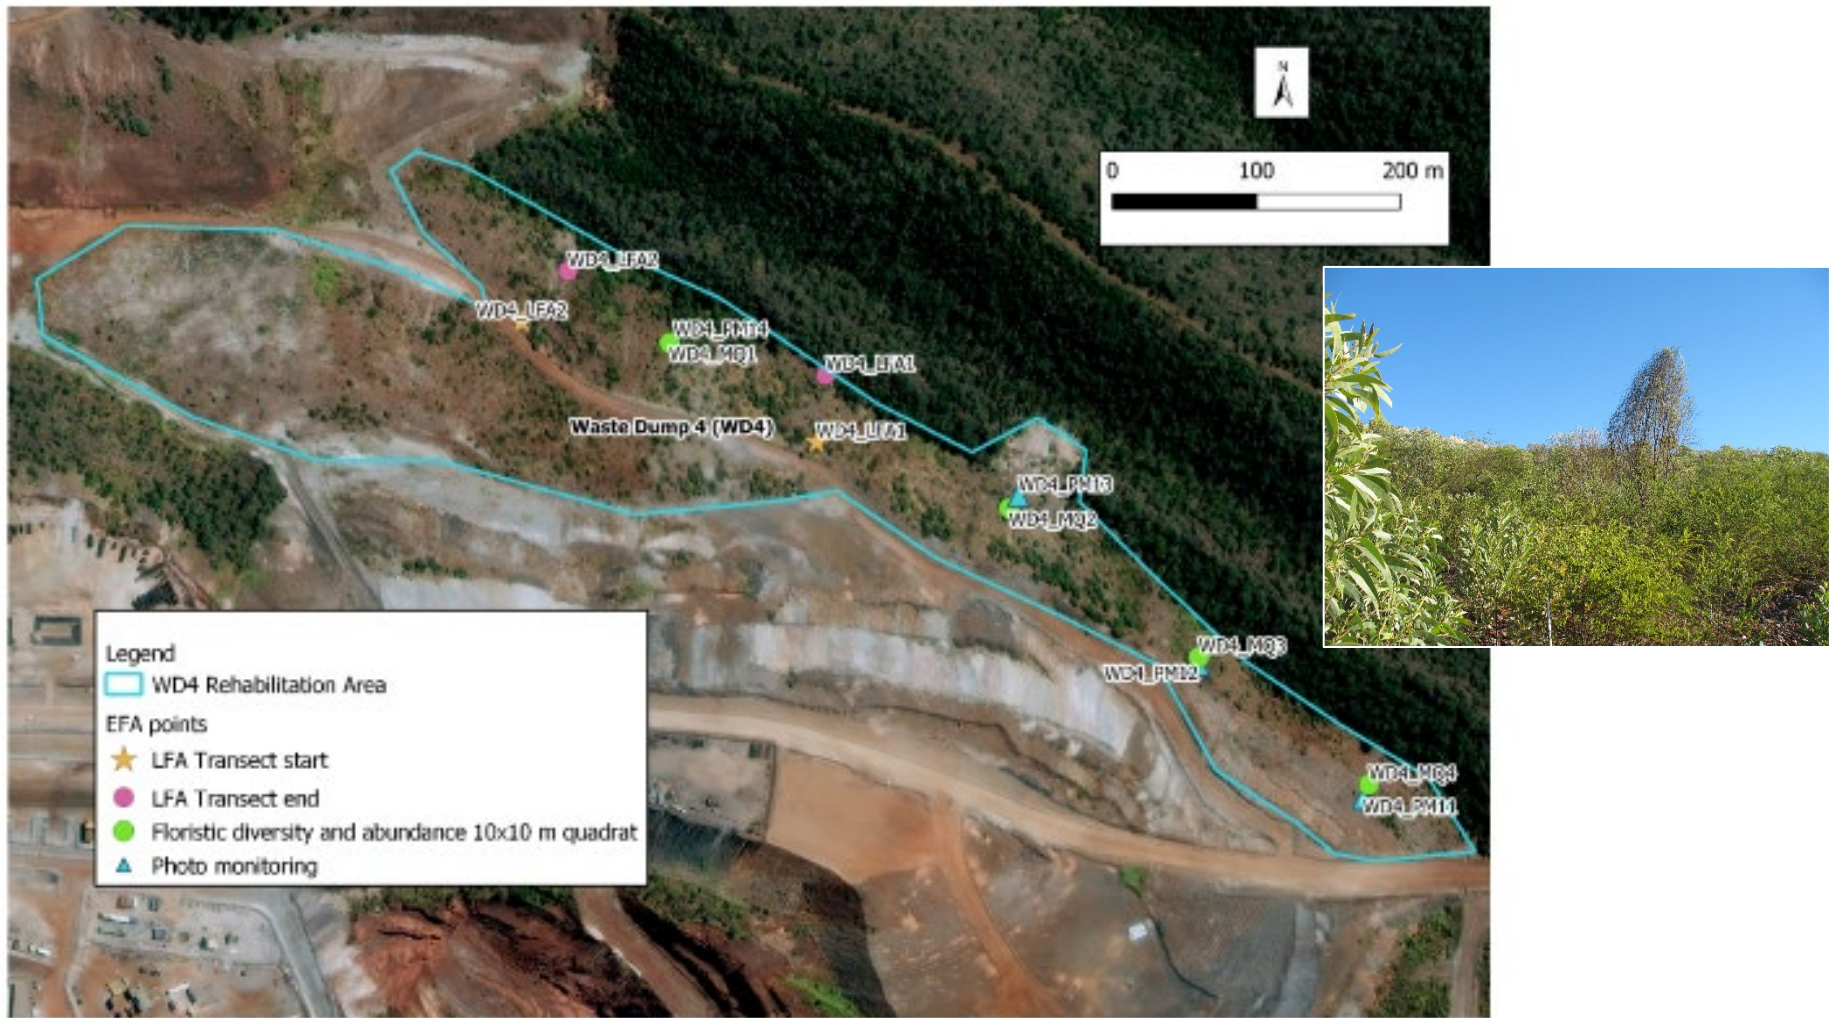
Figure 7-29: WD4 Rehabilitation Area monitoring site layout. Inset photo taken at WD4_LFA1 end facing south.

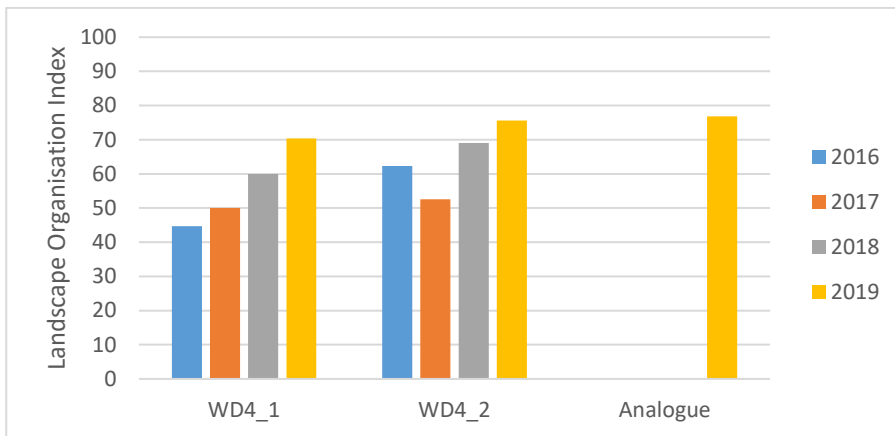
Figure 7-30: Landscape Organisation Index at the WD4 Transects compared to the mean of the Analogue transects

Ripping on the contour at WD4 provided a baseline landscape with troughs recorded in 2016 as occupying approximately 45% of the slope. The bank and trough system has quickly evolved to a slope in most parts of the WD4 slope by 2019, but steady increase in vegetation cover has seen the LOI steadily increase over time, without the same effect as at Bay 4 and Barra Limb. In 2019, LOI has rapidly increased to within 10% of the mean Analogue value. The perennial vegetation cover is high and the distribution of litter is a strong factor in the increased LOI from 2018 to 2019. The patches of litter extend beyond individual canopies, linking up plants that are adjacent. A lack of groundcover makes the accumulation of litter in 2019 vulnerable to erosion.

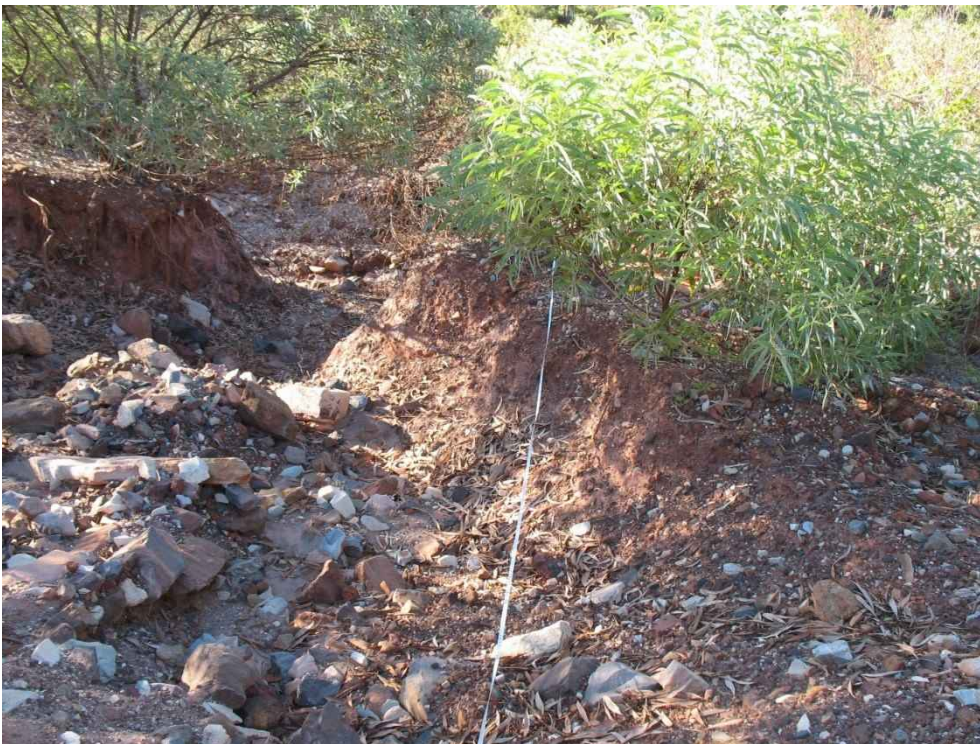
Plate 7-4: Erosion Gully at the Top of the WD4 LFA2 Transect – Poor Performance

There is evidence of erosion at the WD4 landform with one gully occurring right on one monitoring transect (Plate 7-4). Records were made in June of the extent of the erosion and plans were in place for the gully to be filled with competent rock for armouring against future erosion.

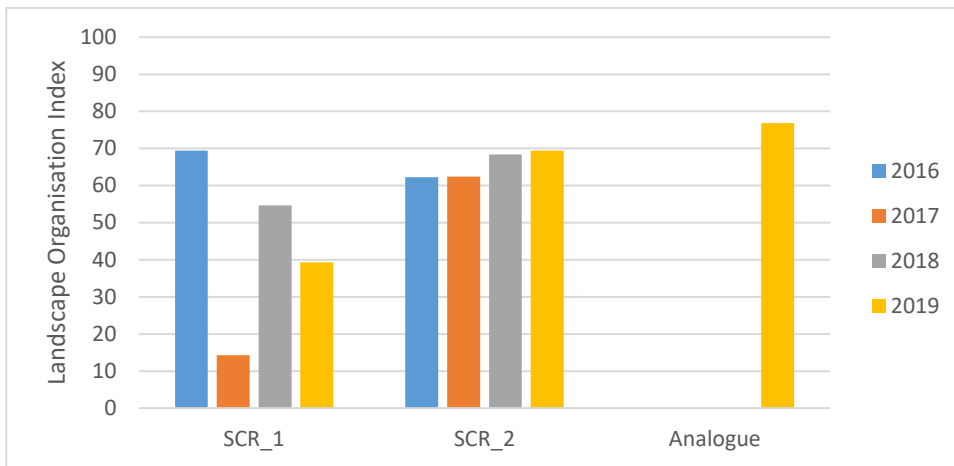
Figure 7-33: Scree rehabilitation area monitoring layout

The ripping on the contour of the Scree slope and the placement of coarse woody litter provided a baseline landscape with troughs and areas of woody litter recorded as occupying 60 - 70% of the transect in 2016. Between 2016 and 2017 rapid landscape evolution occurred at SCR_LFA1, where the bank and trough system eroded and some erosion features appeared on the top half of the transect where the soil profile was deep and rock content was low. Subsequent vegetation growth increased the LOI back up over 50% following the wetter than average wet season in 2017/18. For the SCR_LFA2 transect, LOI has slowly but steadily increased from 60 to 70% between 2016 and 2019. This is predominantly influenced by the intact bank and trough system throughout the transect and good growth of perennial woody vegetation cover.

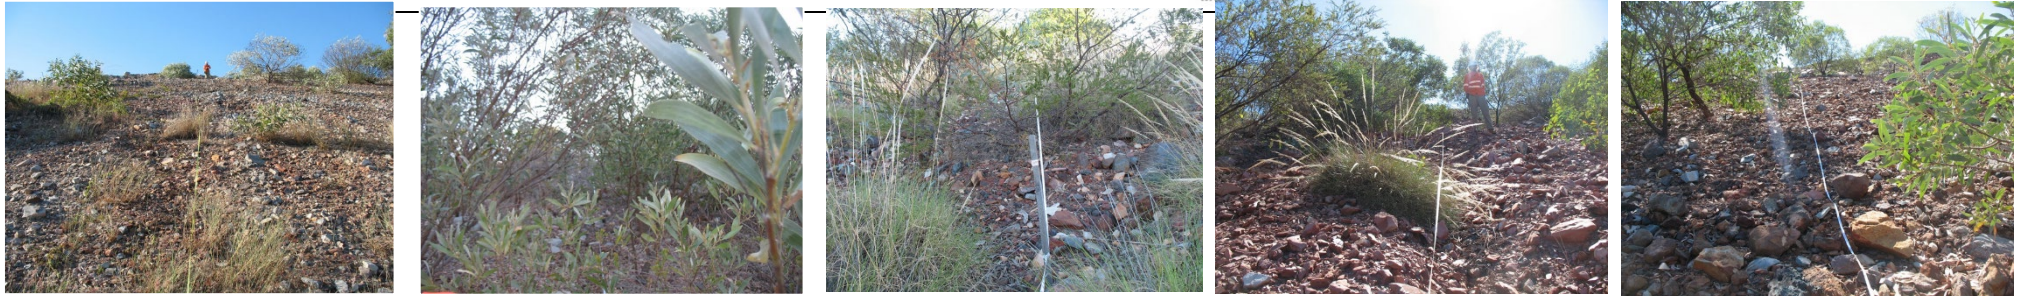
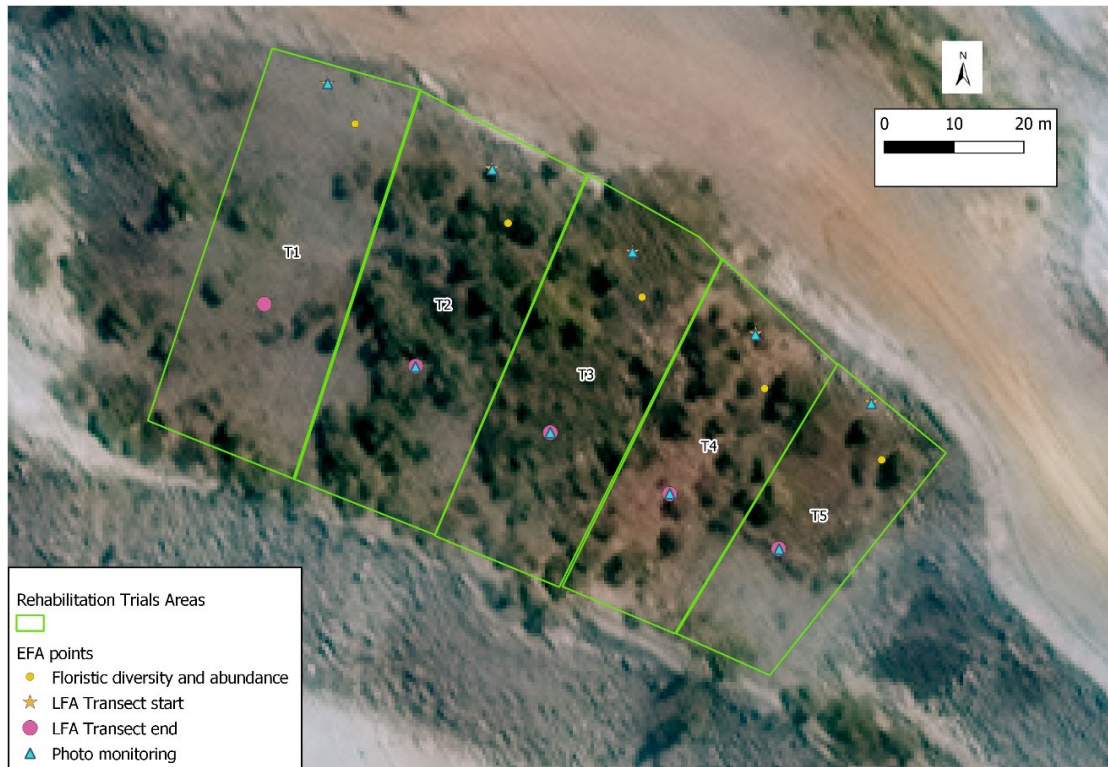
Figure 7-34 Rehabilitation Trials monitoring layout in 2019. Inset photos T1 to T5 (left to right)

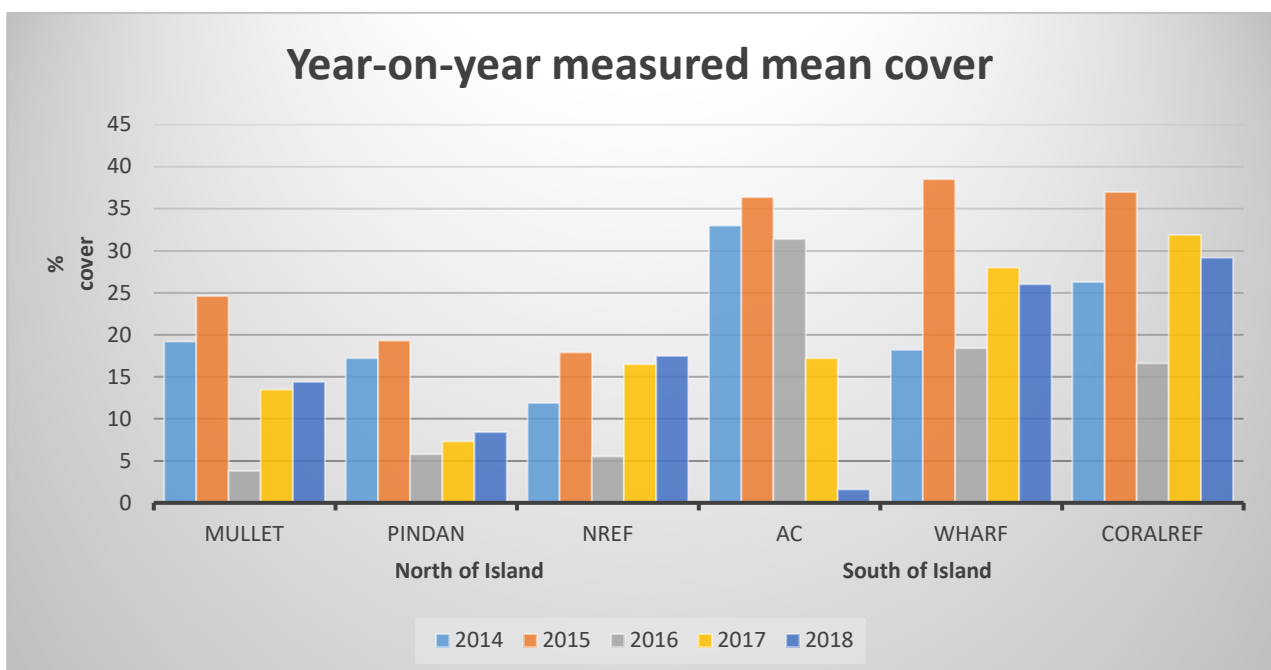
Figure 7-38 Time series of annual results 2014 to 2018 for each monitoring site (three LHS sites are North side of Island; three RHS sites are in the Canal)

- Northern Sites: Coral cover at Mullet Bay and the Reference site remains similar to that recorded in the 2014 and 2015 surveys. Coral cover at Pindan was significantly lower than both that of its reference site for this survey and the levels recorded in 2014/2015. However, coral cover at this site has shown a consistent small upward trend since the low levels recorded in 2016 (Figure 7-40). The low coral cover appears to be largely due to persistently low levels at Pindan Bay East rather than Pindan Bay West.
- Southern Sites: Coral cover at the Wharf and Coral Reference sites remains similar to that recorded before 2016. Live coral cover at Arbitration Cove in 2019 remains substantially below that of baseline surveys and the Reference site, but has increased slightly from levels recorded in the 2018 surveys (Figure 7-40).

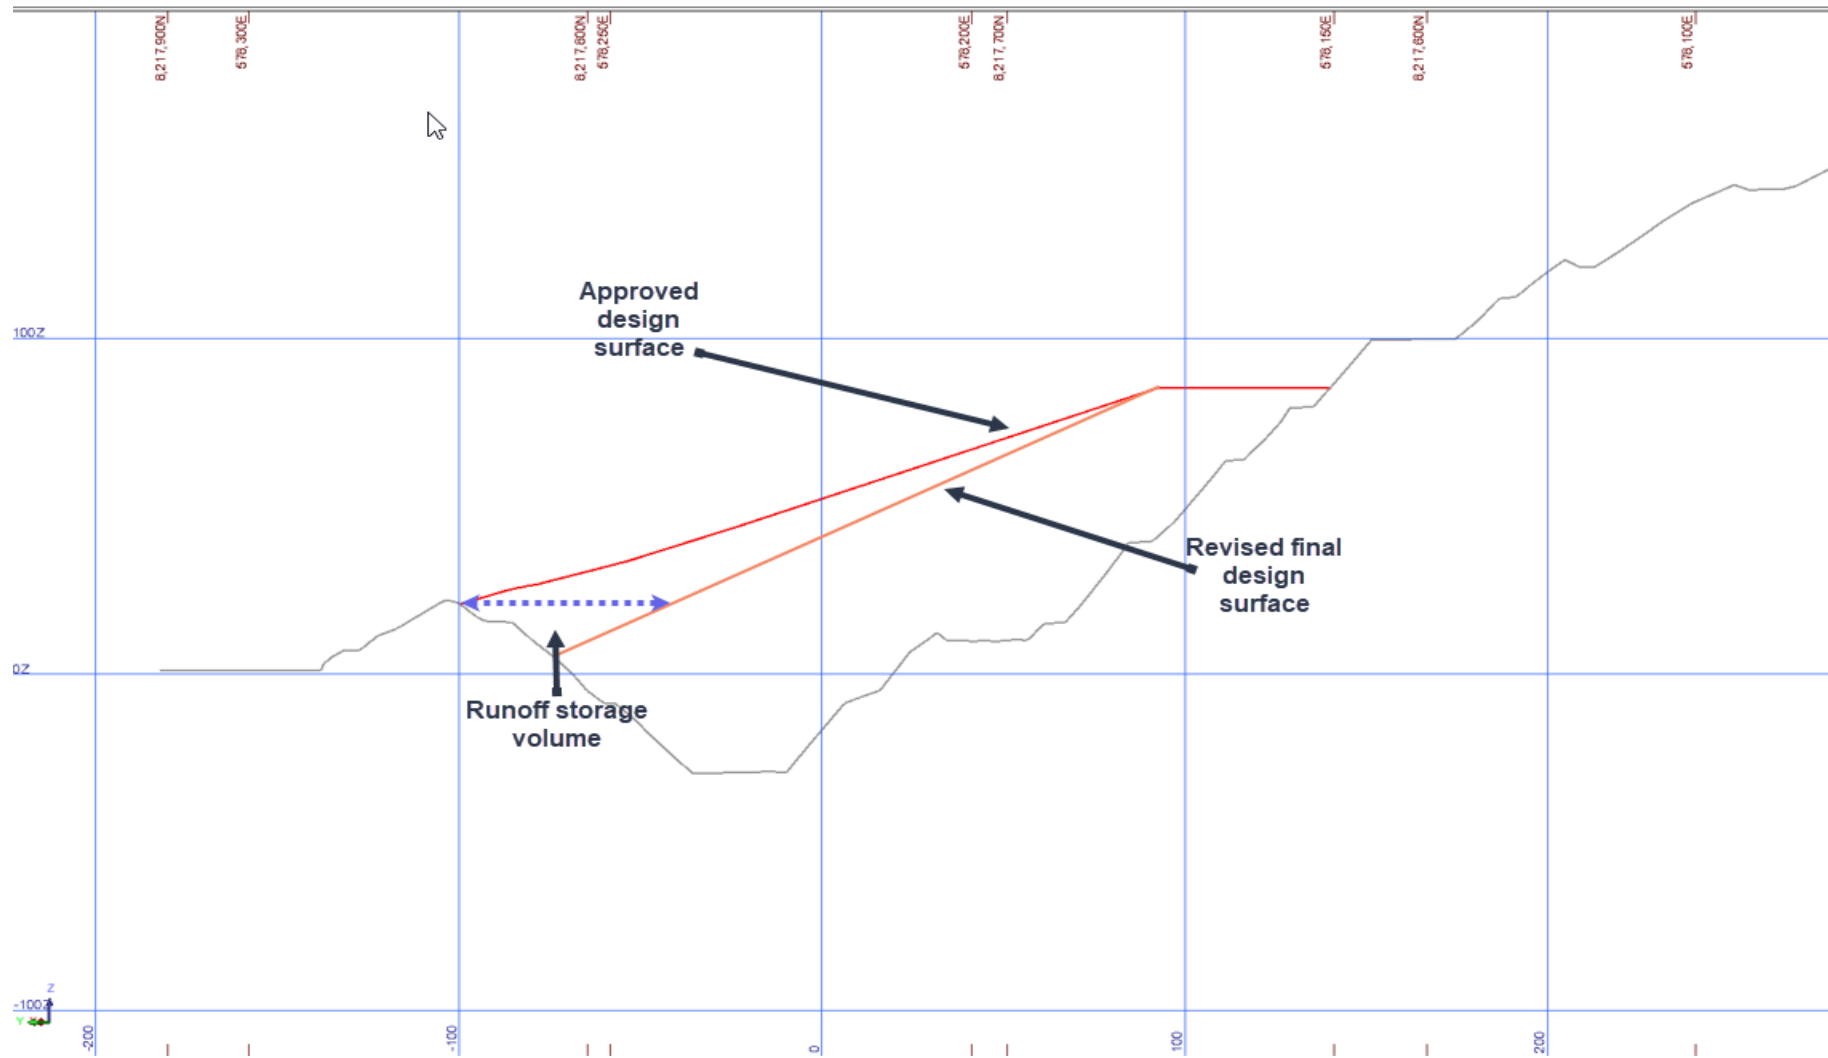
Mullet Pit is currently partly backfilled with mine waste on its eastern and southern sides. It is expected this mine pit will be backfilled with waste rock to form a land surface which approximates the original land surface (Figure 8-8). The current design (approved by MP 34572) allows for complete backfilling of Mullet Pit (Figure 8-9). However, since the approval of that Mining Proposal, through dialogue with DMIRS, an alternate design has been identified which contains a post closure runoff retention sump. A new MP will need to be submitted well prior to closure to seek approval a revised design (Figure 8-10) incorporating a retention sump (section 7.5.4) – at 335,000 m³ it exceeds the rainfall runoff 1:100 ARI 72hr event (an extra 20%) which will retain sediment mobilised in catchment runoff into the surrounding marine environment, Mullet Bay (section 8.6.2). It is worth re-iterating that infiltration of rainfall is a significant factor as the materials are conducive to vertical movement through coarse durable surface and sub-surface rocks.

Figure 8-8: Approved (MP 34572) and Revised (MP Amendment to be Submitted) Mullet Pit backfill Design Surface Concepts

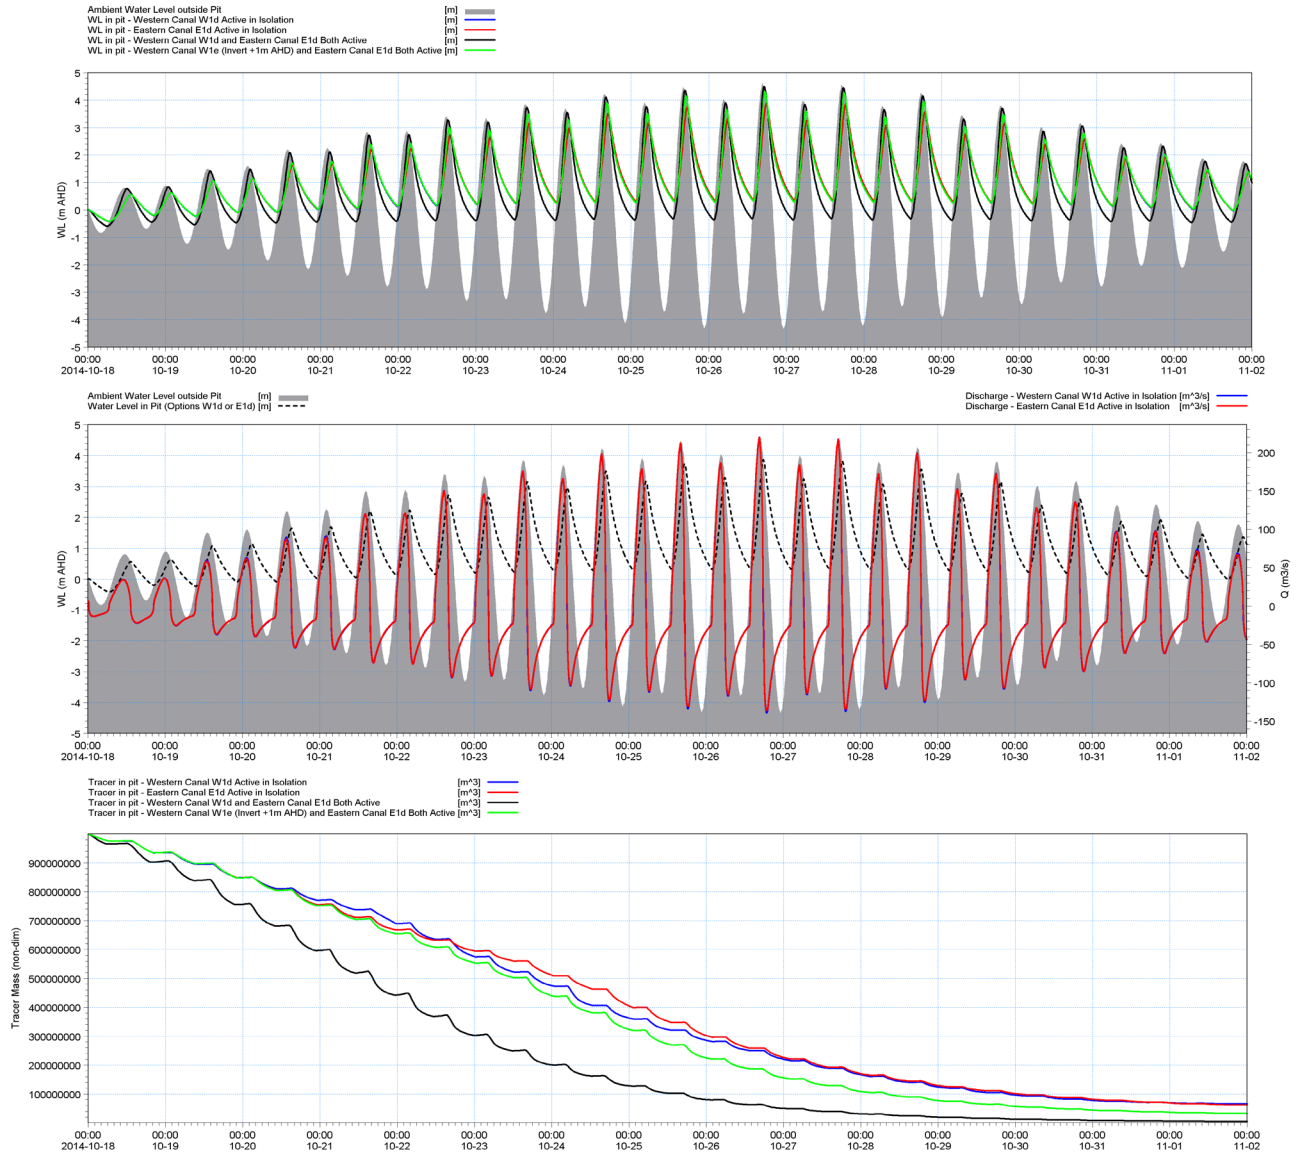
- Environmental impacts of construction (i.e. blasting and subsequent sediment and rock deposition to the marine environment) will be lower, and
- Spring tidal range for one cut (≈ 3.5 m) is significantly lower than for two cuts (≈ 5.0 m) (DHI, 2019), reducing scouring and erosion of pit walls.

Figure 8-13: Tidal Levels in and outside of Re-flooded Main Pit
