Perilya Broken Hill Limited ABN: 46 099 761 289

Broken Hill North Mine

2020 Annual Review

September 2021

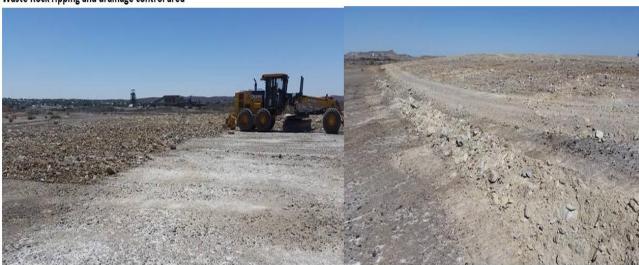
Figure 13 - Photographs of ripping and contouring activities on slime dam 1 $\,$

A non-operational area of Domain 4 known as slime dam 1 was ripped and contoured in late December 2020 as shown in Figure 13, additional areas of Domain 4 will be ripped and contoured in early 2021.

Objective	Performance Indicator	Completion Criteria	Progress at start of MOP	Expected Completion	TARP	Current Status
						State boarder closures. Works started Year 3 December 2020 to Rip and contour the surface of Slime Dam 1 (Figure 13) No work in Domain M per previously discussed delays in Historical and Rehabilitation strategy approvals
	Minimum growth medium depth determined during rehabilitation trials (see Section 8.2) spread over domain.		Not Commenced	In progress (4ha/year from Year 2)	5, 6 & 7 Not triggered - work delayed	Growth medium spreading of Domain 4 linked to above delay. No work in Domain M per previously discussed delays in Historical and Rehabilitation strategy approvals
Phase 4 – Ecosystem and Land Use	Establishment					
Domain K – Rehabilitation Area – Op Domain M – Heritage Conservation	oen Shrubland Area (sections not required to support I	neritage/commercial final land use)

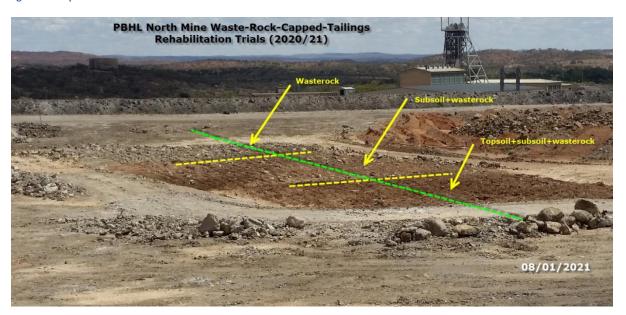
Figure 16 - Topsoil trial area

Half the treatment areas will be seeded with the remaining area to act as a control providing natural germination rates, works are anticipate to be completed by June 2021.
