SEC S-K 1300 Technical Report Summary

Southern Copper Corporation: Buenavista Copper

Golder Associates USA Inc.

February 22, 2023

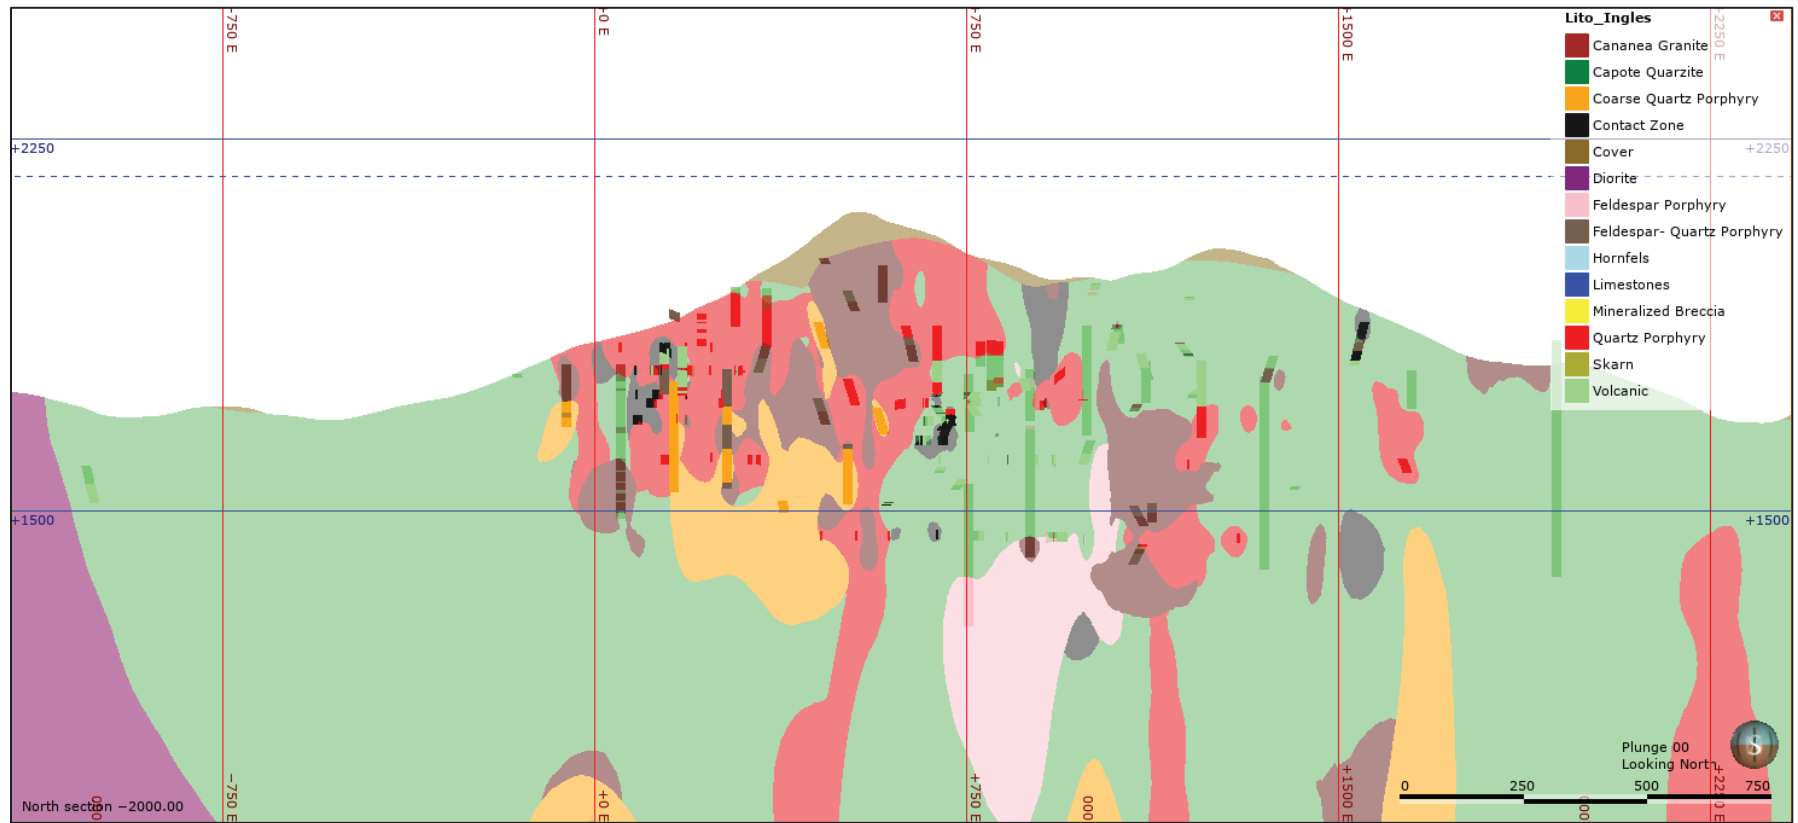
Figure 6.4: BVC Cross Section – Section Line 2000

The BVC deposit is underlain by the volcanic units of the Henrietta and Mesa Formations (Figure 6.4). The Henrietta Formation is widely distributed towards the western portion of the operational areas, while the volcanic sequences of the Mesa Formation extend to the east of the mining operation. These volcanic units are intruded by a series of porphyritic dykes that are located in the central and deep portion of the mining phases.

Diabase dykes with strikes N60°W to 80°W and N40°E, cut the volcanic and porphyry units in the area of the mine workings. Mineralized breccias in the BVC pit (Breccia 301), on the east slope of the Phase 8 development are the remnants of the La Colorada Breccia. All these breccia structures occur near the porphyry intrusion. Contact zones between porphyry and volcanic rocks throughout the district contain economic supergene and hypogene mineralization.

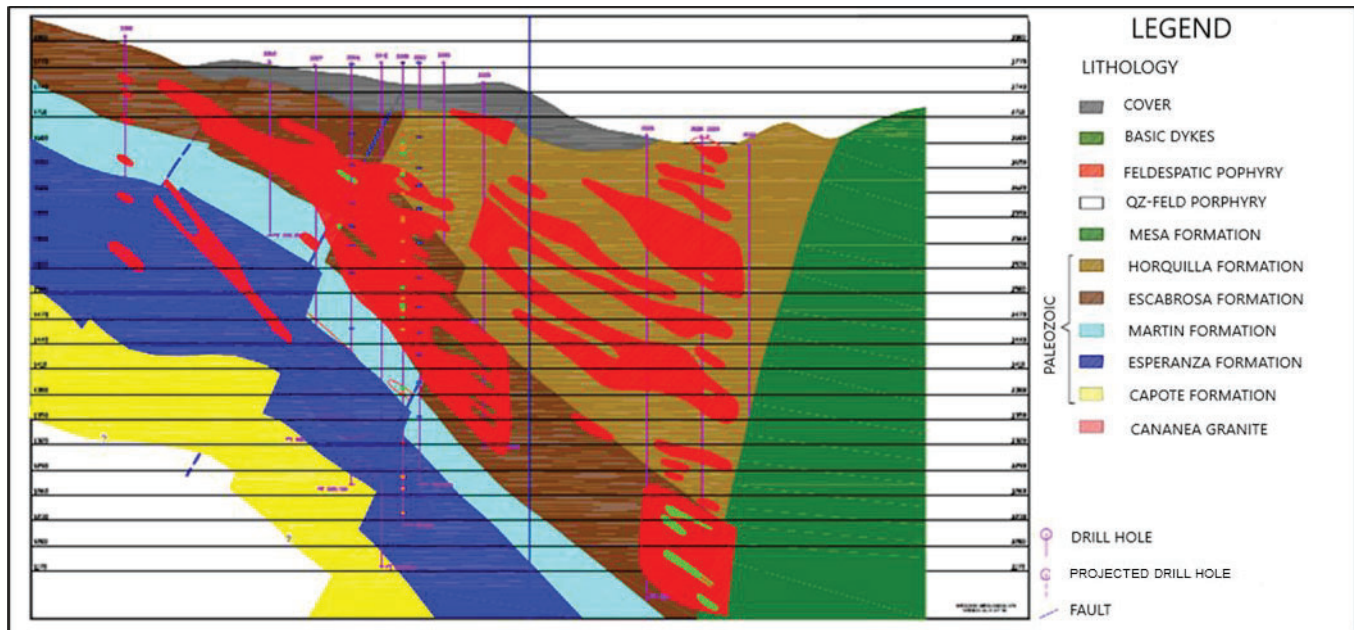
Figure 6.5: BVZ Cross Section

The skarn zone is delimited to the north by the Elisa Fault, with a west-northwest (WNW) orientation, and to the south by the Capote Pass Fault (Meinert, 1982), forming a monocline with a NW-SE direction and a dip of 40 to 60 to the NE. The skarn zone is also present in the Esperanza Formation (Figure 6.5)

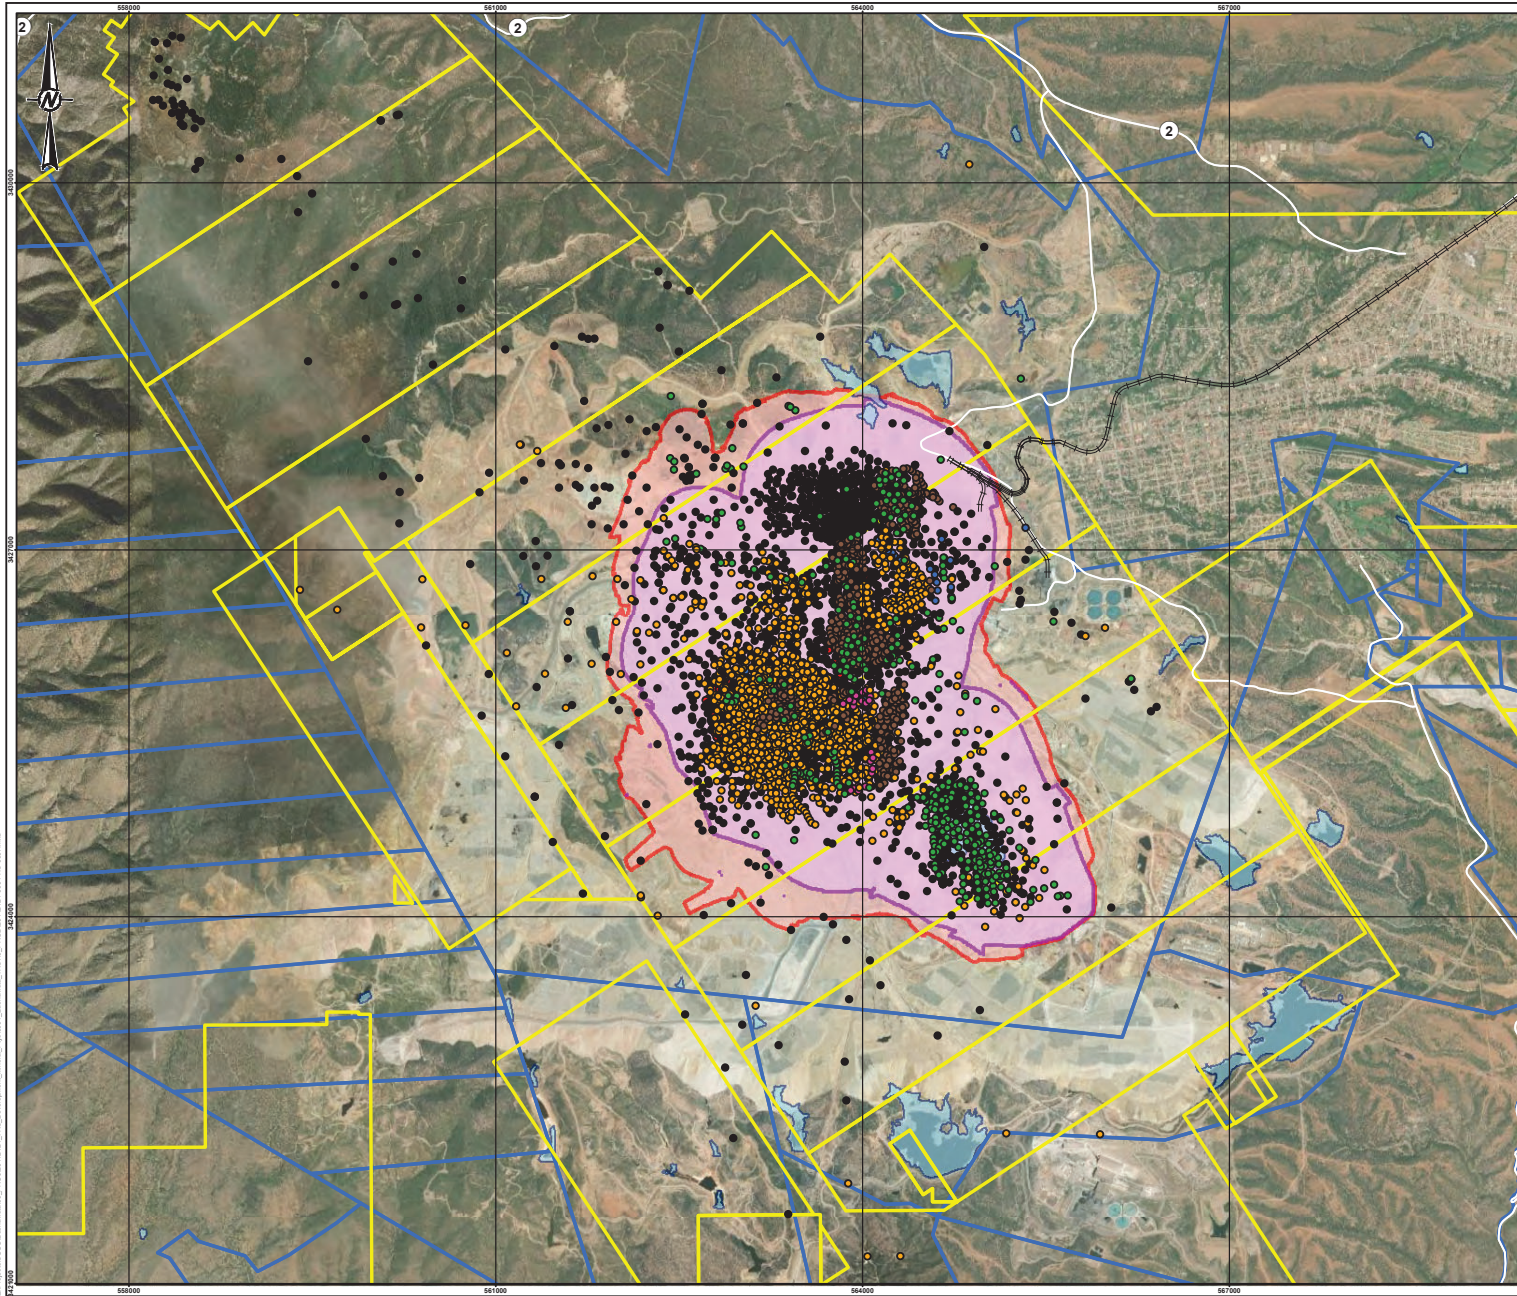
LEGEND

Drill Hole Type
