CENTENNIAL MANDALONG PTY LTD
Mandalong Mine
ANNUAL REVIEW

March 2023

Annual Review Title Block

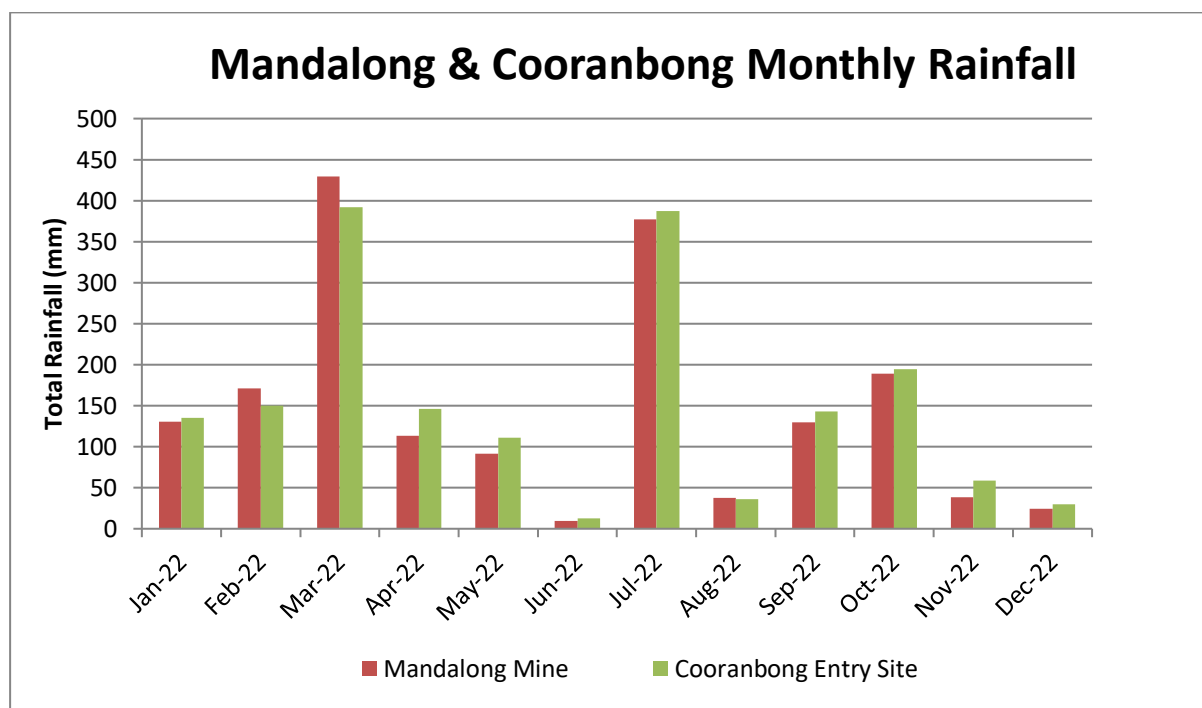
Figure 6-1: Mandalong Mine & Cooranbong Entry Site Monthly Rainfall

For Mandalong Mine, a total of 1742.2 mm of rainfall was recorded at the site during the reporting period. The total annual rainfall for 2022 was higher than the annual average rainfall (1,124 mm) recorded at the Cooranbong Station (BOM station number 61012) from 1889 to 2016. The wettest monthly period in 2022 was March recording 429.4 mm.

For Cooranbong Entry Site, a total of 1796 mm of rainfall was recorded at the site during the reporting period. The total annual rainfall for 2022 was higher than the annual average rainfall (1,124 mm) recorded at the Cooranbong Station (BOM station number 61012) from 1889 to 2016. The wettest recorded monthly period at the Cooranbong Entry Site in 2022 was March recording 391.8 mm.

The total monthly rainfall data is shown below in **Table 6-2** and in **Figure 6-1**.

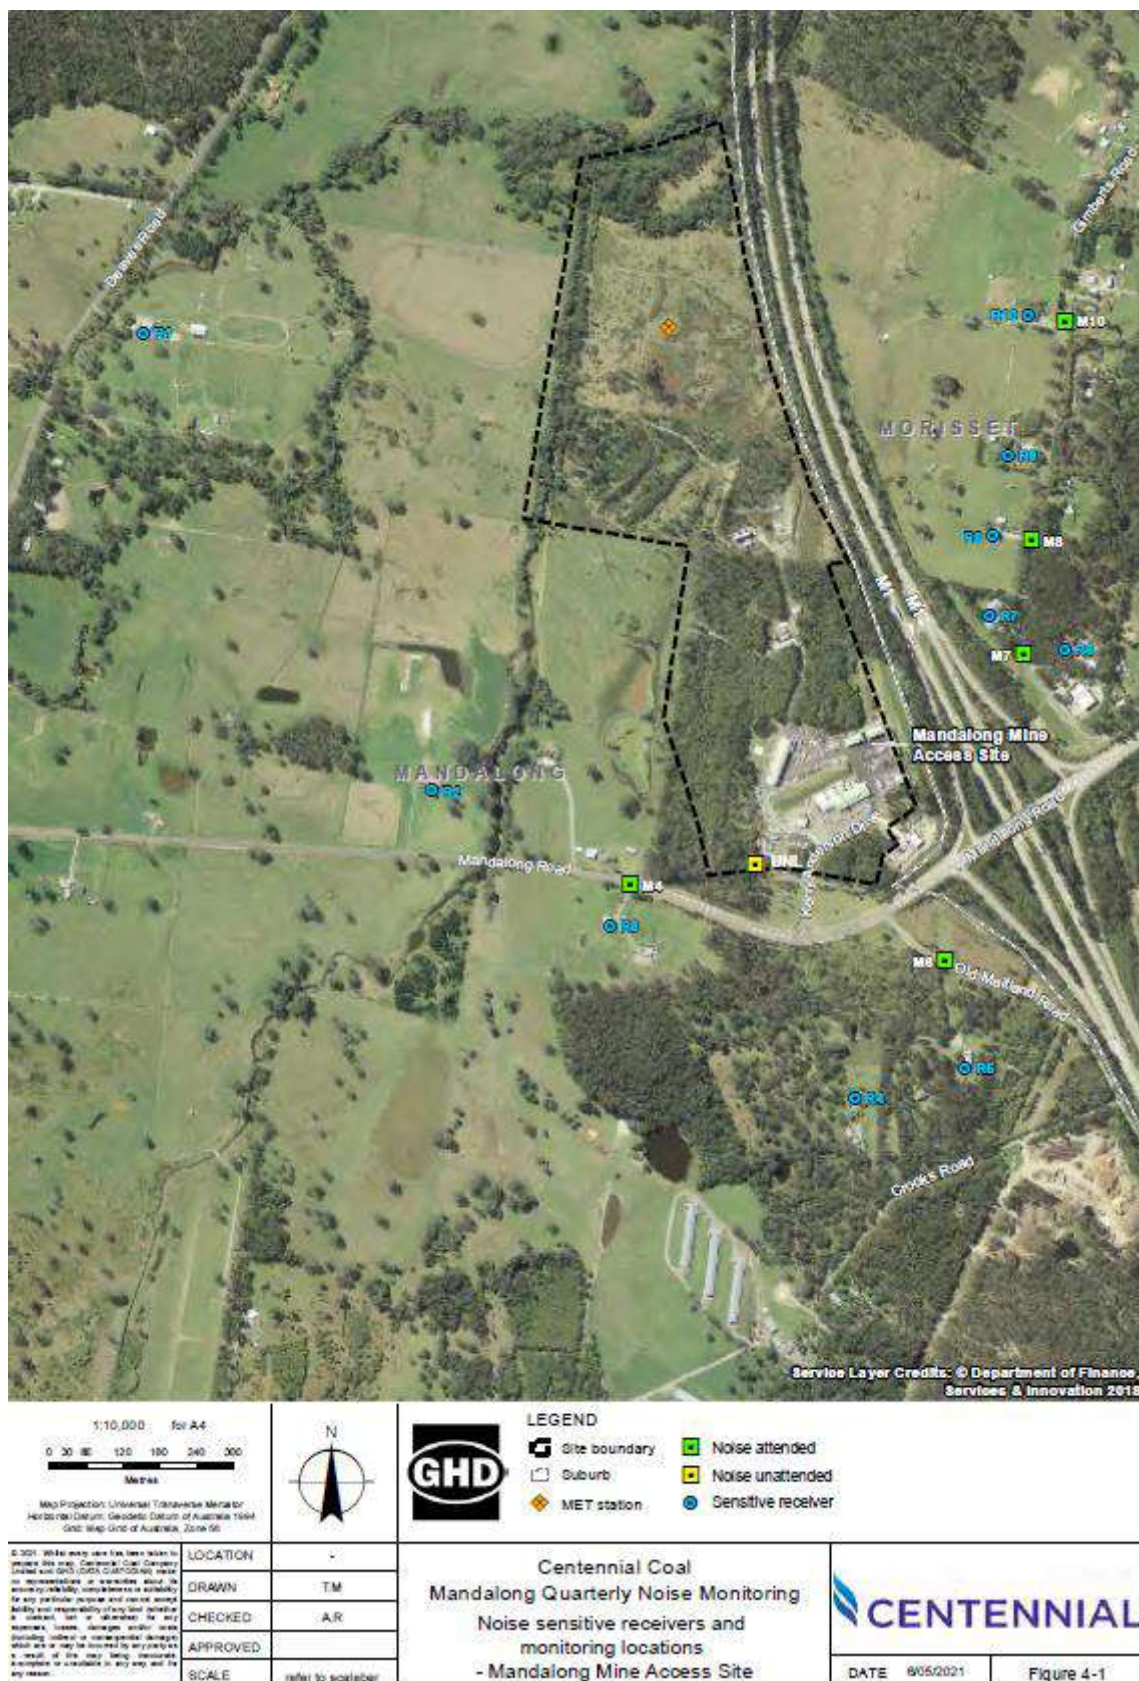
Figure 6-2: Mandalong Mine Noise Monitoring Locations

Noise monitoring was conducted to assess operational noise levels compared to the noise limits specified by SSD-5144, SSD-5145 and EPL 365 in accordance with the requirements of the Northern Region Noise Management Plan (GHD, 2022d). The Mandalong Mine Noise Monitoring Program now requires Centennial Mandalong to survey noise from the operations

at the Mandalong Mine and the Cooranbong Entry Site (shown in [Figure 6-2](#) and

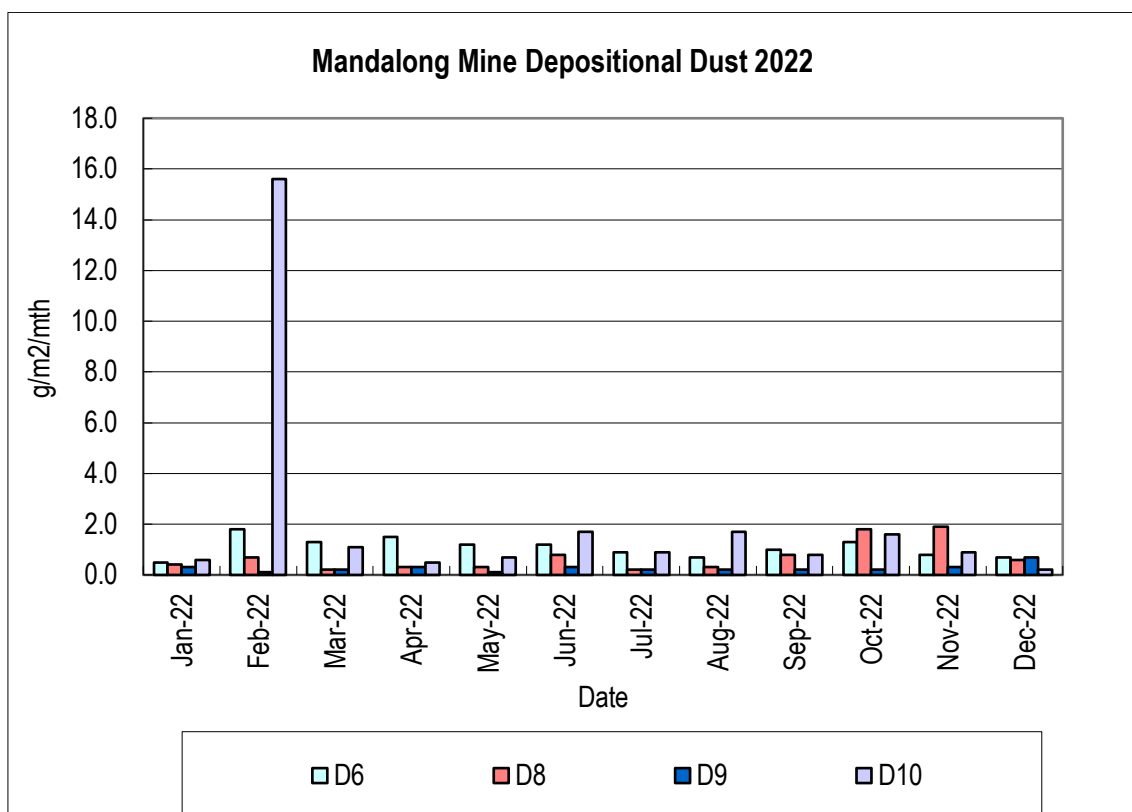
Figure 6-5: Monthly Depositional Dust Results 2022 Mandalong Mine

The cumulative impact result is shown in [Table 6-7](#) and [Table 6-8](#) as an annual average. All dust gauges were compliant with the condition for the reporting period. The maximum cumulative impact was 2.53 recorded at DG10. The incremental impact result is shown in [Table 6-7](#) as the change from PCA. All dust gauges were compliant with the condition for the reporting period. The maximum incremental impact for DG6 is 0.4, DG8 is - 0.1 and DG9 is - 0.3.

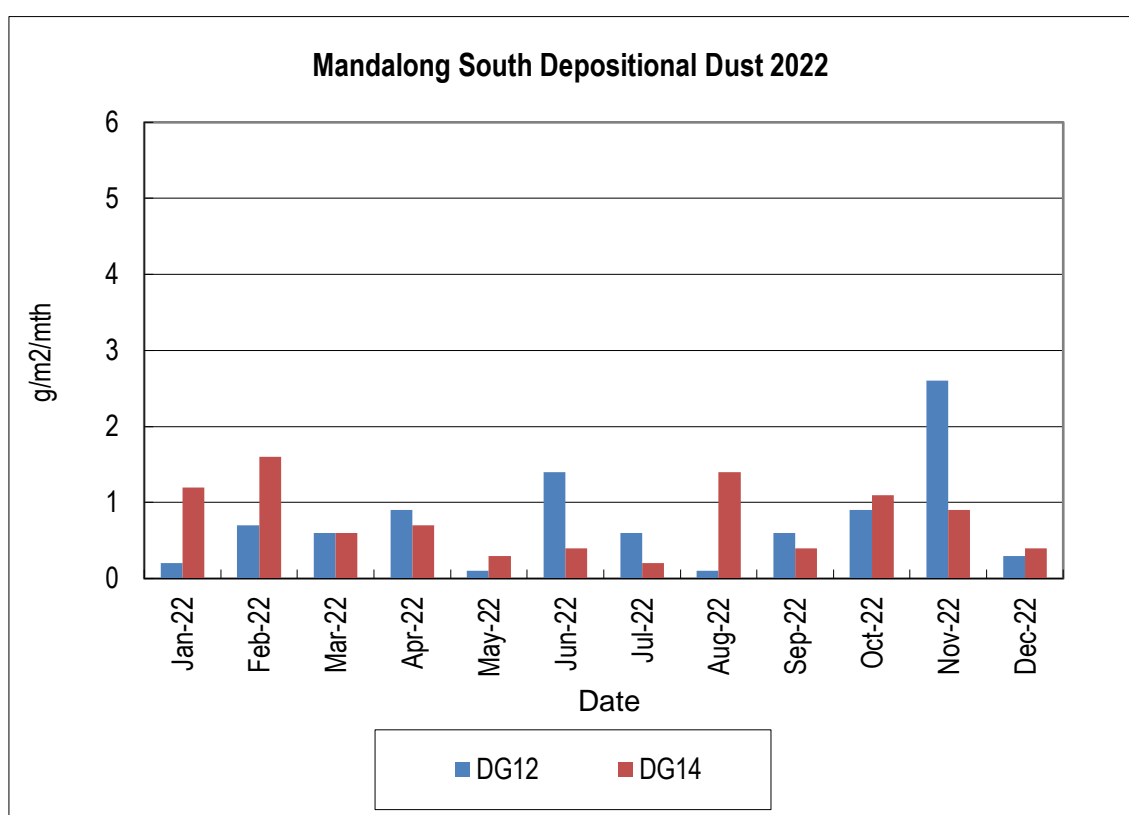
Figure 6-7: Monthly Depositional Results 2022 MSSS

The cumulative impact result is shown in **Table 6-12** as an annual average. The dust gauges were compliant with the condition for the reporting period. The maximum cumulative impact at DG12 was 0.76 and DG14 was 0.79. The incremental impact result is shown in **Table 6-12** as the change from PCA. The dust gauges were compliant with the condition for the reporting period. The maximum incremental impact for DG12 is 0.3 and DG14 is -0.8.

Depositional dust gauges were installed at the Mandalong South Services Site in June 2014 for the purpose of pre-construction air quality monitoring. Construction of the Mandalong South Surface Site access road commenced in February 2017 and construction of the Surface Site commenced in July 2017. The monthly dust deposition results for DG12 and DG14 are provided in **Figure 6-7**. Annual average depositional dust results for 2022 and the consent criteria are provided in **Table 6-11**, **Table 6-12** and **Figure 6-7**.

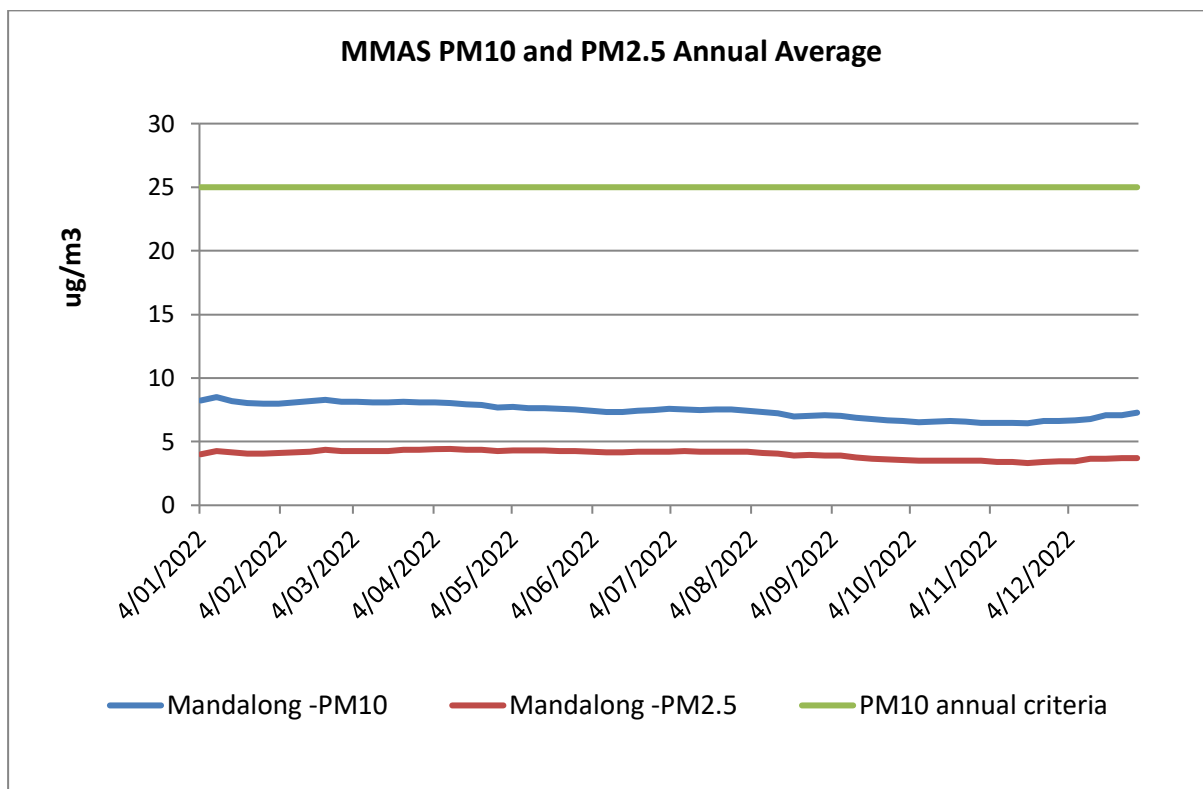
Figure 6-11: MMAS PM10 and PM2.5 Annual Average Monitoring Results and Limit Criteria

The 24-hr average PM₁₀ concentrations recorded nil exceedances of the Development Consent SSD-5144 24-hr criterion of 50ug/m³ in the 2022 monitoring period.

The maximum PM₁₀ concentration of 30.8µg/m³ and TSP concentration of 34.96µg/m³ were recorded on 18 December 2022. The maximum PM_{2.5} concentration of 15.3µg/m³ was recorded on 30 November 2022. There is no maximum 24hr concentration limit for TSP and PM_{2.5}.

PM10 and PM2.5 monitoring results are shown in **Figure 6-11** and **Figure 6-12**. The results are presented as an annual average for the report period (January 2022 to December 2022). The monitoring results for the TSP and PM10 annual and 24-hour average from January to December 2022 are in accordance with the predictions from the air quality impact assessment for the Mandalong Southern Extension Project EIS (SLR, 2013).

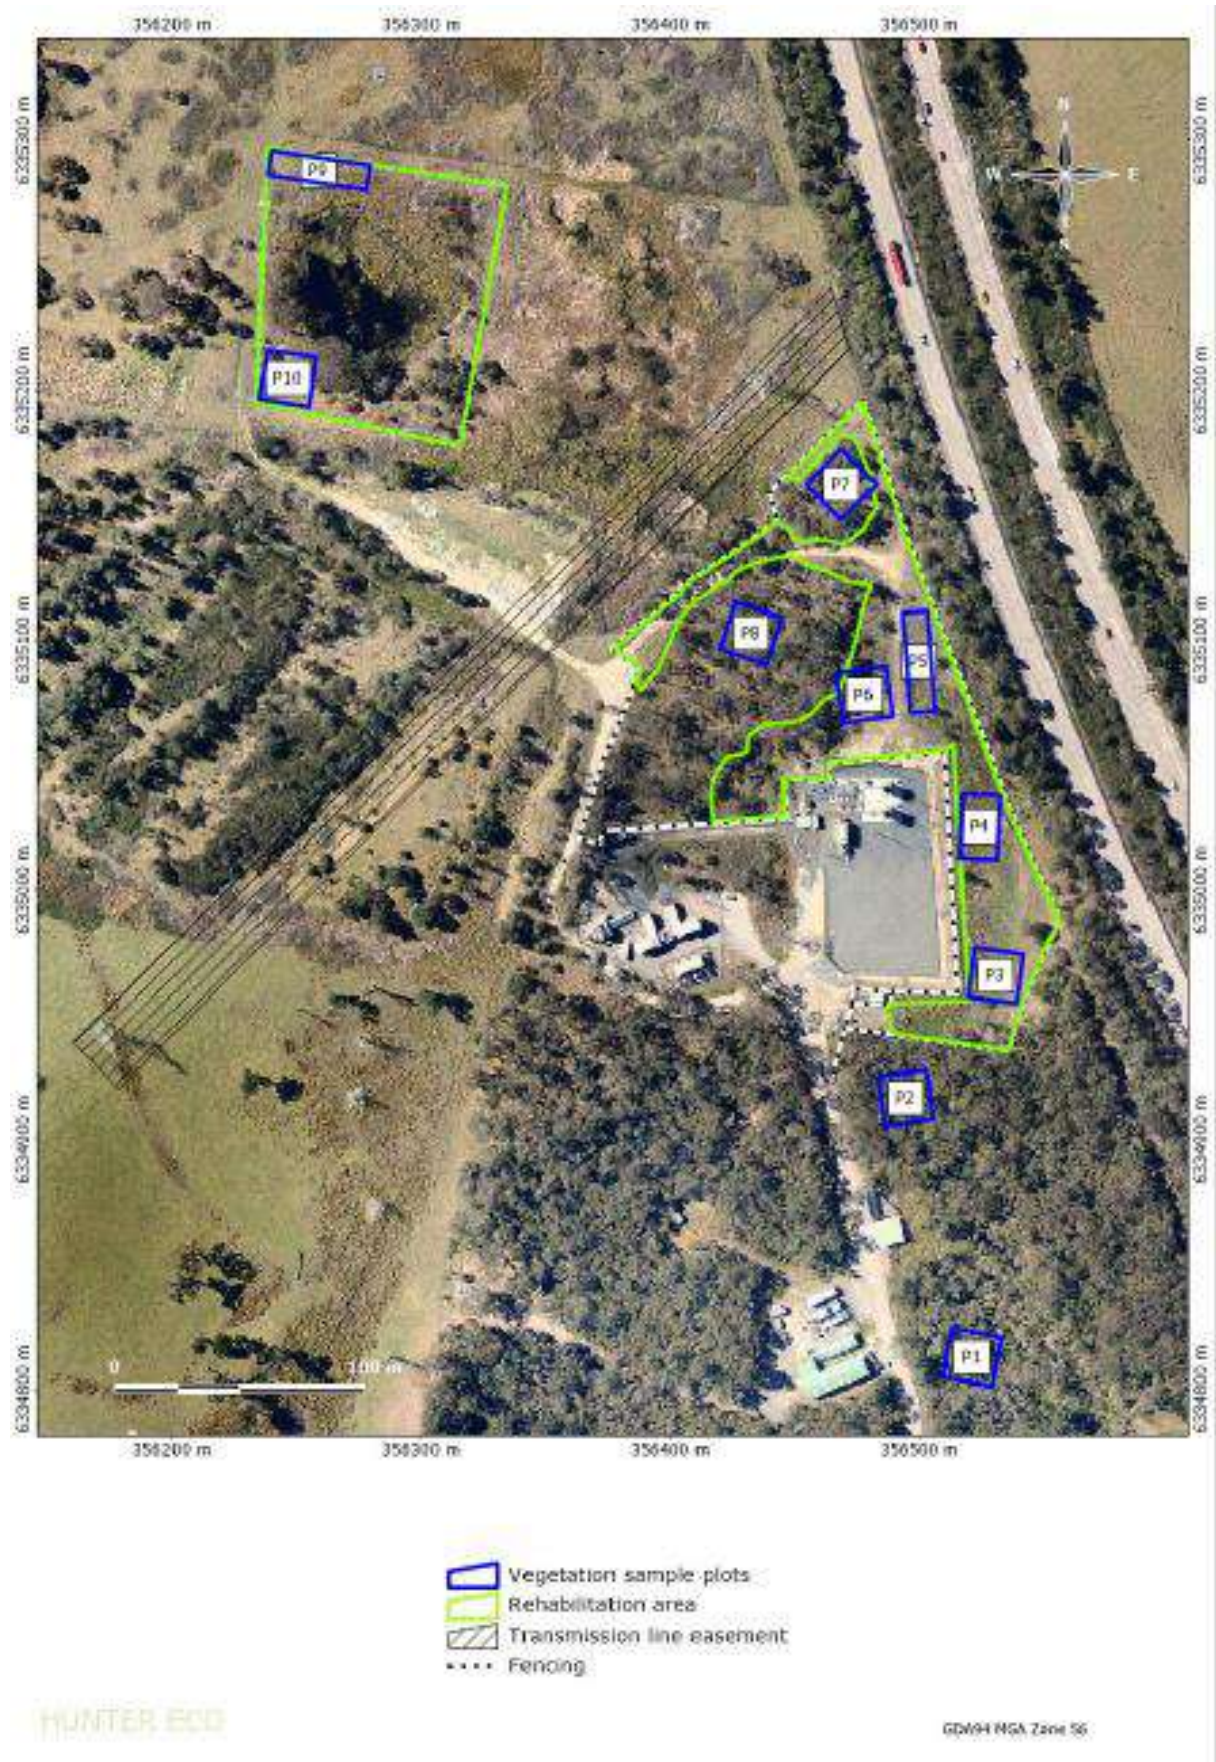
Figure 6-19: Location of Floristic Sample Plots

- the tall tussock Vasey Grass (*Paspalum urvillei*) is the most abundant weed across all reference plots;
- the high threat weed Noogoora Burr (*Xanthium occidentale*) in Plots 3, 4 and 5 needs destroying before it can fruit;
- there are a number of Tick Bush (*Kunzea ambigua*) growing inside and just outside the southern gate and should be destroyed before they can spread further inside (Hunter Eco, 2023a).
