Rehabilitation Management Plan

Broken Hill North Mine

July 2023

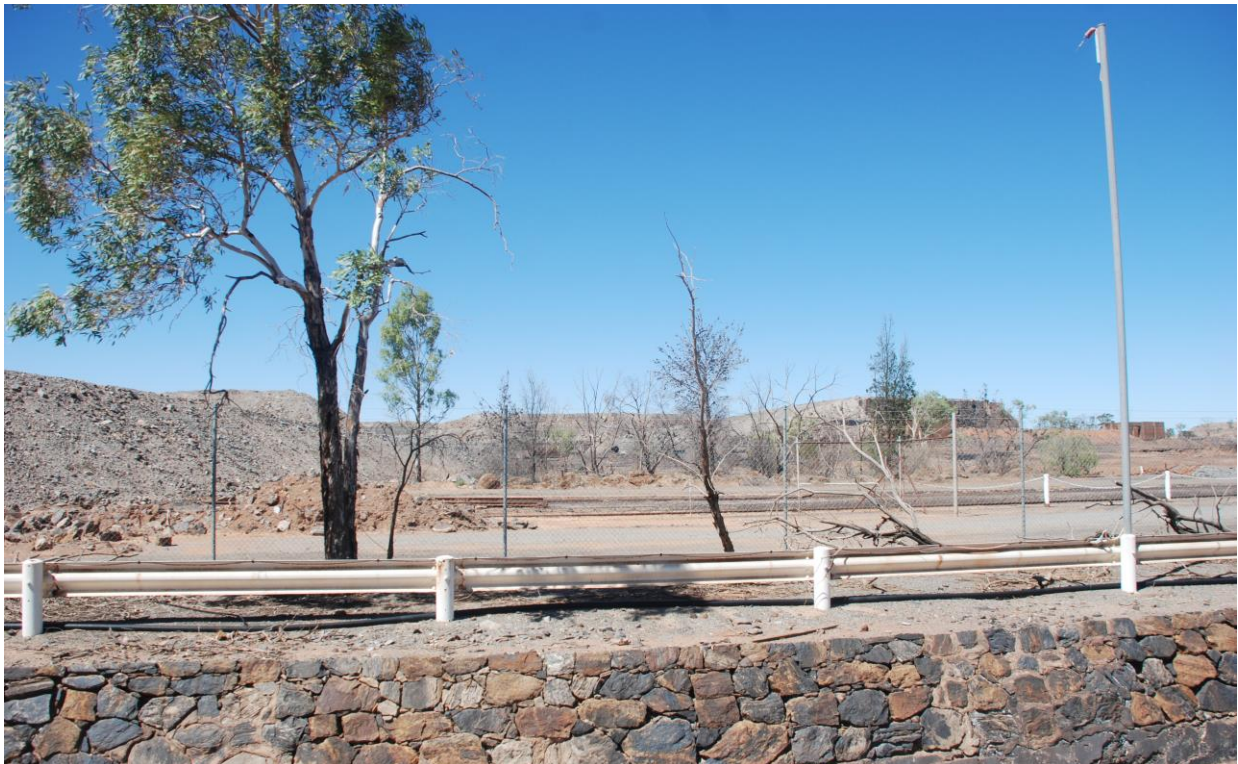
Photo date: 25 February 2021

Plate 1 Dead trees including eucalyptus and casuarina species within a previously irrigated trial section of McCulloch's Flat following multiple drought periods

irrigation systems to deliver water. Following the cessation of irrigation, drought periods and other extreme climatic conditions resulted in the mortality of most trees planted in these areas. Vegetation which has persisted in these areas is largely dominated by chenopod shrubland characteristic of remnant vegetation in the Broken Hill region.

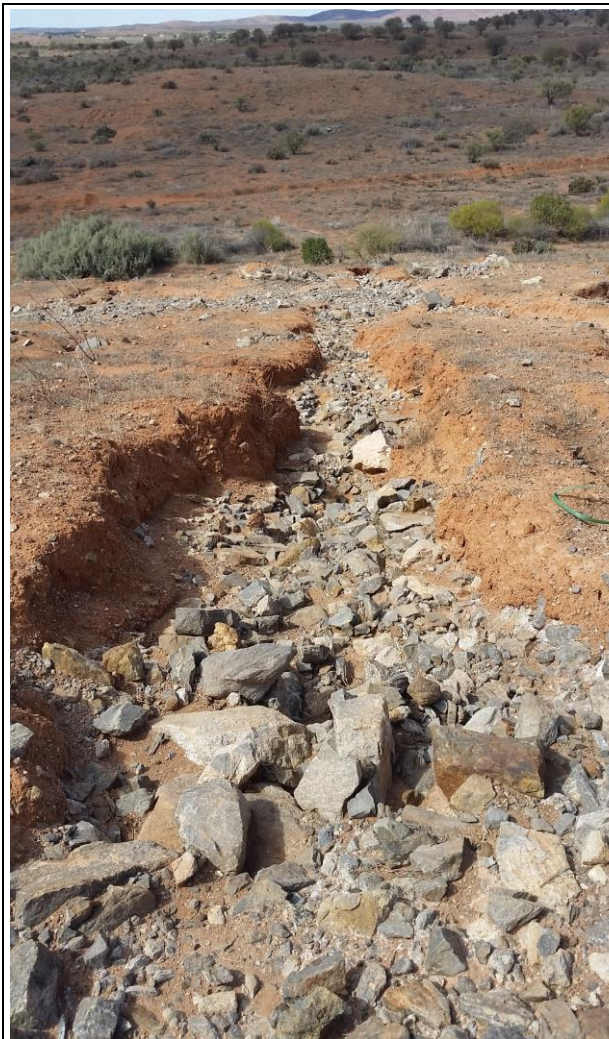
Plate 2 Erosion on the Batter of the Potosi WRE

Preliminary rehabilitation of the Waste Rock Emplacement (WRE) at the Company's Potosi Mine, including profiling of final batter slopes and the spreading of growth medium resources, was undertaken by Pasminco in 2000 prior to the acquisition of the site by the Company. Large sections of the Potosi WRE subsequently experienced substantial erosion in the form of gullying because of concentrated rainfall runoff flowing down exposed soil surfaces (**Plates 2 and 3**). In some sections of the Potosi WRE batters, erosional gullies achieved depths exceeding 450mm and exposed underlying waste rock material following the erosion of overlying subsoil and topsoil.

The depth of topsoil and subsoil resources applied to the Potosi WRE batters (i.e. up to 1m in some areas), combined with the dispersive nature of this material and the absence of vegetation, was identified as a key issue contributing to erosion of the batter surfaces. This issue was addressed by the Company in 2017 and 2018 through the removal of excessive growth medium from these surfaces and the retention of a shallower growth medium profile with a depth of between 150mm and 250mm.

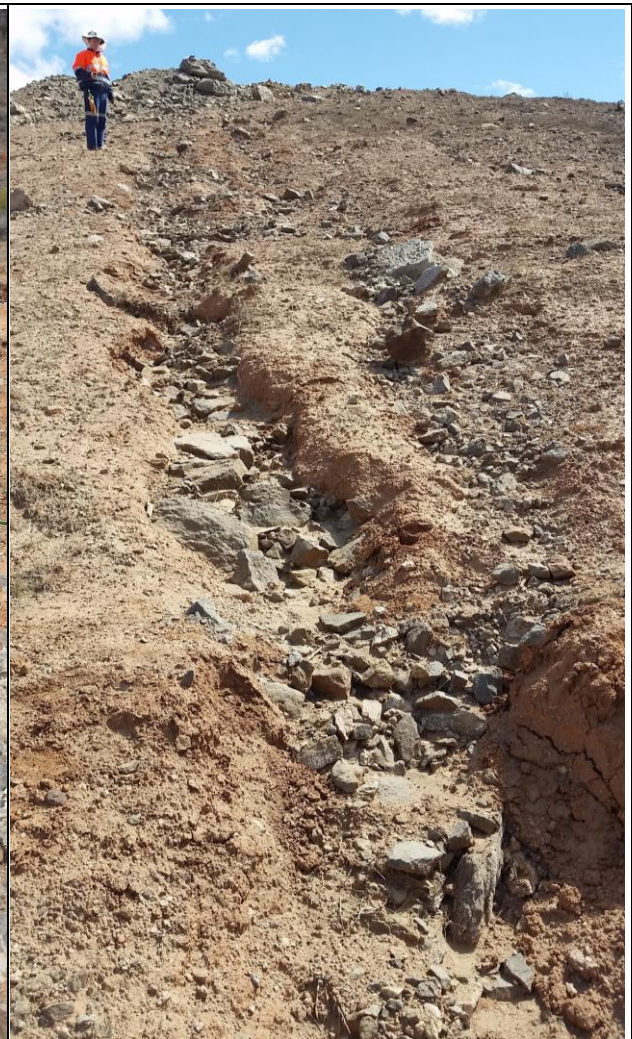
Plate 3 Erosion on the Batter of the Potosi WRE

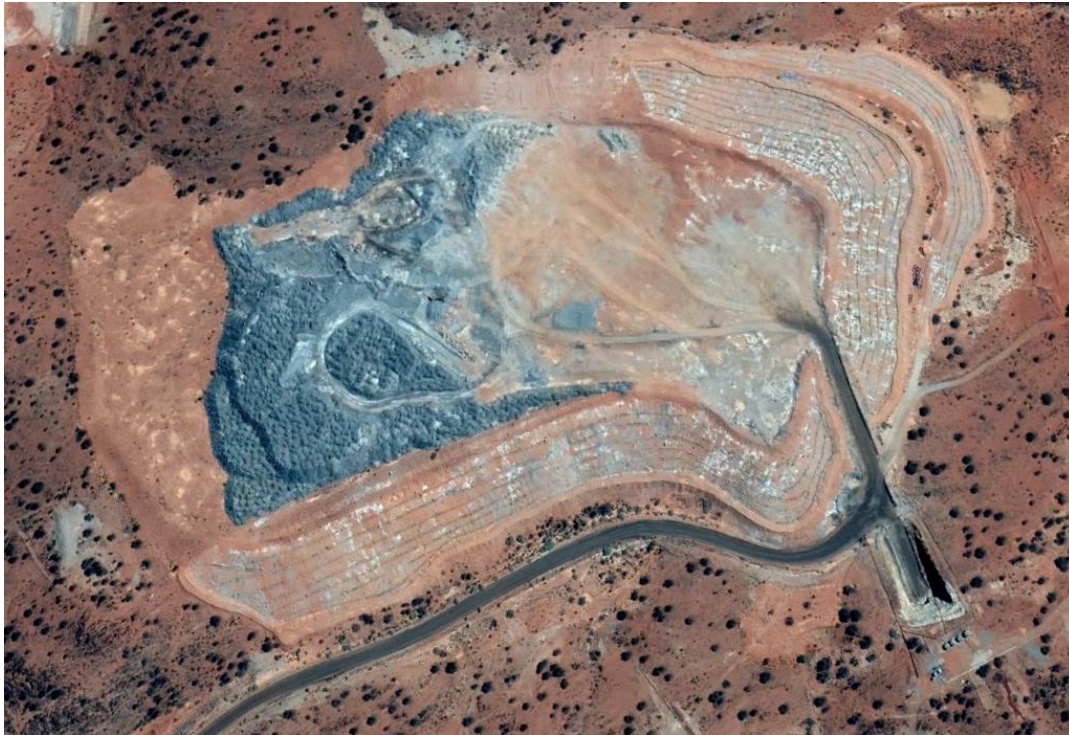
Plate 4 Aerial view of the Potosi WRE (January 2019) following reprofiling and contour ripping of batters

Additionally, the Potosi WRE batters were reprofiled and contour ripped to reduce surface water sheet flow velocity and to integrate the topsoil into the rip lines, thereby creating “run-on” zones to capture both runoff and any sediment prior to the establishment of vegetation (**Plates 4 and 5**).

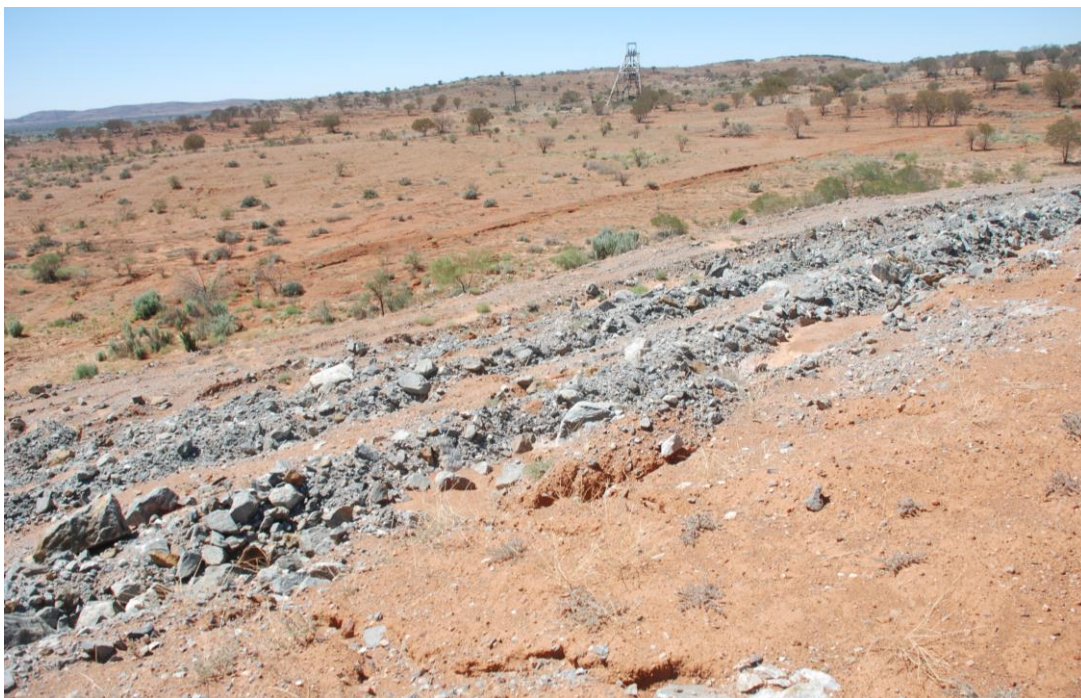
Plate 5 Contour ripping and integration of growth medium into underlying waste rock material on the eastern Potosi WRE batter

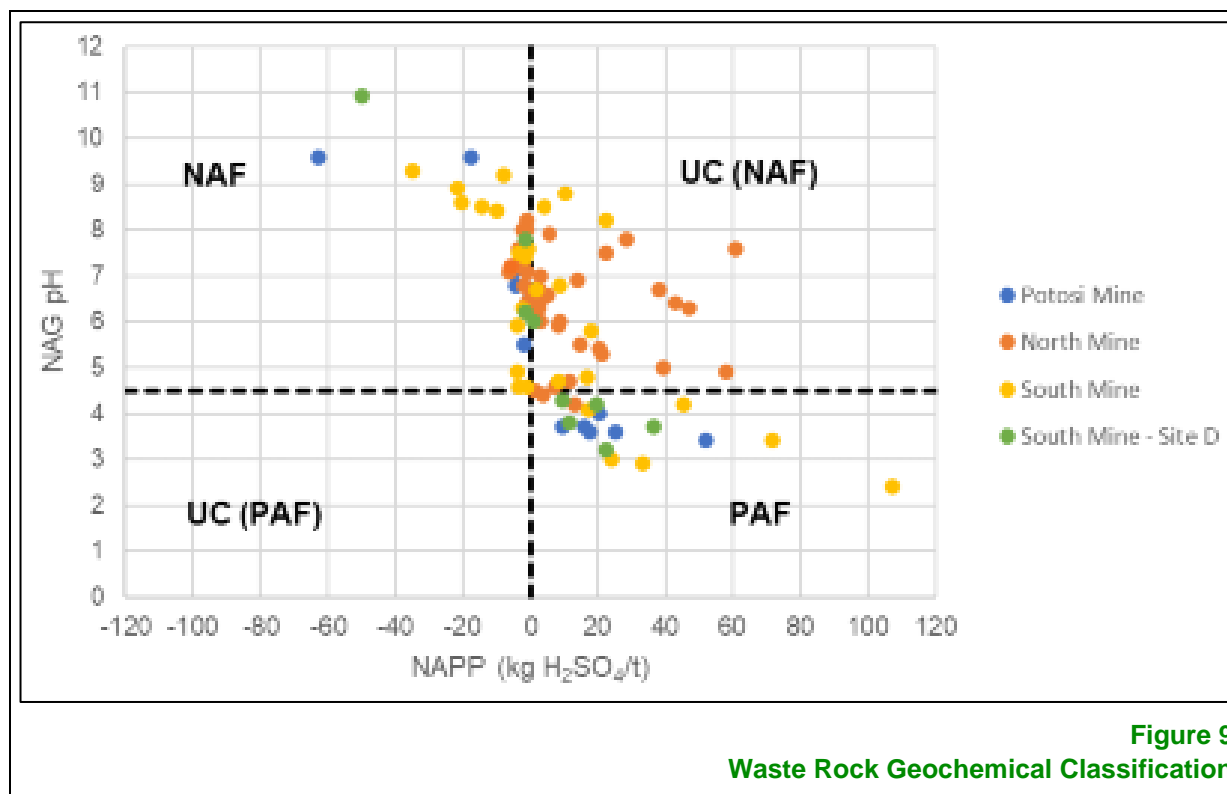
Table 12 and **Figure 9** present the results of waste rock characterisation analyses conducted for waste rock samples (samples collected did not represent final land use and included waste rock not exposed to surface conditions) at the Mine Site in 2021. In summary, the Net Acid Production Potential (NAPP) results for waste rock range between 18.1kgH₂SO₄/t and 30.5kgH₂SO₄/t and the Net Acid Generation (NAG) results for waste rock range between 5.2 pH and 6.1 pH. As such, all waste rock samples are classified as uncertain.

The results of the study found that 38 samples were classified as NAF and 19 were classed as PAF (**Table 12**). Most of the PAF classes samples had a low capacity to generate acidity (i.e. less than 5kg H₂SO₄/t). An additional 34 samples were of uncertain acid forming potential - this classification is conservative since the samples contain a large proportion of sulfate and non-acid generating sulfides which are influencing the NAPP calculation. The results of the test work indicates that there is potential for acid generation waste rock at the locations below:

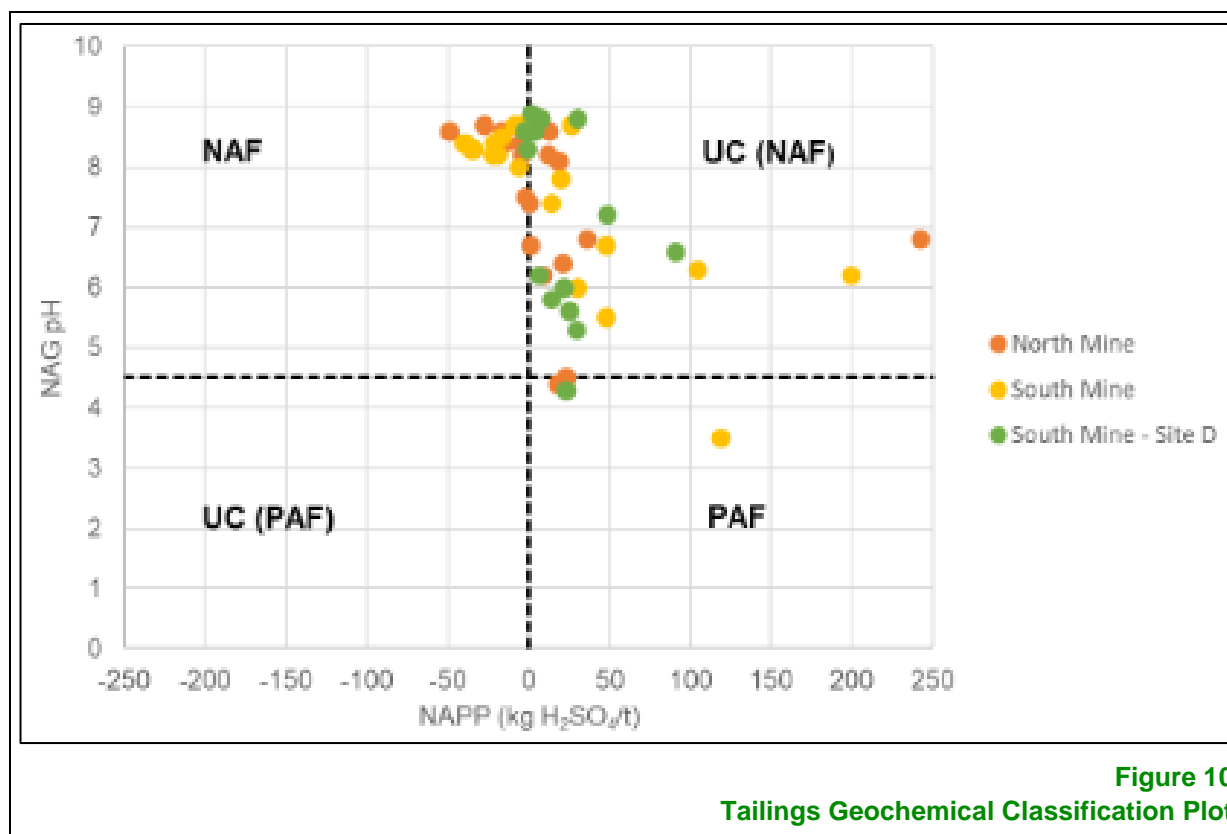
Geochemical characterisation of tailings material at the Mine Site was undertaken in September 2020 for samples collected from Site AB, Site C and Site D (Cells 1, 2 and 3) and is presented in **Tables 13** and **14** and **Figure 10**.

Of the 53 samples tested, 30 were of uncertain acid forming potential, 20 were classed as NAF, and 3 were classed as PAF (two with low capacity to generate acidity). Similar to the waste rock samples, the presence of a large proportion of sulfate and non-acid generating sulfides is influencing the NAPP calculation for the tailings samples.

The classification of the samples is summarised in **Table 14** and illustrated graphically in the geochemical classification plot in **Figure 10**. In summary:
