# **DENDROBIUM MINE AND CORDEAUX COLLIERY ANNUAL REVIEW FY23**

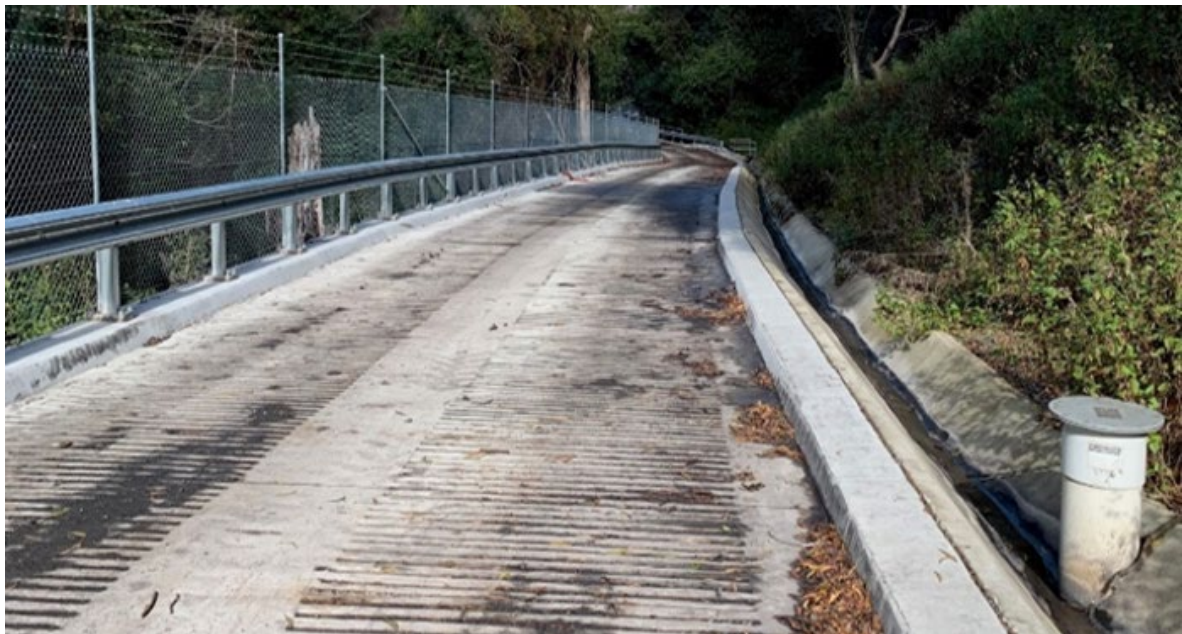
**Plate 1: Lower Portal Road Upgrade**

The construction works for the Lower Portal Road were completed during FY23 (Plate 1). This allows additional access in the event of an emergency requiring the use of the secondary roadway and also for repair works to be undertaken on the Upper Portal Road.

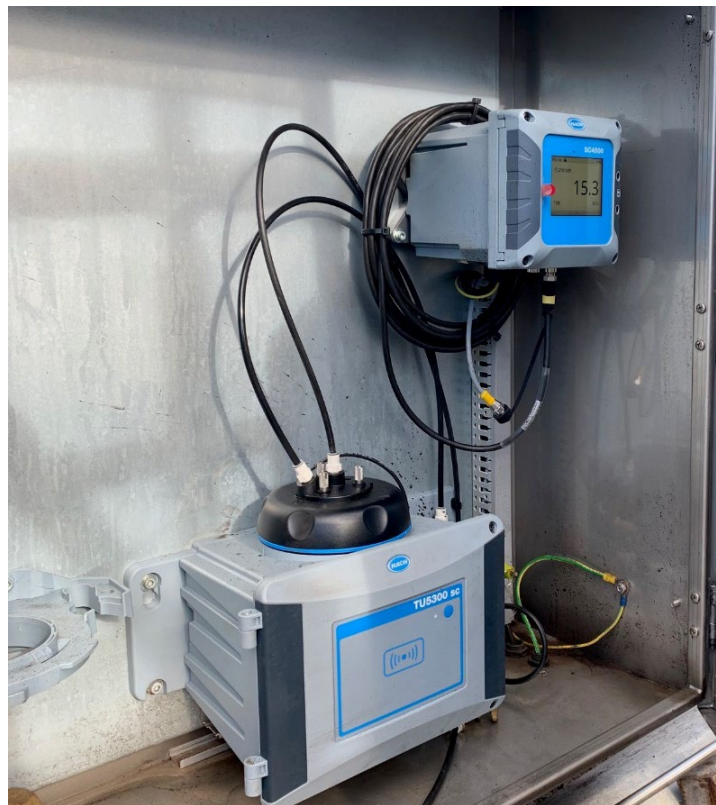
**Plate 2: New Turbidity Sensor – KVCLF**

A turbidity sensor, as shown in Plate 2, was installed as part of this project at the KVT and connected to the SCADA system to constantly monitor the water quality being discharged and actively identify potential issues. Some minor amendments are required to the SCADA/alarming system during FY24.

During FY23, flowmeters were installed on the Dendrobium dewatering pipeline at LDP 5 and at the KVT. The aim of this project is to provide leak detection via flow reconciliation for the pipeline in the event of a pipeline leakage or failure. Alarms are also provided via the SCADA system to automatically alert mine staff to potential issues.

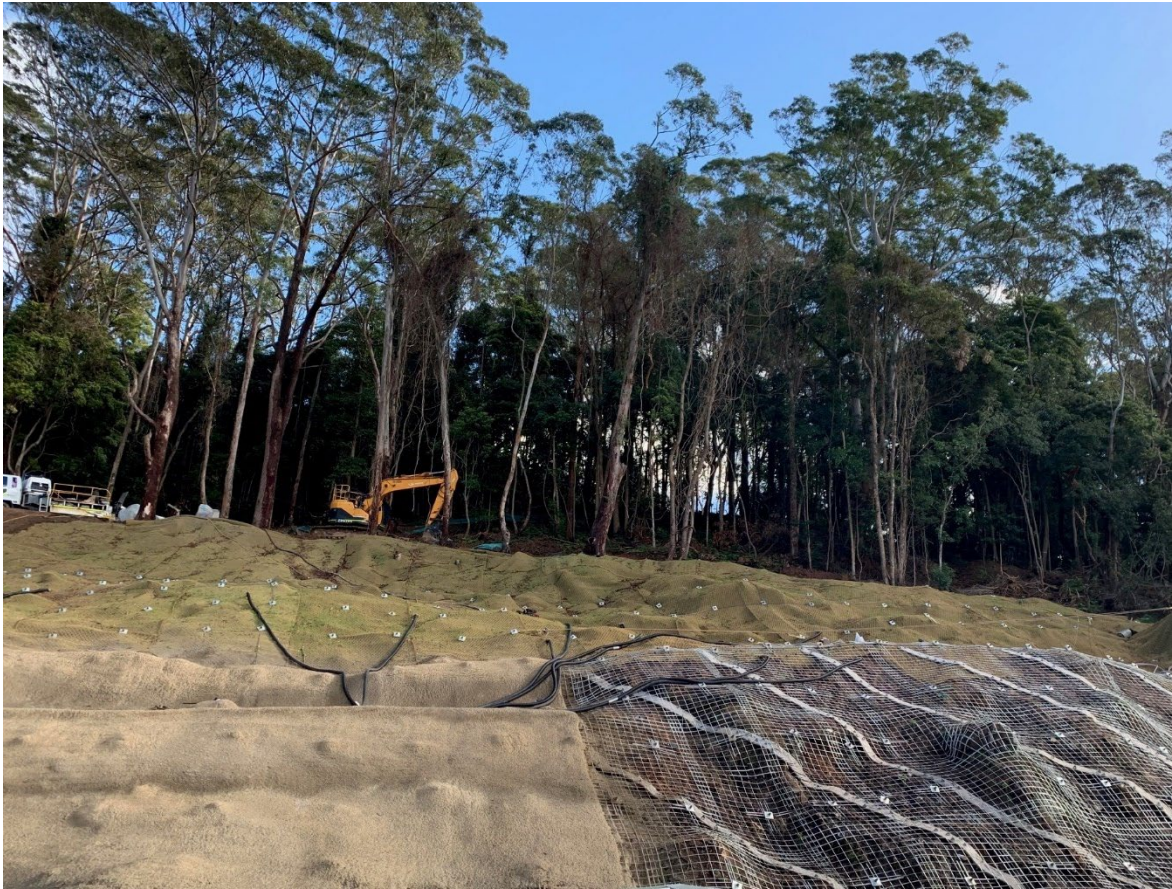
**Plate 3: Slope Remediation Works - Dendrobium Pit Top**

A specialist engineering consultant was engaged to prepare a design to remediate the slope using soil nails, shotcrete and soil reinforcing mesh (see Plate 3). A specialist contractor commenced works in FY23, with completion due in FY24.

As a result of excessive rainfall throughout FY22, a significant landslip occurred on the western boundary of the site adjacent to the Operations Building. Damage was observed to the personnel transport shelter and bathhouse infrastructure due to soil movement and falling trees.

An engineering consultancy was engaged to provide a permanent repair solution utilising soil nails, shotcrete and “Greenax” mesh that avoided undercutting the unstable material and will allow vegetation to re-establish. Works commenced in FY23, with completion due in FY24.

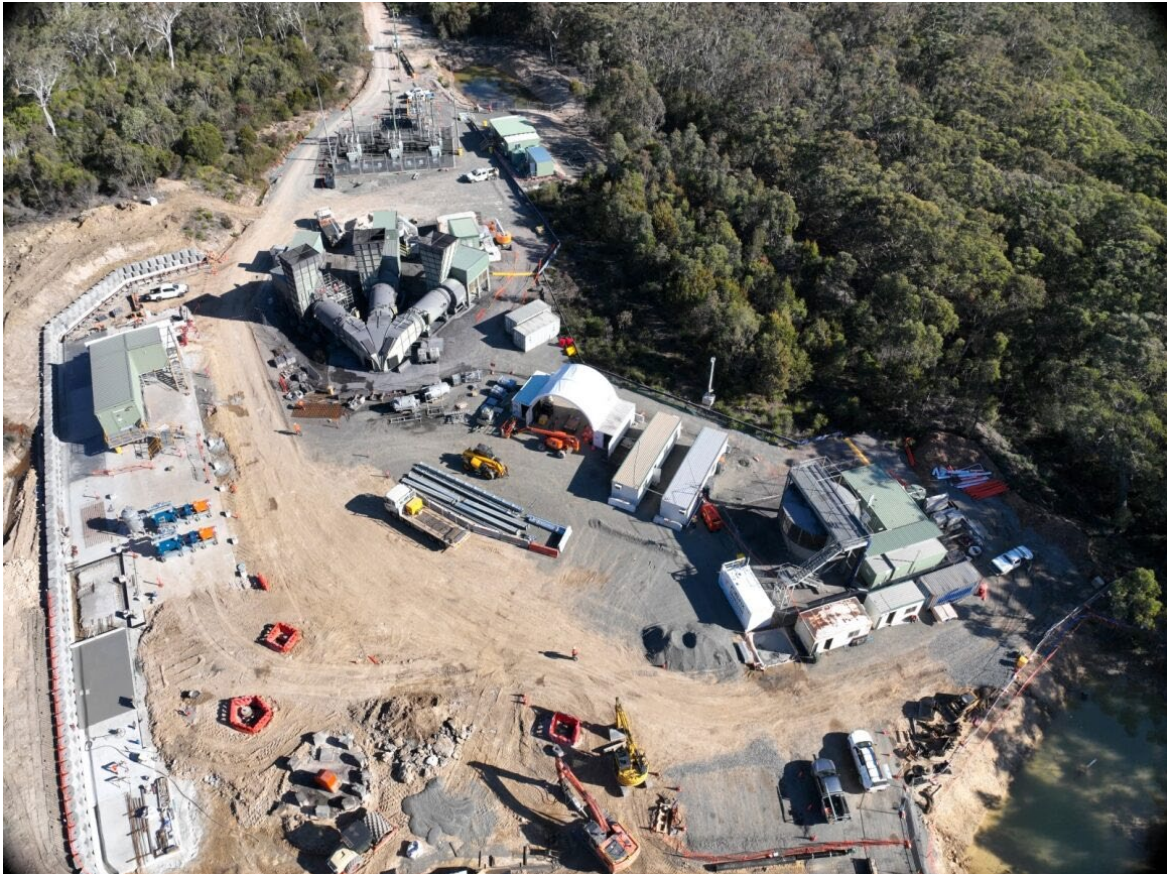
**Plate 4: Gas Management Infrastructure Progress - July 2023**

Works on the Area 3C gas management infrastructure commenced in FY23, with completion due in FY24. The infrastructure is required for drainage of gas from Area 3C. Works were delayed due to rainfall in FY22 and early FY23, and a temporary plant is required to be installed prior to completion of permanent infrastructure. Once the permanent works have been completed, the disturbed areas of the site without infrastructure will be rehabilitated. Progress as of July 2023 is shown in Plate 4.

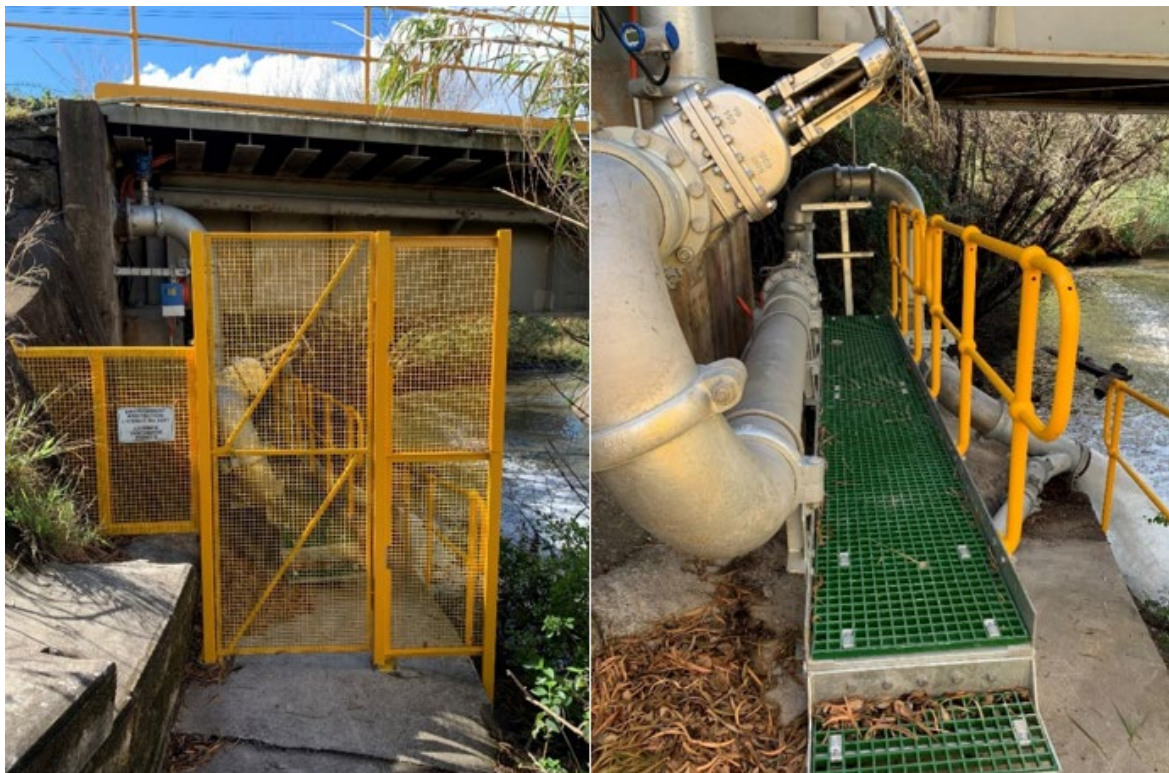
**Plate 5: LDP 5 access gate (left) and walkway (right)**

Work was completed during FY23 on the installation of a walkway and formalised sample points at LDP 5 to improve safety during sampling activities, along with a hydraulically efficient mixer for brine discharge from the Appin North and Appin West Water Treatment Plants (WTPs). These works are shown in Plate 5.

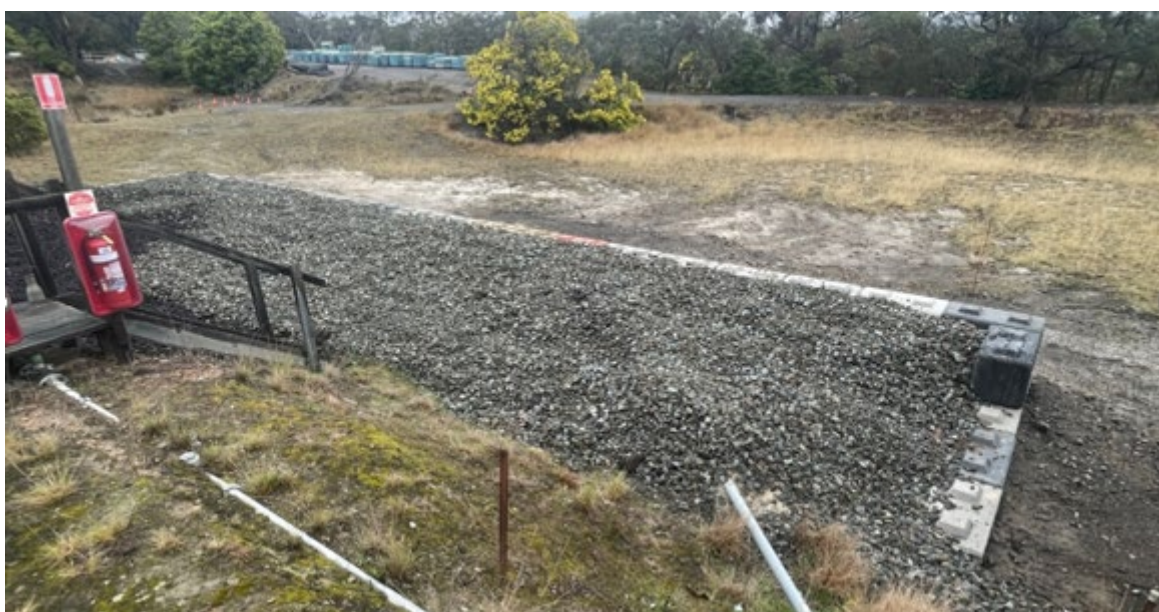
**Plate 6: New retaining wall behind Primary Separation Lagoon at Cordeaux Colliery**

Repairs were also undertaken to the retaining wall behind the Primary Separation Lagoon (Plate 6). The work reinforces the ground behind the dam wall and provides structural support to water and sewage pipes that pass behind the dam wall.

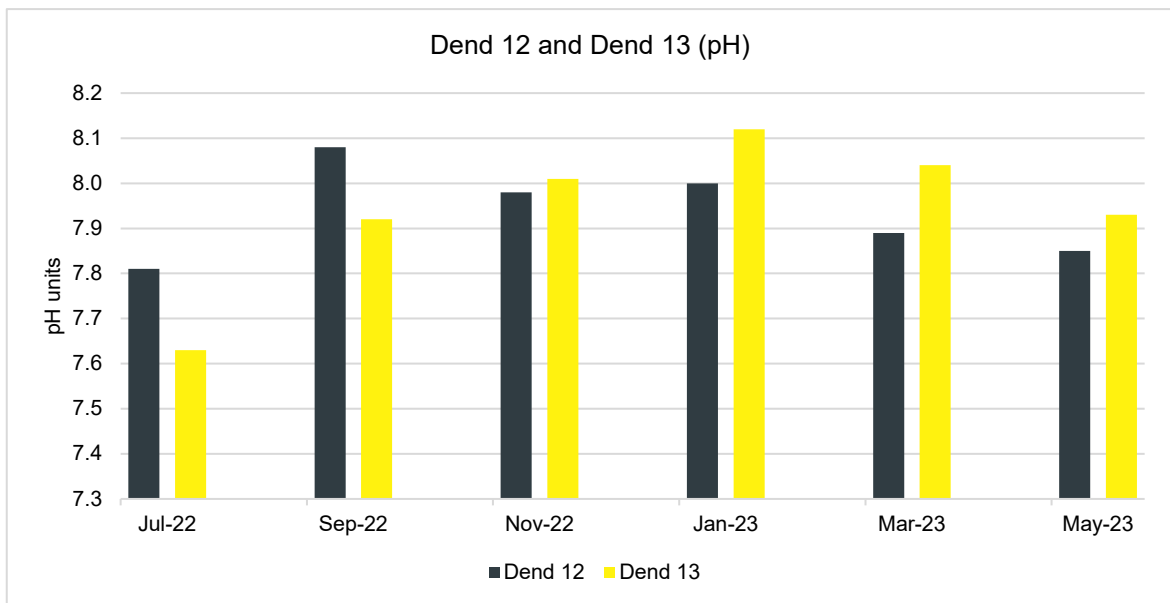
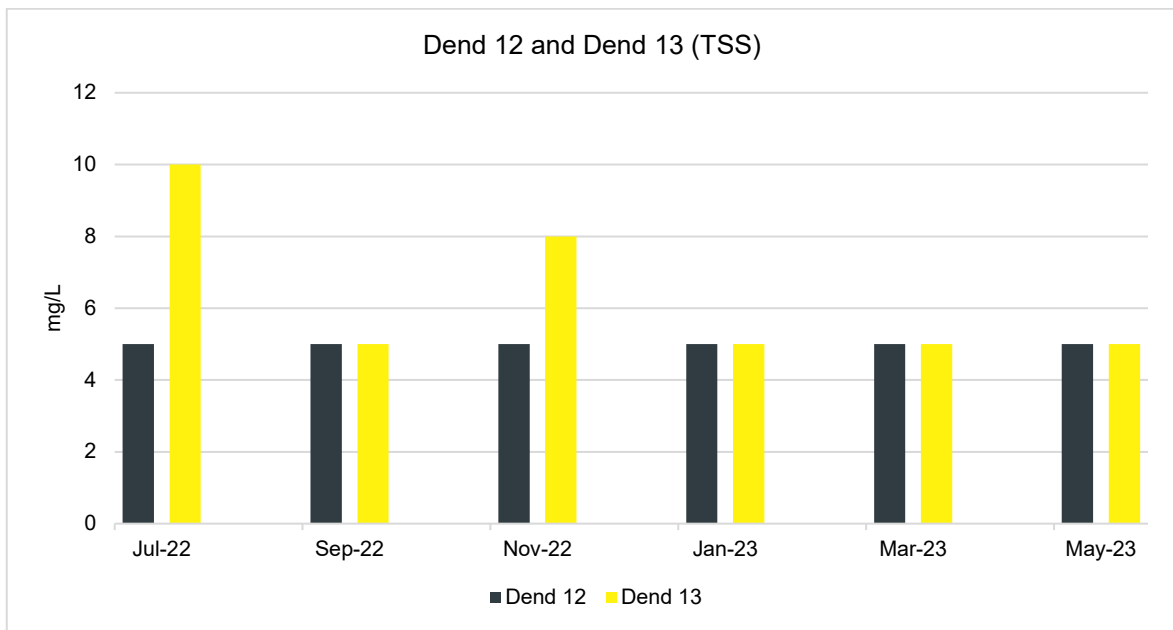
A comparison of the water quality results from Dend 12 (upstream of Pit Top) and Dend 13 (downstream of Pit Top) indicate that there is no significant variation in TSS, oil and grease levels, or pH. The results are summarised in Table 18 and Table 19. Trends for pH, EC and TSS for FY23 are shown in Figure 6, Figure 7 and Figure 8 respectively. Overall trends show water quality has been stable in relation to the Dendrobium Pit Top site. Graphs depicting long-term trends in water quality are provided in Appendix 5.

**Figure 6: Dend 12 and Dend 13 Results FY23 – pH**

**Figure 7: Dend 12 and Dend 13 Results FY23 – EC**

**Figure 8: Dend 12 and Dend 13 Results FY23 – TSS**

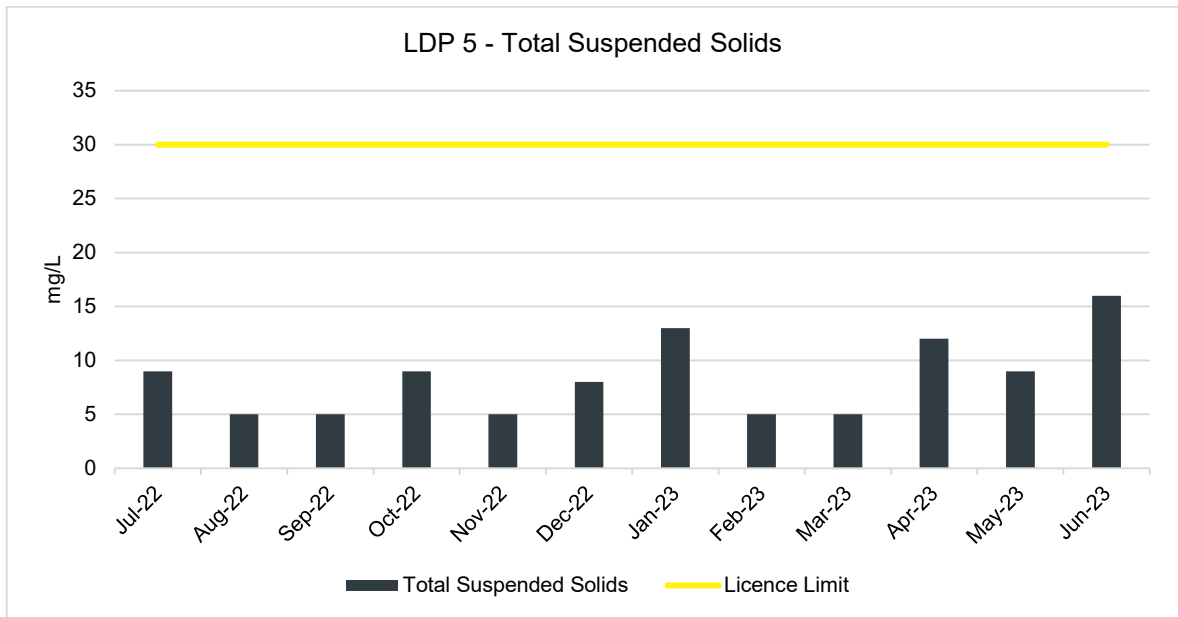
A summary of monitoring results for the reporting period against the water quality concentration limits in EPL 3241 is provided in Table 20. The reporting period saw no non-compliances recorded against the EPL water quality concentration limits during the monthly compliance monitoring and is in line with trends from previous reporting periods. The general trends for LDP 5 remained relatively consistent for FY23 as shown in Figure 9 and Figure 10.

Figure 9: LDP 5 - pH (FY23)

Figure 10: LDP 5 - TSS (FY23)

Long-term average trends have shown generally stable results within limits. A noticeable increase in zinc concentrations has been observed due to increased sampling during periods of brine discharge. Elevated EC is recorded when brine is being discharged at the time the sample is collected. An increase in TSS is likely as a result of the change in dewatering from the old Kemira workings to the NWM D2 pump station being pumped directly to LDP 5. Graphs depicting trends in water quality over previous years is provided in Appendix 5.

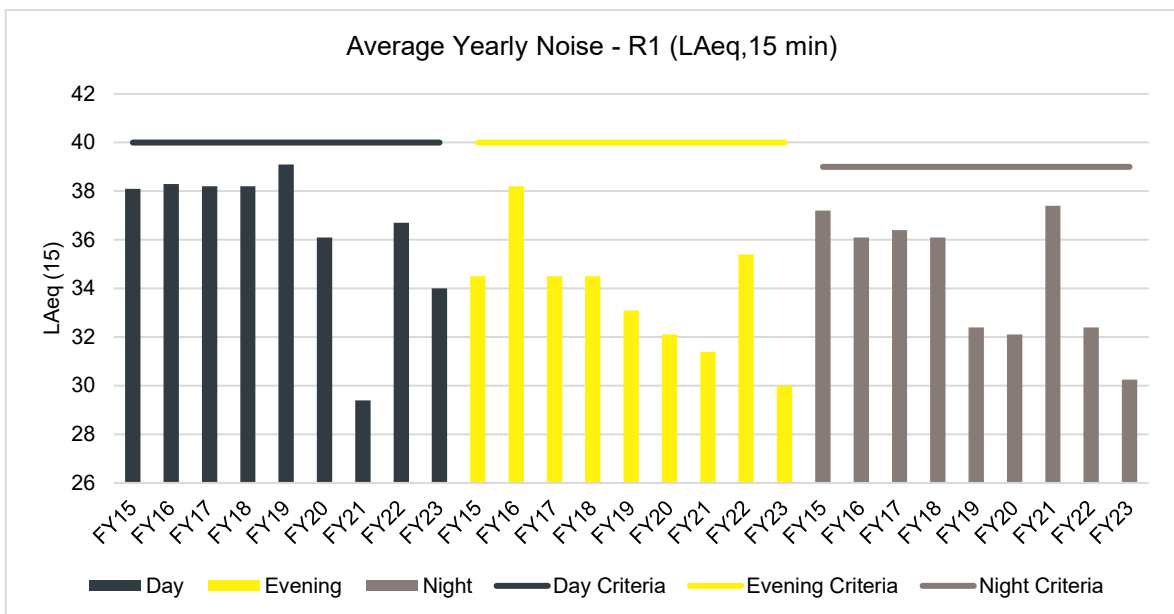
R1 is located to the north of the Pit Top. Representative LA<sub>eq,15min</sub> noise results did not exceed the noise criteria during the reporting period. The LA<sub>eq,15-min</sub> representative noise results for R1 for FY23 are provided in Figure 13 and annual averages are provided in Figure 14.

**Figure 13: Site R1 Noise Compliance (LA<sub>eq,15 min</sub>) – FY23**

**Figure 14: Site R1 Noise Compliance (LA<sub>eq,15 min</sub>) – FY15 to FY23**

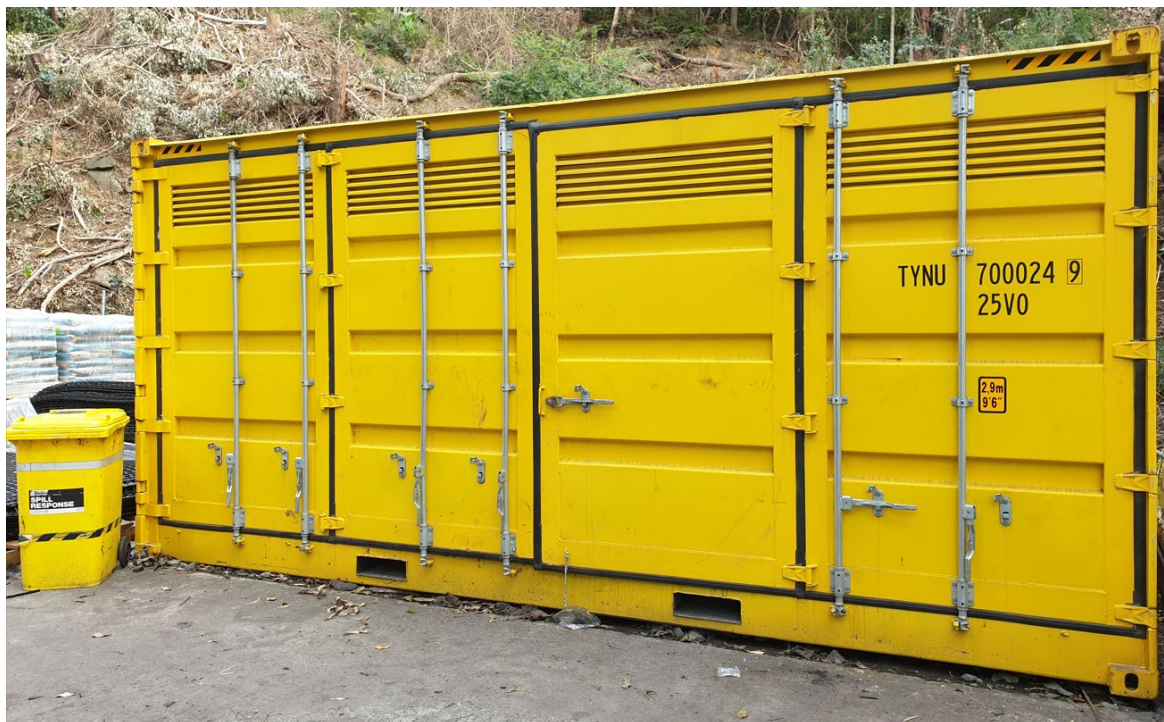
**Plate 8: Hydrocarbon Storage Container**

In this reporting period, a second self-bunded hydrocarbon storage container (as shown in Plate 8) was installed along the Portal Road.

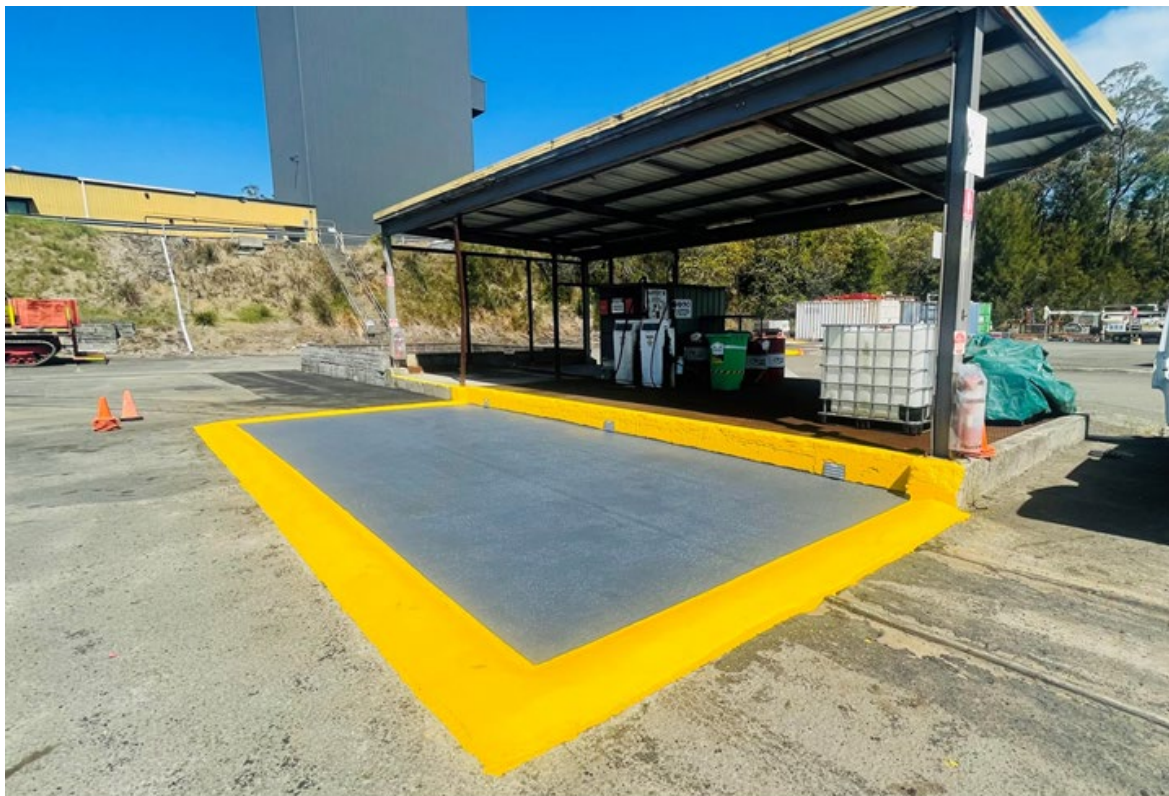
**Plate 9: Newly constructed bunding of diesel filling point, Cordeaux Colliery**

During the reporting period a bund was installed around the diesel filling point (Plate 9). This serves to contain any spills while filling vehicles and tanks and direct them to the large undercover bund directly adjacent to the filling point. From here contaminated liquid can be removed from the dedicated sump.

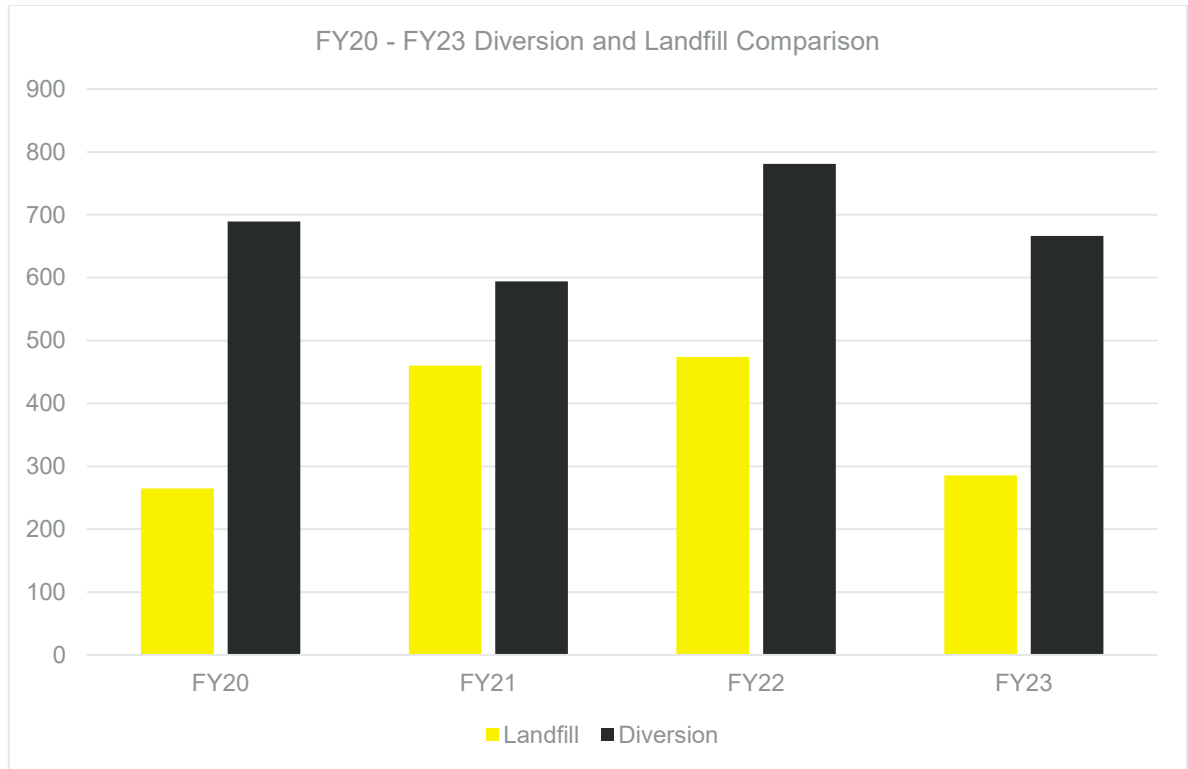
facility is an alternative end-of-life treatment and final disposal of products opportunity. Approximately 77% of total waste was recycled off-site during the reporting period. Waste to landfill has reduced largely due to the reduced use of particulate filters (see Figure 23).

**Figure 23: Recycled and landfill waste streams for FY20 - FY23**

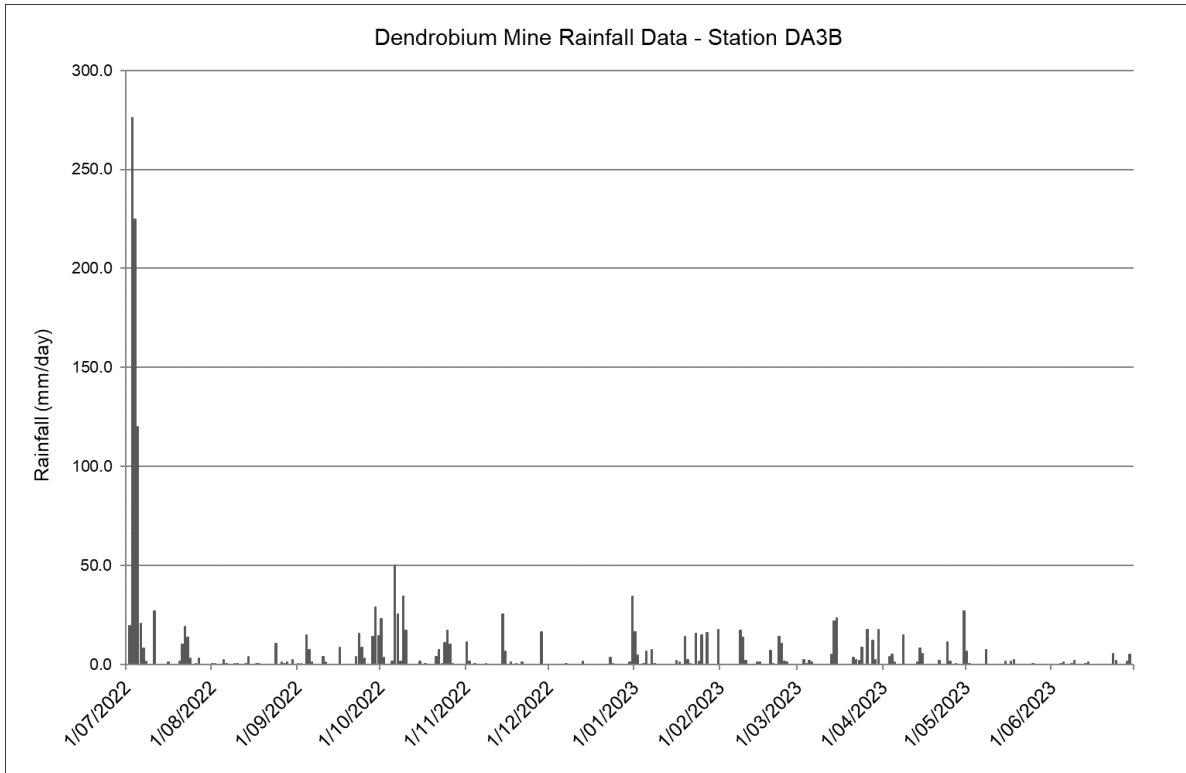
Rainfall recorded in the Dendrobium Mine area at the DA3B weather station during the reporting period was 1652 mm, a decrease when compared to the previous reporting period in which 2274.5 mm rainfall was recorded. Most of FY23 experienced below average rainfall, with the exception of the first week of July which recorded 40% of the annual rainfall total for FY23. Daily rainfall for the weather station at DA3B is displayed in Figure 26. Annual rainfall data for FY11 to FY23 is displayed in Figure 27.

**Figure 26: Dendrobium daily rainfall data for FY23**

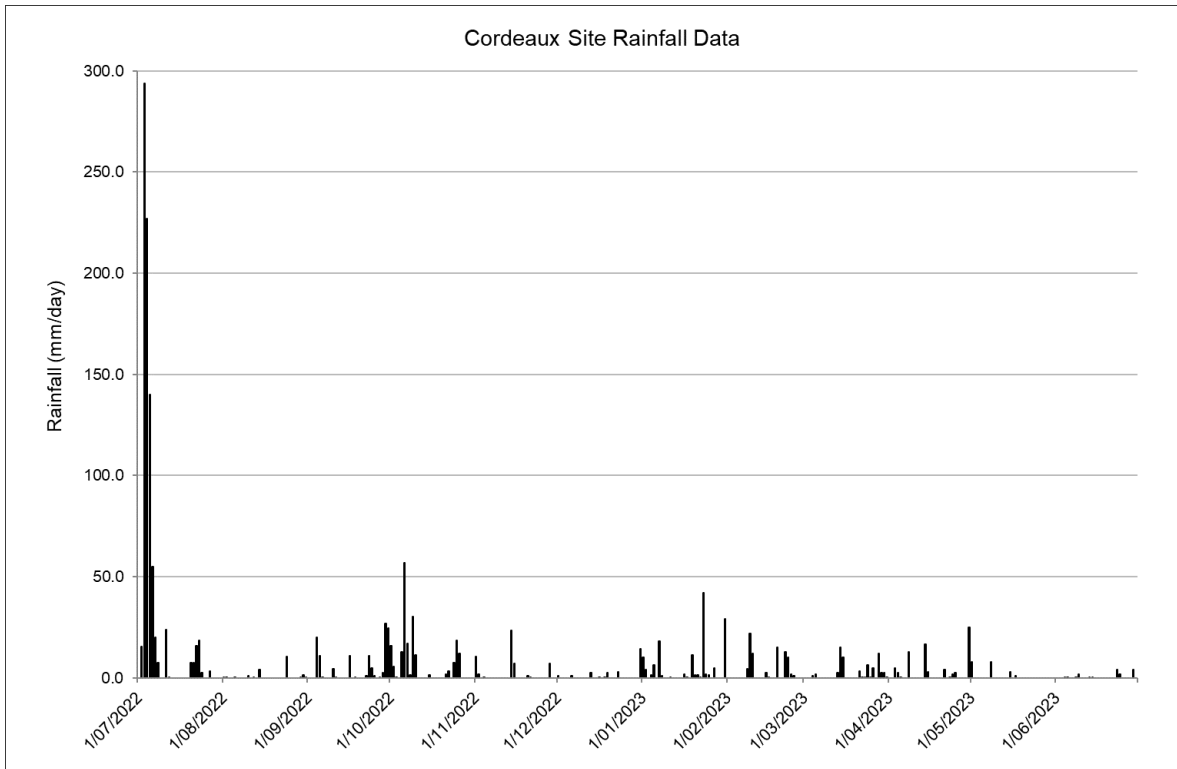
Rainfall for the Cordeaux surface facilities is recorded on a daily basis from a rainfall gauge located at the Cordeaux Colliery Pit Top. The Cordeaux site received a total of 1649 mm of rainfall during the reporting period, which was a decrease from the previous reporting period (1962 mm). Low rainfall was recorded for most of the reporting period with the exception of the first week of July, which recorded 46% of the annual rainfall total for FY23. Annual rainfall recorded at the Cordeaux Colliery rain gauge is displayed in Figure 28. Figure 29 shows the annual total rainfall recorded for FY11 to FY23.

**Figure 28: Cordeaux FY23 daily rainfall - site rain gauge**

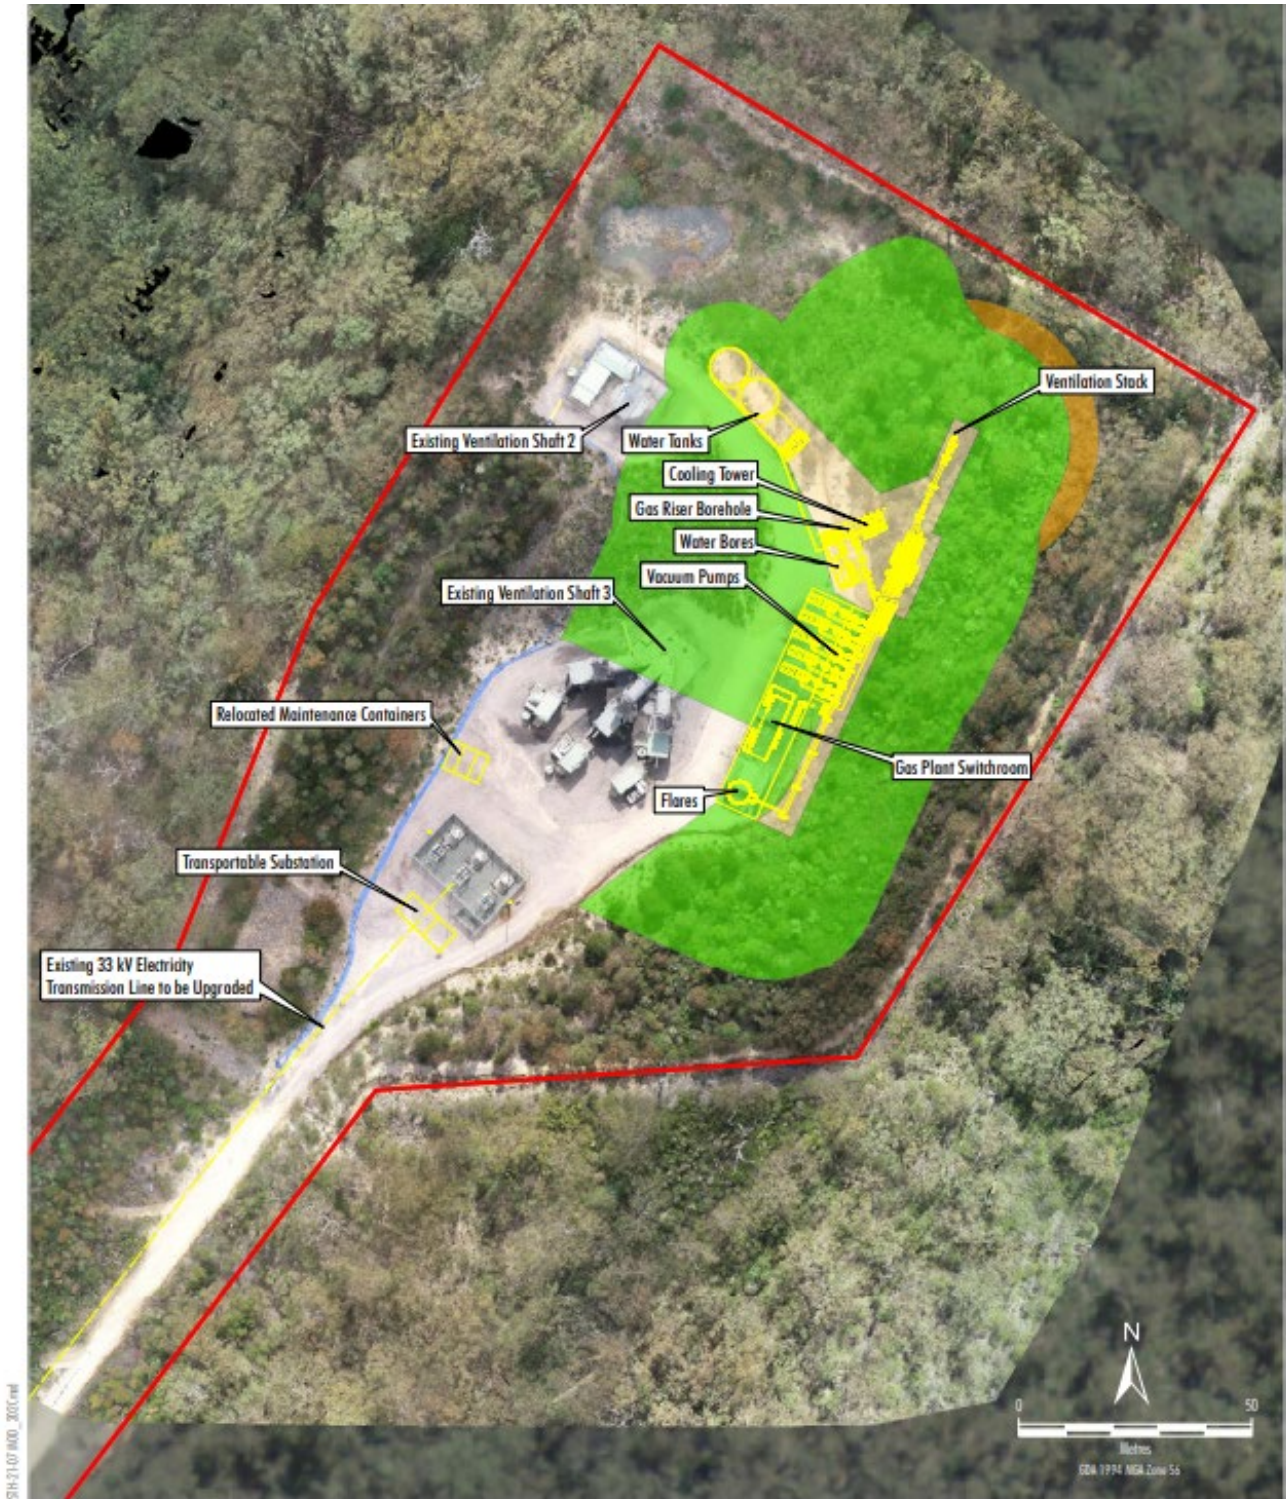
### Plan 7: Site Layout – Proposed Gas Management Infrastructure

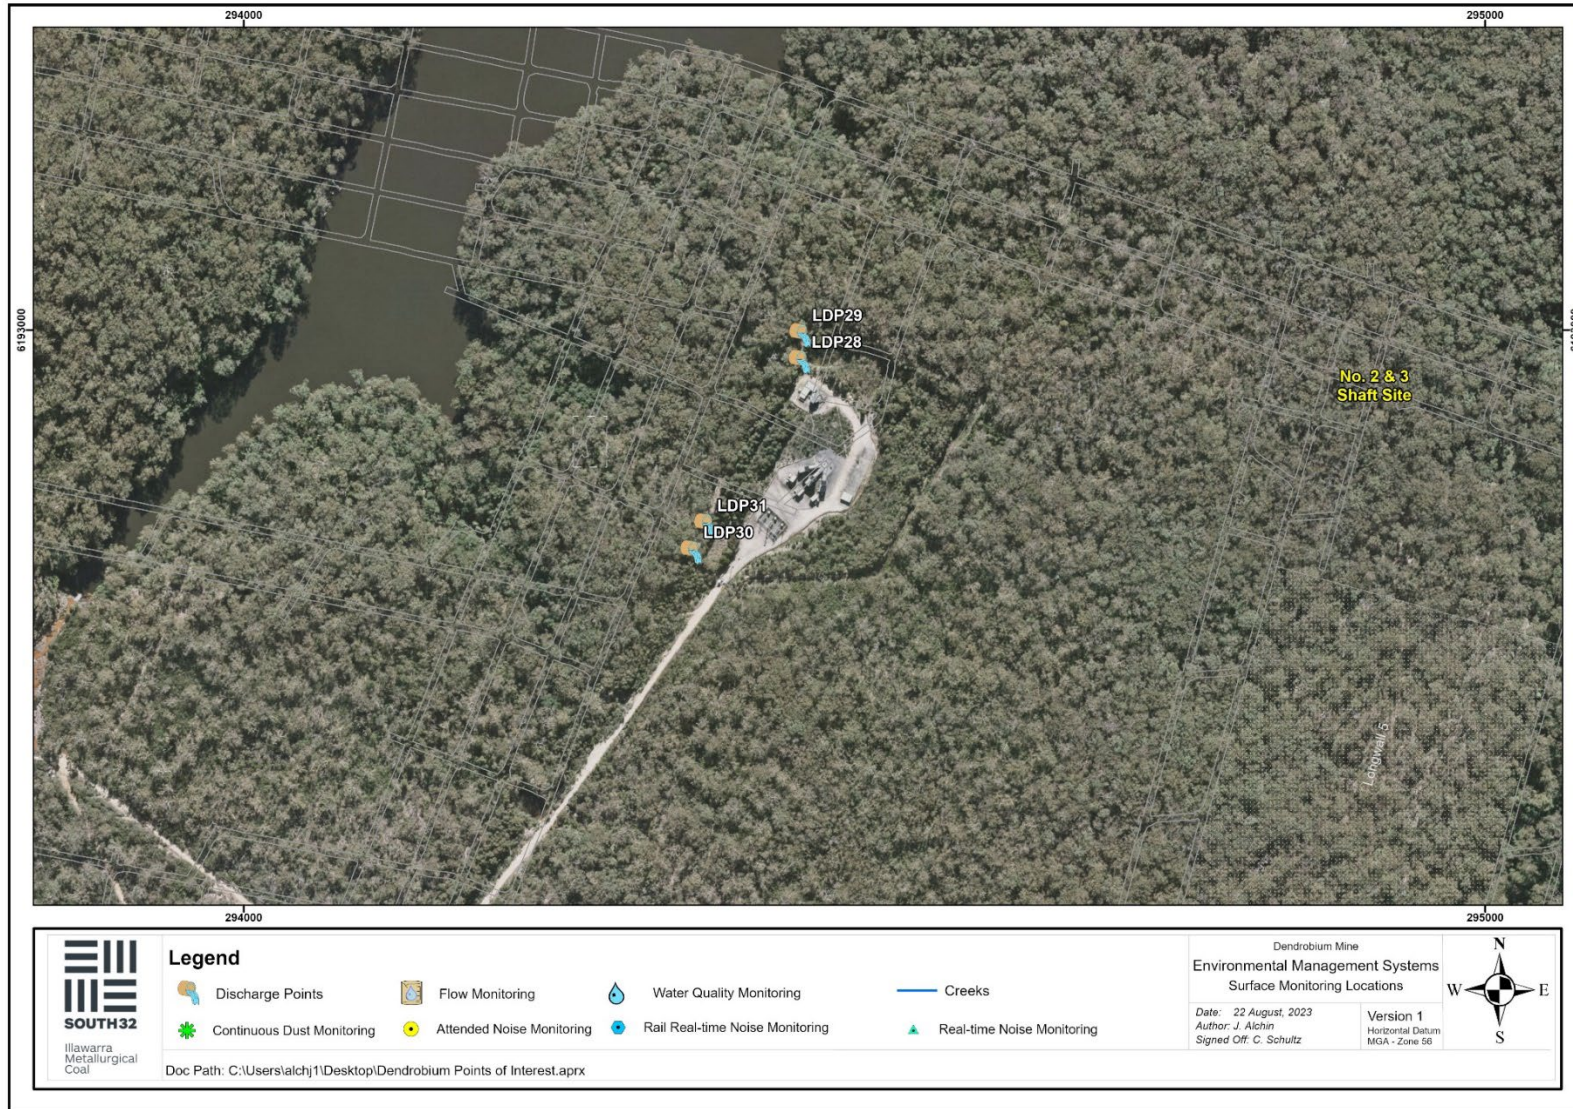
### Plan 10: Monitoring Locations – Ventilation Shaft 2/3

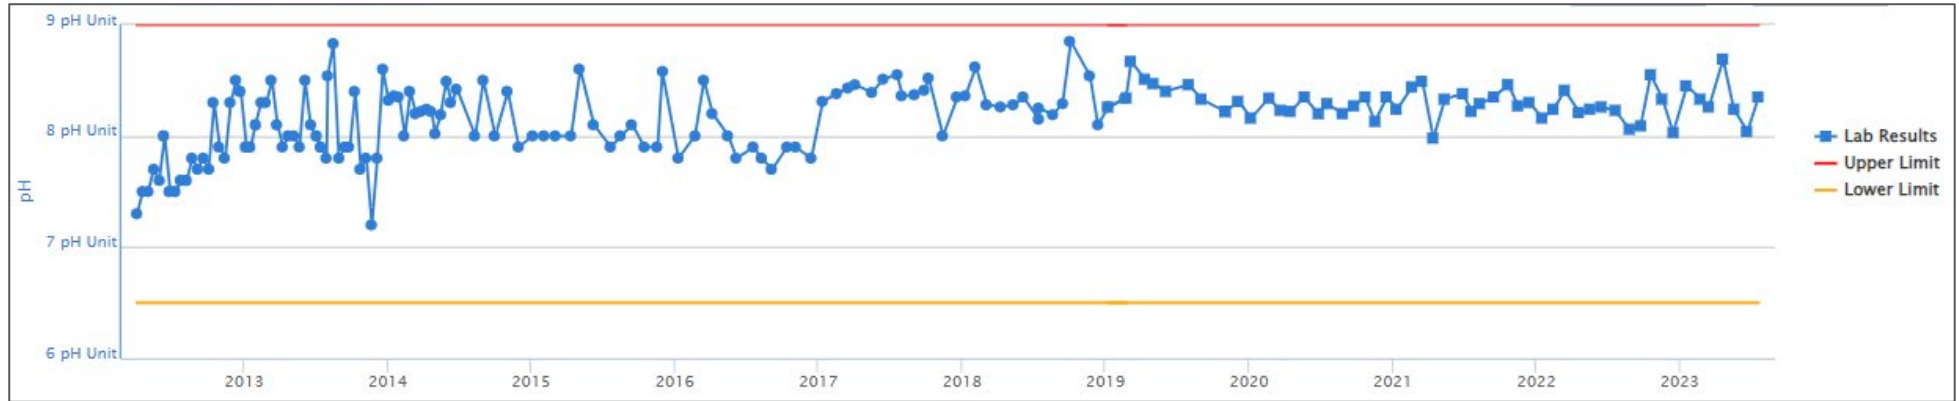
### pH

## LDP 5

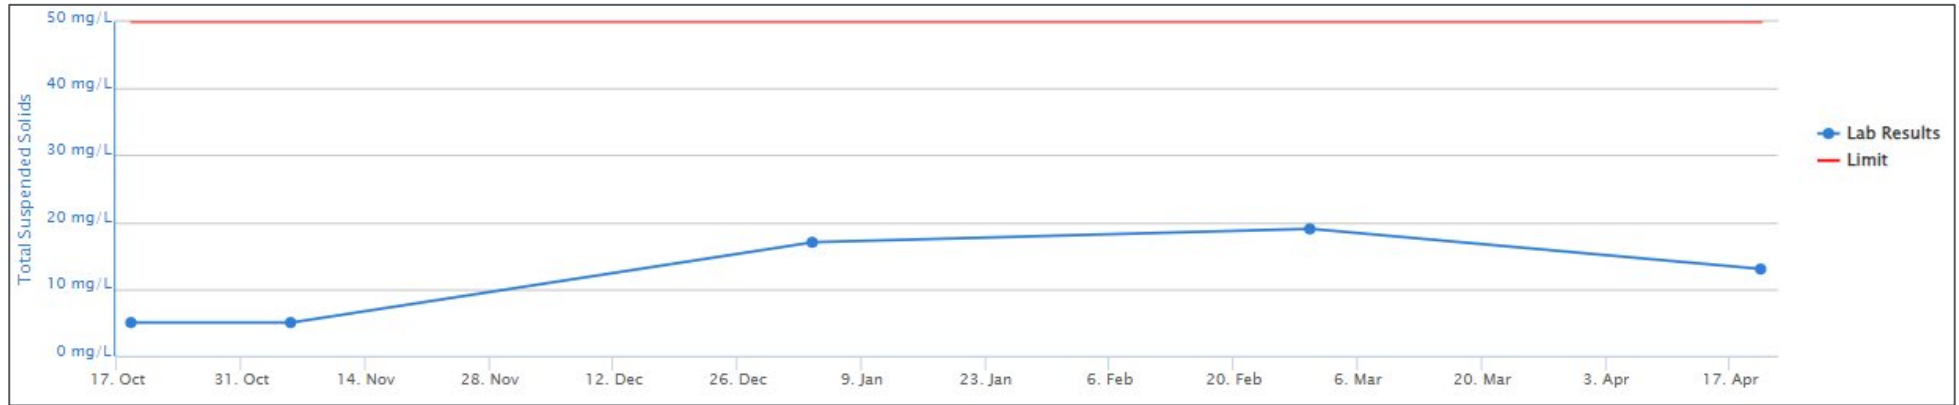
### Total Suspended Solids

## LDP 31
