**BULGA
COAL**

ANNUAL REVIEW

1 January – 31 December 2023

Prepared by
Umwelt (Australia) Pty Limited
on behalf of
Bulga Coal Pty Ltd

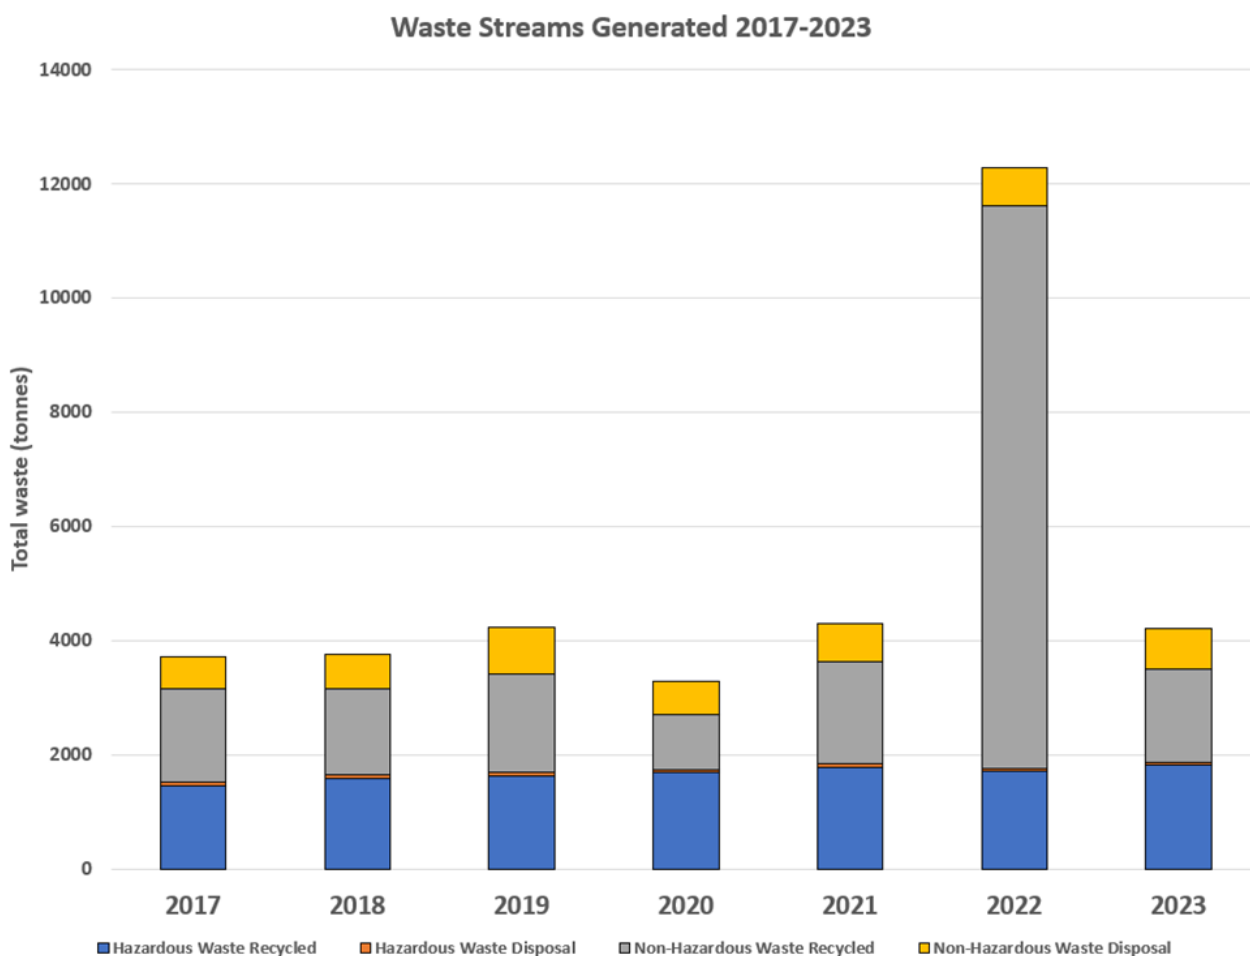
Figure 4.2 2018 – 2023 Waste Streams Generated

A summary of waste disposal from 2017 to 2023 is presented in **Figure 4.2**. The figure shows non-hazardous waste recycled has fluctuated significantly between 2021 to 2023. The changes in volumes and recycled material reflect the staged decommissioning of the underground laydown areas and dragline decommissioning (8,949 t) during 2022.

Bulga Coal produced 4,211 t of waste during 2023, which represents a substantial decrease from previous years (12,295 t in 2022). The main cause of this variation has been the completion of the dragline demolition and recycling of Bulga Underground Operations equipment (8,949 t) in 2022. Scrapping and offsite disposal of redundant underground equipment continued during 2023, with lower volumes (686 t) compared to 2022. As much as was practical equipment and parts have been sold for reuse. 82.3 % of the waste produced by Bulga Coal (3,465 t) was recycled. 1,389 t of scrap steel was recycled during the reporting period. Bulga generated 43.9 t of hazardous waste which included oily rags/absorbents, contaminated soil and medical/sanitary waste. Bulga produced 702.2 t of non-hazardous waste (including mixed solid waste) that was disposed to landfill.

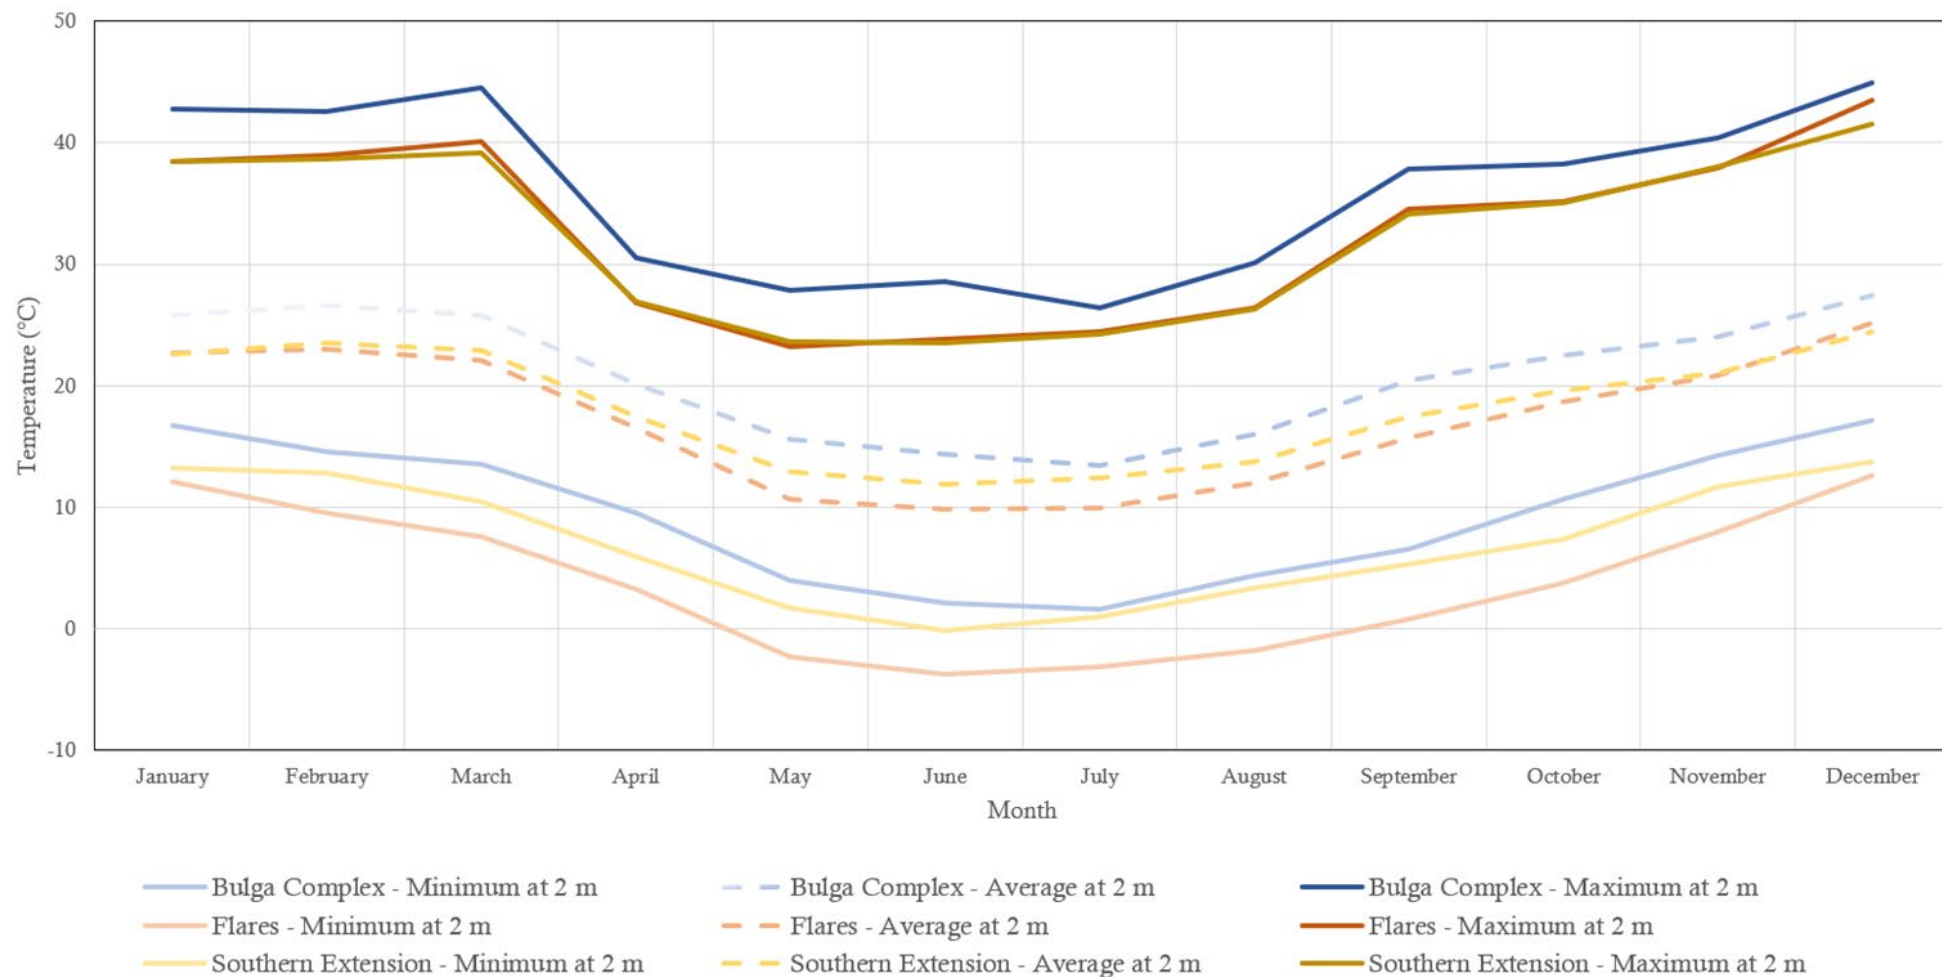
Figure 6.5 2023 Monthly Temperature 2 m (Degrees Celsius) at Representative Monitoring Stations

As shown in **Table 6.2** and **Table 6.3**, the daily minimum and maximum surface level temperatures ranged across Bulga’s three monitoring stations at 2 metres and 10 metres above surface level from -3.73°C to 44.9°C respectively. Refer to **Table 6.4** for humidity recorded over the reporting period. Relative humidity was not monitored continuously at the Flares Meteorological Station due to an equipment failure on the relative humidity sensor failing intermittently during July and August 2023; the sensor was replaced in September 2023. During November 2023 the Flares relative humidity sensor recorded erroneous data; this was identified and fixed in early December 2023.

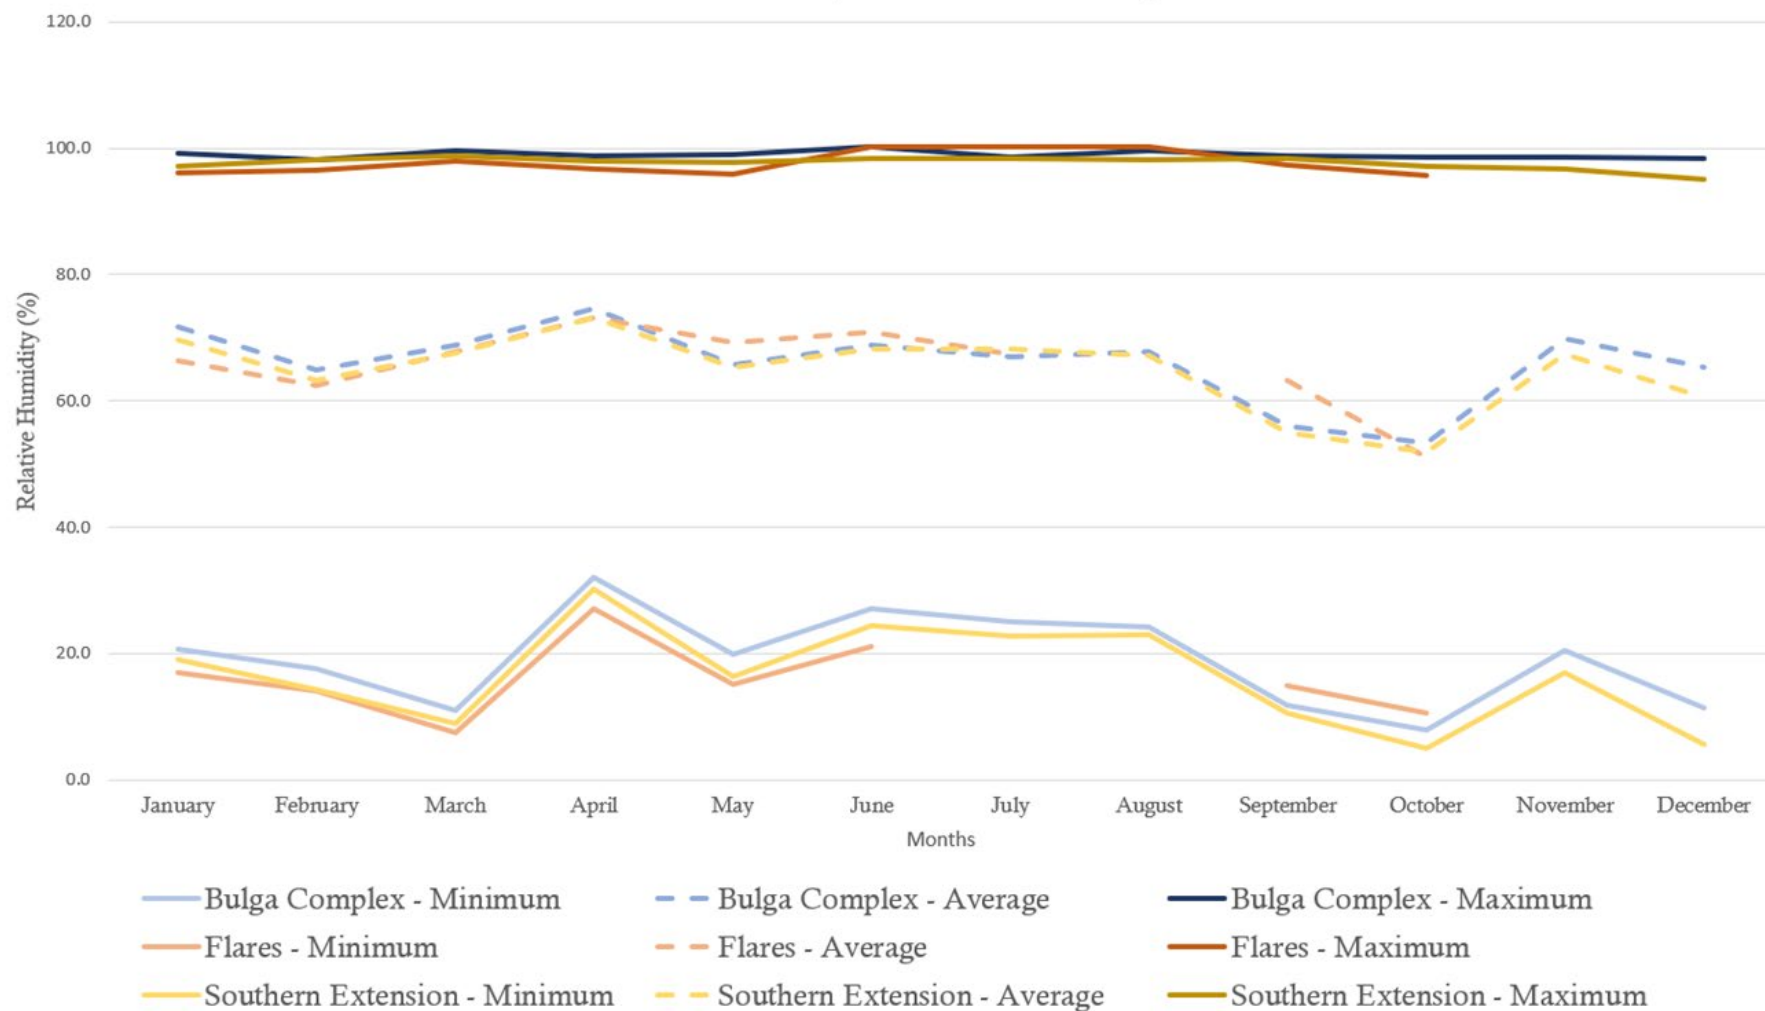
Figure 6.7 2023 Relative Humidity (%) at Representative Monitoring Stations

* Relative humidity was not monitored continuously at the Flares Meteorological Station due to an intermittent equipment failure on the relative humidity sensor from July to August 2023. The sensor was replaced in September 2023. During November 2023 the Flares relative humidity sensor recorded erroneous data; this was identified and fixed in early December 2023.

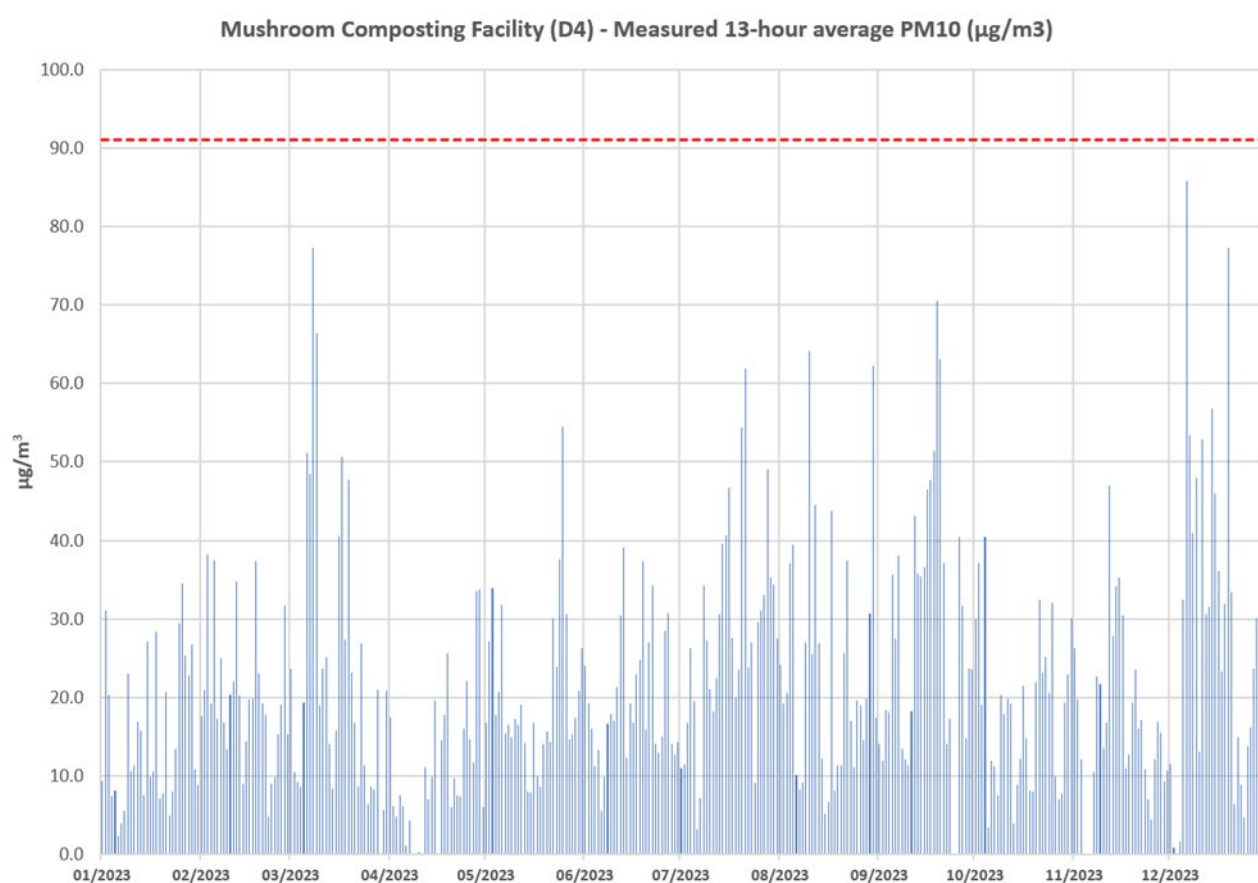
Figure 6.15 Mushroom Composting Facility (D4 Sampling Results 2023 – 13-hour PM₁₀ Averages)

Figure 6.15 presents the PM₁₀ 13-hour average measured at the Mushroom Composting Facility (D4 TEOM monitor) against the 13-hour average Assessment Level of 91 µg/m³. The Assessment Level only applies during the approved operating hours of the Mushroom Composting Facility. These are between 6:00 am and 7:00 pm Monday to Friday, and any additional operating hours of the Mushroom Composting Facility, provided that:

As shown in **Figure 6.15**, there were no occasions where levels were above the assessment level of 91 µg/m³.

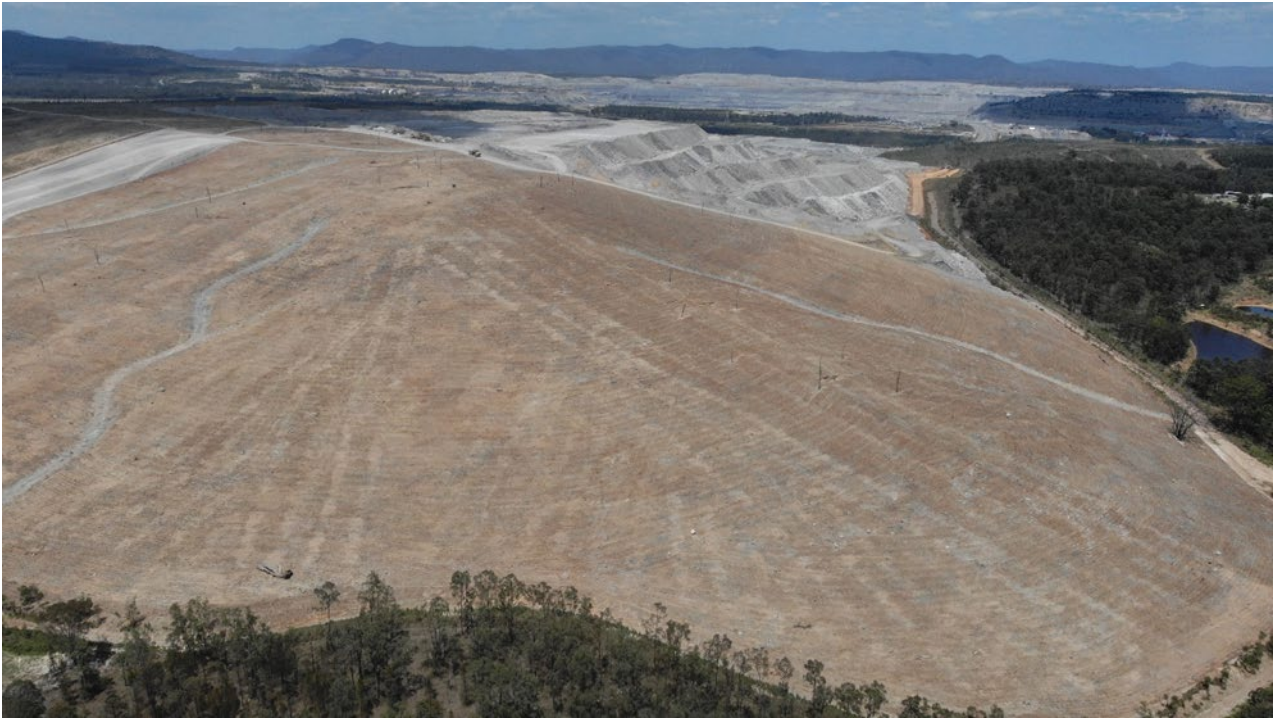
Photo 8.1 Rehabilitation completed in 2023 at the Eastern Emplacement Area

During 2023, Bulga Open Cut continued to implement a geomorphic natural landform design, as shown in **Photo 8.1**. Shaping of overburden dumps occurred on both the Eastern Emplacement Area and the East Pit Dumps. Bulga Open Cut continued to progressively rehabilitate all available overburden emplacement areas which have reached final landform extents.

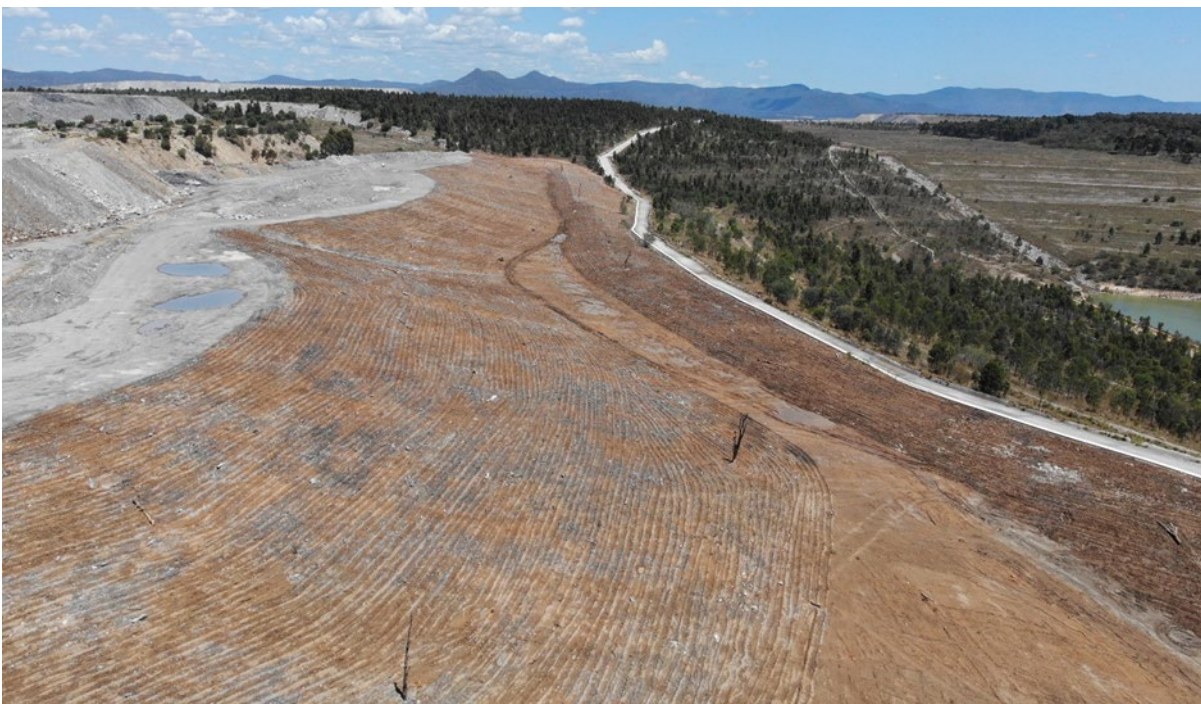
Photo 8.2 Deep ripping of topsoil in progress at the East Pit Emplacement in 2023

Stockpiled topsoil was spread at a nominal thickness of 100 mm on the shaped landform. Topsoil was sourced directly from topsoil stripping activities and topsoil stockpiles stored onsite. Gypsum was applied immediately after at a rate of 8 t/ha and then deep ripped to a depth of 450 mm to incorporate the topsoil into overburden material to create a suitable seed bed, as shown in **Photo 8.2** and **Photo 8.3**.

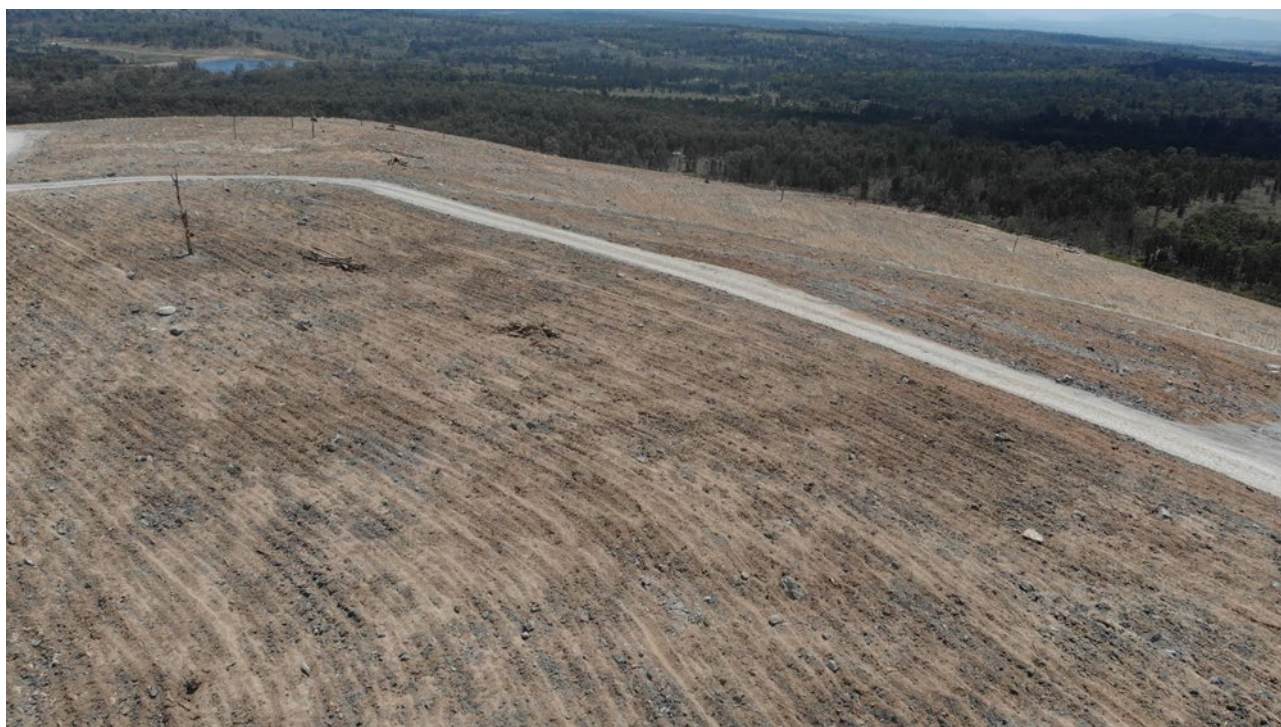
Photo 8.3 Topsoil applied and ripped on the Eastern Emplacement Area in 2023
