# HUNTER VALLEY OPERATIONS

## 2023 ANNUAL ENVIRONMENTAL REVIEW

# REPORT | 2023 ANNUAL ENVIRONMENTAL REVIEW

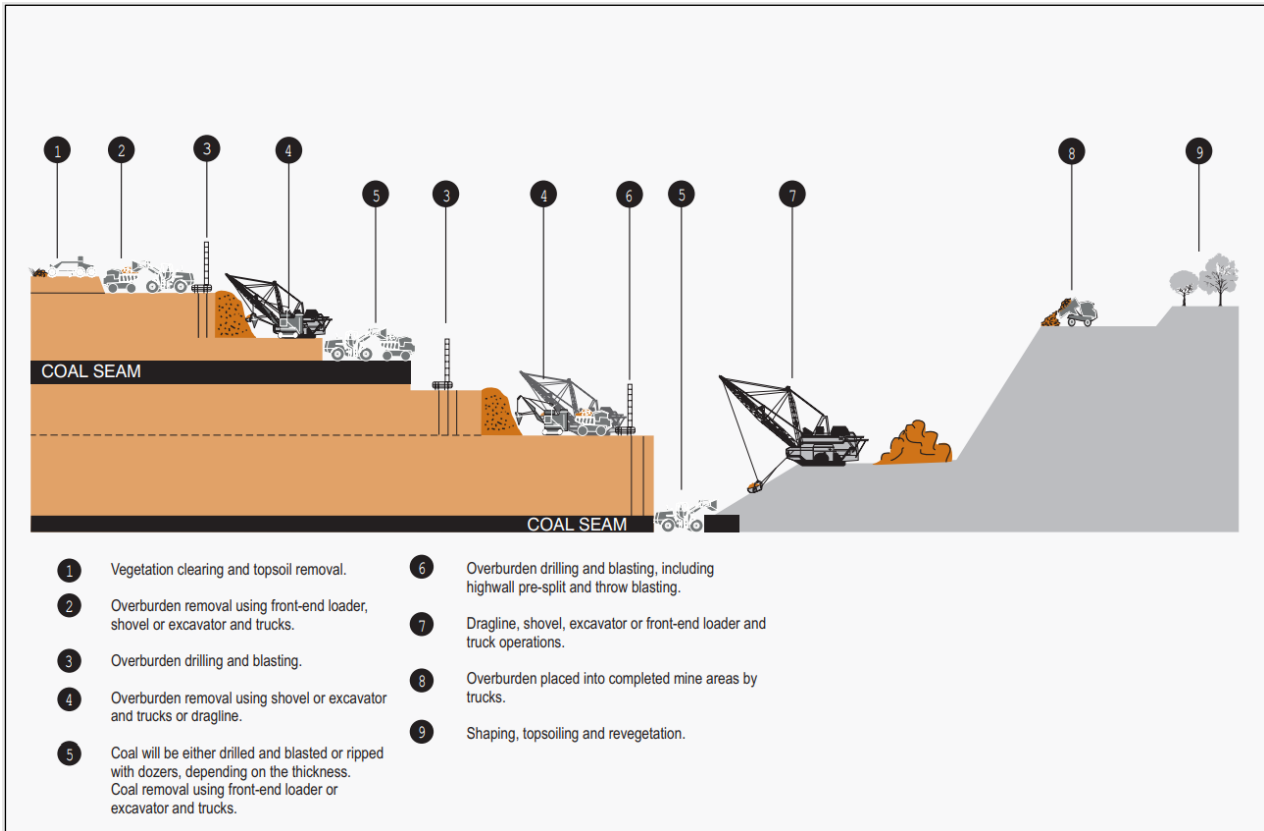
Figure 4-1: Open Cut Mining Schematic

Areas to be mined are geologically modelled, a mine plan is formed, and the relevant mining locations are surveyed prior to mining. The mining process is illustrated in **Figure 4-1**. There are no active underground workings at HVO.

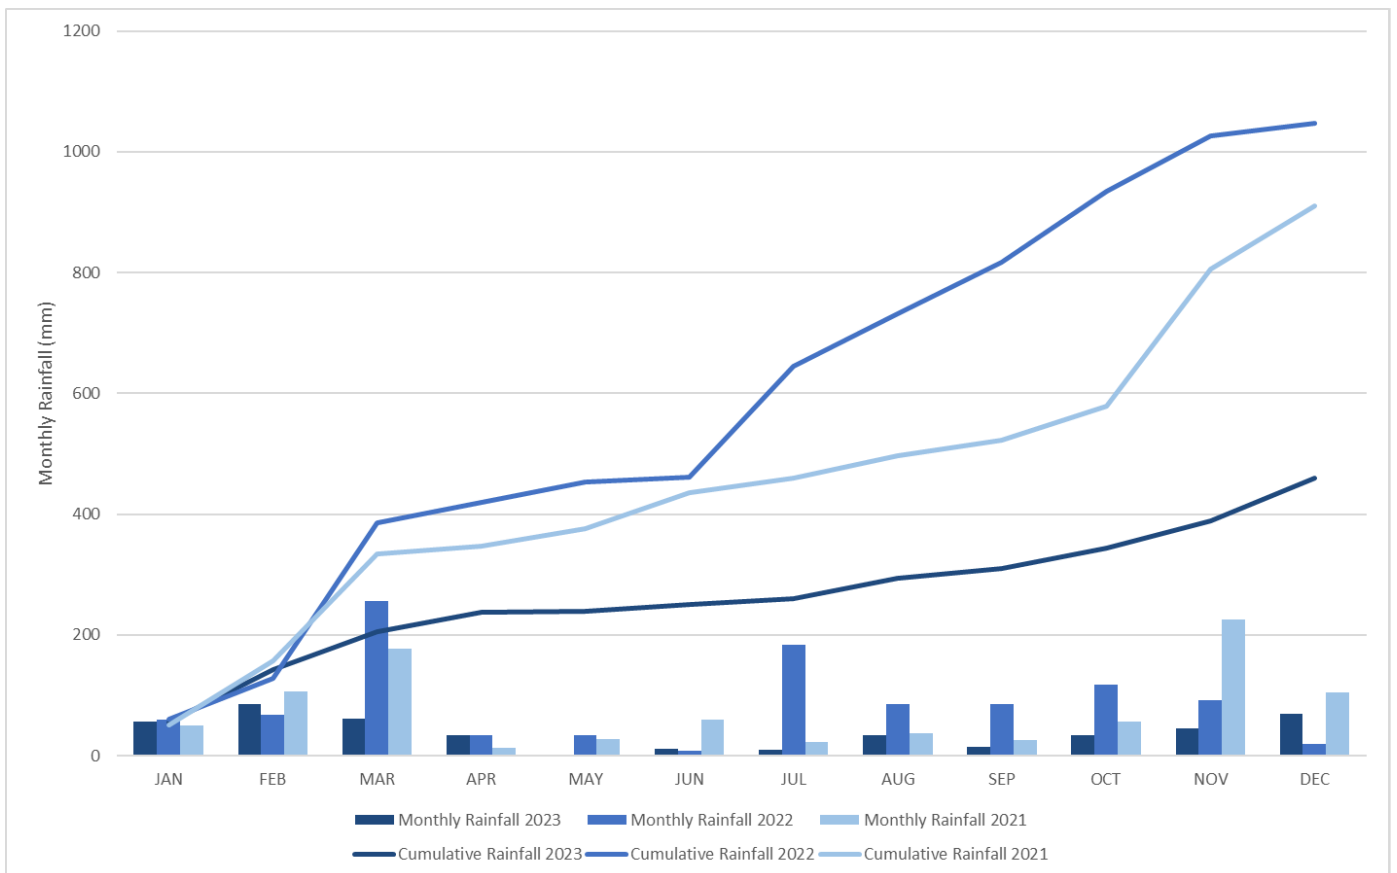
Figure 6-1: HVO Corporate Meteorological Station 2021 – 2023 Rainfall Data

Total annual rainfall for 2023 was 459.0mm (recorded at the HVO Corporate Meteorological Station) compared to 1047.2mm in 2022 and 910.2mm in 2021. (**Figure 6-1**).

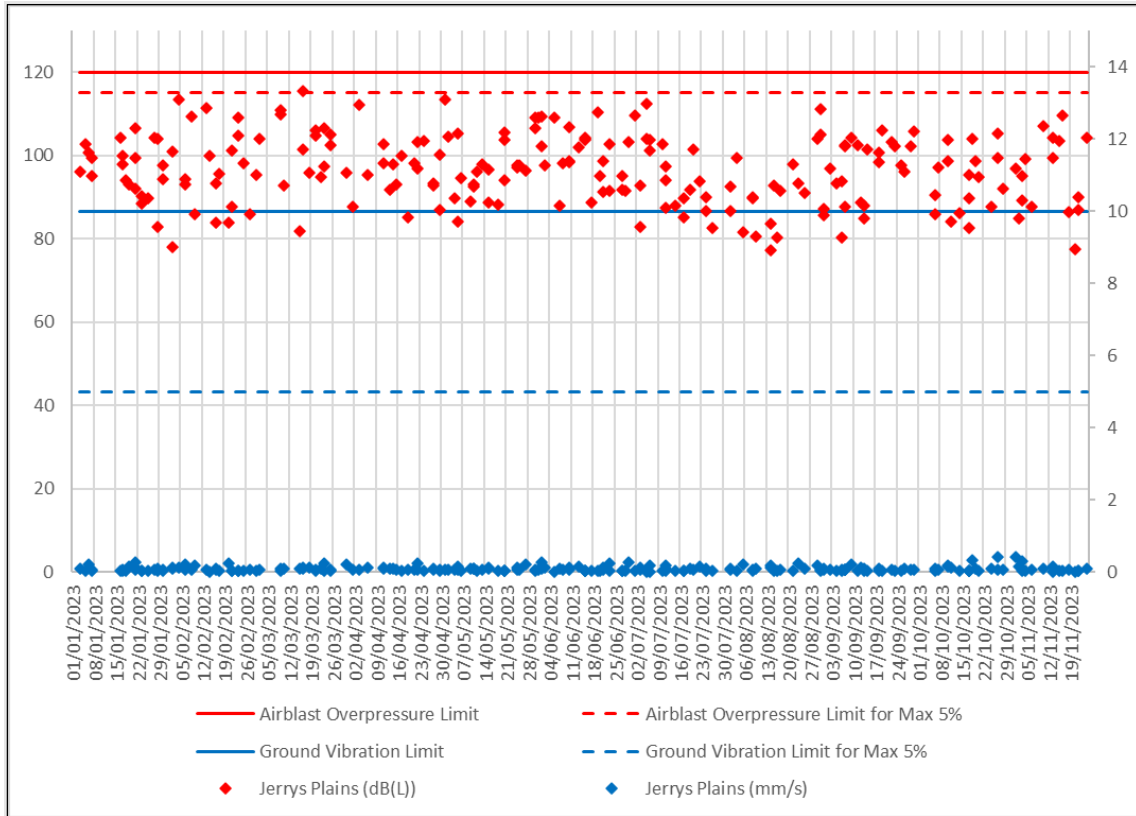
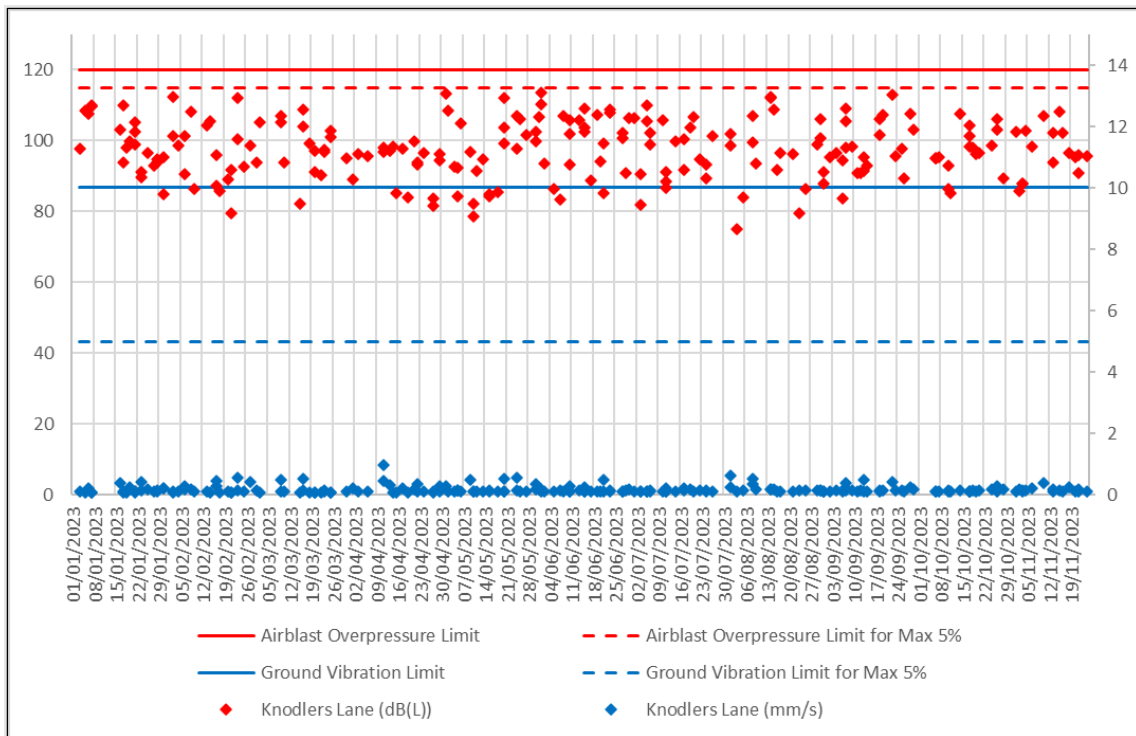
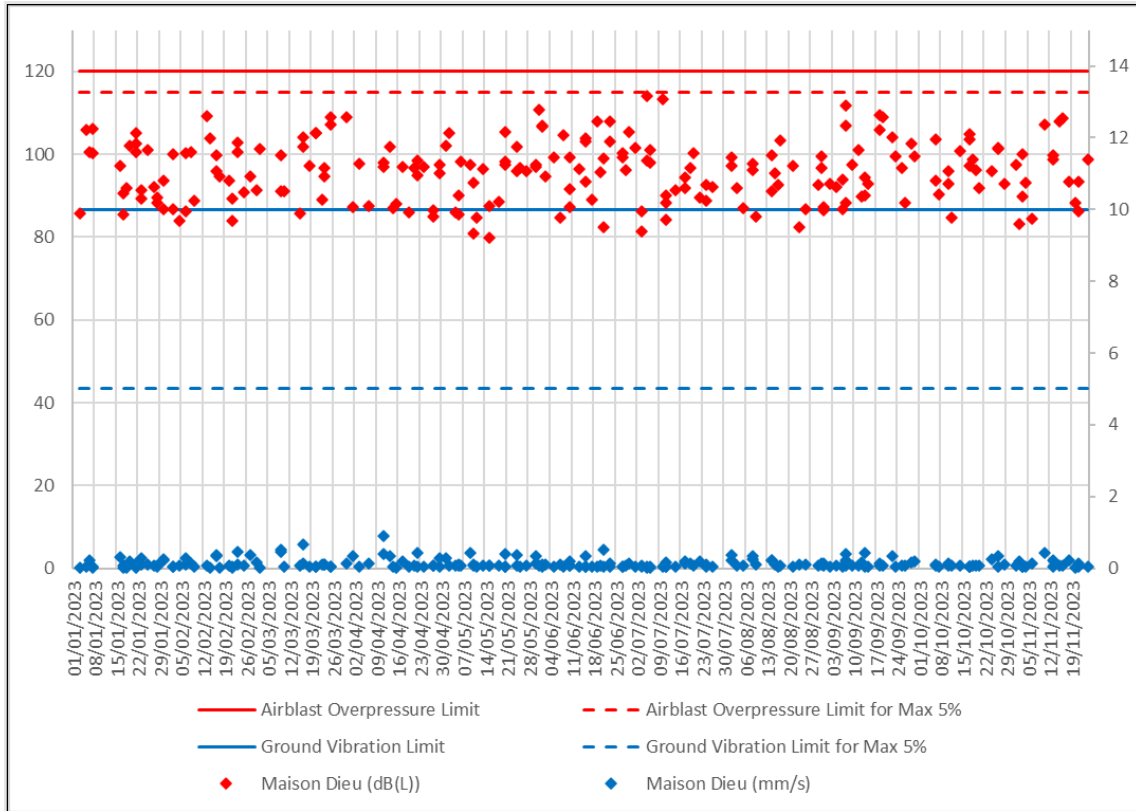
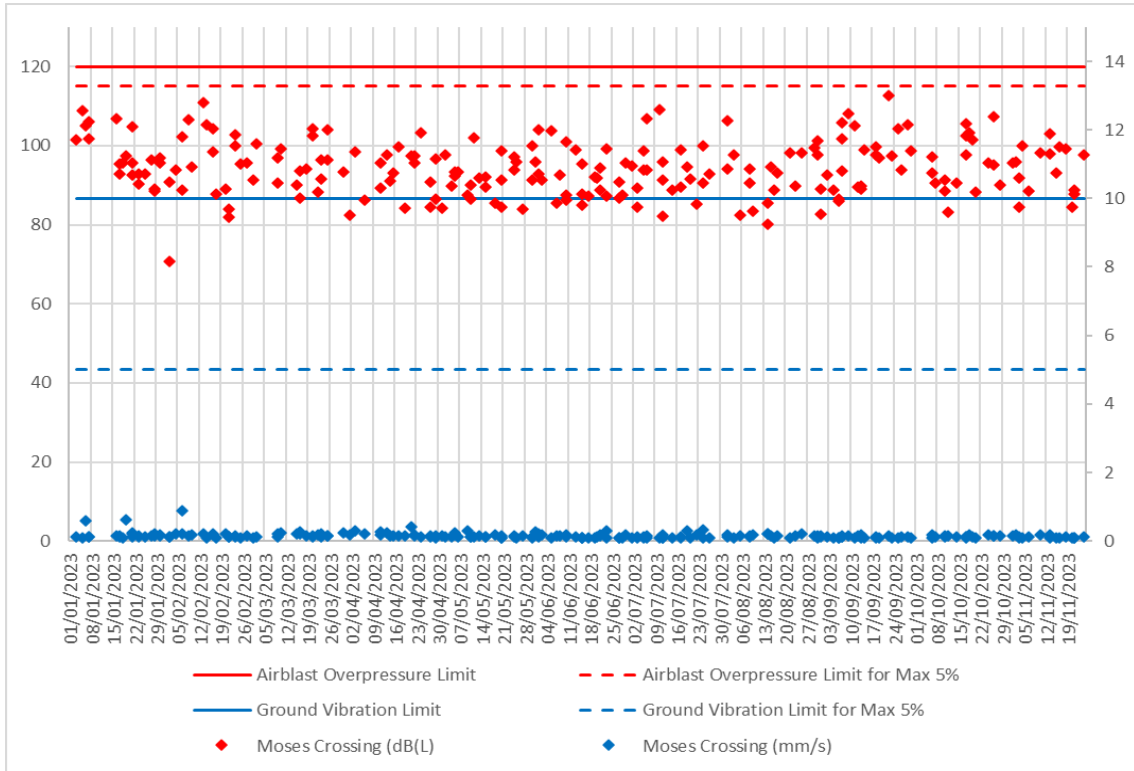
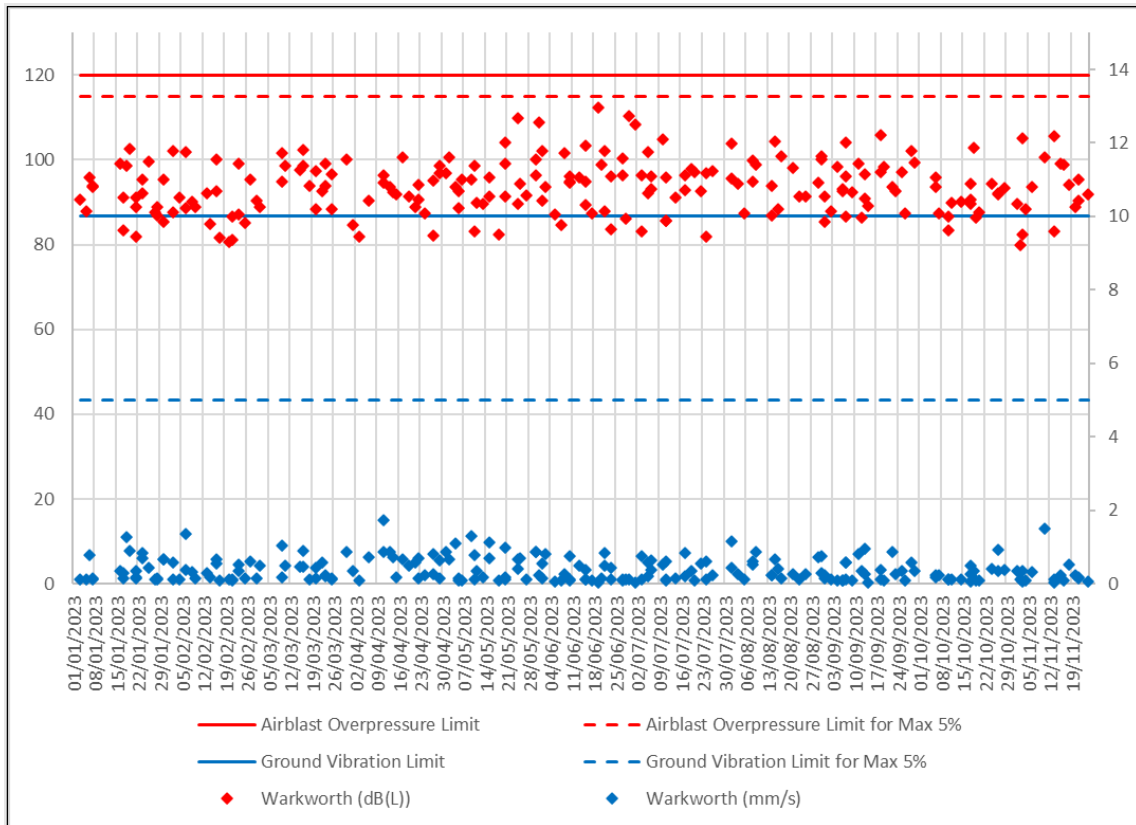
236 blast events were initiated at HVO during the reporting period. 119 blasts were fired at HVO South, and 117 at HVO North. HVO complied with all blasting related consent and licence conditions. Air blast overpressure and ground vibration results for all blasts fired during the reporting period are presented in **Figure 6-4** to **Figure 6-8**.

In accordance with PA 06\_0261, long term blast monitoring data has been reviewed to identify any trends in the monitoring data over the life of the project. Both ground vibration and overpressure monitoring results have remained generally consistent since monitoring commenced, with no increasing trends developing in the data. Notably in 2023 there was only one exceedance of 115 dB(L) air blast overpressure criteria.

Monitoring Location	2021		2022		2023	
	Percentage of blasts over 115dB(L) (%)	Percentage of blasts >5mm/s (%)	Percentage of blasts over 115dB(L) (%)	Percentage of blasts >5mm/s (%)	Percentage of blasts over 115dB(L) (%)	Percentage of blasts >5mm/s (%)
Moses Crossing	0	0	0	0	0	0
Jerrys Plains	0	0	0	0	0.4	0
Warkworth	0	0	0	0	0	0
Maison Dieu	0	0	0	0	0	0
Knodlers Lane	0	0	0.8	0	0	0

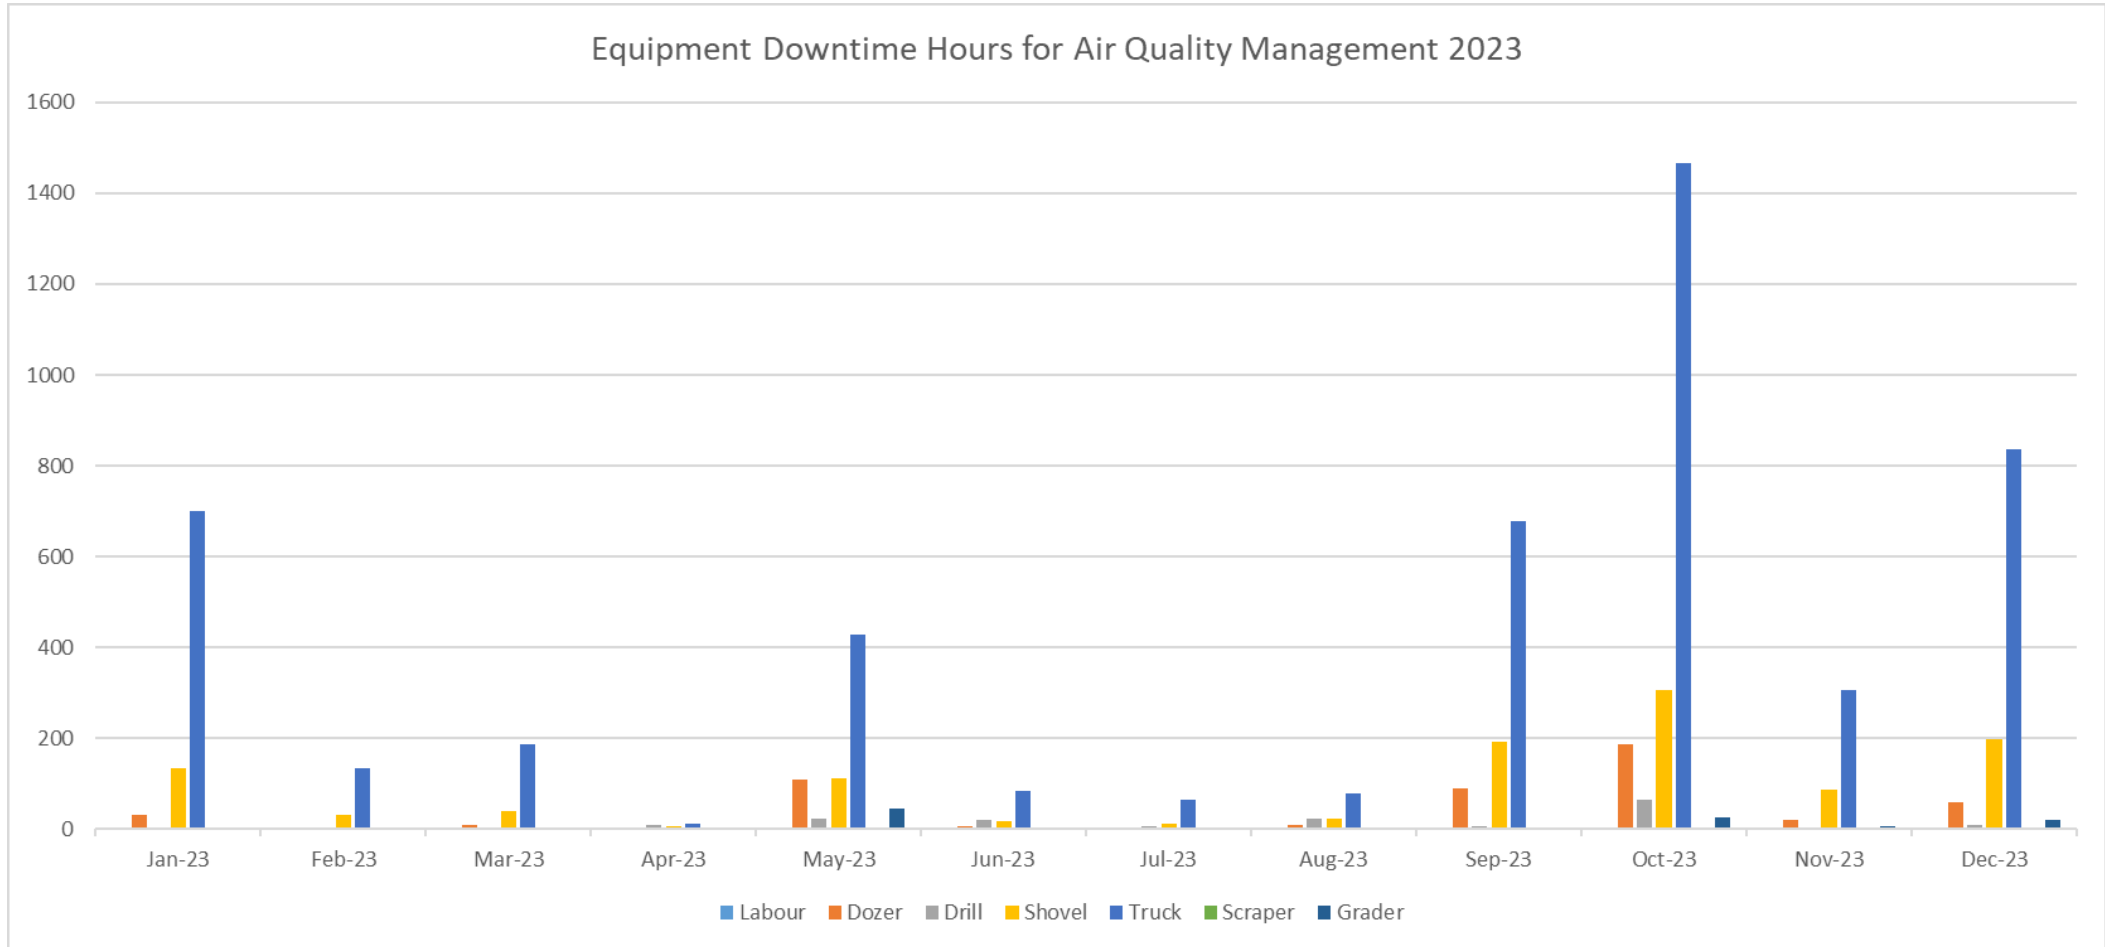
Figure 6-10: Equipment Downtime Hours for Air Quality Management 2023

In response, 7,013 hours of equipment downtime was recorded due to air quality management. A detailed breakdown of air quality related equipment stoppages (per month, per equipment type) presented in **Figure 6-10**. Note that these delays are instances where operations were completely stopped and does not include occasions where operations were changed/modified but not stopped (e.g. changed from exposed dump to in-pit dump).

A total of 3,150 real time alarms for air quality and meteorological conditions were received and acknowledged during 2023, which is an increase from 551 alarms recorded during 2022. This increase is likely due to the decrease in wet weather days recorded across site in 2023.

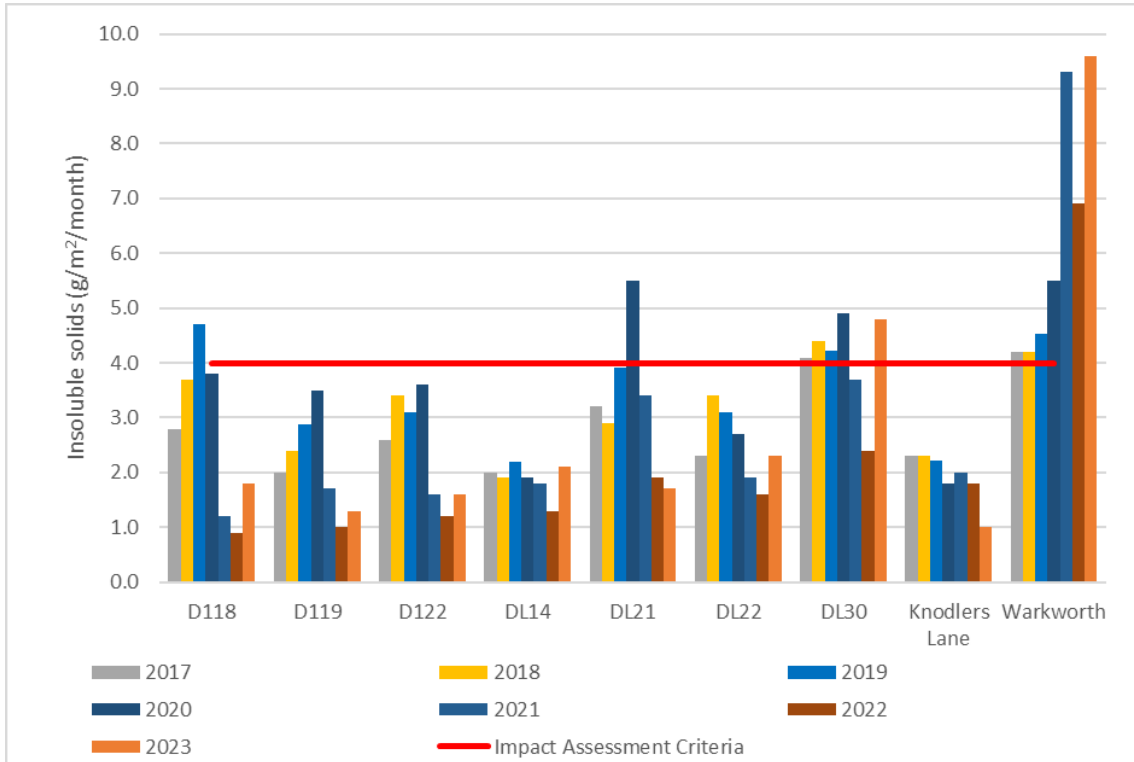
Figure 6-12: Annual Average Insoluble Matter Deposition Rates 2017-2023

Depositional dust is monitored at nine locations in accordance with the AQGGMP. The annual average insoluble matter deposition rates in 2023 compared with the depositional dust impact assessment criterion and previous years' data are shown in **Figure 6-12**.

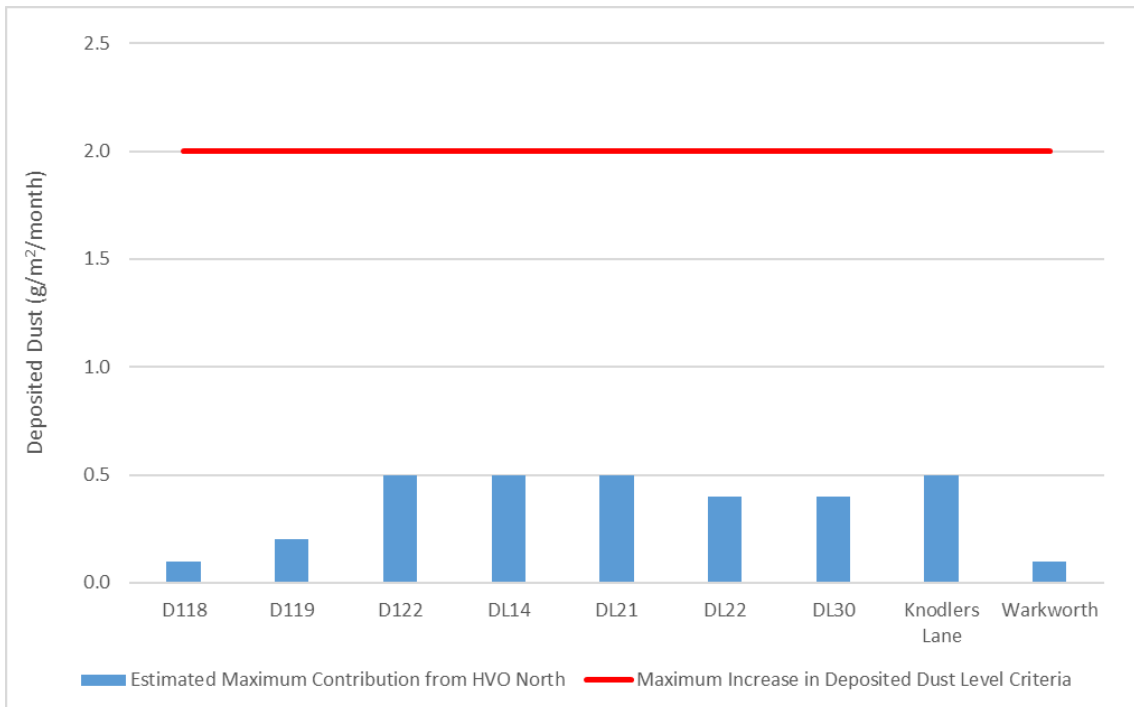
Figure 6-13: Maximum Allowable Increase in Deposited Dust Level 2023

The DL30 and Warkworth monitoring locations exceeded the annual average insoluble matter deposition rate criteria of 4 g/m<sup>2</sup>/month (HVO North only) during 2023. However, all results were below the maximum insoluble solids incremental increase criterion of 2 g/m<sup>2</sup>/month and hence compliant with criteria (**Figure 6-13**).

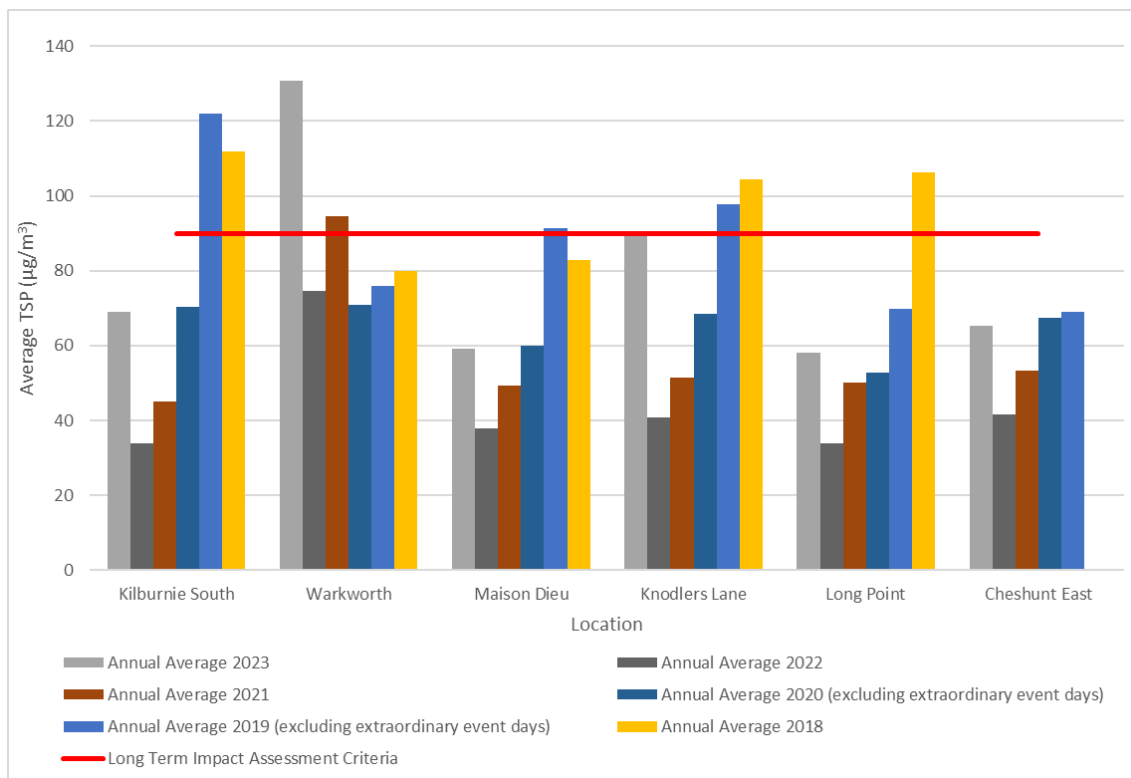
Figure 6-14: Annual Average TSP Concentrations 2017 to 2023 (Excludes Extraordinary Events)

Annual average TSP concentrations recorded in 2023 compared with the long-term impact assessment criterion and data from previous years are shown in **Figure 6-14**. TSP results in 2023 are considered to be similar to levels recorded from 2018 to 2020 with the exception of Warkworth which recorded 130.8  $\mu\text{g}/\text{m}^3$  compared to a criteria of 90  $\mu\text{g}/\text{m}^3$ .

Contributions at the TSP monitors were estimated to be the 24-hour concentrations minus an estimated background level on the corresponding day. The background level is considered to be the level which excludes the contribution from HVO but may include the influence of other sources, including other mines, localised sources, or regional sources of background dust. For the Warkworth monitor, which is often downwind of HVO South and a neighbouring mine concurrently, the daily contribution is considered to include both mines. In order to determine the contribution from HVO South alone, the combined mining increment was scaled by the proportion of time the monitor was downwind of HVO South relative to the total time the monitor was downwind of both mines during each 24-hour period.

Further methodology for determining HVO contribution is presented in Section 2.7.1 of **Appendix A**. This investigation method has determined the maximum possible contribution of HVO South to the Warkworth annual average to be 51.9  $\mu\text{g}/\text{m}^3$ .

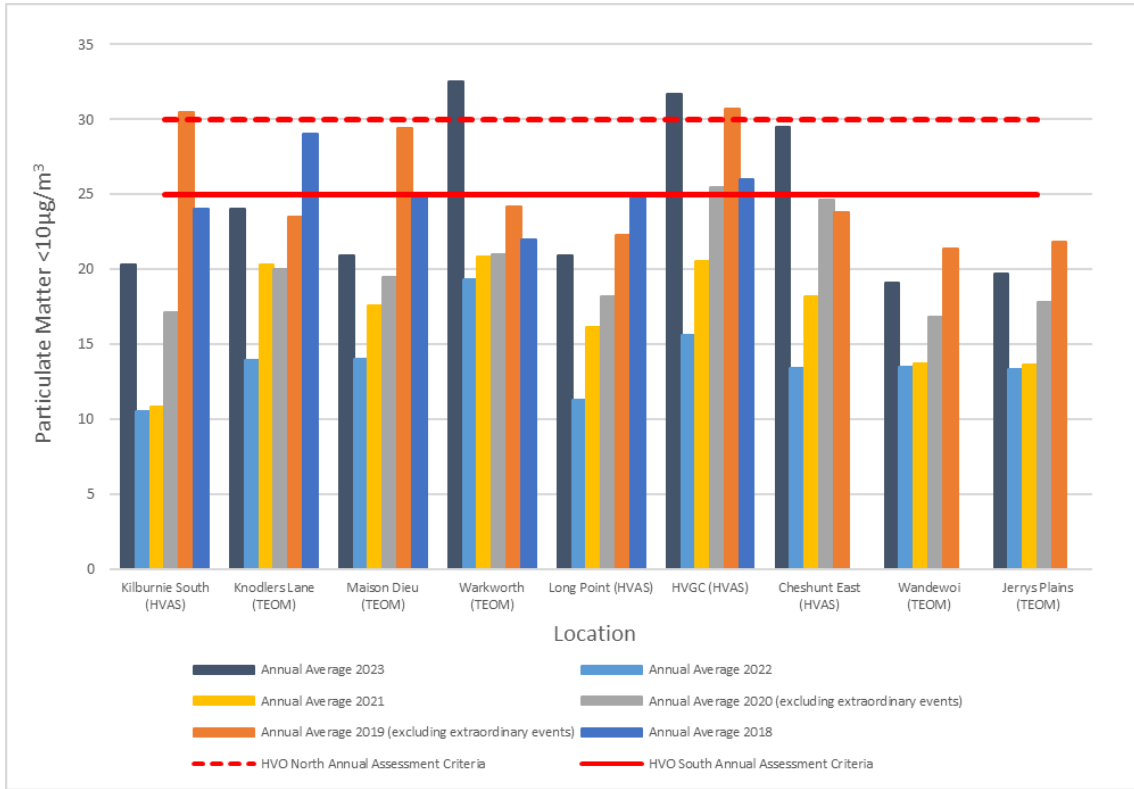
Figure 6-16: Annual Average HVAS PM10 Results 2018 to 2023

A comparison of the long term PM<sub>10</sub> impact assessment criterion and previous years' data are shown in **Figure 6-16**.

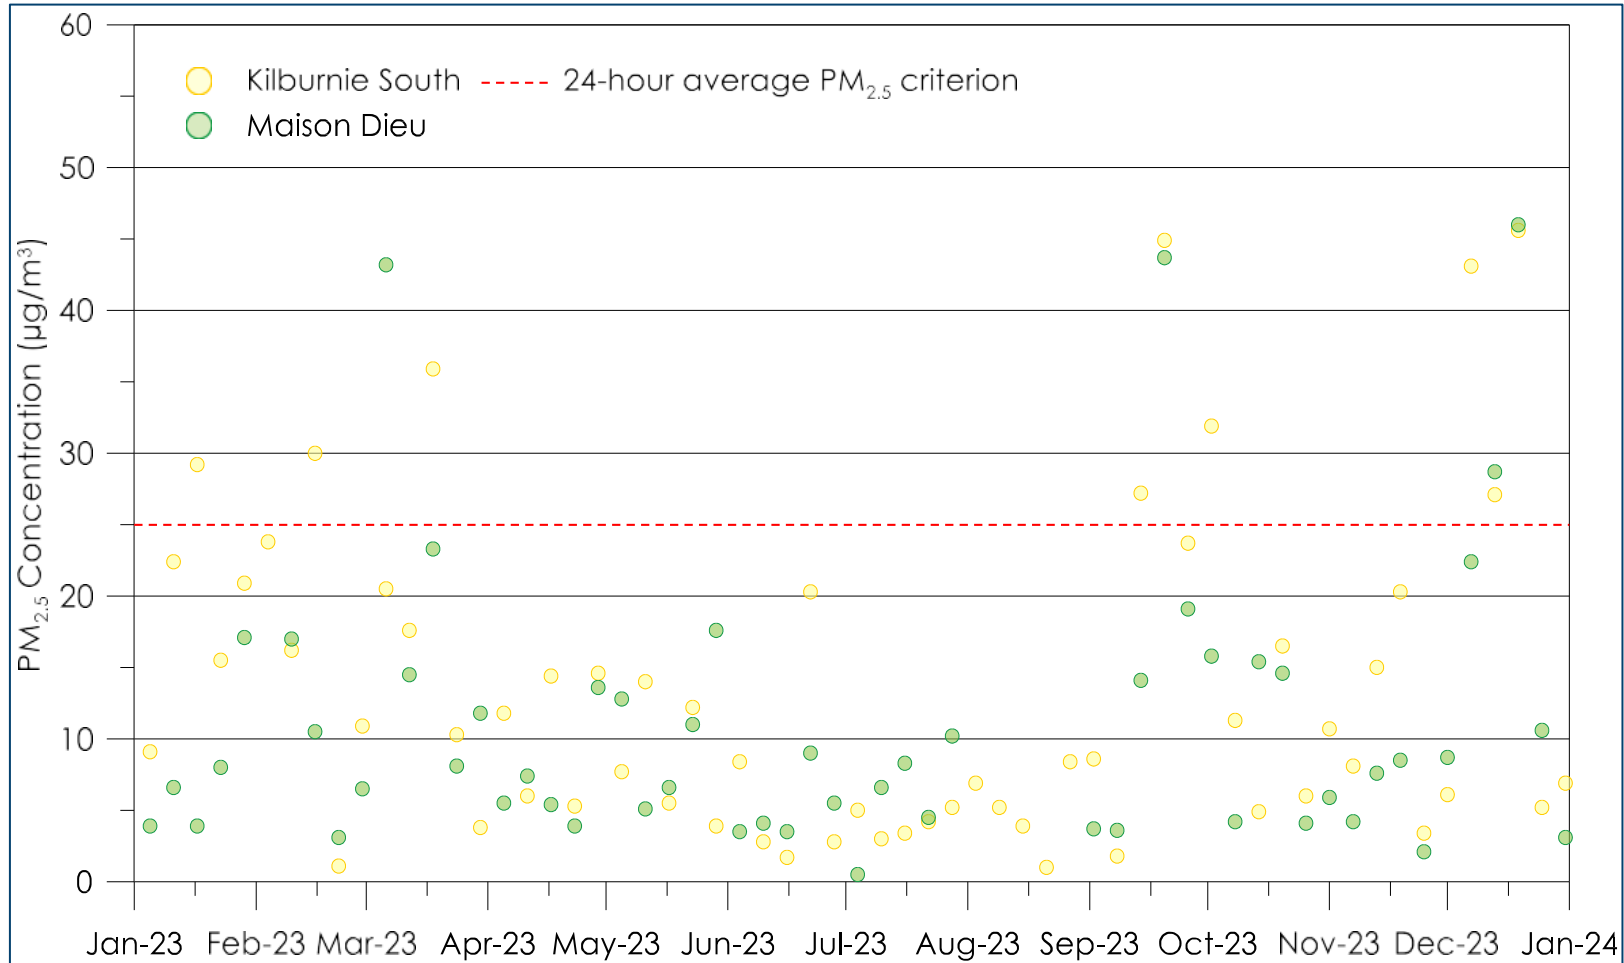
Figure 6-17: 24-hour Average PM<sub>2.5</sub> Results 2023

PM<sub>2.5</sub> samples were collected at Maison Dieu and Kilburnie South using HVAS, and these results are provided in **Table 6-16** and **Figure 6-17**.

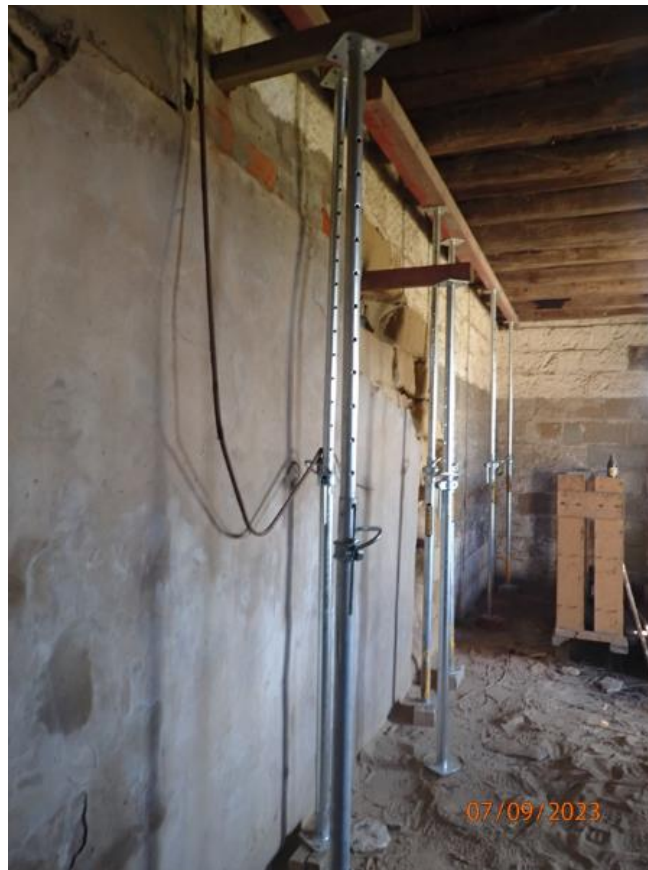
Figure 6-20: Archerfield Homestead Distillery Wall underpinning

- Yard maintenance works and Termite Interception System inspections at LEP listed European heritage properties.
- Progress on HVO 's plan for an Historic Homestead Project, which included the completion of detailed survey and condition reports for the Archerfield, Wandewoi and Carrington Stud homesteads. An inspection of selected homesteads by the CCC took place in May 2023 (**Figure 6-19**).
- Discussion of the Chain of Ponds Inn Annual Management Report prepared by Liddell Coal.
- The Cockatoo Fence Asset Protection Zone maintenance works which were completed in November 2023 with the manual brush cutting of existing firebreaks on either side of the fence structure.
- A presentation on the Archerfield Distillery wall temporary underpinning works completed in Q3 2023 (**Figure 6-20**)

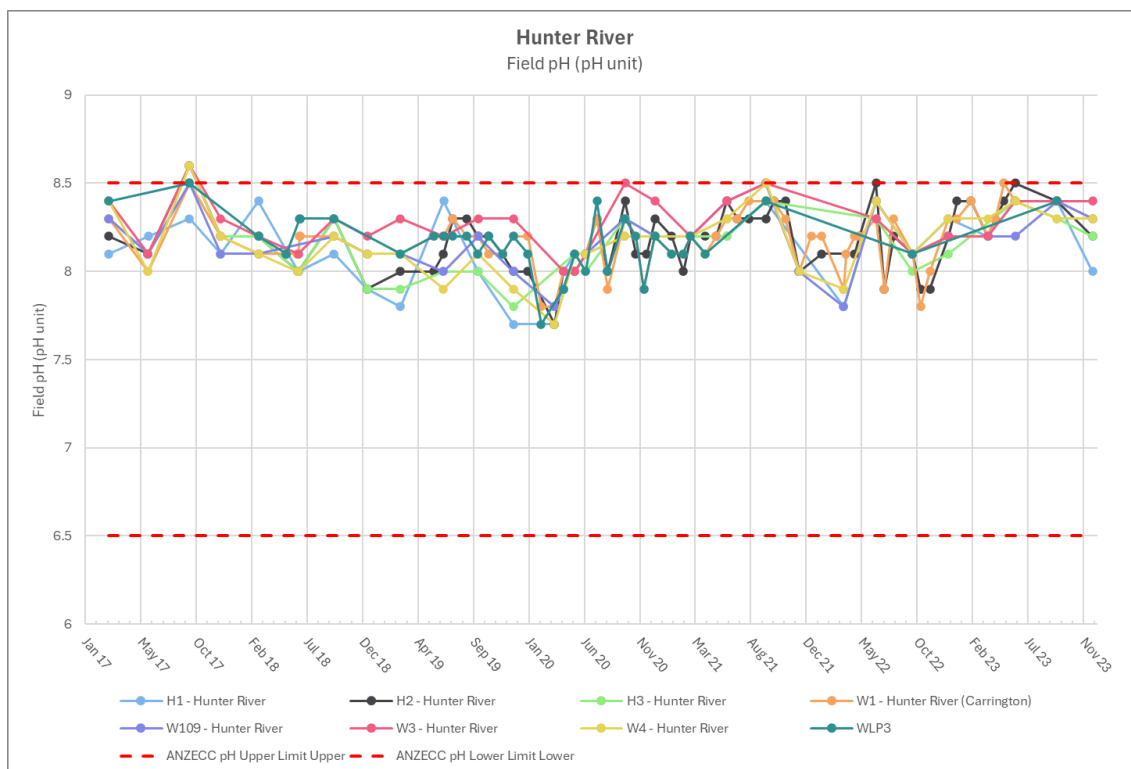
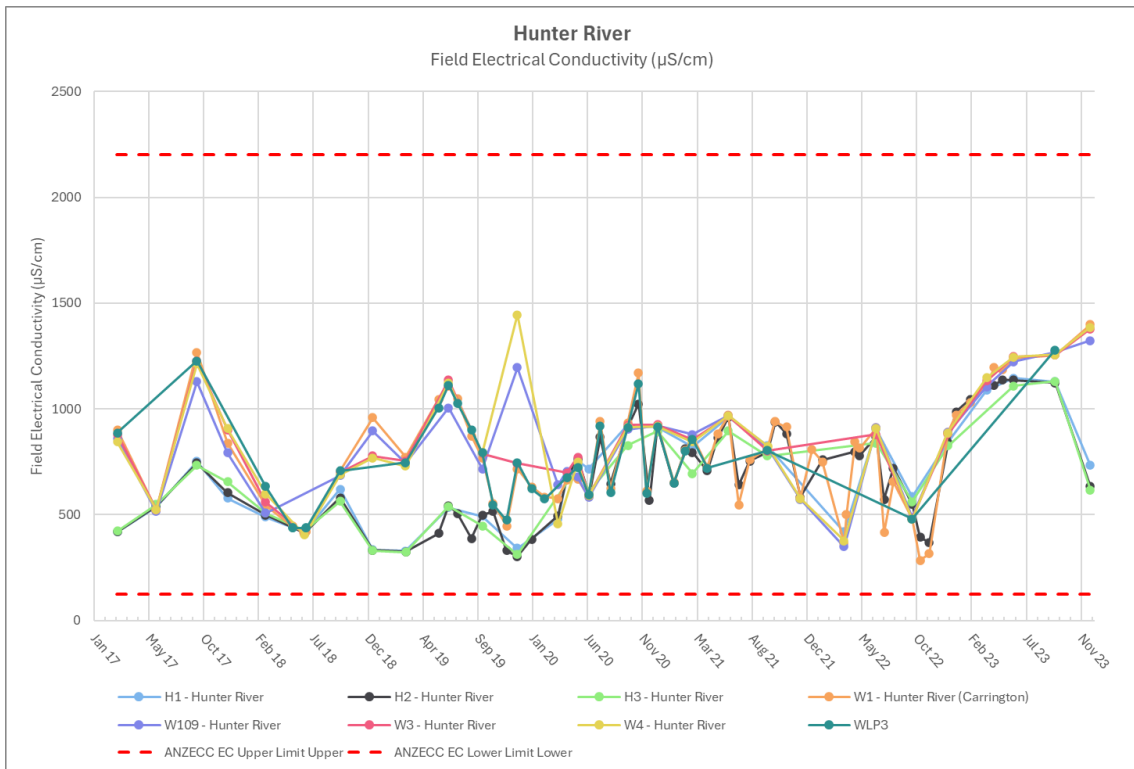
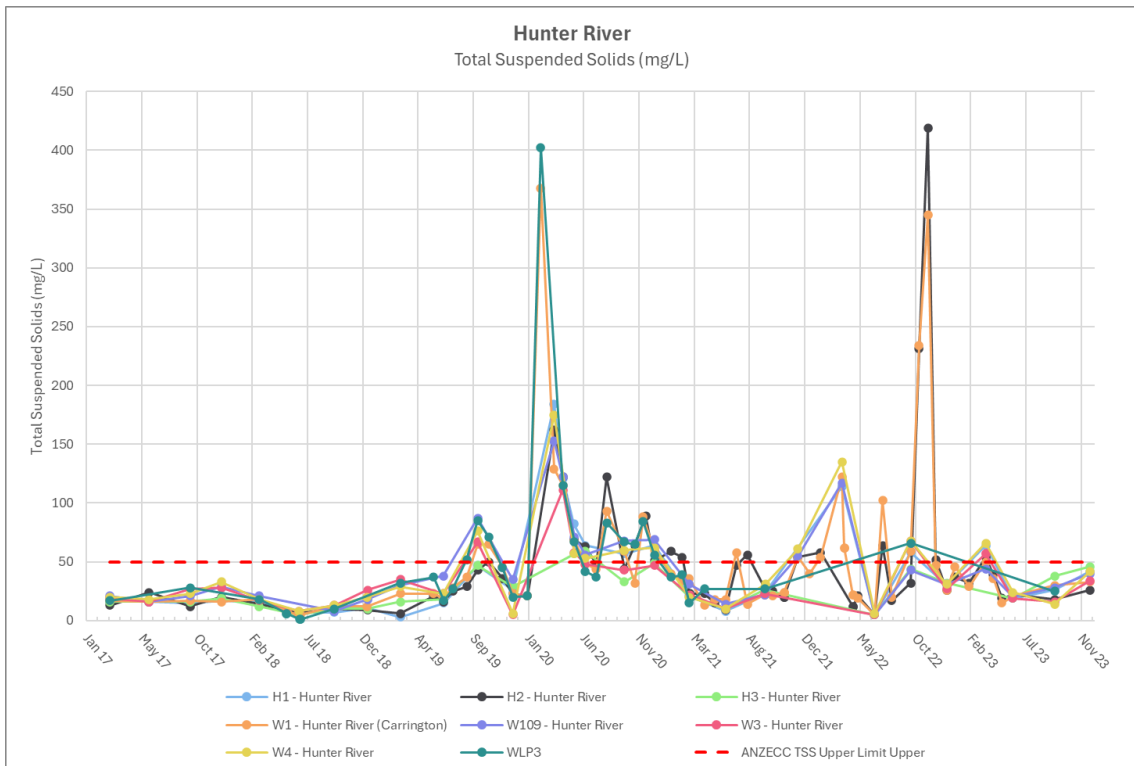
The Hunter River was sampled from eight monitoring locations during 2023. Long term trends for pH, EC and TSS are shown in **Figure 7-5** to **Figure 7-7**.

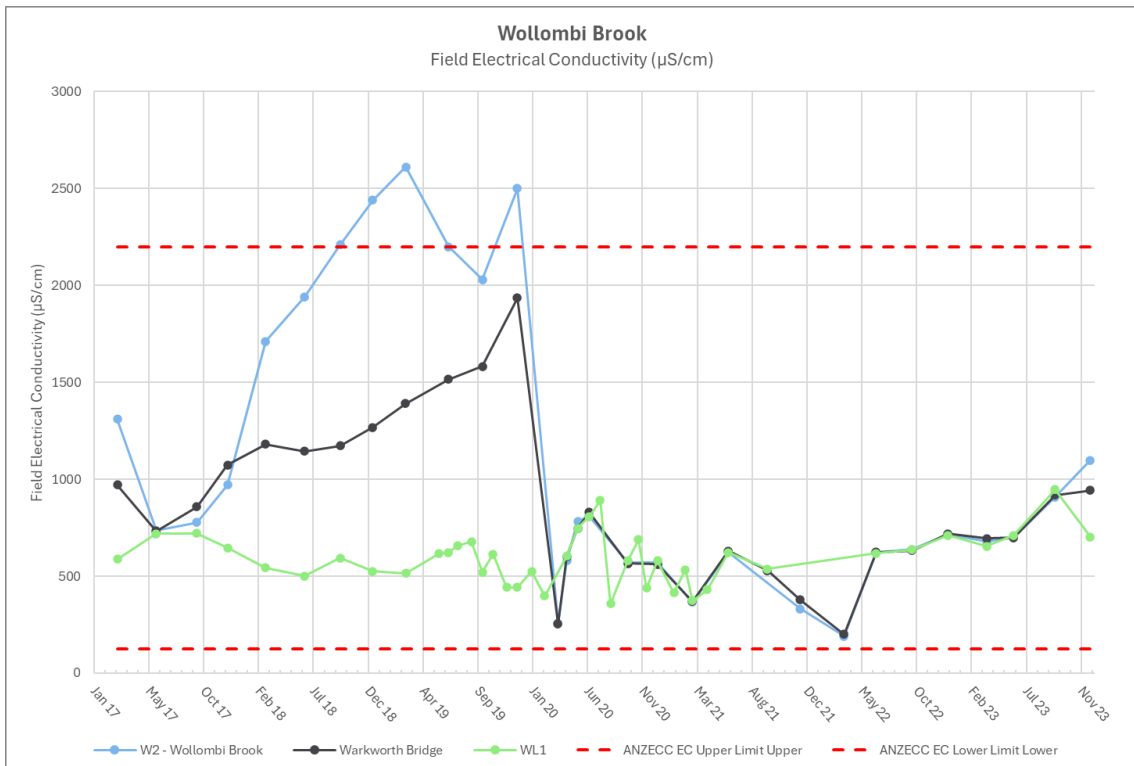
Figure 7-9: Wollombi Brook EC Trends 2017 - 2023

Wollombi Brook was sampled from three monitoring locations during 2023. Long term trends for pH, EC and TSS from Wollombi Brook are shown in **Figure 7-8** to **Figure 7-10**. Results were generally consistent with historical trends and acceptable ranges. Trigger exceedance results are detailed in **Table 7-4**.

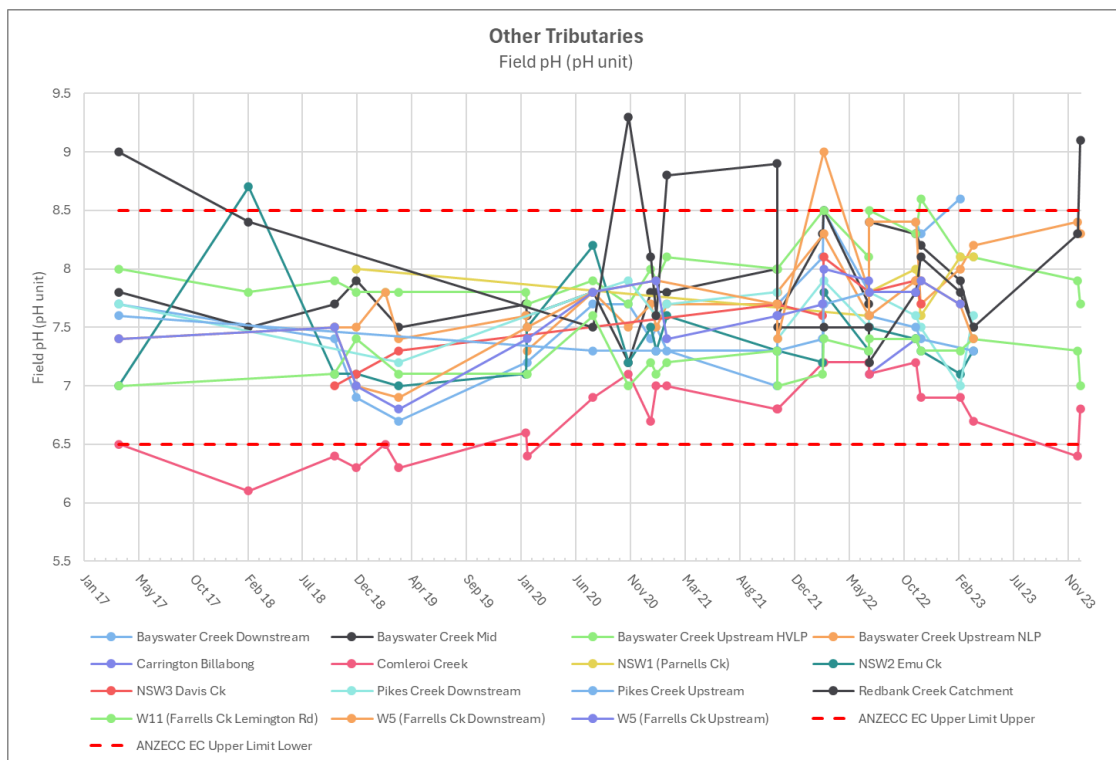
Figure 7-11: Other Tributaries pH Trends 2017 - 2023

Long term trends for pH, EC and TSS are shown **Figure 7-11** to **Figure 7-14**. On occasion, some sampling sites recorded results outside of the internal trigger levels however, results for water quality remained generally consistent with historical trends. The ephemeral nature of these monitoring locations is the primary reason for the considerable variation in physical water quality.

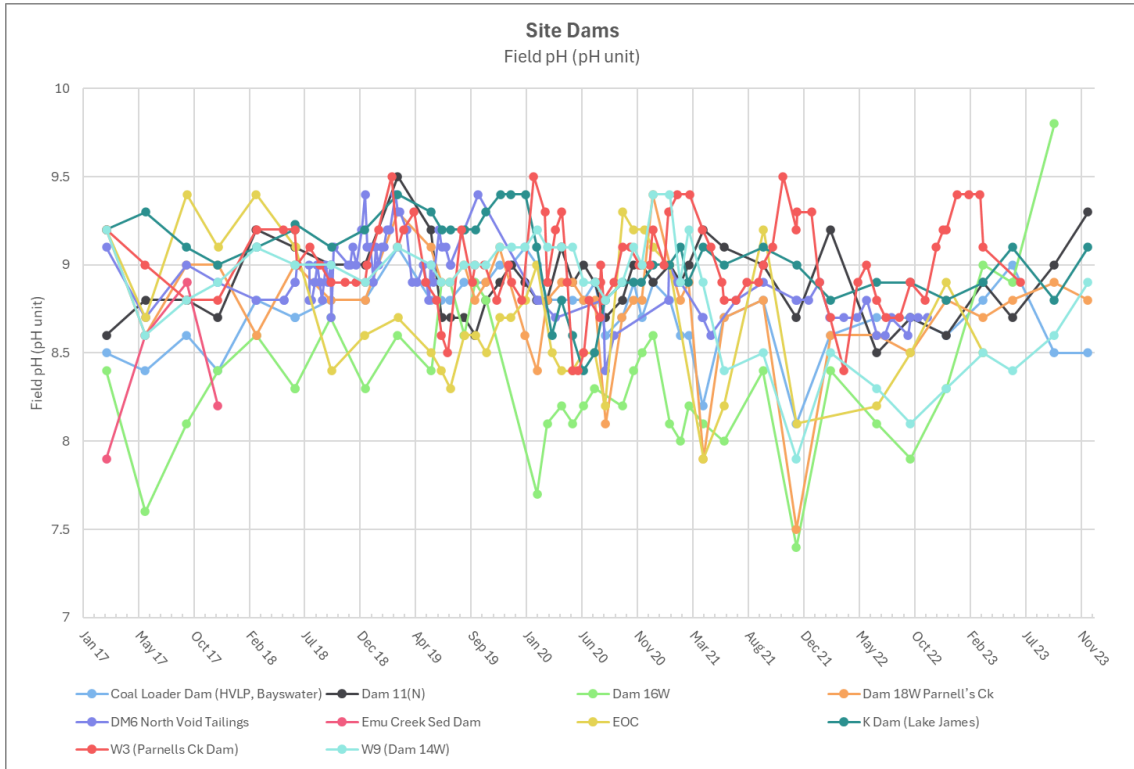
Figure 7-15: HVO Site Dams pH Trends 2017 - 2023

During 2023 monitoring was completed at across 10 onsite dams. Long term trends for pH, EC and TSS are shown in **Figure 7-15** to **Figure 7-17**. HVO's onsite dams do not have impact assessment criteria. Results for water quality remained generally consistent with historical water quality trends.

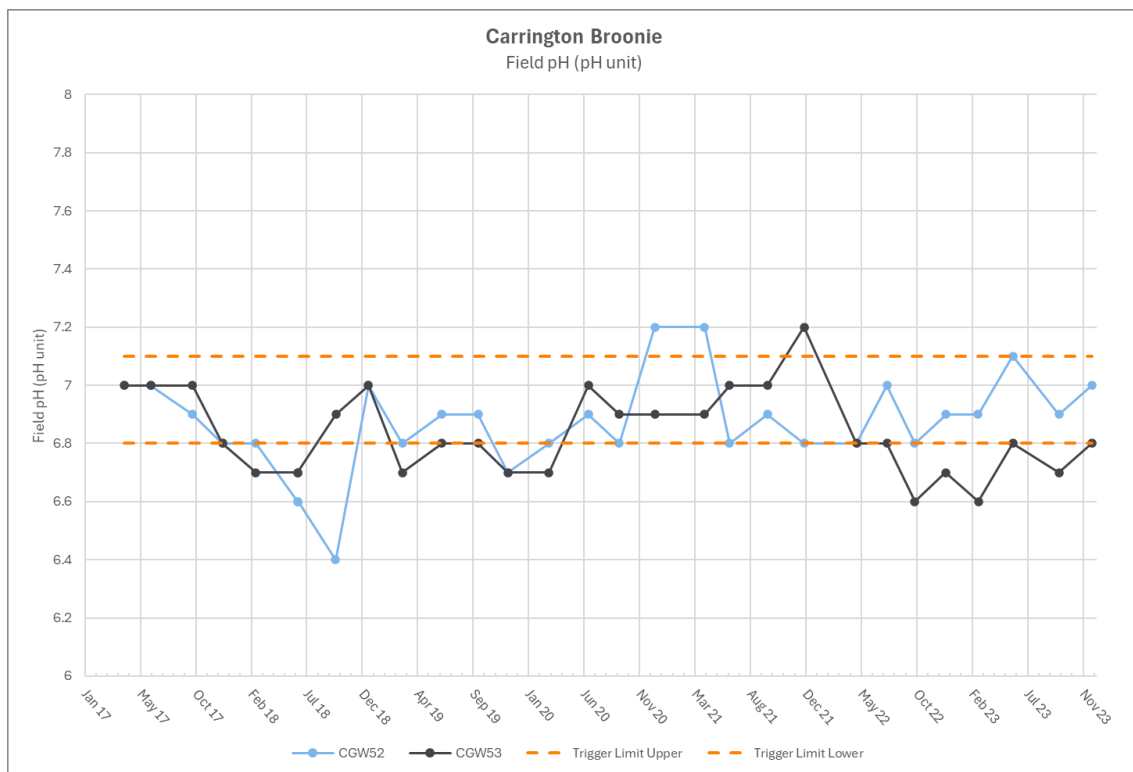
Figure 7-19: Carrington Broonie Groundwater pH Trends 2017 - 2023

The EC, pH and SWL trends for 2017 to 2023 for Carrington Broonie Seam groundwater bores are shown in Figure 7-19 to Figure 7-21 respectively. Water quality results were generally consistent with historical ranges with some minor variation noted with pH and SWL results. These levels were considered to be consistent with historical concentrations, with no adverse impacts identified.
