# HUNTER VALLEY OPERATIONS

## 2023 ANNUAL ENVIRONMENTAL REVIEW

# REPORT | 2023 ANNUAL ENVIRONMENTAL REVIEW

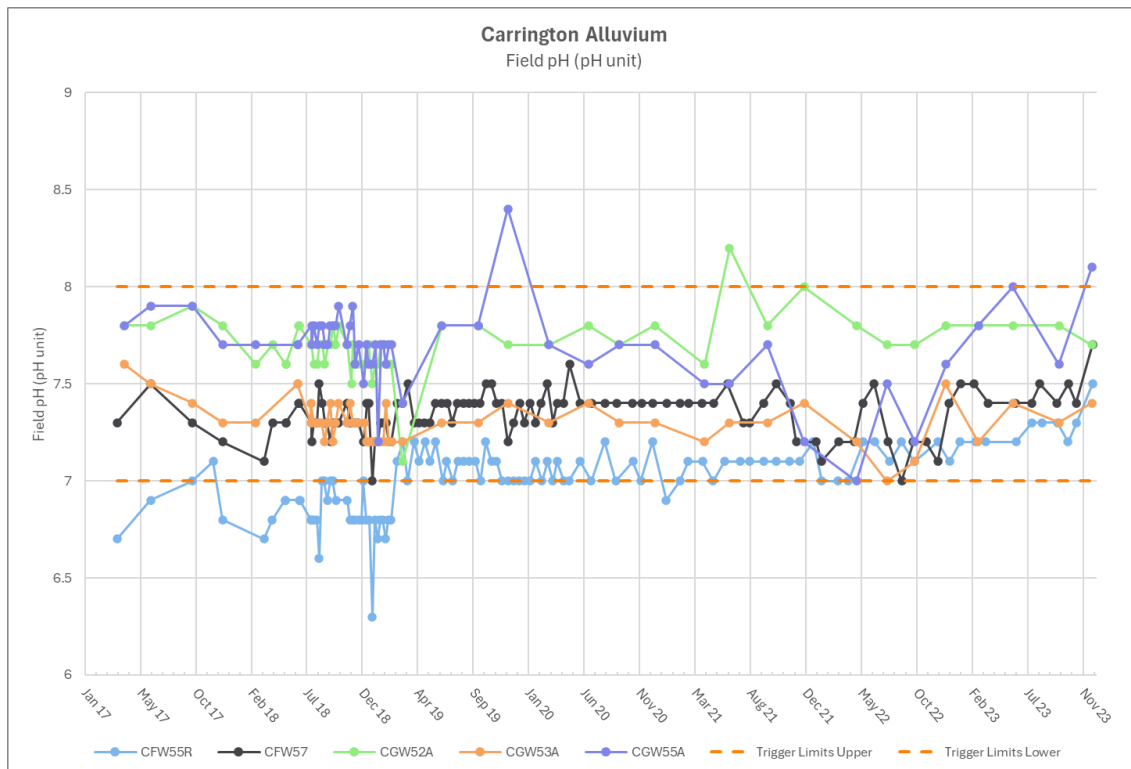
Figure 7-22: Carrington Alluvium Groundwater pH Trends 2017 - 2023

The EC, pH and SWL trends for 2017 to 2023 for Carrington Alluvium groundwater bores are shown in Figure 7-22 to Figure 7-24. Water quality results were generally consistent with historical trends.

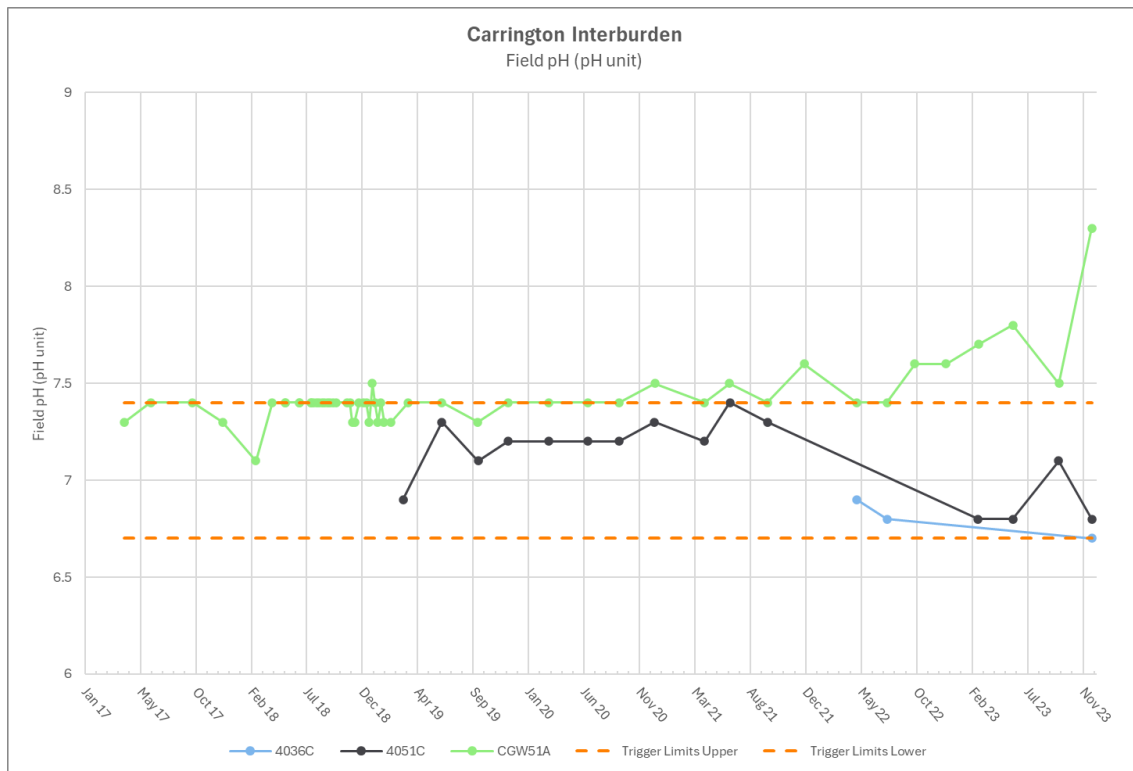
Figure 7-25: Carrington Interburden Groundwater pH Trends 2017 – 2023

The EC, pH and SWL trends for 2017 to 2023 for groundwater bores in the Carrington Interburden are shown in Figure 7-25 to Figure 7-27 respectively. Water quality results were generally consistent with historical trends aside from CGW51a pH. There have been six consecutive readings above the pH trigger level at CGW51a since September 2022 – refer to Table 6.2 of Appendix B.

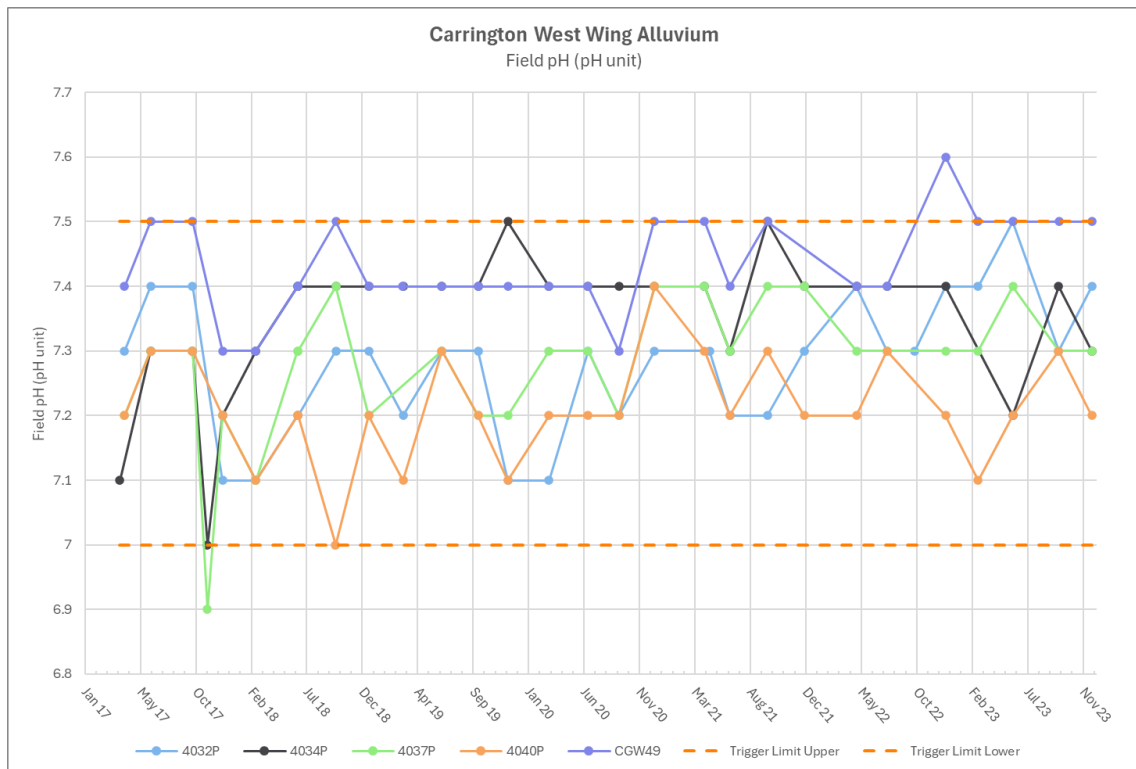
Figure 7-28: Carrington West Wing Alluvium Groundwater pH Trends 2017 - 2023

Results are shown in Figure 7-28 to Figure 7-30. Water quality results were generally consistent with historical trends. Bore CGW49 intersects alluvium within the western limb of the paleochannel. Historical readings show that bore CGW49 has recorded pH ranging between 7.3 and 7.7. Review of pH readings remained fairly stable and within historical levels over 2023. The results show no adverse impacts due to mining.

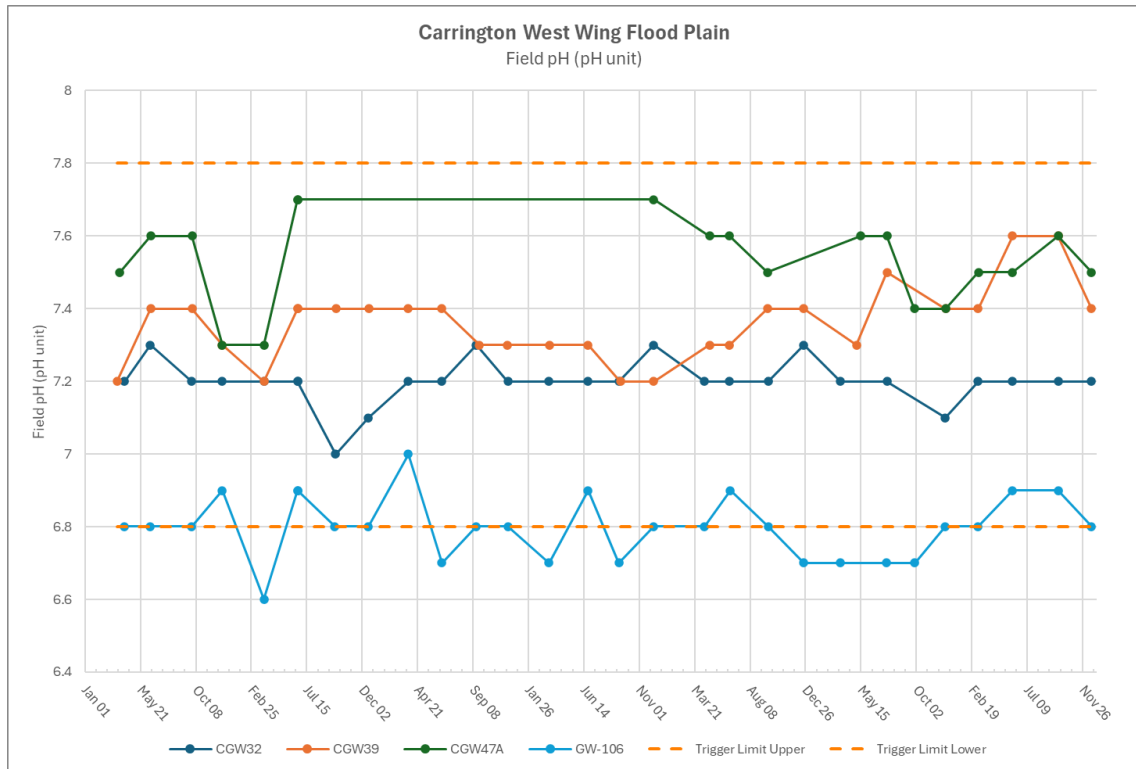
Figure 7-31: Carrington West Wing Flood Plain Groundwater pH Trends 2017 - 2023

Results are shown in Figure 7-31 to Figure 7-33. Water quality results were generally consistent with historical trends.

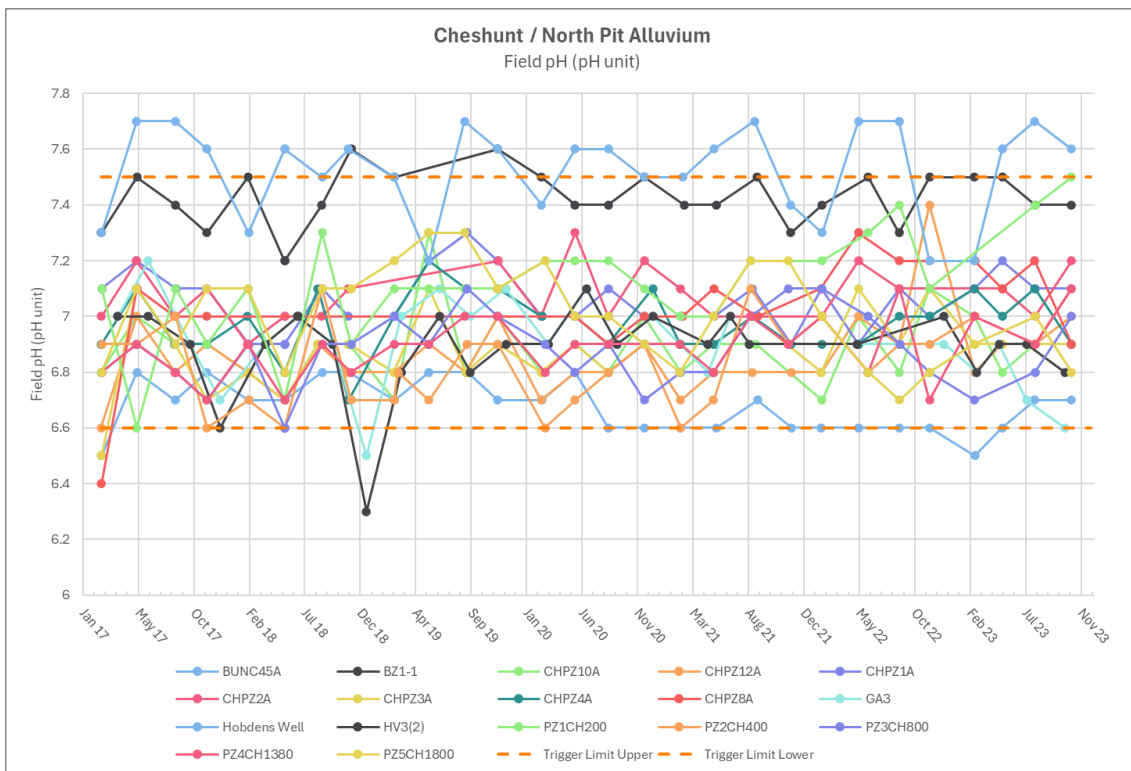
Figure 7-34: Cheshunt / North Pit Alluvium Groundwater pH Trends 2017 - 2023

Electrical Conductivity, pH and SWL trends for 2017 to 2023 are shown in Figure 7-34 to Figure 7-36. Water quality results were generally consistent with historical trends. Hobdens Well is screened within alluvium, located between the Hunter River and Cheshunt Pit. Historical readings show that Hobdens Well has recorded pH ranging between 7.1 and 7.8. Review of pH readings indicated levels fluctuated slightly, but within historical levels over 2023. It is recommended by Umwelt that the trigger level is updated to reflect historical trends.

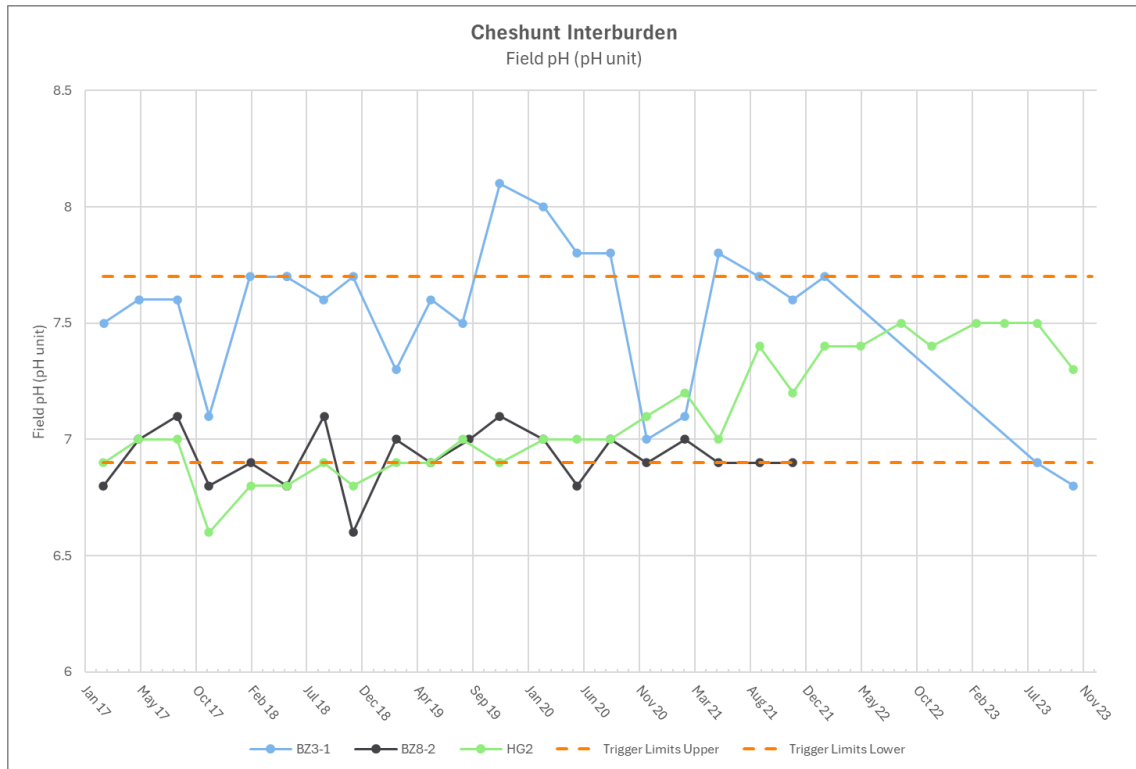
Figure 7-37: Cheshunt Interburden Groundwater pH Trends 2017 - 2023

The EC, pH and SWL trends for 2017 to 2023 are shown in Figure 7-37 to Figure 7-39. Water quality results were generally consistent with historical trends.

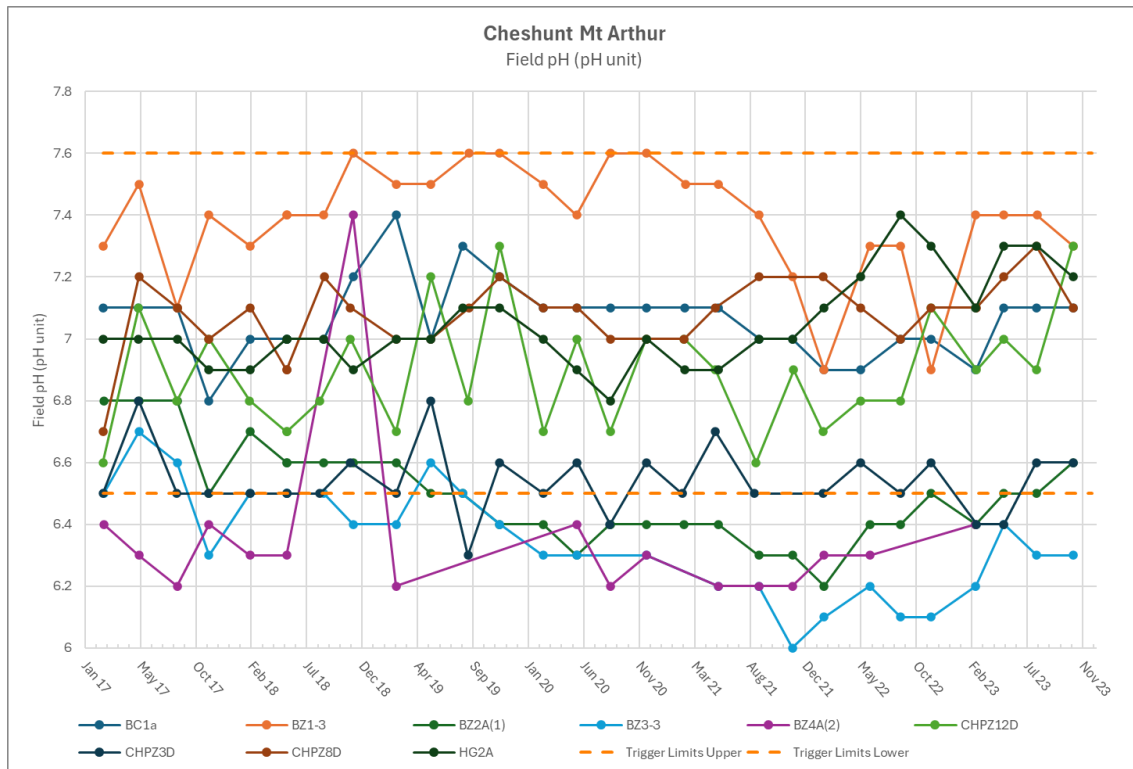
Figure 7-40: Cheshunt Mt Arthur Groundwater pH Trends 2017 - 2023

The pH, EC and SWL trends for 2017 to 2023 are shown in Figure 7-40 to Figure 7-42. Water quality results were generally consistent with historical trends except for pH. Based on historical data, pH results from all three bores have been gradually trending downward since July 2011. The groundwater level measured at the bores has typically been within or below the screened section of bores BZ4A(2) and BZ3-3 (pH – 5<sup>th</sup> Percentile). Purging/sample collection within bore BZ2A(1) and BZ3-3 may induce localised groundwater drawdown to within the screened section. This may be the cause of the reducing pH measured at these bores. The updated draft WMP includes amendments to the Cheshunt - Mt Arthur seam groundwater monitoring, including:

Bore BZ3-3, located between Cheshunt Pit and the Hunter River, and had an increasing pH trend between June 2006 (6.0) and August 2012 (7.1) followed by a decreasing trend between December 2012 (7.1) and November 2022 (6.1). The 2023 readings ranging between of 6.2 and 6.4 are within the historical range. The 2019 Groundwater Annual Review (SLR, 2020) recommended further investigation of the bore condition and construction to confirm the geology being monitored in all of the 'BZ' bores in the Cheshunt area to understand the cause of the variability in the trends between the bores. Comprehensive water quality analysis was undertaken in August 2022. The results indicated the declining pH trend is not due to connectivity to spoil water via the nearby fault.

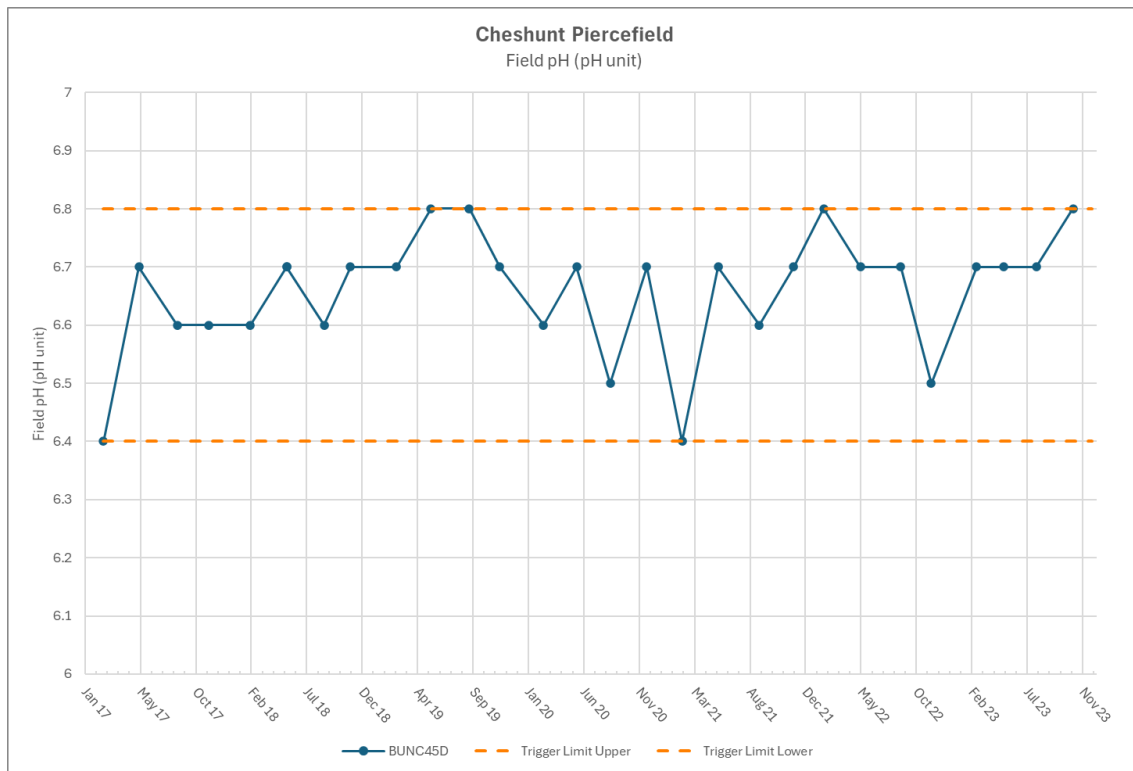
Figure 7-43: Cheshunt Piercefield Groundwater pH Trends 2017 - 2023

The pH, EC and SWL trends for 2017 to 2023 are shown in Figure 7-43 to Figure 7-45. Water quality results were generally consistent with historical trends.

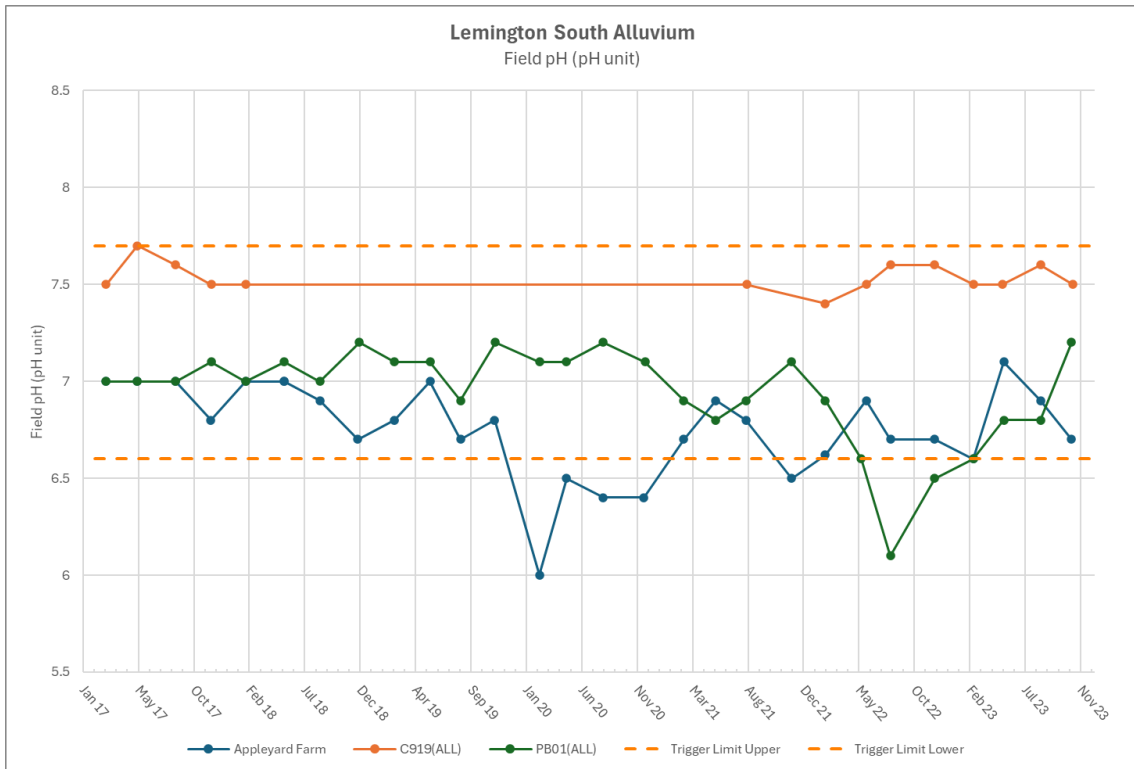
Figure 7-46: Lemington South Alluvium Groundwater pH Trends 2017 - 2023

The pH, EC and SWL trends for 2017 to 2023 are shown in Figure 7-46 to Figure 7-48. Water quality results were generally consistent with historical trends aside from one EC reading above the trigger level in Q4. Refer to Table 5.4 of Appendix B.

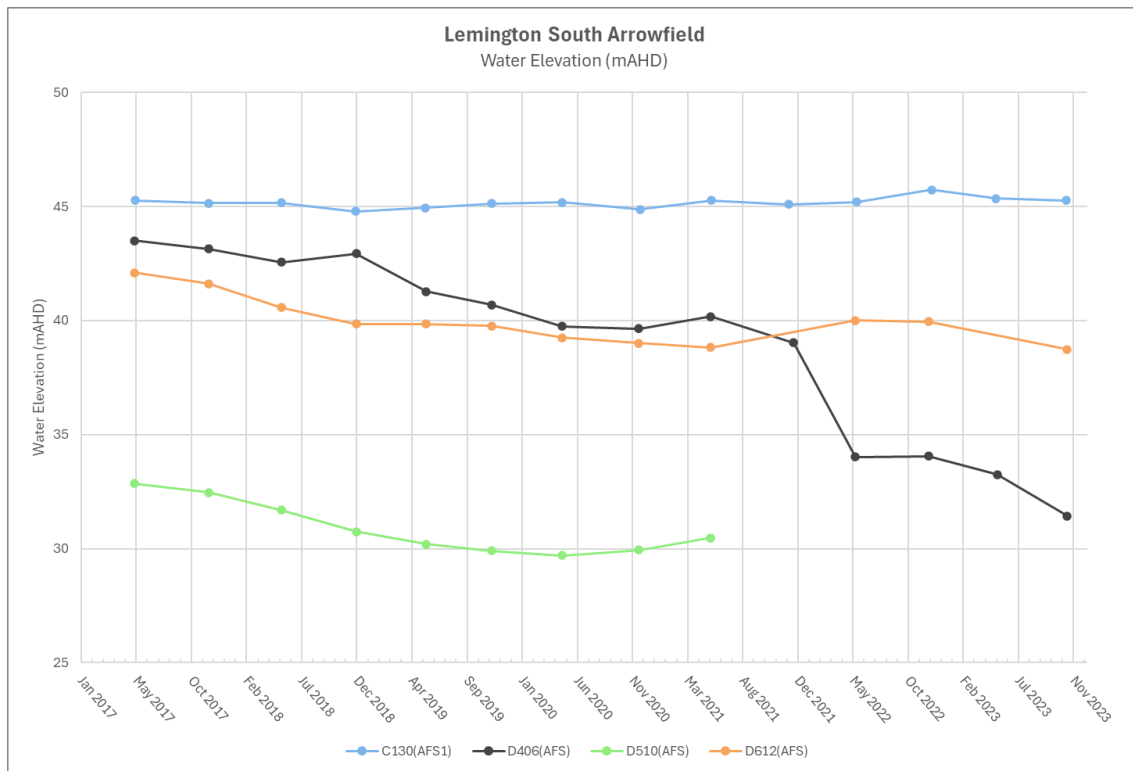
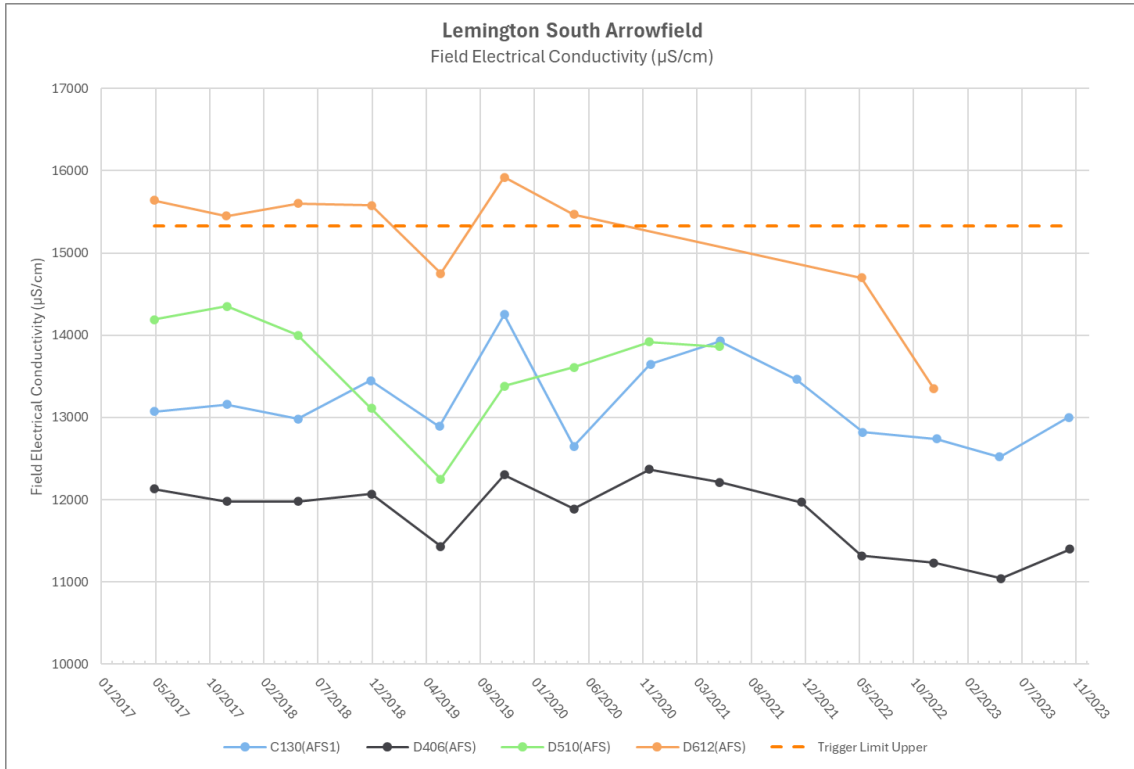
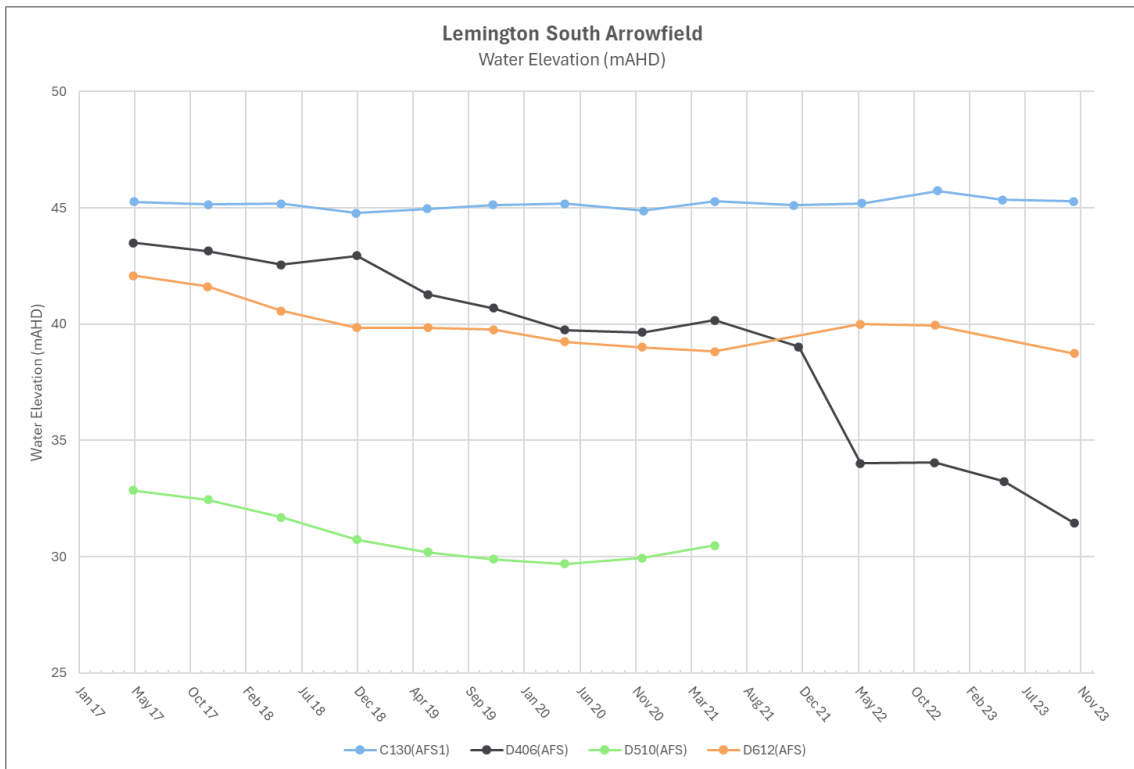
Figure 7-49: Lemington South Arrowfield Groundwater pH Trends 2017 - 2023

Figure 7-50: Lemington South Arrowfield Groundwater EC Trends 2017 - 2023

Figure 7-51: Lemington South Arrowfield Groundwater SWL Trends 2017 - 2023

The pH, EC and SWL trends for 2017 to 2023 are shown in Figure 7-49 to Figure 7-51. Water quality results were generally consistent with historical trends.

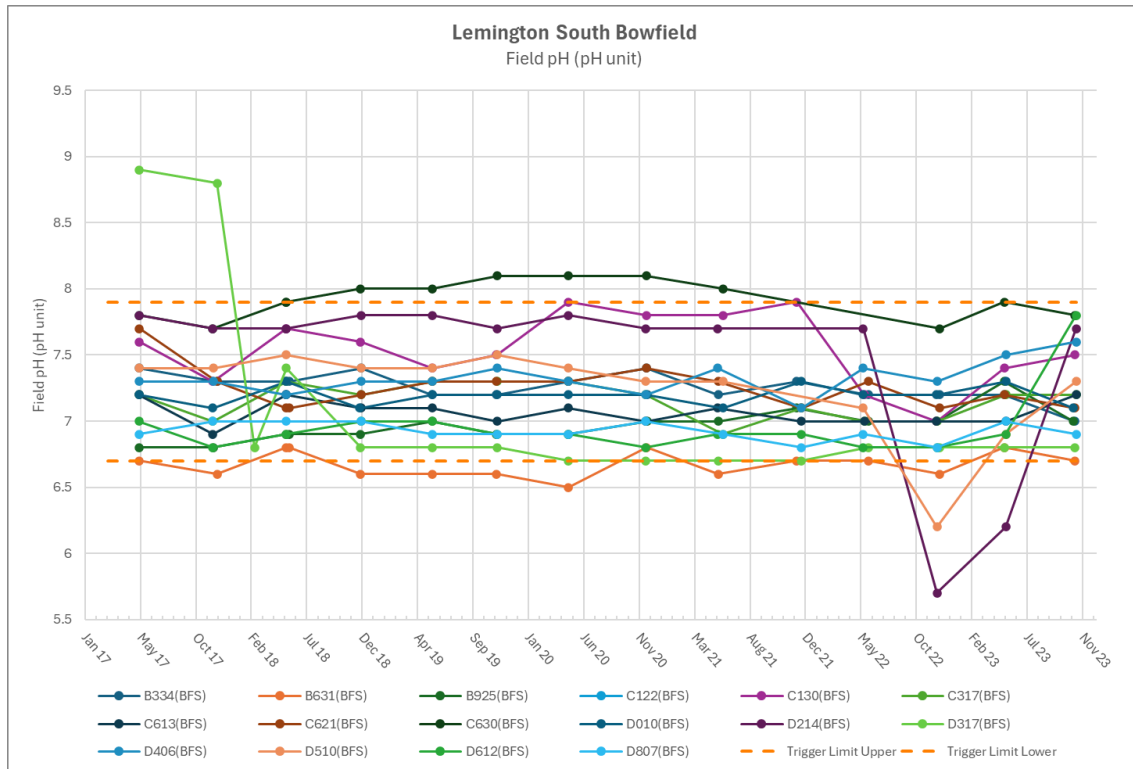
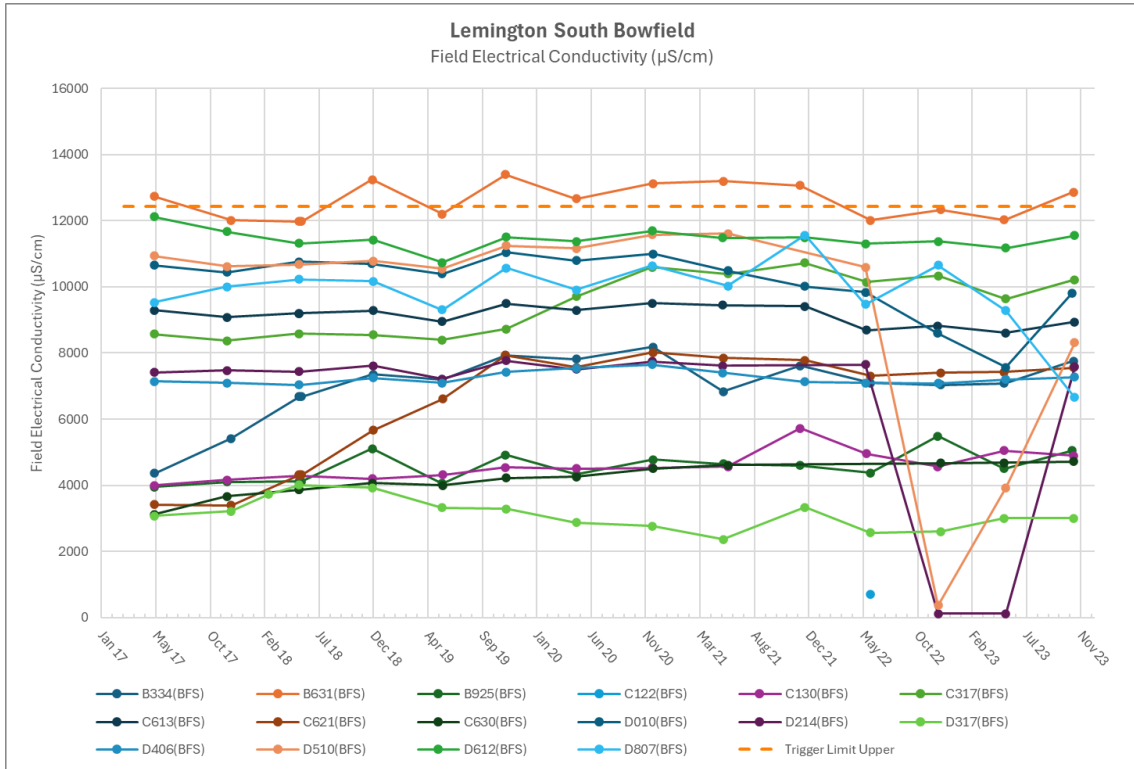
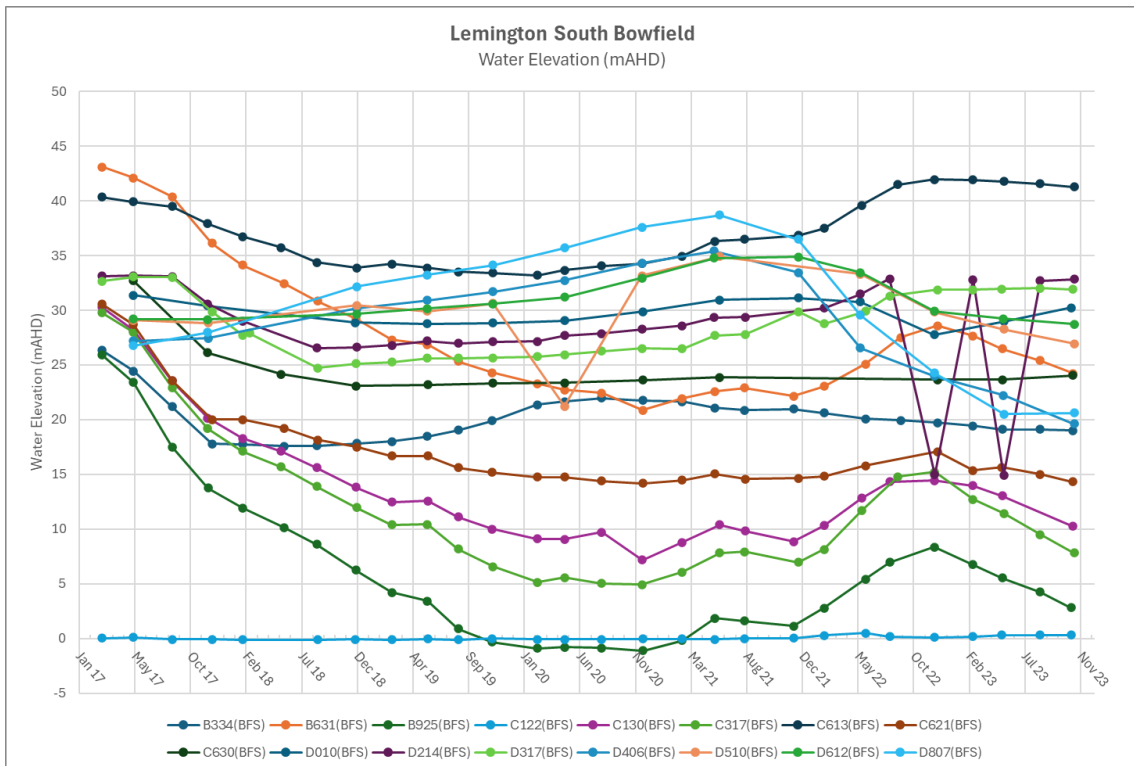
Figure 7-52: Lemington South Bowfield Groundwater pH Trends 2017 – 2023

Figure 7-53: Lemington South Bowfield Groundwater EC Trends 2017 – 2023

Figure 7-54: Lemington South Bowfield Groundwater SWL Trends 2017 - 2023

The pH, EC and SWL trends for 2017 to 2023 are shown in Figure 7-52 to Figure 7-54. Water quality results were generally considered to be consistent with historical trends. There were no exceedances of trigger levels (3 or more consecutive events) in 2023.

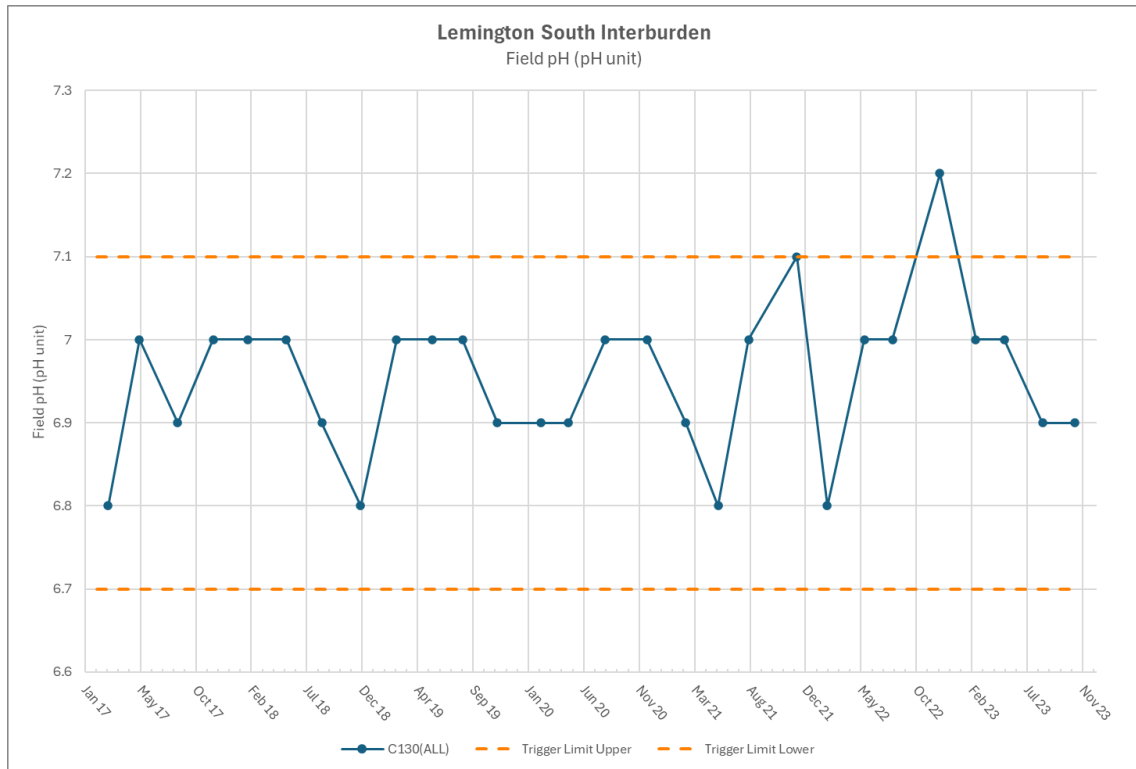
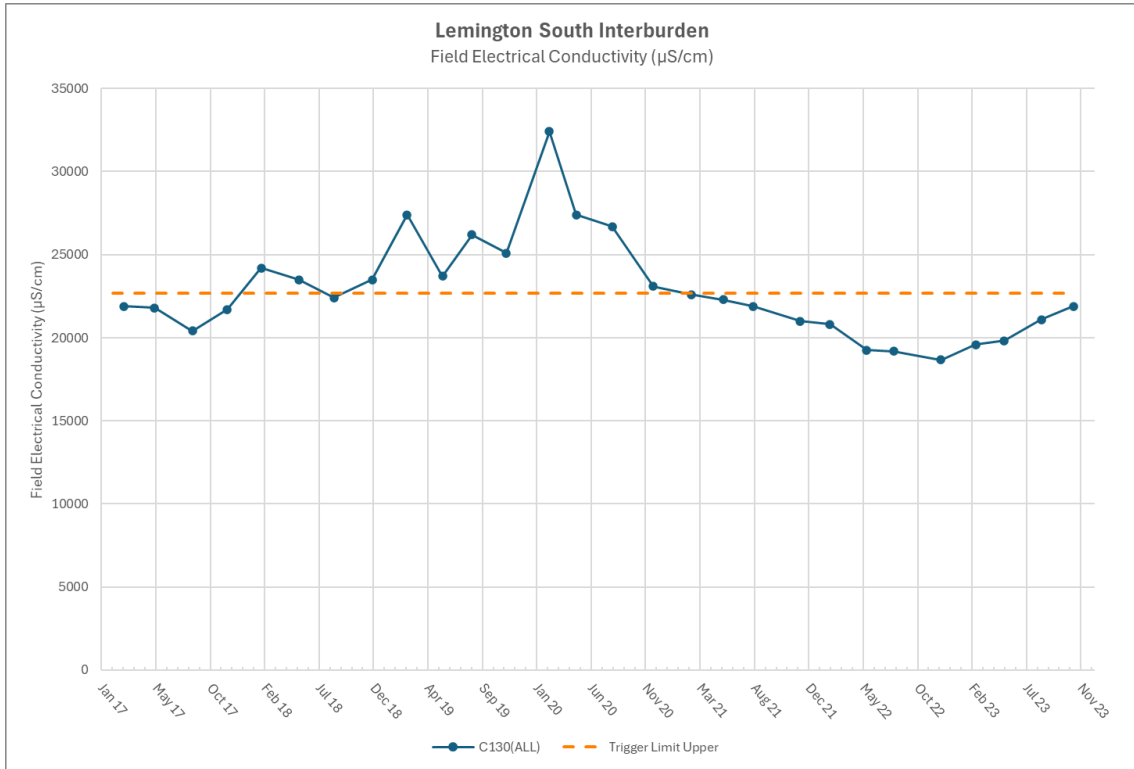
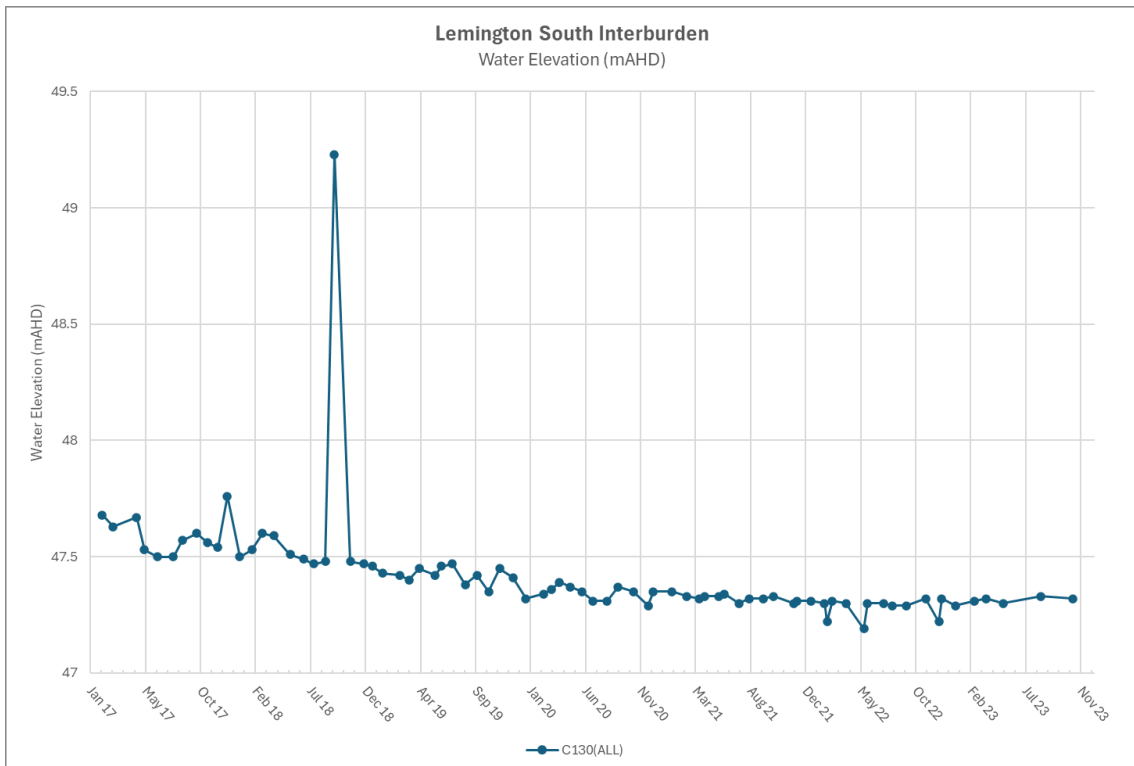
Figure 7-55: Lemington South Interburden Groundwater pH Trends 2017 - 2023

Figure 7-56: Lemington South Interburden Groundwater EC Trends 2017 - 2023

Figure 7-57: Lemington South Interburden Groundwater SWL Trends 2017 - 2023

The pH, EC and SWL trends for 2017 to 2023 are shown in Figure 7-55 to Figure 7-57. Historical readings of C130(ALL) show regular fluctuations of pH between 6.6 and 7.2 The 2023 readings for pH are considered consistent with historical concentrations.

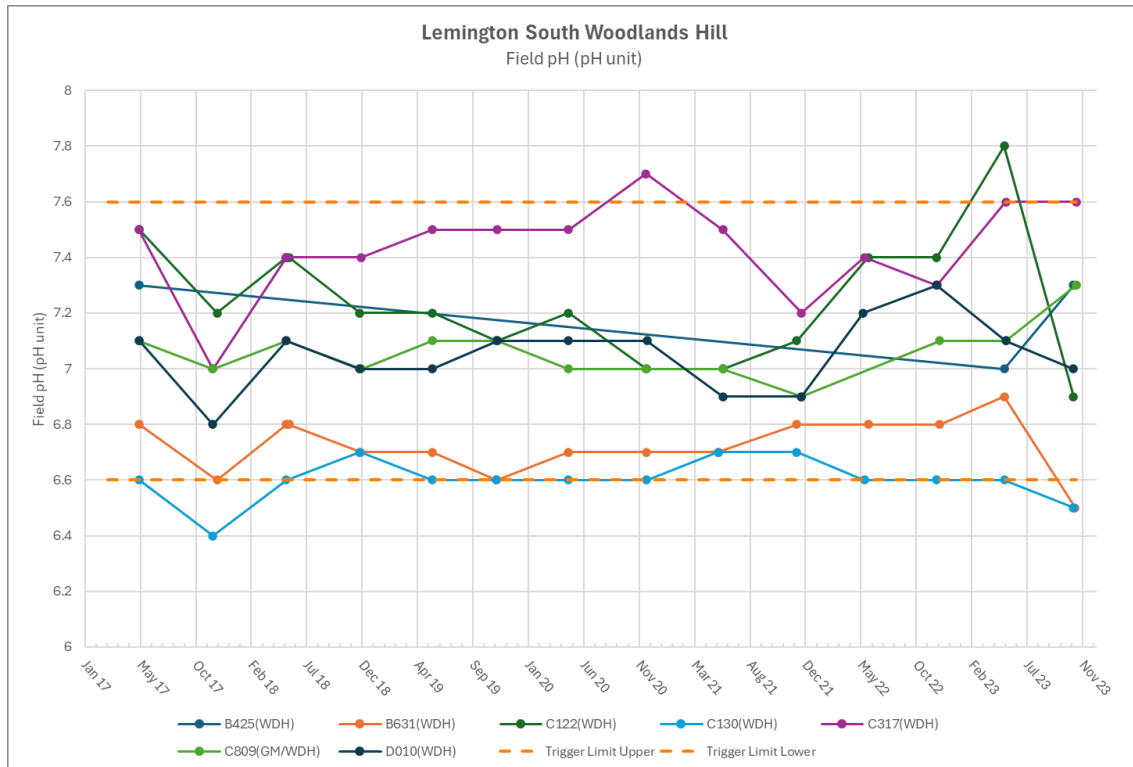
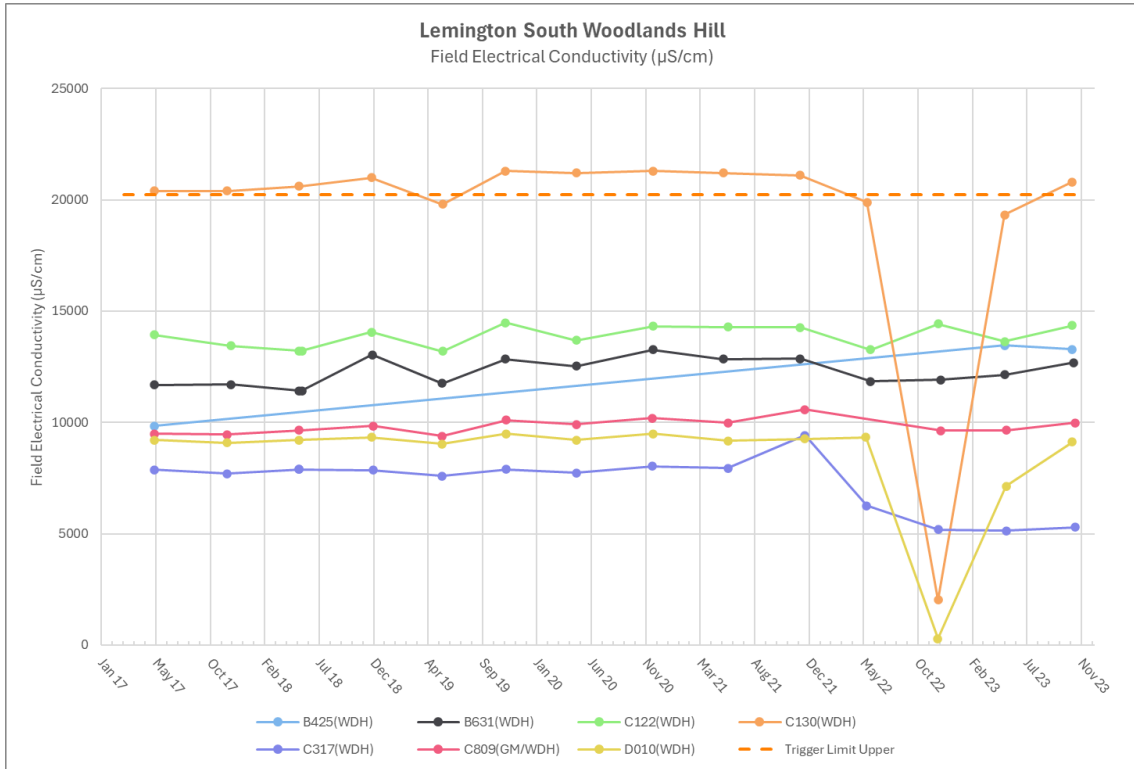
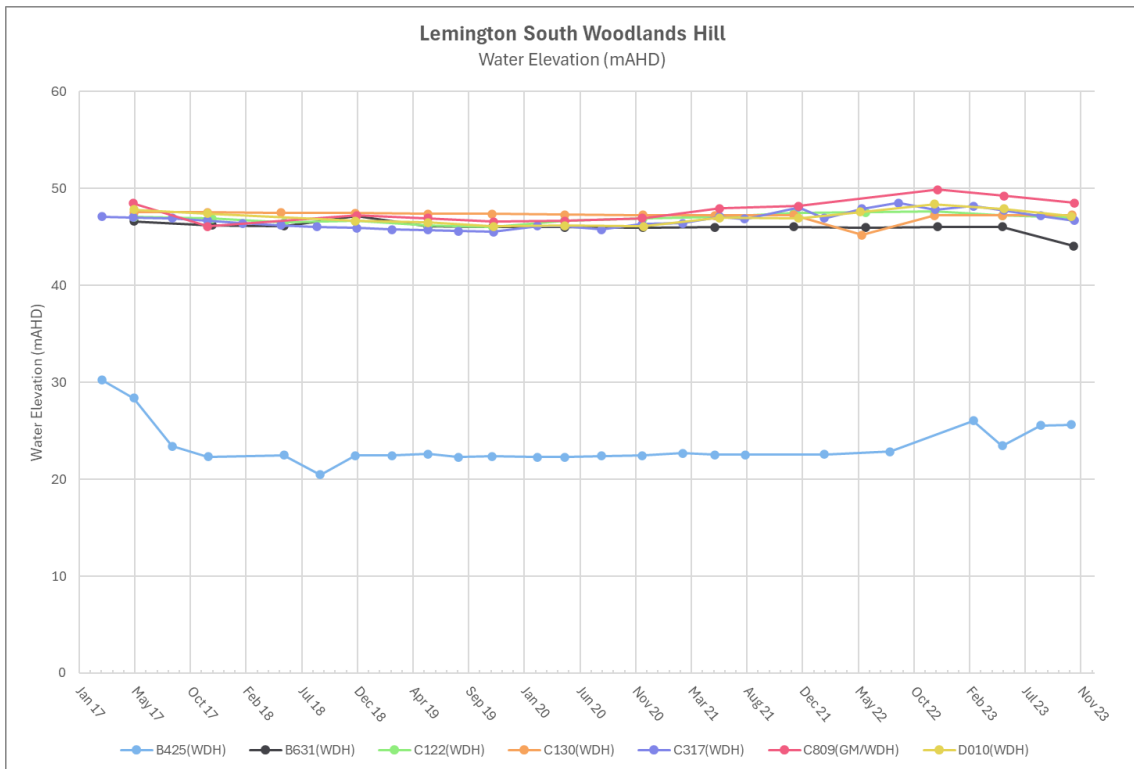
Figure 7-58: Lemington South Woodlands Hill Groundwater pH Trends 2017 – 2023

Figure 7-59: Lemington South Woodlands Hill Groundwater EC Trends 2017 - 2023

Figure 7-60: Lemington South Woodlands Hill Groundwater SWL Trends 2017 - 2023

The pH, EC and SWL trends for 2017 to 2023 are shown in Figure 7-58 to Figure 7-60. Water quality results were generally consistent with historical trends, with no measurements outside of trigger limits for three (3) consecutive monitoring events or greater.

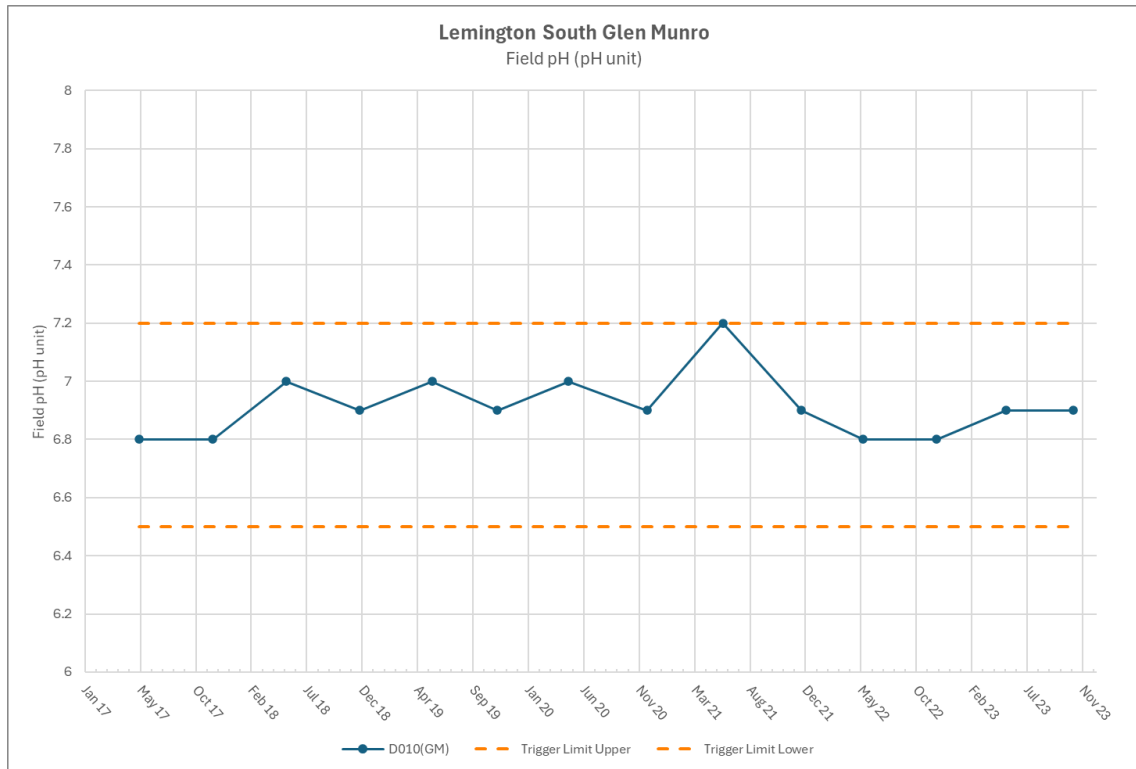
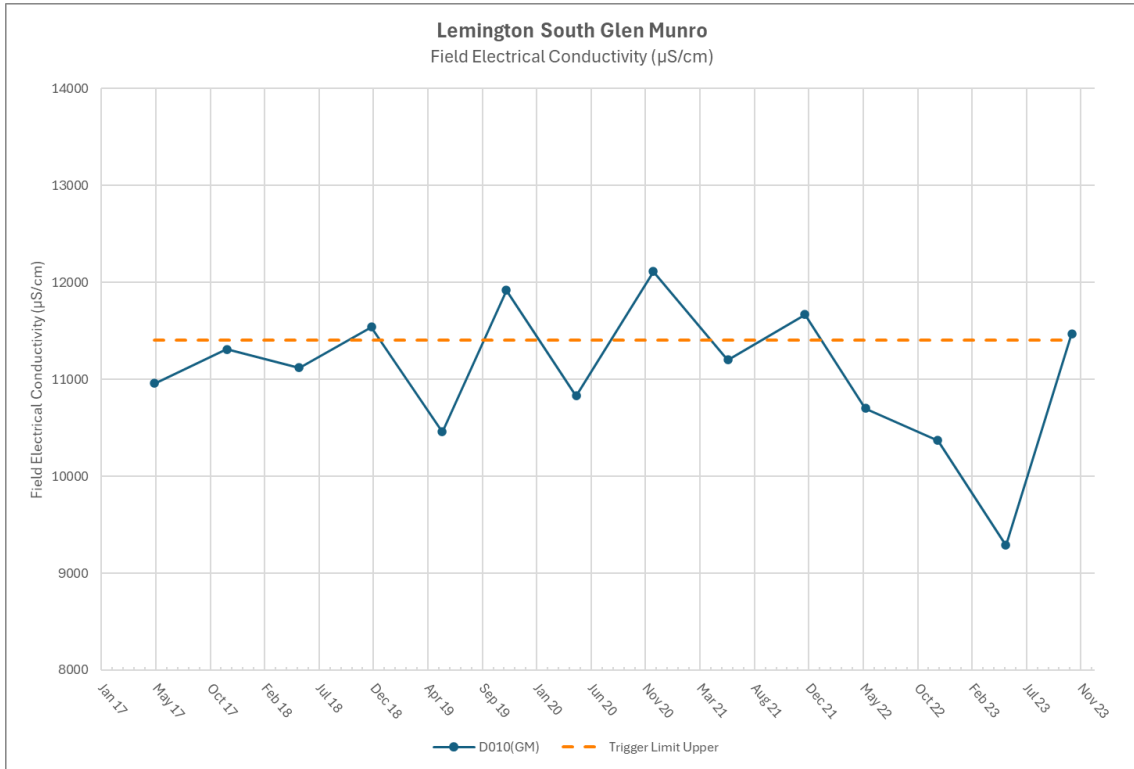
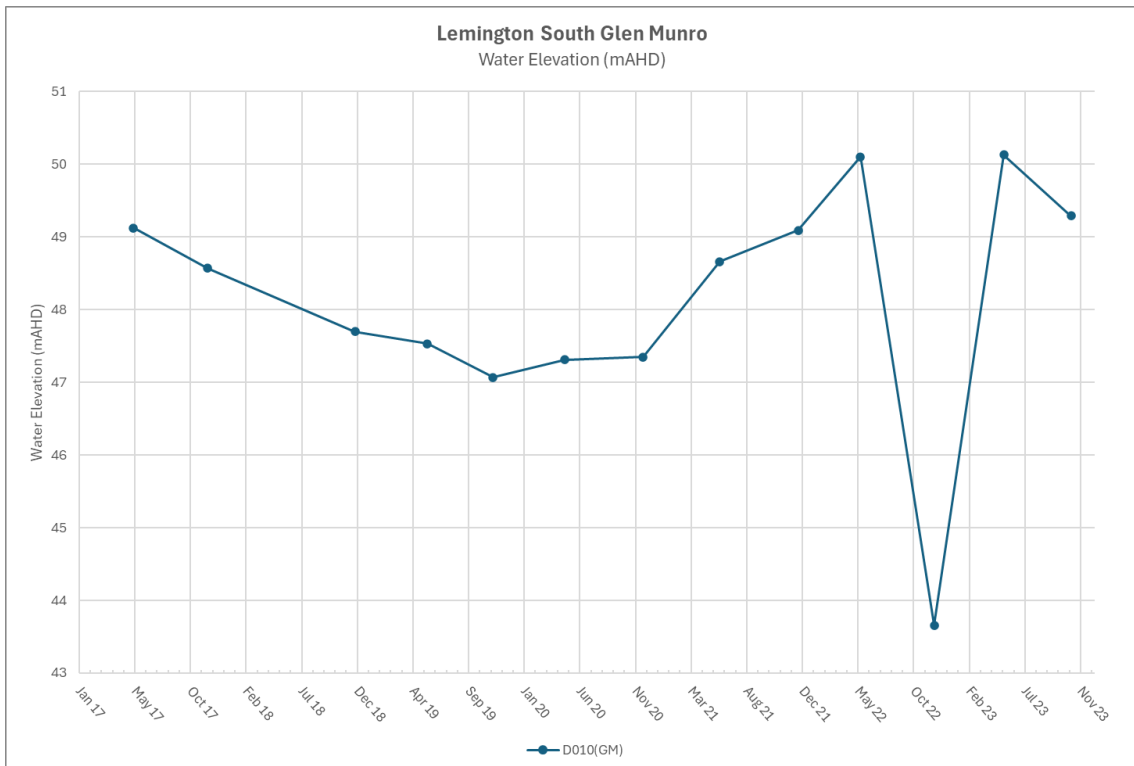
Figure 7-61: Lemington South Glen Munro Groundwater pH Trends 2017 - 2023

Figure 7-62: Lemington South Glen Munro Groundwater EC Trends 2017 - 2023

Figure 7-63: Lemington South Glen Munro Groundwater SWL Trends 2017 - 2023

pH, EC and SWL trends at Lemington South Glen Munro from 2017 to 2023 are shown in Figure 7-61 to Figure 7-63. Water quality results were generally consistent with historical trends.

The assignment of trigger values has been removed for bore D010(GM) in the draft WMP that has been submitted to DPHI for approval.
