# HUNTER VALLEY OPERATIONS

## 2023 ANNUAL ENVIRONMENTAL REVIEW

# REPORT | 2023 ANNUAL ENVIRONMENTAL REVIEW

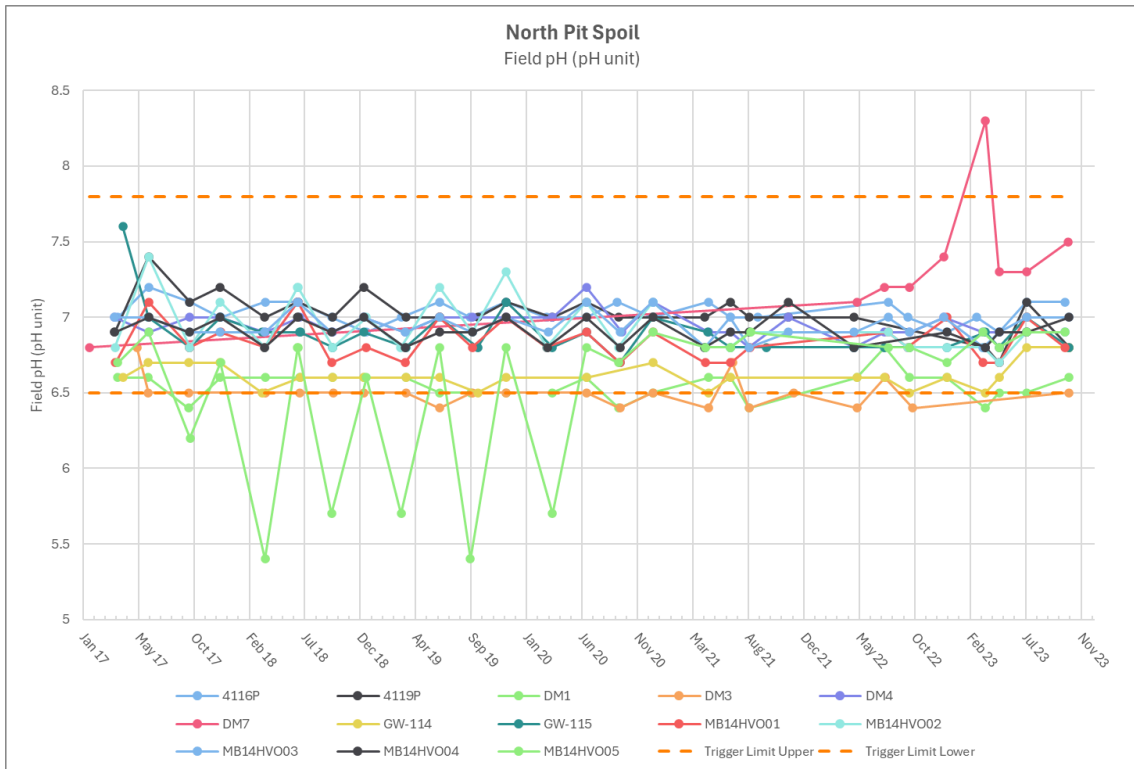
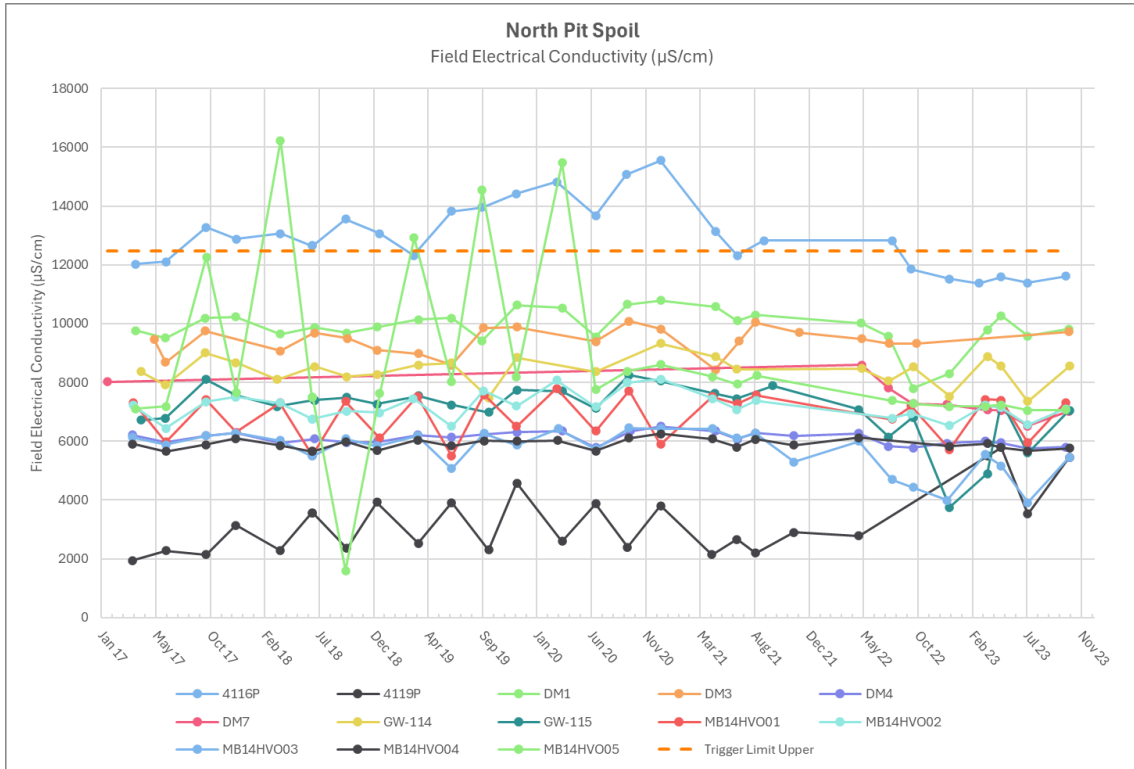
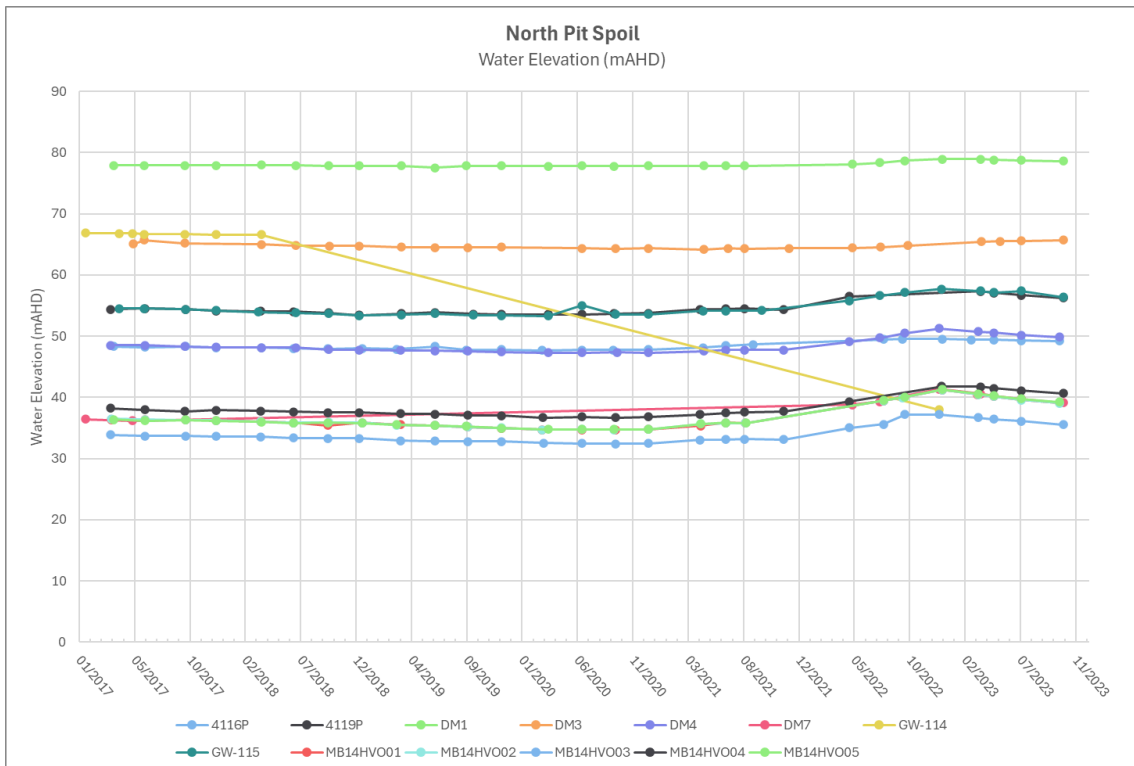
Figure 7-64: North Pit Spoil Groundwater pH Trends 2017 - 2023

Figure 7-65: North Pit Spoil Groundwater EC Trends 2017 – 2023

Figure 7-66: North Pit Spoil Groundwater SWL Trends 2017 - 2023

The pH, EC and SWL trends for 2017 to 2023 are shown in Figure 7-64 to Figure 7-66. Groundwater within the spoil flows from northern-most bore DM1 in a southerly direction towards the southern-most bore MB14HVO03. EC and pH was found to generally be within historical levels.

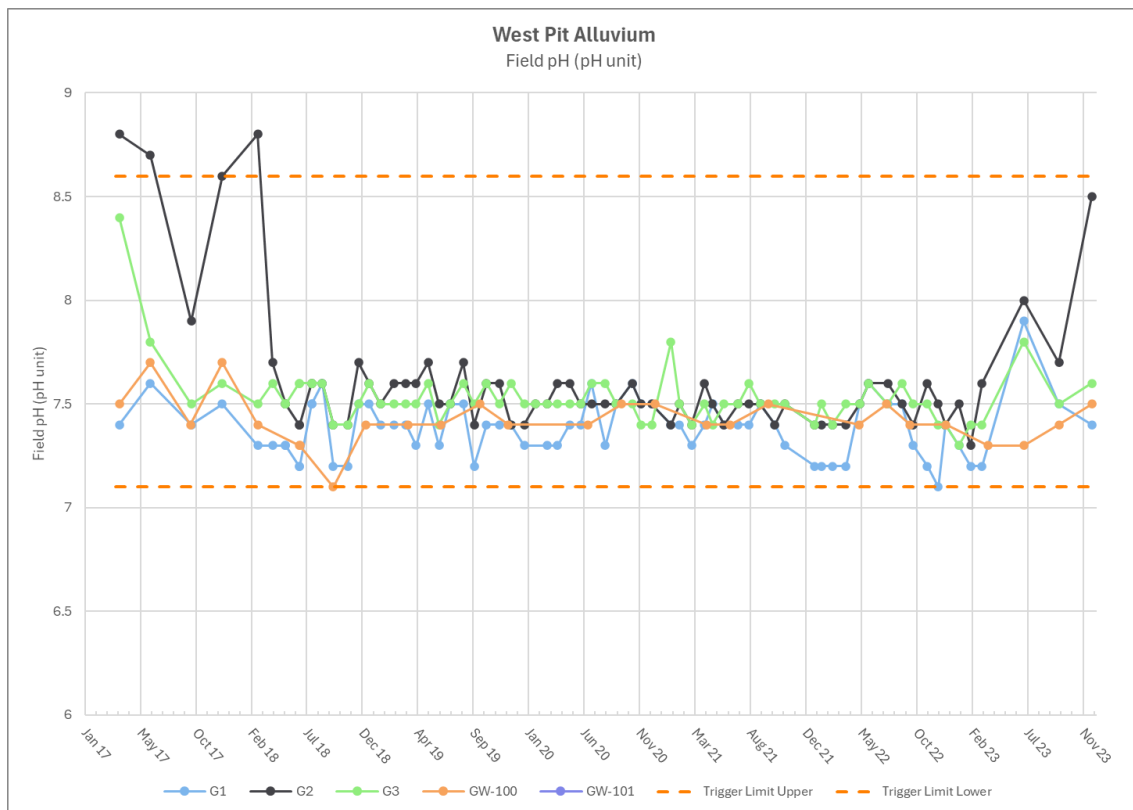
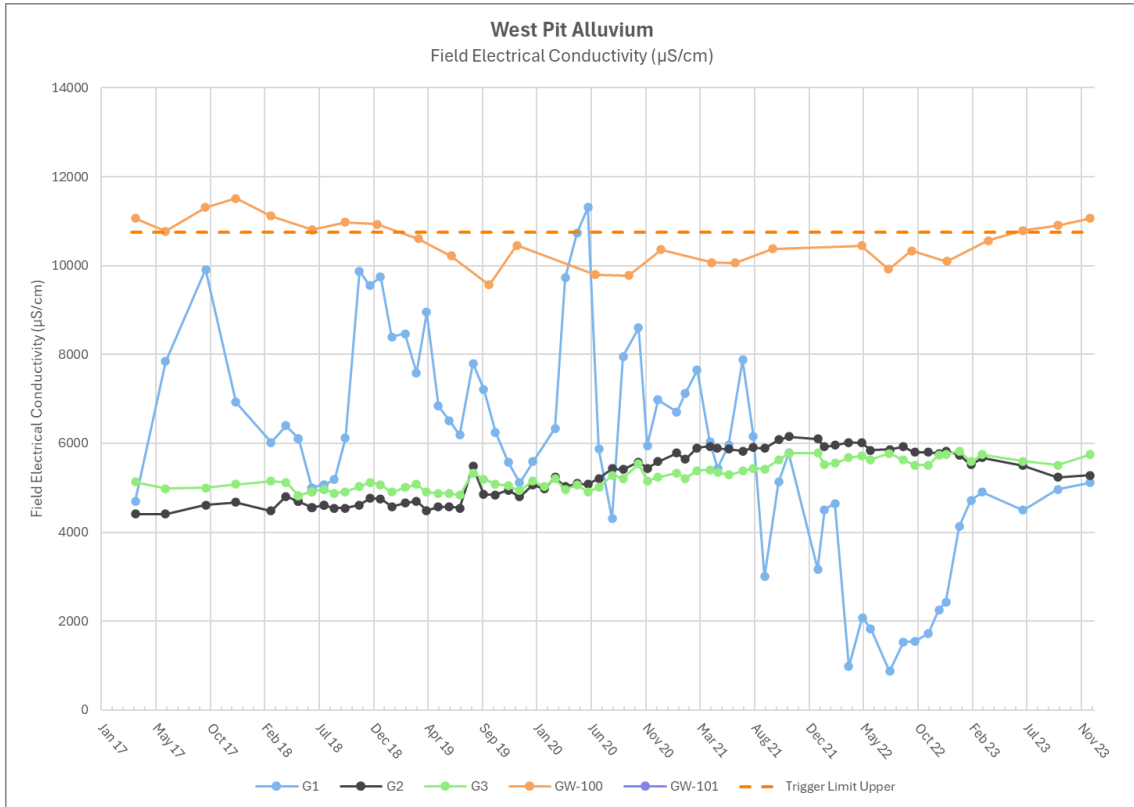
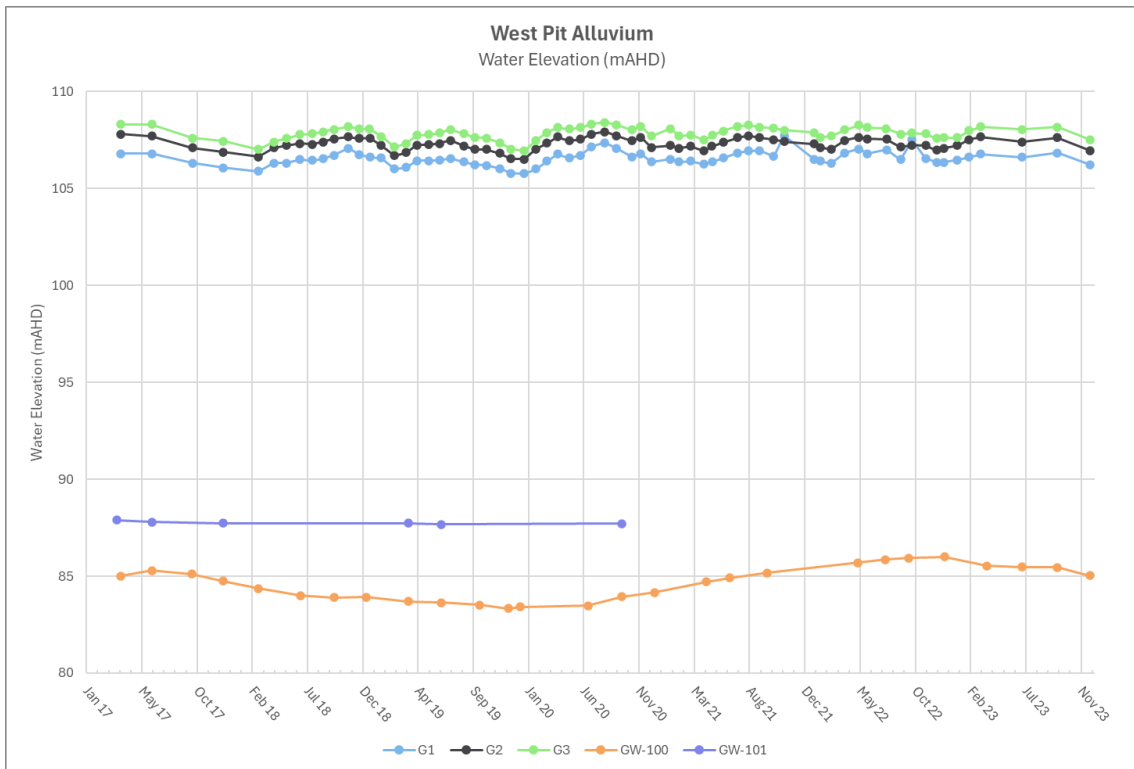
Figure 7-67: West Pit Alluvium Groundwater pH Trends 2017 - 2023

Figure 7-68: West Pit Alluvium Groundwater EC Trends 2017 - 2023

Figure 7-69: West Pit Alluvium Groundwater SWL Trends 2017 - 2023

The pH, EC and SWL trends for 2017 to 2023 are shown in Figure 7-67 to Figure 7-69. Bore GW-101 was unable to be sampled due to insufficient water and lack of access throughout 2023. Water quality results were generally consistent with historical trends.

Bore GW-100 recorded consecutive EC readings above the trigger level from April to December 2023 (Q2, Q3 and Q4). Prior to 2023 EC concentrations remained relatively stable. The EC exceedances are understood to be due to declining groundwater levels. Trends will continue to be monitored to determine if they are related to mining activities. Further detail on this exceedance is presented in Table 6.2 of Appendix B. Water levels at GW-100 were rising during 2023 but are within trigger limits.

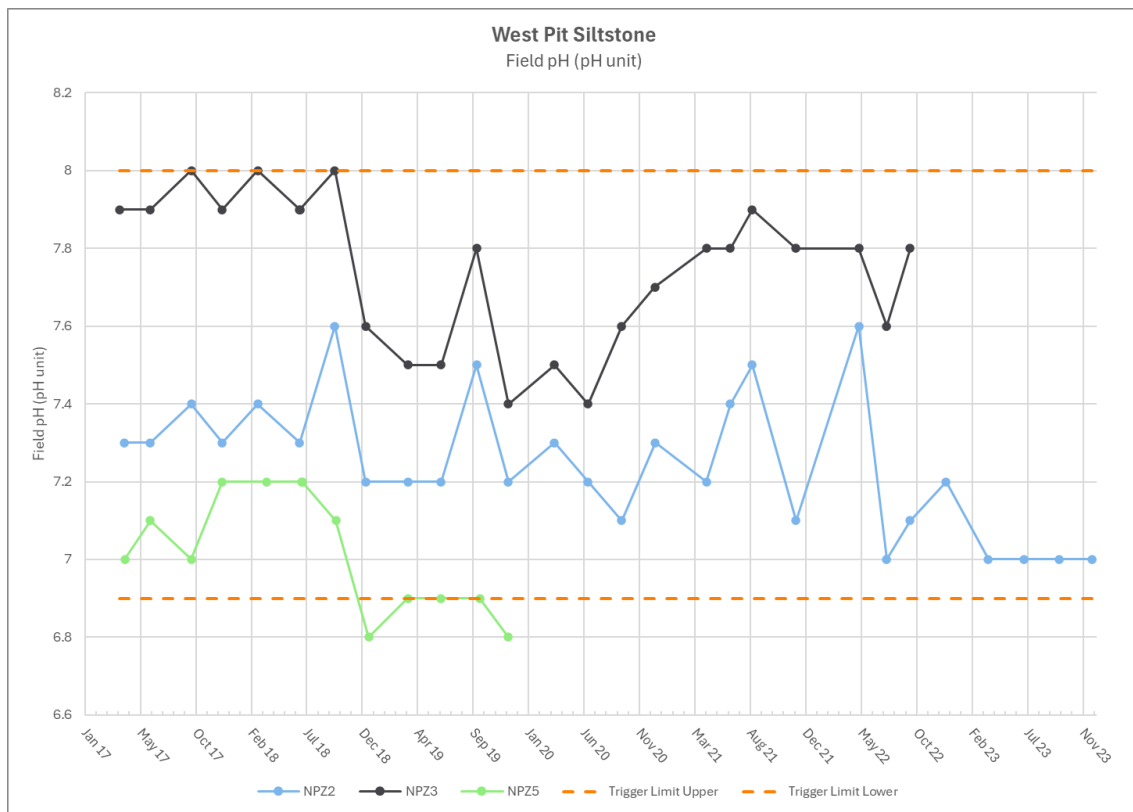
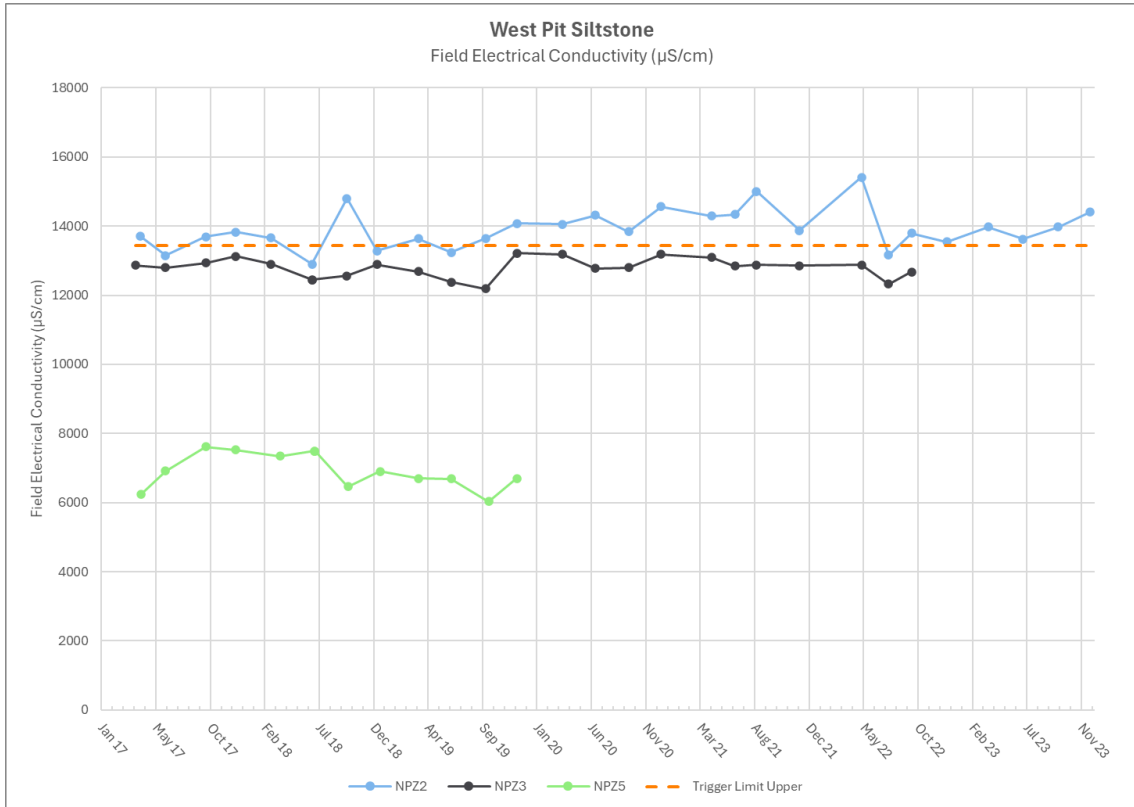
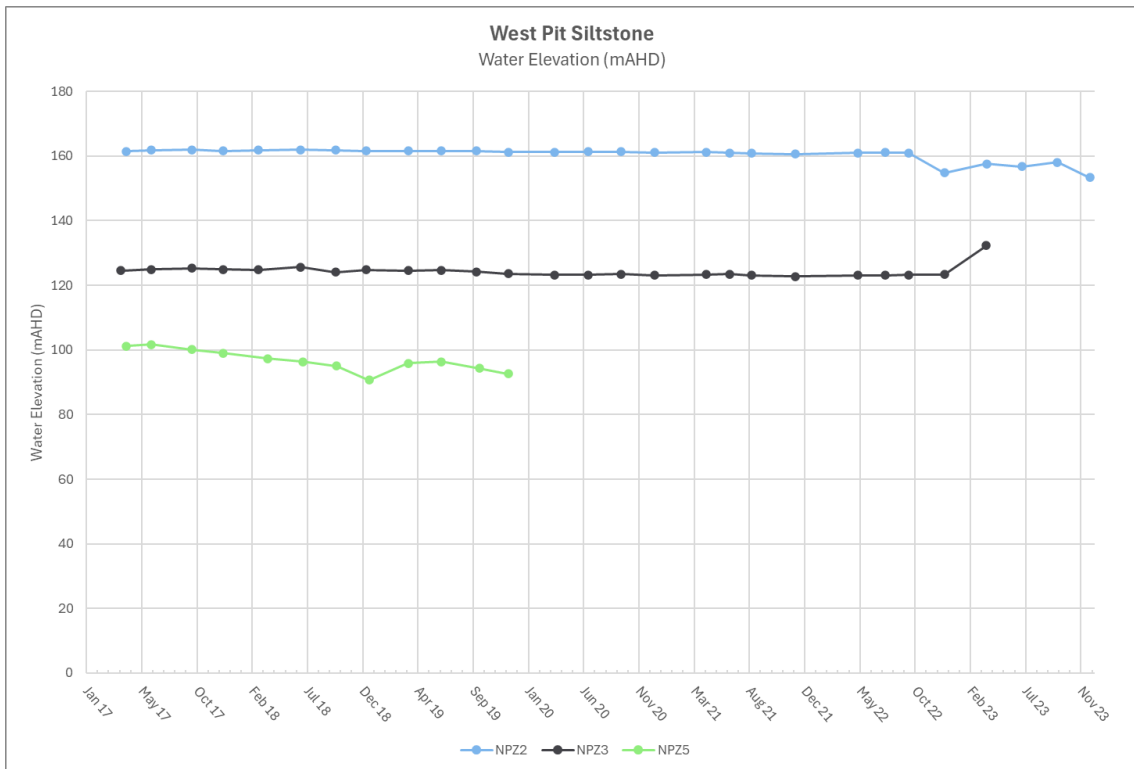
Figure 7-70: West Pit Sandstone/Siltstone Groundwater pH 2017 - 2023.

Figure 7-71: West Pit Sandstone/Siltstone Groundwater EC Trends 2017 - 2023

Figure 7-72: West Pit Sandstone/Siltstone Groundwater SWL Trends 2017 – 2023

The pH, EC and SWL trends for 2017 to 2023 are shown in Figure 7-70 to Figure 7-72. Water quality results were generally consistent with historical trends.

EC was above trigger limit at NPZ2 for all readings during the monitoring period. NPZ2 is located northwest of West Pit beyond the outcrop of coal seams mined at West Pit and intersects Interburden sequences beneath the coal seams. EC readings range from 12,590 µS/cm (December 2014) and 19,400 µS/cm (December 2009). The 2023 readings are consistent with historical concentrations. The 2019 Groundwater Network Review (SLR, 2019a) noted that the bore is unlikely to detect relevant site impacts and recommended removal from the compliance monitoring network but kept in operational monitoring network for future work. The bore has already been removed from the compliance monitoring network in version 3.4 of the WMP which is currently with DPHI for approval.

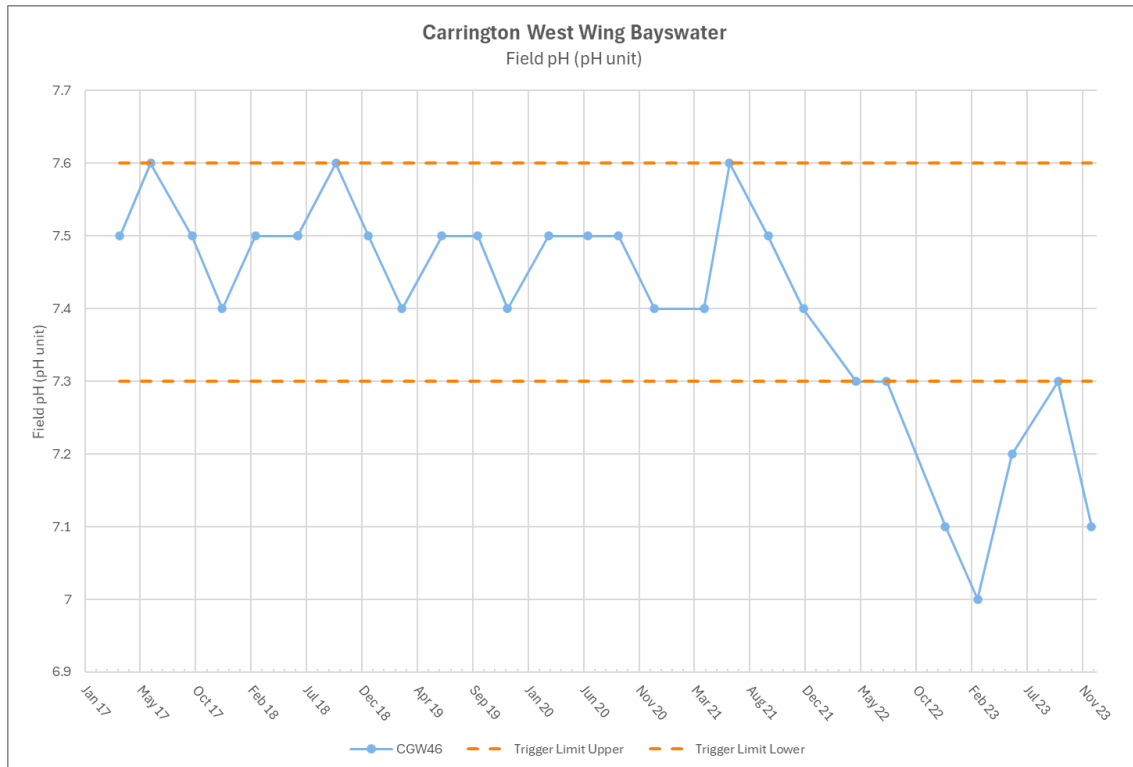
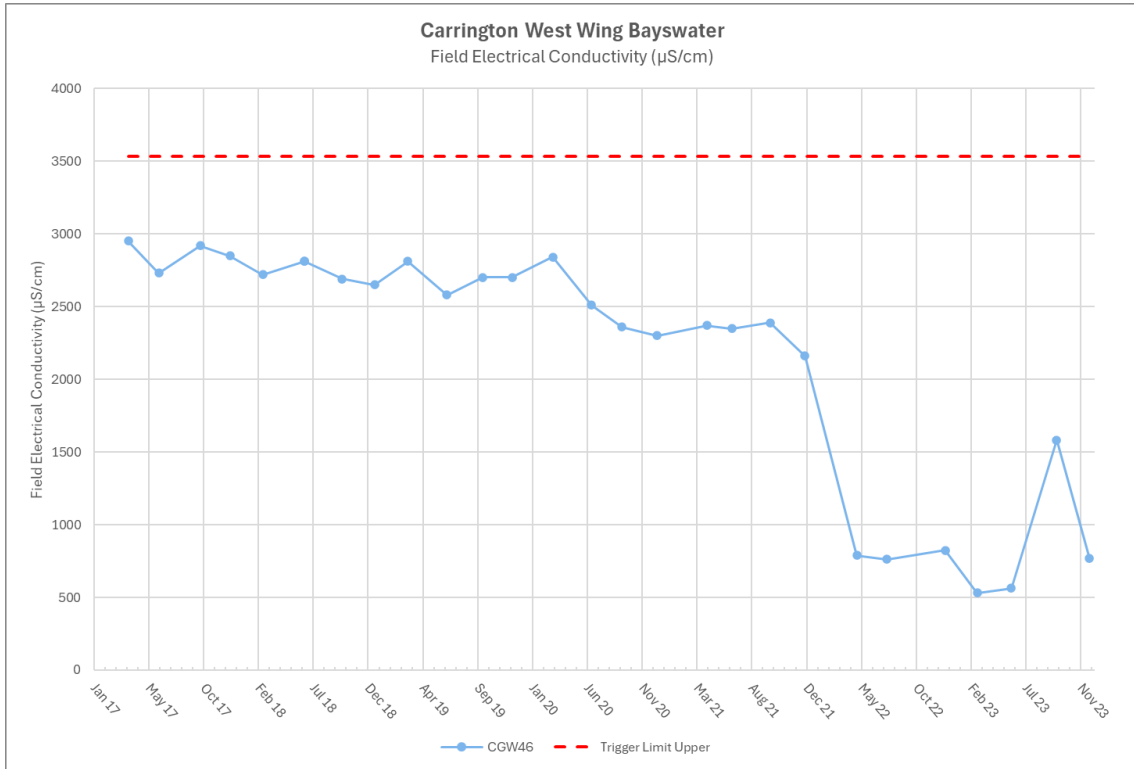
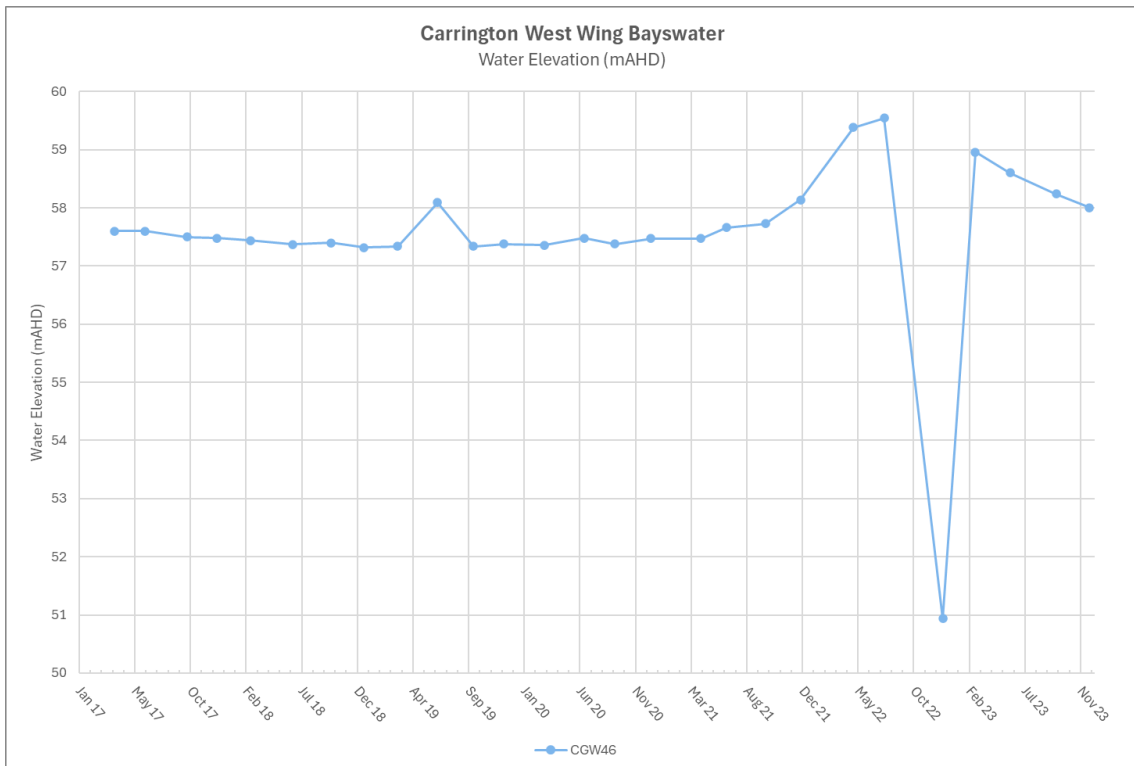
Figure 7-73: Carrington West Wing Bayswater Groundwater pH Trends 2017 to 2023

Figure 7-74: Carrington West Wing Bayswater Groundwater EC Trends 2017 to 2023

Figure 7-75: Carrington West Wing Bayswater Groundwater SWL Trends 2017 to 2023

The pH, EC and SWL trends for 2017 to 2023 are shown in Figure 7-73 to Figure 7-75. Water quality results showed a drop in EC and SWL. Bore CGW46 recorded pH below the lower trigger level in Q1, Q2 and Q4. Historical pH readings for the bore since 2005 show regular fluctuations of between 7.1 and 7.8. The 2023 readings ranging from 7.0 to 7.3 are considered consistent with historical concentrations, with no adverse impacts identified. The bore was cleaned and purged by AECOM in 2023 and will be reassessed using a borehole camera in 2024.

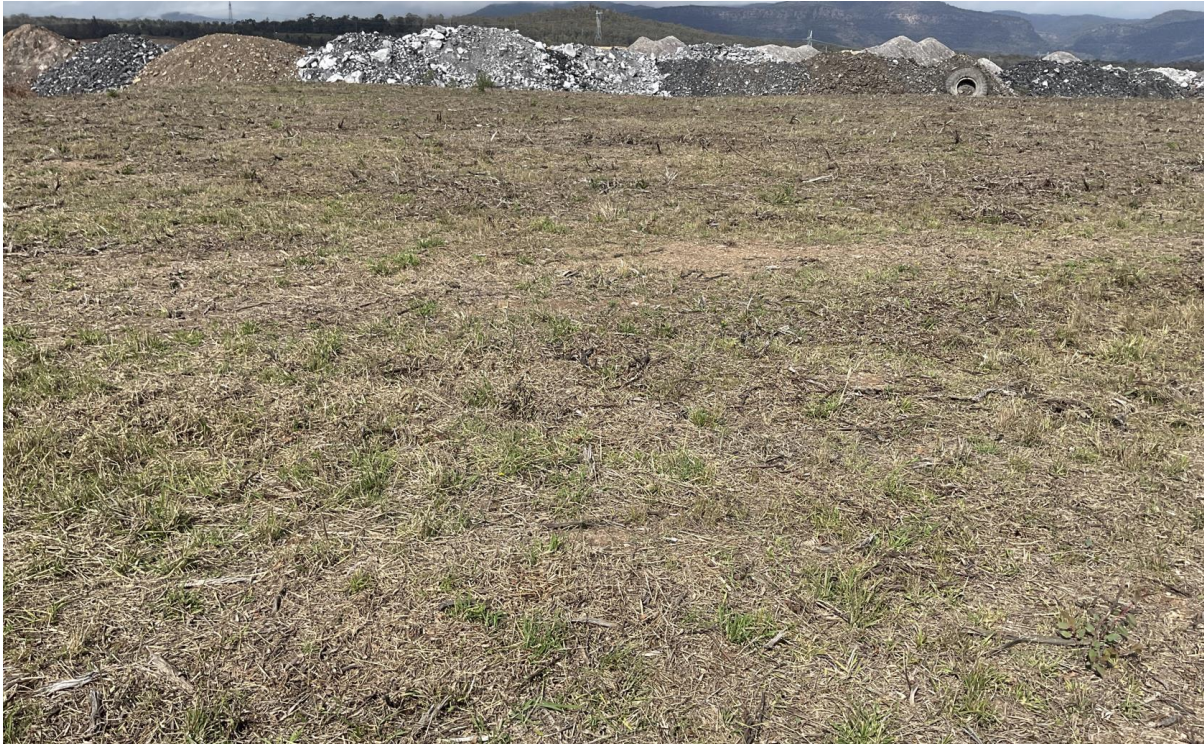
Figure 8-5: Mulching of Acacia Saligna at HVORIV202002

Broadacre weed treatment within rehabilitation areas is undertaken using agricultural methods comprising boom sprays, wick wipers and slasher/mulchers. In existing rehabilitation areas boom spraying is primarily used to manage cover crop and fallow areas prior to sowing to final native seed mixes. Pre-emergent application of herbicide is used when appropriate and necessary to control emerging weeds in the period between sowing and germination of the desired species. Wick wiping targets rapidly growing exotic grasses and other erect growing weeds in the period following native germination while desirable species remain below the wiper target zone. Slashing and mulching is also used to remove rank pasture grasses and stimulate fresh growth. In 2023, HVO completed a target campaign to mulch Acacia Saligna with 8.7ha of thick Acacia Saligna mulched using a forestry mulcher which can be seen below in **Figure 8-5**. This campaign will continue to be implemented in 2024.

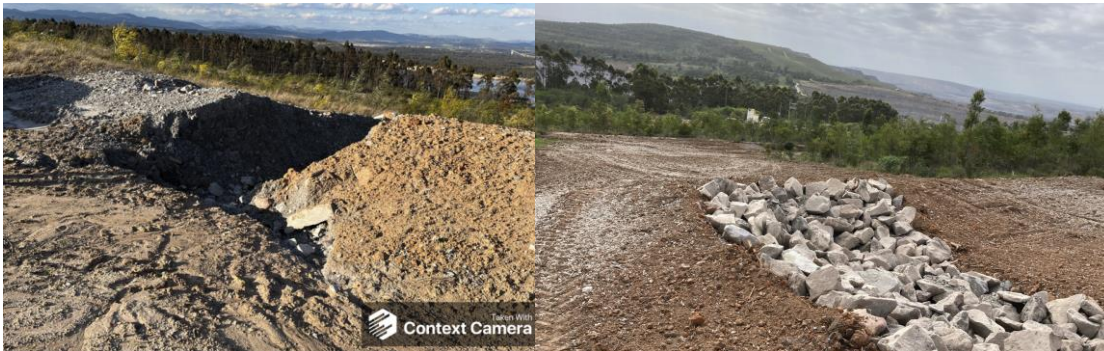
Figure 8-6: Erosion repair at HVOWES202201

Drainage structures such as contour banks, drop structures and sediment dams are largely functioning as designed and require little to no maintenance, particularly in more recently established rehabilitation areas. Erosion repairs were conducted across the site in 2023 in line with the annual rehabilitation maintenance plan including drainage repair, contour re shaping and desilting. An example of contour repair conducted at HVO WES202201 is provided in Figure 8-6.

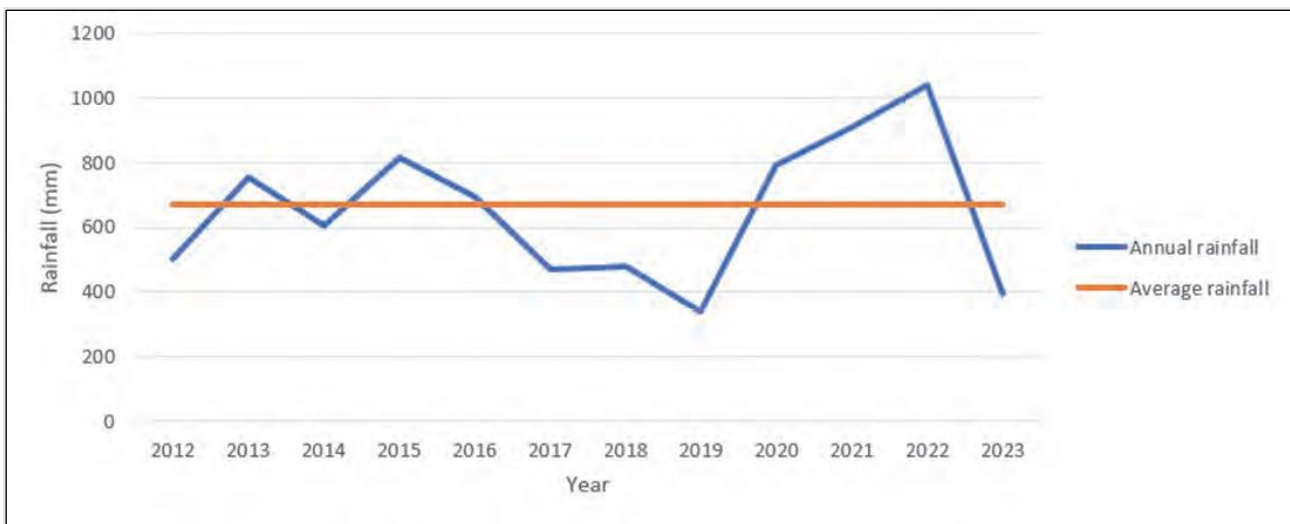
Figure 8-16: Annual rainfall at HVO Lemington since 2012 (to 15/12/2023)

With the decline in the La Nina weather patterns of previous years, the rainfall received in 2023 was below the average for HVO (**Figure 8-16**). The total rainfall for the year at HVO (Corp) was 459 mm, which was a large decrease on 2022.

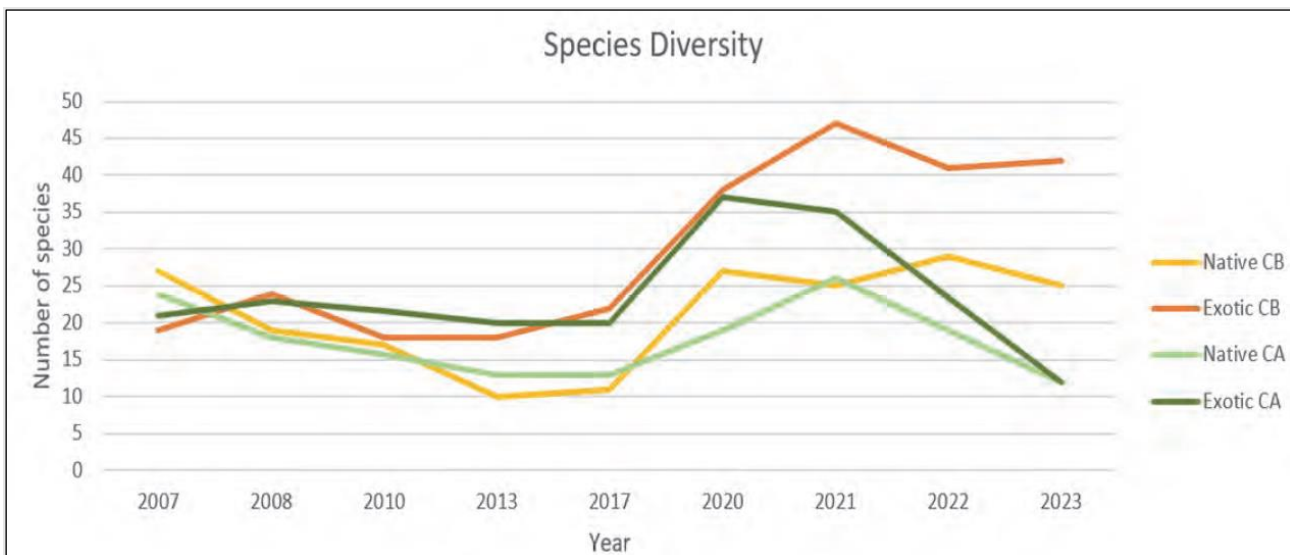
Figure 8-17: Change in Species Diversity Over Time at Carrington Billabong (orange) and the Reference Site (green)

There are several factors that influence the diversity, cover and abundance of flora. This includes rainfall incidence and site characteristics e.g. local catchment and run-on areas. **Figure 8-17** illustrates the trends in floral diversity over time for Carrington Billabong and the Reference site. In general, there has been a gradual increase in the diversity of native and exotic species over time, with a minor increase in diversity of

exotics and minor decrease in native species compared to last year. Since 2008, there has been a greater diversity of exotic species compared to natives, with exotic species representing 63% of species recorded at Carrington Billabong in 2023. However, this is mostly influenced by CB5, as native and exotic species diversity were equal at CB1 and CB2. CB5 occurs on the adjacent floodplain, which is open and drier than the other monitoring locations. CB5 has not been planted, received supplementary seeding or subject to specific weed control other than slashing, and the plot is more representative of the adjacent agricultural landscape. At CB5, exotics species comprise 79% of the total species which is a trend that has occurred at most years within CB5.

A decrease in species diversity has occurred since 2021 at the Reference Site. This is likely due to the flood event in 2022 and early 2023, where the billabong was flooded for most of 2022 and the first few months of 2023, resulting in no data captured in 2022. Long periods of inundation have resulted in the death of most plants and the data captured in 2023 shows early recovery since floodwaters have receded, with low species diversity, equally represented by native and exotic species.

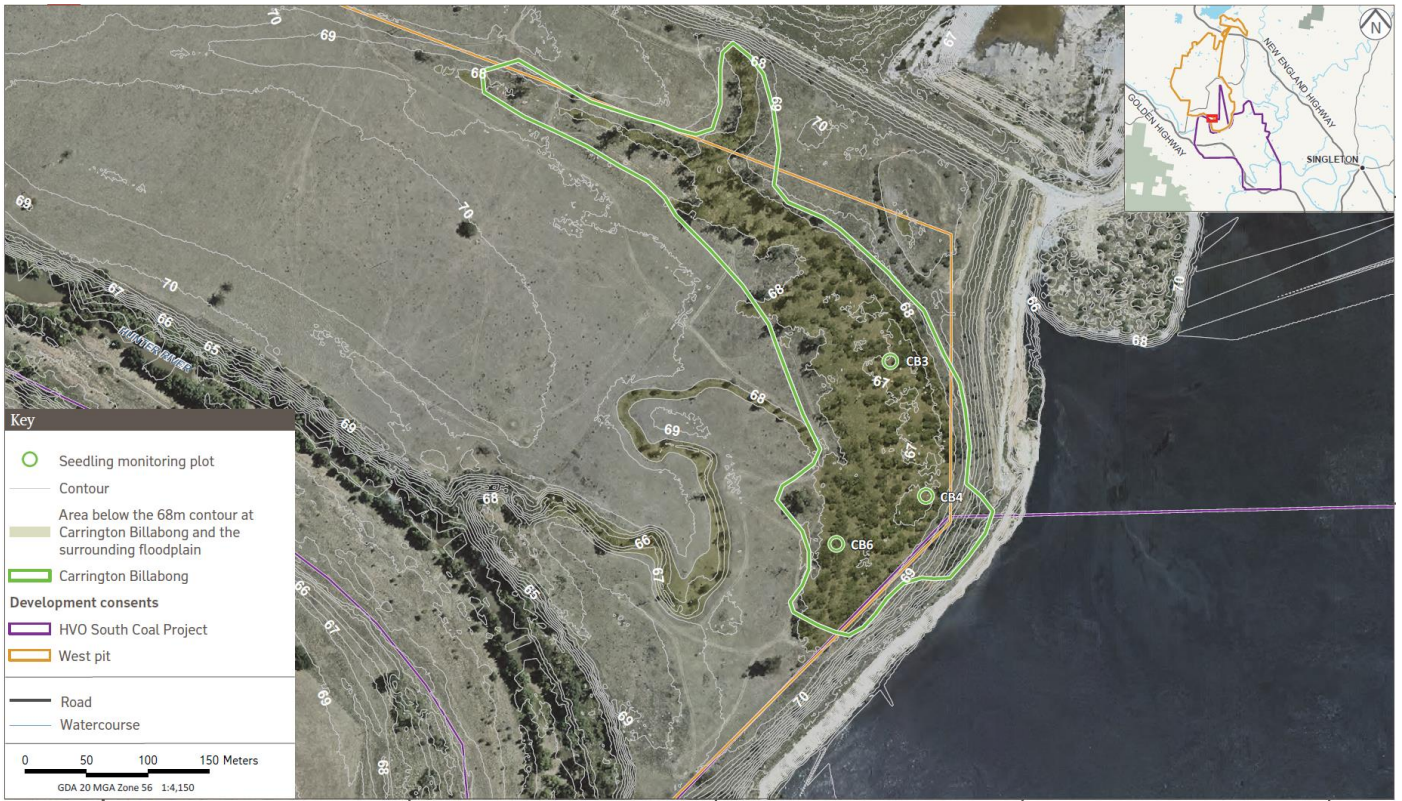
Figure 8-18: Contour Elevations within the Carrington Billabong

Patterns in the density of seedlings were noted in the field and reviewed against contour data derived from Digital Elevation Models (Geoscience Australia, 2023) (**Figure 8-18** and **Figure 8-19**).

At Carrington Billabong, seedlings were most evident within the lower parts of the site, predominantly below the 68 m contour. All three seedling monitoring plots at Carrington Billabong (CB3, CB4 and CB6) are located below the 68 m contour and seedling plot data were extrapolated within this area to estimate the total number of seedlings at Carrington Billabong. As with previous surveys, there were few naturally occurring seedlings outside this area. When dead seedlings are removed from the data, the estimated number of seedlings at Carrington Billabong has decreased.

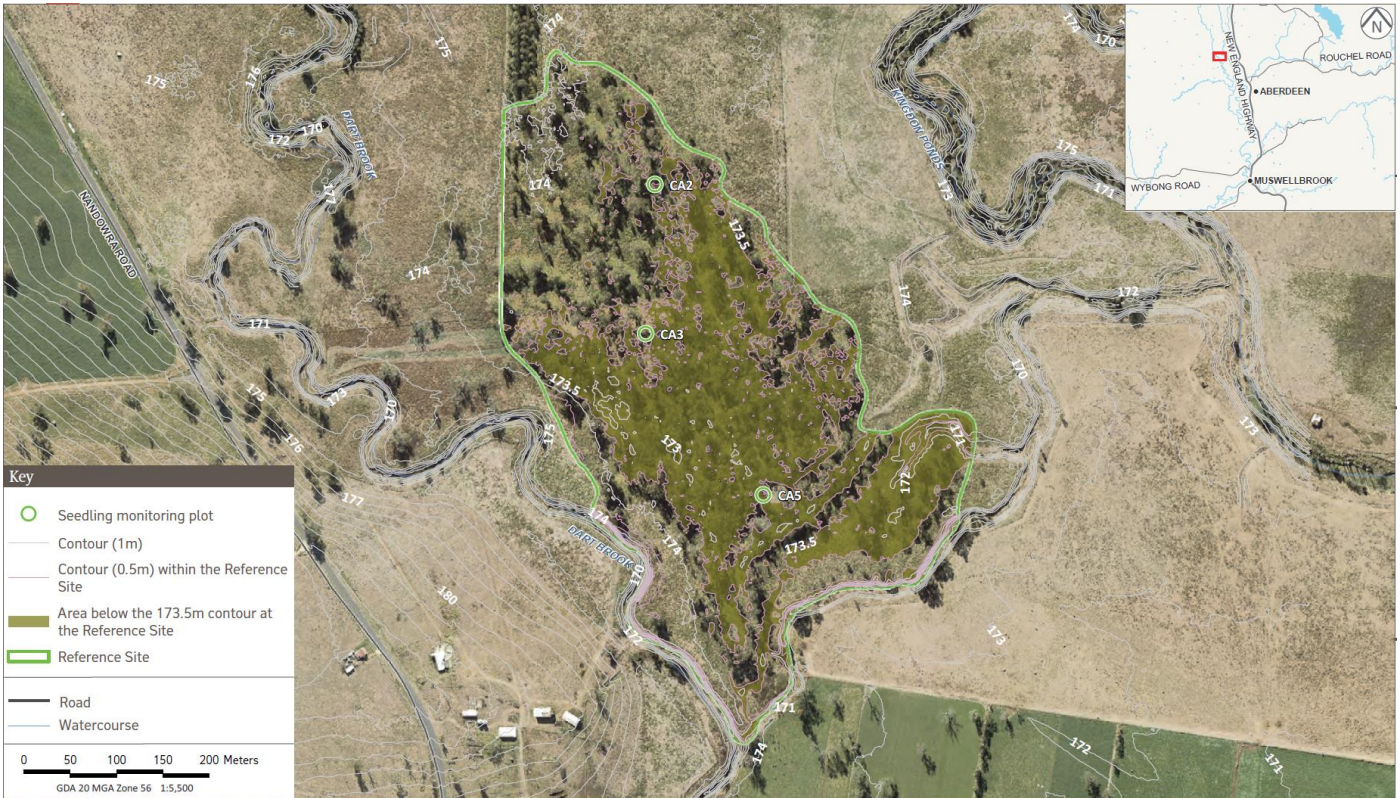
Figure 8-19: Contour Elevations within the Reference Site

At the Reference Site, seedling densities were also higher in the lower parts of the site (below the 173.5 m contour), with fewer seedlings on higher ground. Data from seedling monitoring plot CA5 was used to estimate seedling numbers in the lower parts of the site, while the average of CA2 and CA3 was used to extrapolate seedling numbers in the higher areas. The number of seedlings estimated in the Reference Site has decreased.

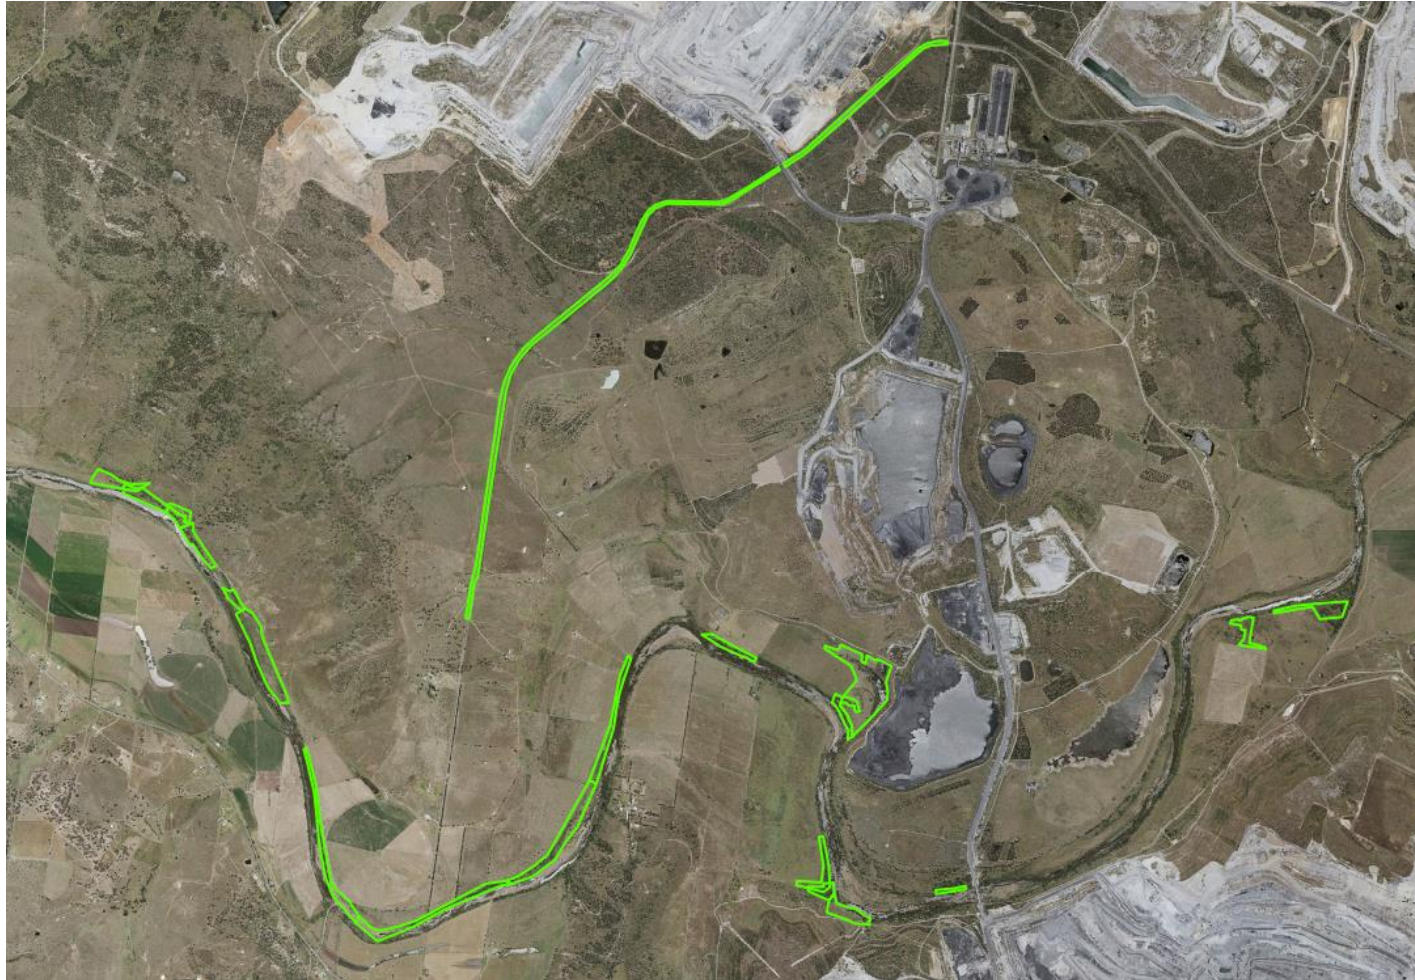
Figure 8-21: Riparian areas managed for weeds along the Hunter River and areas of treated Coolatai grass along Lemington Road

The areas along the Hunter River that were treated for riparian weeds are shown in **Figure 8-21**.

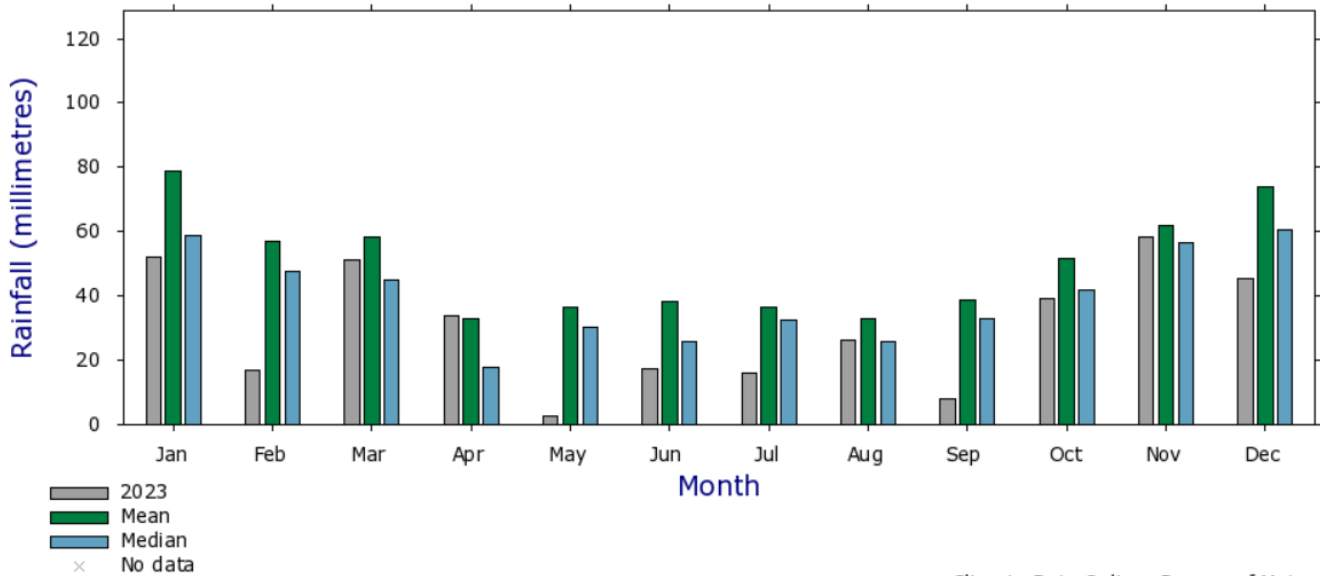
Figure 8-22: Rainfall Records Recorded at the Merriwa (Roscommon) Gauge - 2023

Overall, the rainfall recorded at the closest weather station to the Goulburn River BA exceeded the average total rainfall in 2023 (**Figure 8-22**). In this period, the Merriwa (Roscommon gauge) received 367.6 mm, which is below the mean average rainfall for the area (600 mm) and well below the rainfall received in 2022 (862.8 mm). A decline in the rainfall received was typical of records occurring across the Hunter Valley during 2023.

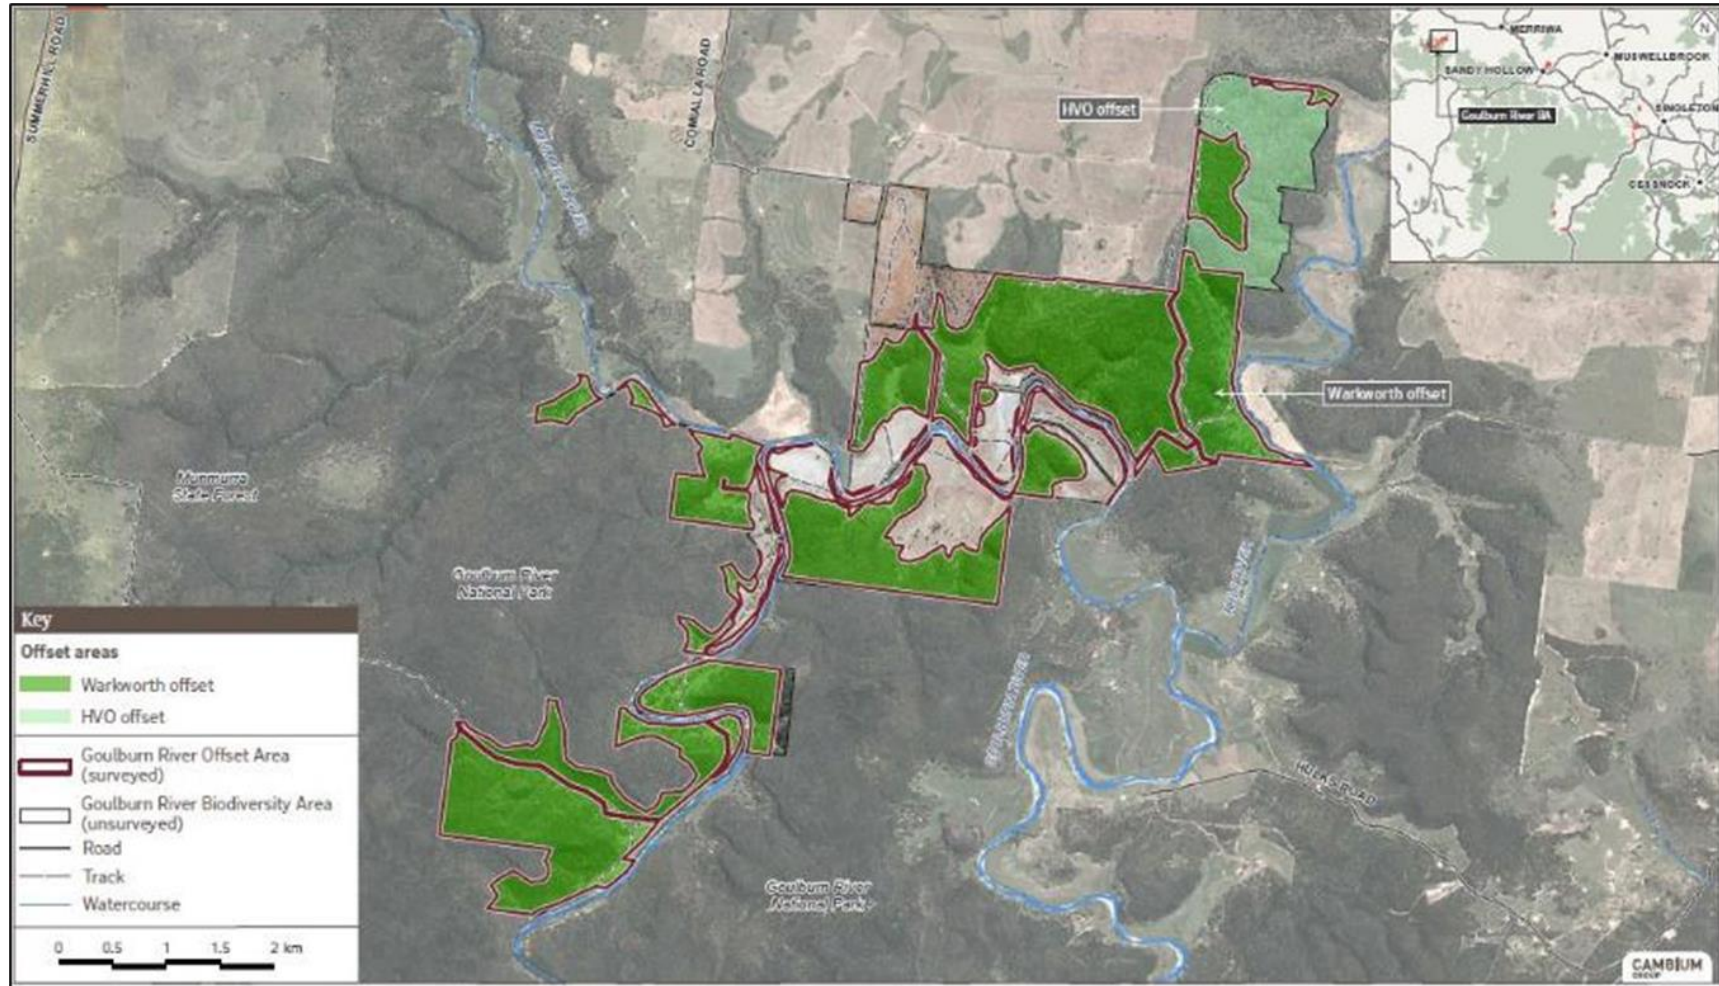
Figure 8-23: HVO's Goulburn River Offset and Adjoining Warkworth Mine Offset

The Goulburn River BA is located near the town of Merriwa and, when considered in combination with the adjoining offset for the Warkworth Mine, forms an area of protected vegetation extending from the Goulburn River National Park (**Figure 8-23**). The Goulburn River BA is managed according to the Goulburn River Management Plan that is available on the HVO website.
