# HUNTER VALLEY OPERATIONS

## 2023 ANNUAL ENVIRONMENTAL REVIEW

# REPORT | 2023 ANNUAL ENVIRONMENTAL REVIEW

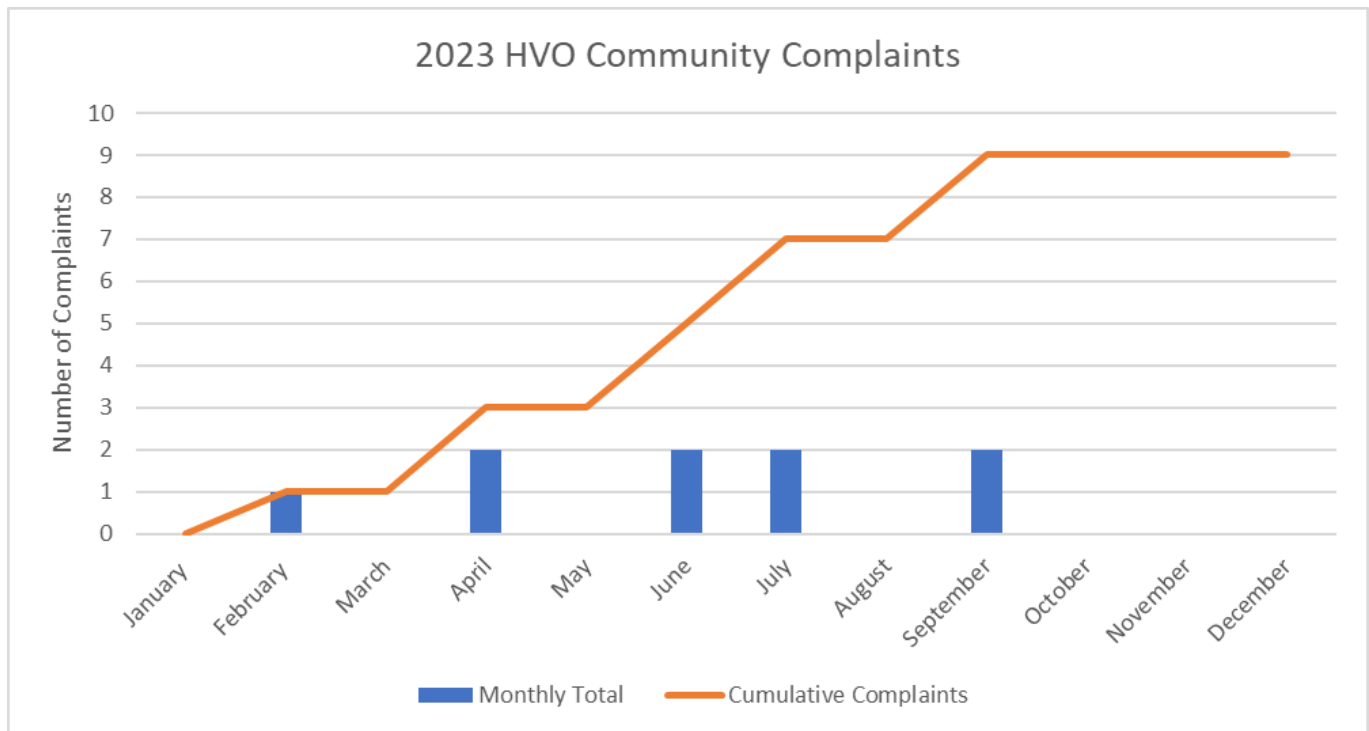
Figure 9-1: Summary of Community Complaints in 2023

A total of 9 complaints were received by HVO during 2023 (Figure 9-1) This represents a slight increase over 7 complaints for the previous year, however it is lower than typically received at HVO (Figure 9-3). Complaints were related to traffic, lighting, blasting and dust. Figure 9-2 provides further detail regarding the number of complaints per complaint type. Details of complaints received in 2023 are included in Table 9-1.
