***CENTENNIAL MANDALONG PTY LTD***  
***Mandalong Mine***  
***ANNUAL REVIEW***

**March 2024**

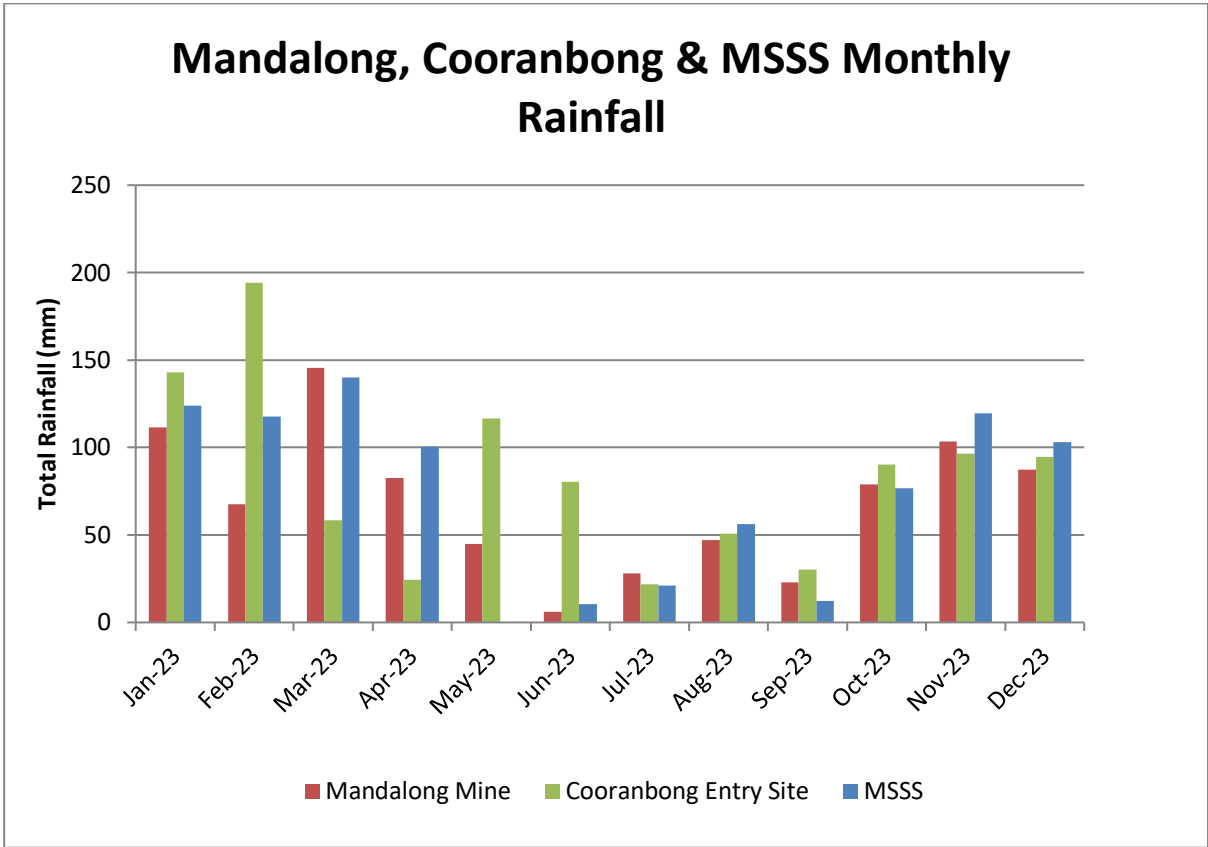
**Figure 6-1: Mandalong Mine, Cooranbong Entry Site & MSSS Monthly Rainfall**

For Cooranbong Entry Site, a total of 1,001 mm of rainfall was recorded at the site during the reporting period. The total annual rainfall for 2023 was lower than the annual average rainfall (1,124 mm) recorded at the Cooranbong Station (BOM station number 61012) from 1889 to 2016. The wettest recorded monthly period at the Cooranbong Entry Site in 2023 was February recording 194.2 mm.

For the Mandalong South Surface Site (MSSS), a total of 901.6 mm of rainfall was recorded at the site during the reporting period. The total annual rainfall for 2023 was lower than the annual average rainfall (1,124 mm) recorded at the MSSS Station (BOM station number 61012) from 1889 to 2016. The wettest recorded monthly period at the MSSS in 2023 was March recording 140.2 mm.

The total monthly rainfall data is shown below in **Table 6-2** and in **Figure 6-1**.

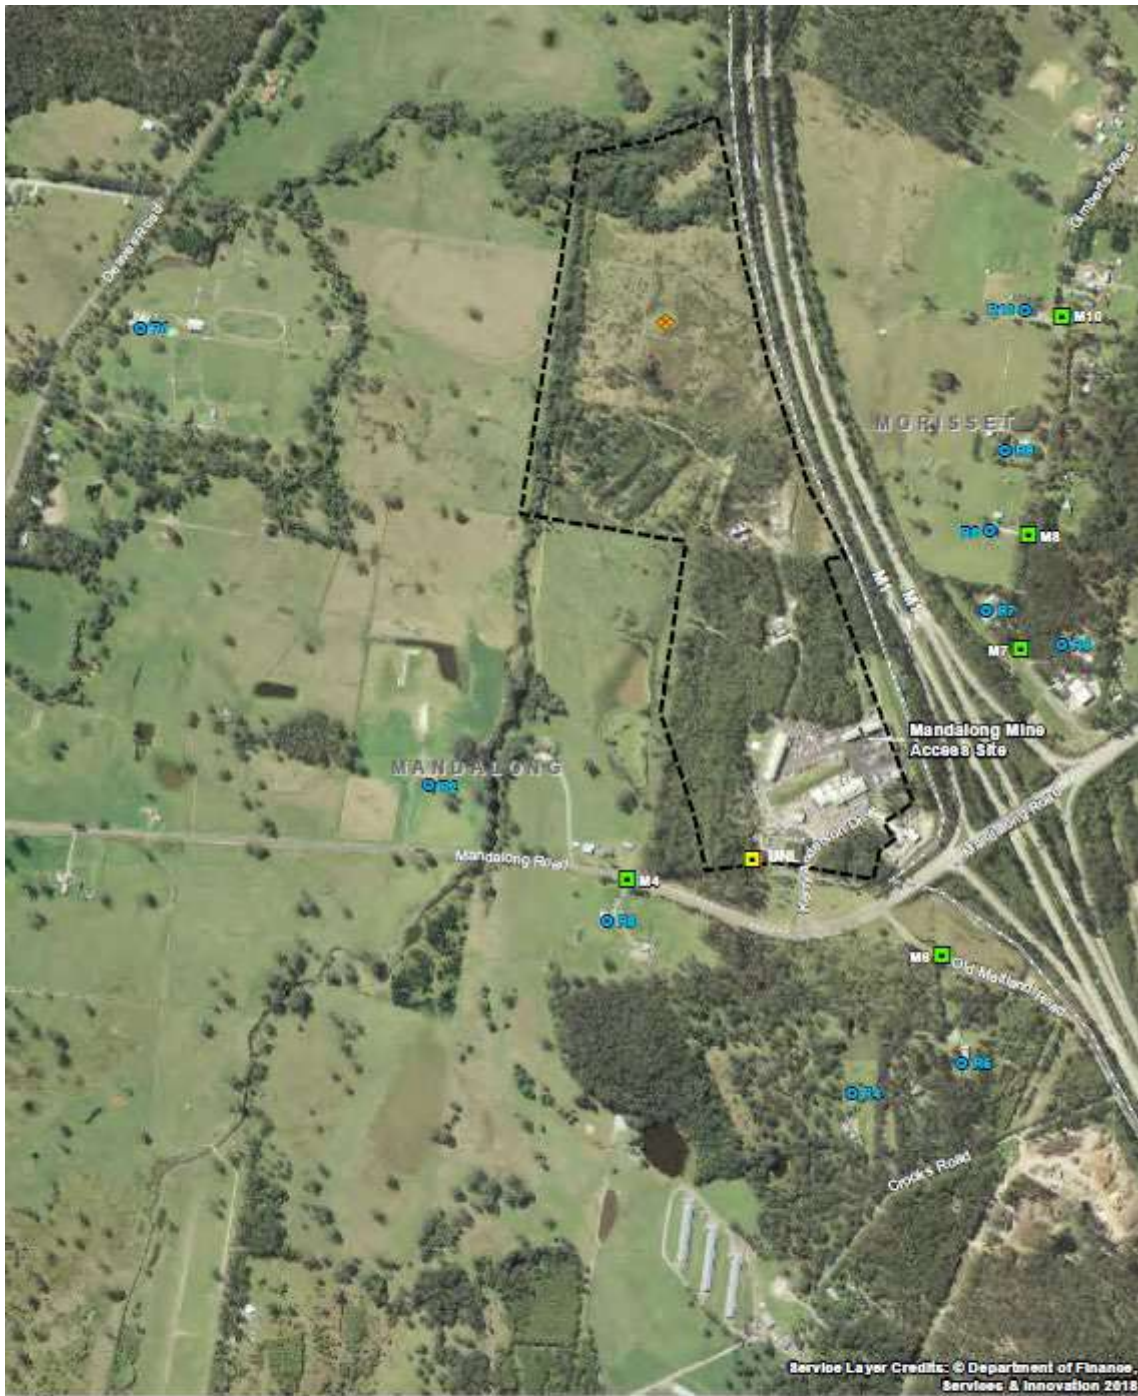
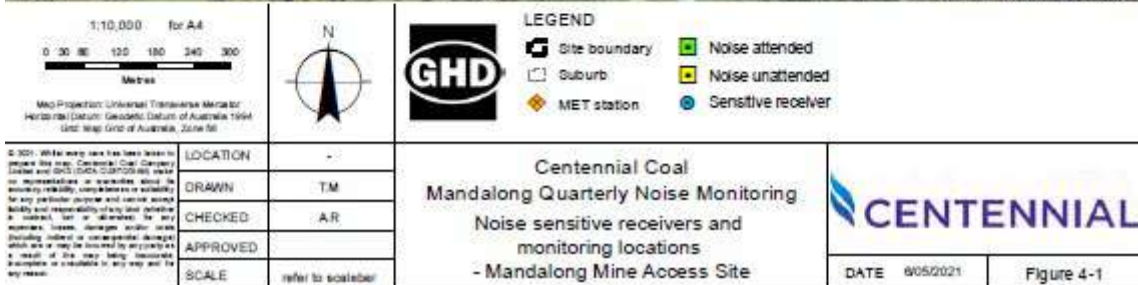
Figure 6-2: Mandalong Mine Noise Monitoring Locations

Noise monitoring was conducted to assess operational noise levels compared to the noise limits specified by SSD-5144, SSD-5145 and EPL 365 in accordance with the requirements of the Northern Region Noise Management Plan (GHD, 2022d). The Mandalong Mine Noise Monitoring Program now requires Centennial Mandalong to survey noise from the operations at the Mandalong Mine and the Cooranbong Entry Site (shown in **Figure 6-2** and **Figure 6-3**) on a quarterly basis and at the Mandalong South Surface Site (**Figure 6-4**) on a monthly basis.

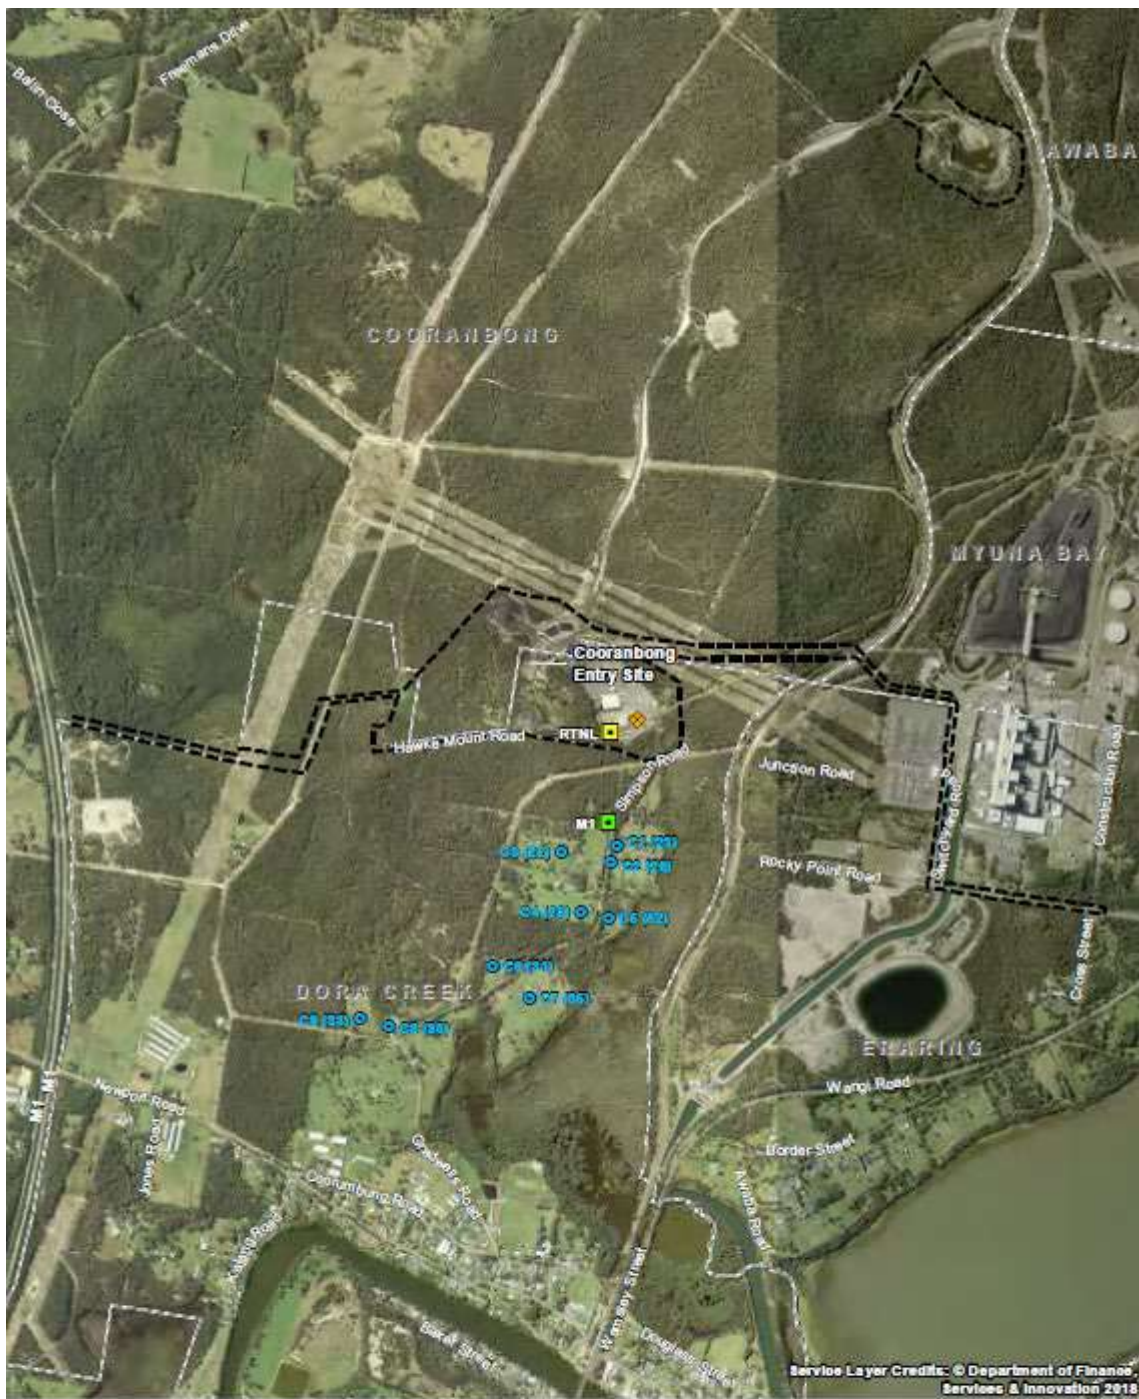
Figure 6-3: Cooranbong Entry Site Noise Monitoring Locations

<p>1:25,000 for A4</p> <p>0 80 160 320 480 640 800</p> <p>Meters</p> <p>MAG Projection: Universal Transverse Mercator Horizontal Datum: Geoidetic Datum of Australia 1984 Grid: Map Grid of Australia, Zone 56</p>						<p><b>LEGEND</b></p> <ul style="list-style-type: none"> <li> Site boundary</li> <li> Suburb</li> <li> Noise unattended</li> <li> MET station</li> <li> Noise attended</li> <li> Noise unattended</li> <li> Sensitive receiver</li> </ul>	
<p>© 2021. All the maps used have been taken to prepare this map. Centennial Coal Company Limited and GHD (GHD) CORPORATION, shall not be responsible or liable for any errors, omissions or liability for any and/or damage and/or consequential loss and/or responsibility of any kind whether in contract, tort or otherwise, for any numbers, losses, damages or other costs (including interest or consequential damages) which are or may be incurred by any party as a result of the map being reviewed, accepted or available in any way and for any reason.</p>		<p>LOCATION -</p> <p>DRAWN TM</p> <p>CHECKED AR</p> <p>APPROVED</p> <p>SCALE refer to scalebar</p>		<p>Centennial Coal Mandalong Quarterly Noise Monitoring Noise sensitive receivers and monitoring locations - Cooranbong Entry Site</p>

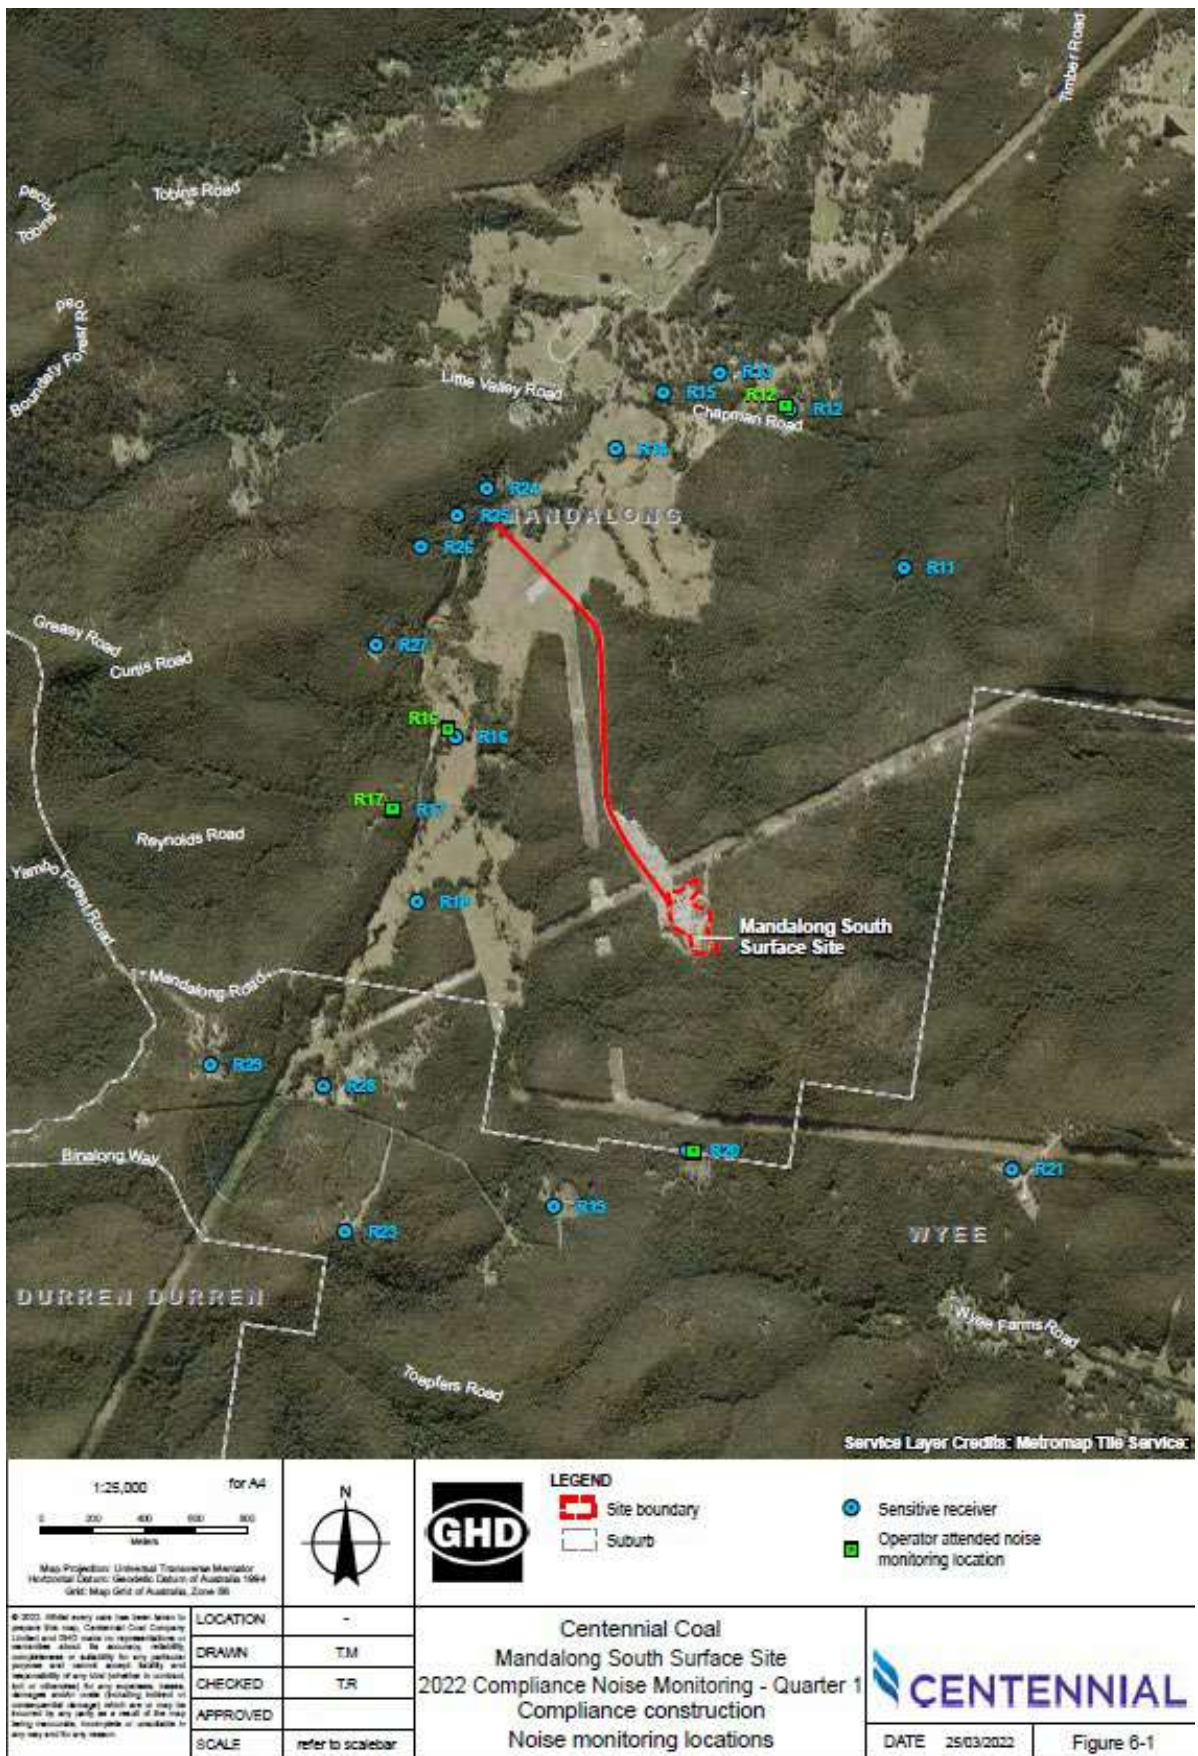
Figure 6-4: MSSS Noise Monitoring Locations

GHD was engaged by Centennial Mandalong to conduct noise compliance monitoring for the operational activities at the Mandalong South Surface Site in accordance with the Northern Region Noise Management Plan (GHD, 2022d). The noise monitoring network locations at the Mandalong South Surface Site are shown in **Figure 6-4**. Since April 2022, noise monitoring has been undertaken monthly at the Mandalong South Surface Site.

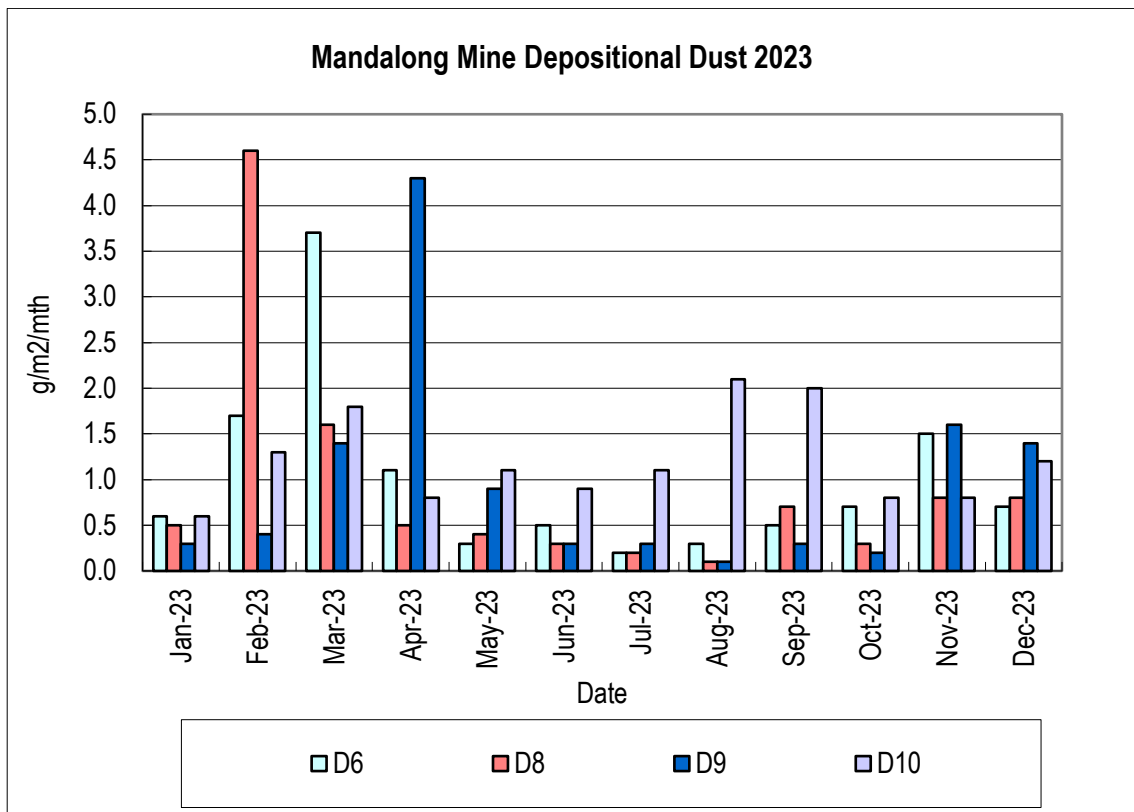
**Figure 6-5: Monthly Depositional Dust Results 2023 Mandalong Mine**

Insoluble Solids (Combustible Matter + Ash) g/m <sup>2</sup> /month			
	DG6	DG8	DG9	DG10
<b>Long Term Average</b>	1.3	0.7	1.1	1.6
<b>Annual Average (2023 Reporting Period)</b>	1	0.9	1	1.2
<b>Pre-Construction Average</b>	0.8	0.8	0.9	*
<b>Limit Criteria</b>	4.0	4.0	4.0	4.0

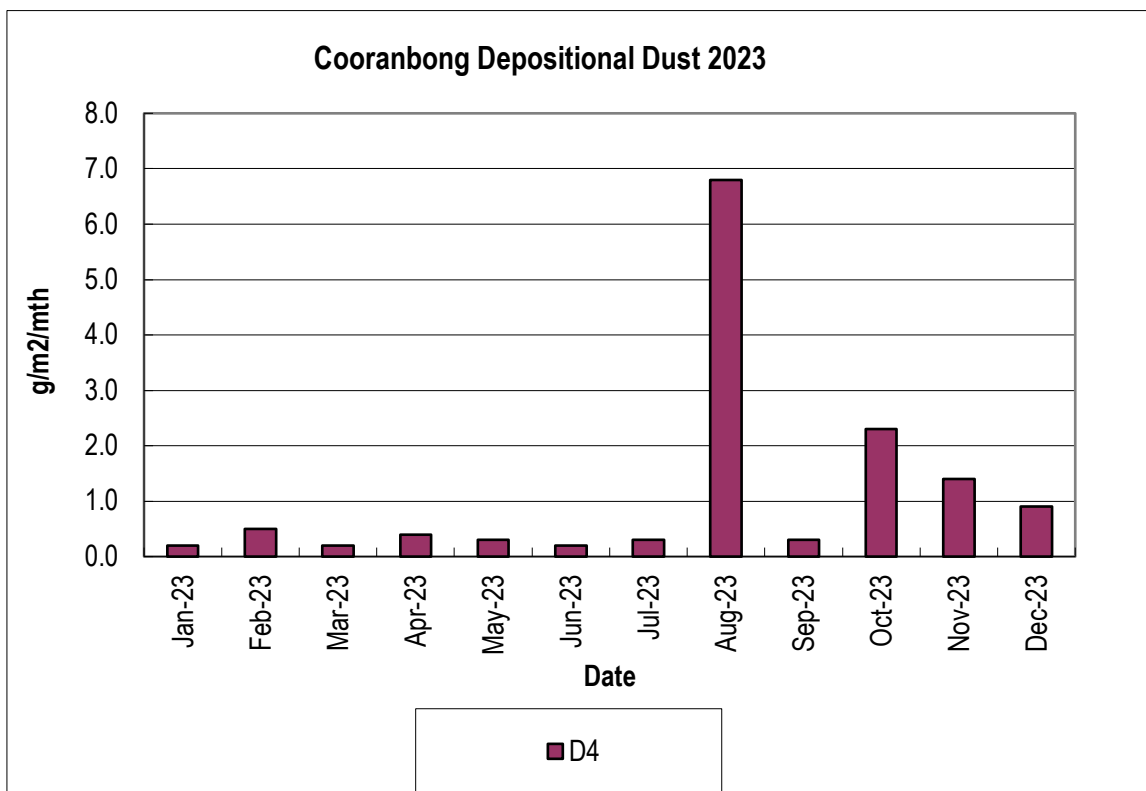
**Figure 6-6: Monthly Depositional Results 2023 CES**

Insoluble Solids (Combustible Matter + Ash) g/m <sup>2</sup> /month
	<b>DG4</b>
Long Term Average	1.2
Average 2023 (Reporting Period)	1.2
Limit criteria (annual average)	4.0

Annual average depositional dust results for 2023 and the LTA are provided in [Table 6-6](#) and [Table 6-7](#). The complete monthly dust monitoring data is provided in [Figure 6-6](#).

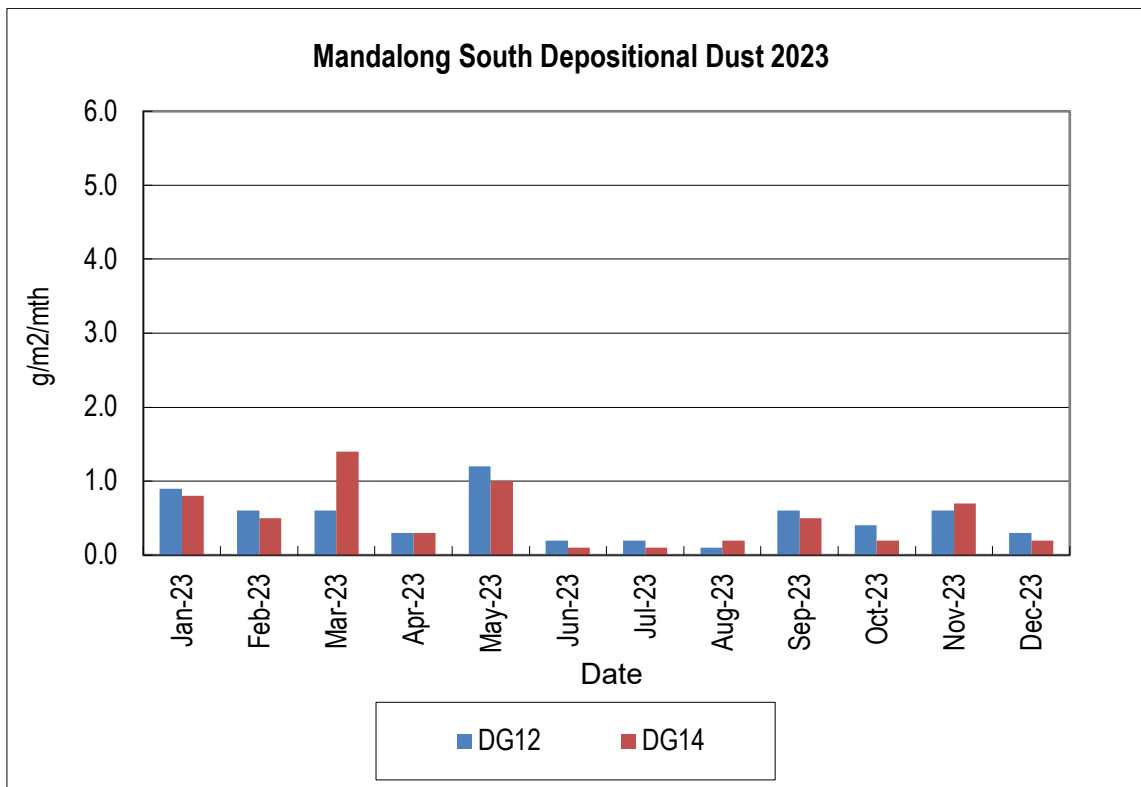
**Figure 6-7: Monthly Depositional Results 2023 MSSS**

Insoluble Solids (Combustible Matter + Ash) g/m <sup>2</sup> /month	
	DG12	DG14
Long Term Average	0.7	1.5
Average 2023 (Reporting Period)	0.5	0.5
Limit Criteria	4.0	4.0

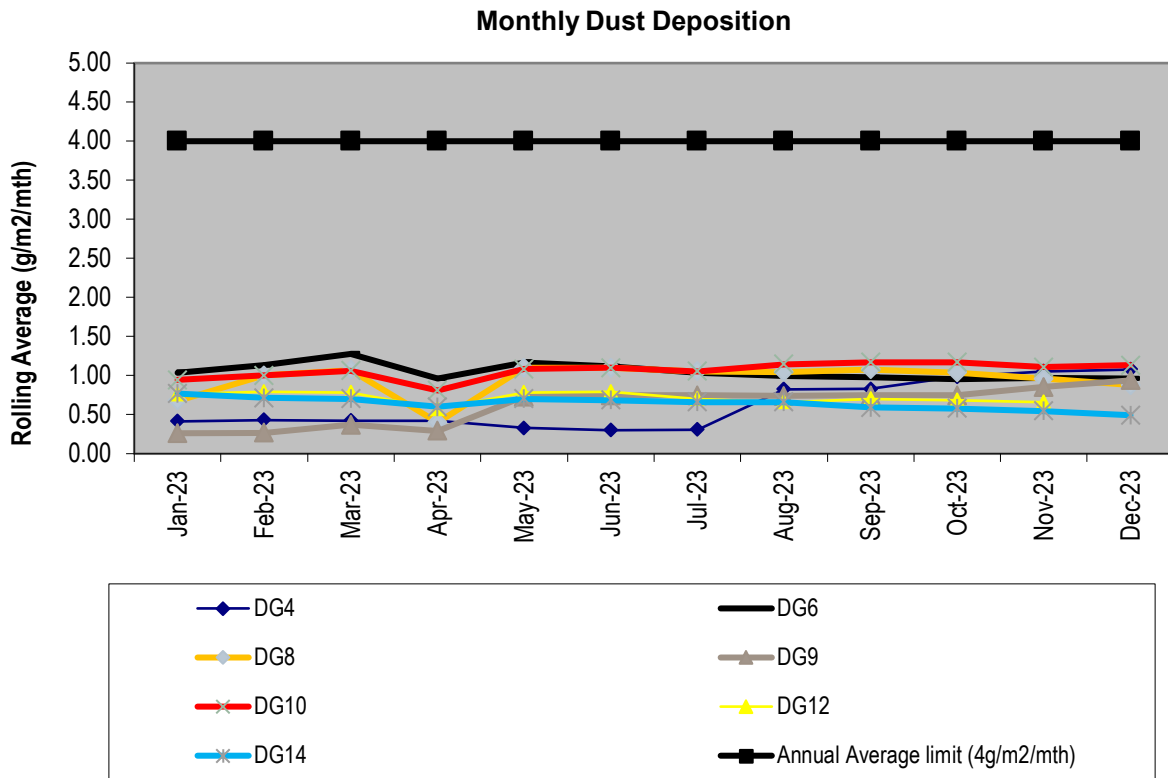
**Figure 6-8 Dust Deposition Rolling Annual Average and Limit Criteria**

The cumulative impact result is shown in **Table 6-12** as an annual average. The dust gauges were compliant with the condition for the reporting period. The maximum cumulative impact at DG12 was 0.79 and DG14 was 0.77. The incremental impact result is shown in **Table 6-12** as the change from PCA. The dust gauges were compliant with the condition for the reporting period. The maximum incremental impact for DG12 is 0.3 and DG14 is -0.8

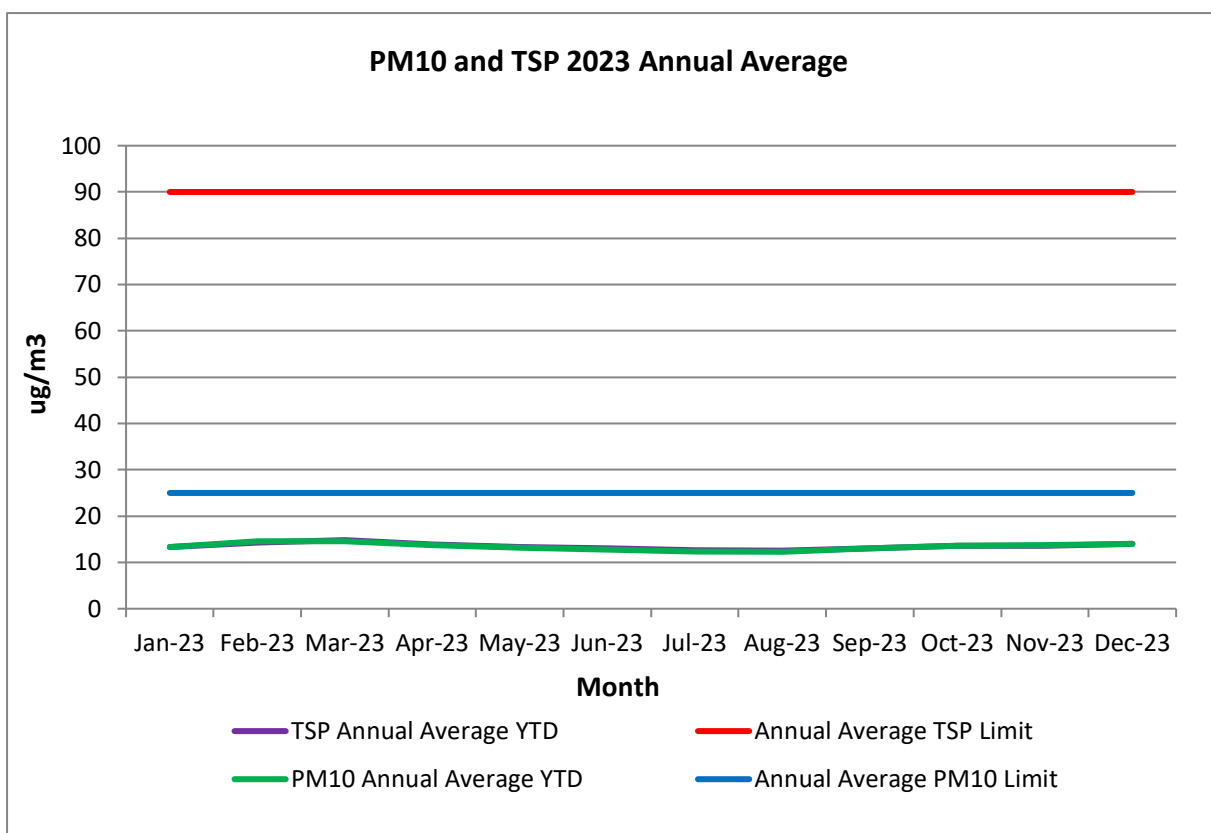
**Figure 6-9: PM10 and TSP 2023 Annual Rolling Average and Limit Criteria**

TSP and PM10 monitoring results are shown in **Figure 6-9**, **Figure 6-10**, **Figure 6-11** and **Figure 6-12**. The results are presented as an annual average for the reporting period (January 2023 to December 2023). The monitoring results for the TSP and PM10 annual and 24 hour average from January to December 2023 are in accordance with the predictions from the air quality impact assessment for the Cooranbong Distribution Project EA (GSS Environmental, 2012) and the predictions from the air quality impact assessment for the Northern Coal Logistics Project EIS (SLR, 2014).

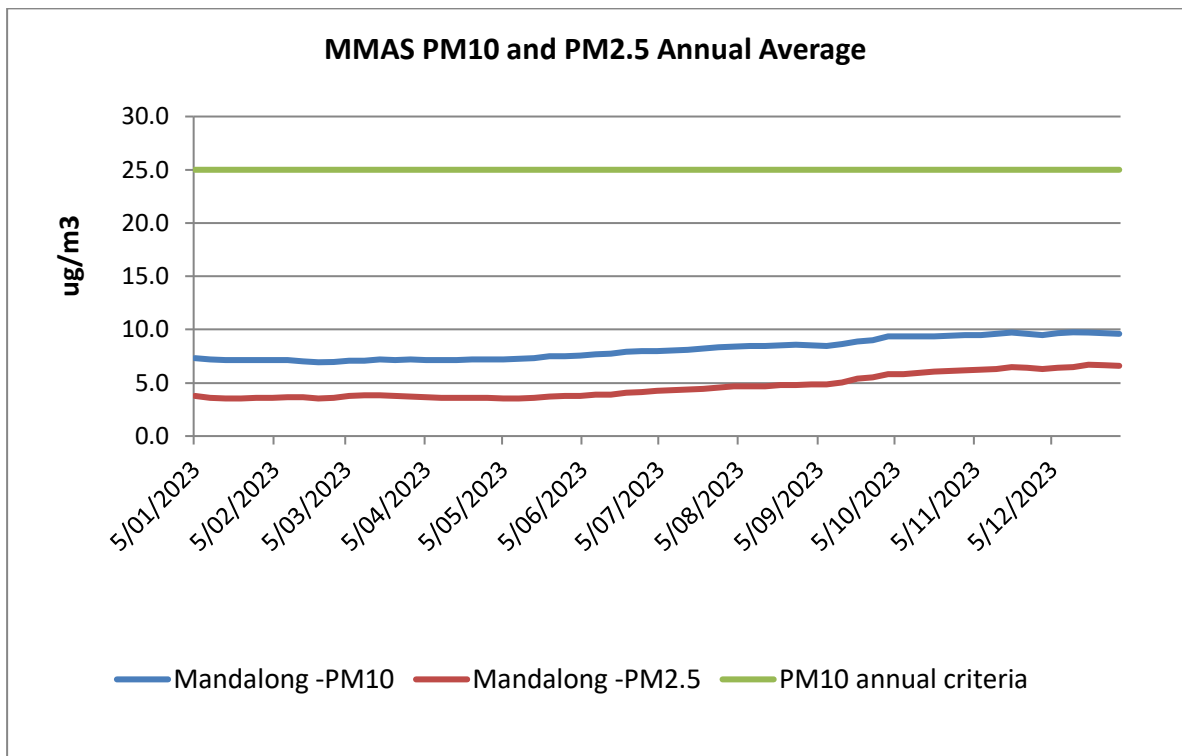
**Figure 6-11: MMAS PM10 and PM2.5 Annual Average Monitoring Results and Limit Criteria**

The 24-hr average PM<sub>10</sub> concentrations recorded nil exceedances of the Development Consent SSD-5144 24-hr criterion of 50µg/m<sup>3</sup> in the 2023 monitoring period.

The maximum PM<sub>10</sub> concentration of 28.7µg/m<sup>3</sup> and TSP concentration of 32.5µg/m<sup>3</sup> were recorded on 19 December 2023. The maximum PM<sub>2.5</sub> concentration of 27.3µg/m<sup>3</sup> was recorded on 19 December 2023. There is no maximum 24hr concentration limit for TSP and PM<sub>2.5</sub>.

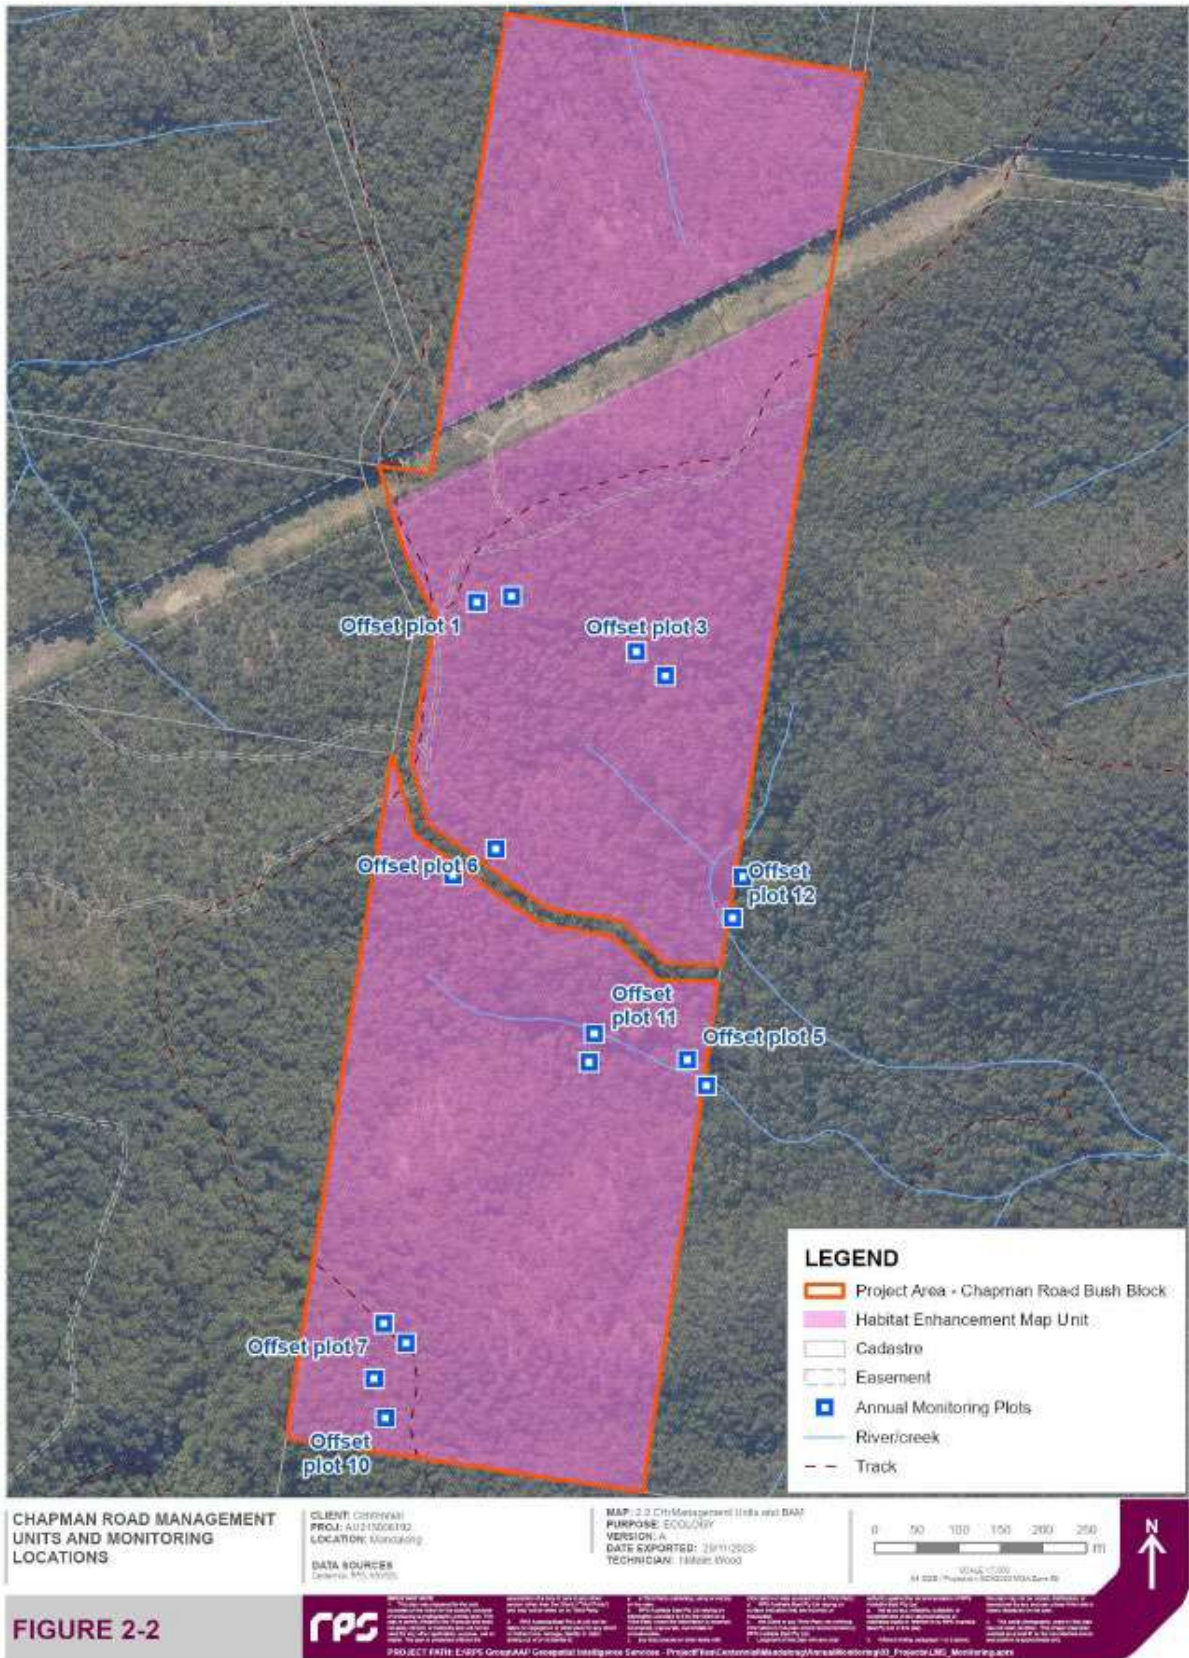
Figure 6-19 : Chapman Road Bush Block Offset Area

'Conservation management of land through practices that retain or improve habitat'. (RPS, 2024e).

580 DP733227; Lot A DP110119; Lot 902 DP541065 and Lot 152 DP755238 as shown in [Figure 6-18](#) and [Figure 6-19](#) and their total areas indicated in [Table 6-14](#).

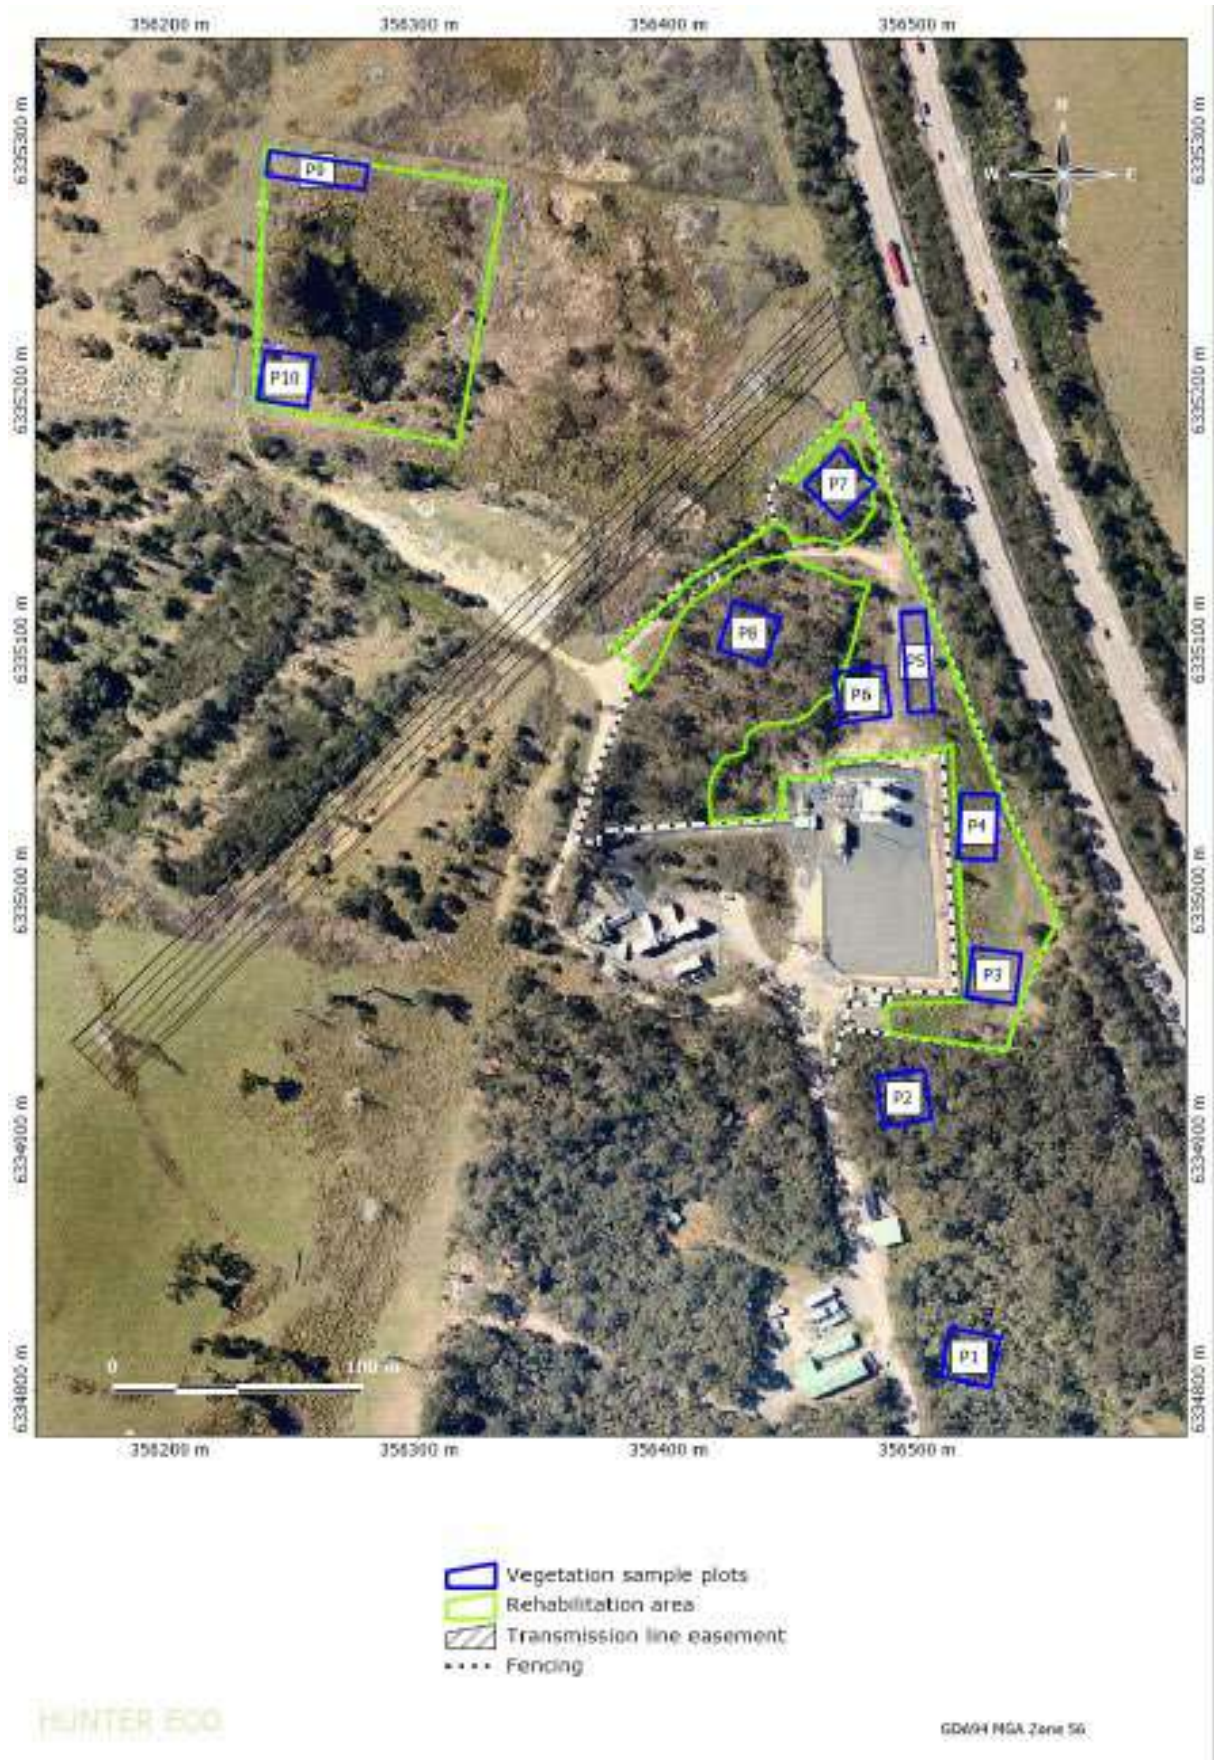
**Figure 6-20: Location of Floristic Sample Plots**

The aim of the monitoring program conducted by Hunter Eco was to collect data that would enable a quantitative comparison between the relatively undisturbed communities and the areas being rehabilitated. This is achieved through the collection of floristic data from 400 m<sup>2</sup> permanently established plots. The normal plot size is 20 m x 20 m but the dimension can vary depending on the configuration of the available space. Two plots were established in each of the two undisturbed communities and two in each of the two areas being rehabilitated to these communities: eight plots in all.

All plots were permanently established with star pickets at each corner in 2012, and floristic data was collected on 15 December 2023. Hunter Eco (2023b) has concluded that a significant milestone has been reached in 2023 with cluster analysis now showing that there is no significant difference in overall native floristic composition between reference and rehab plots for both targeted threatened communities.

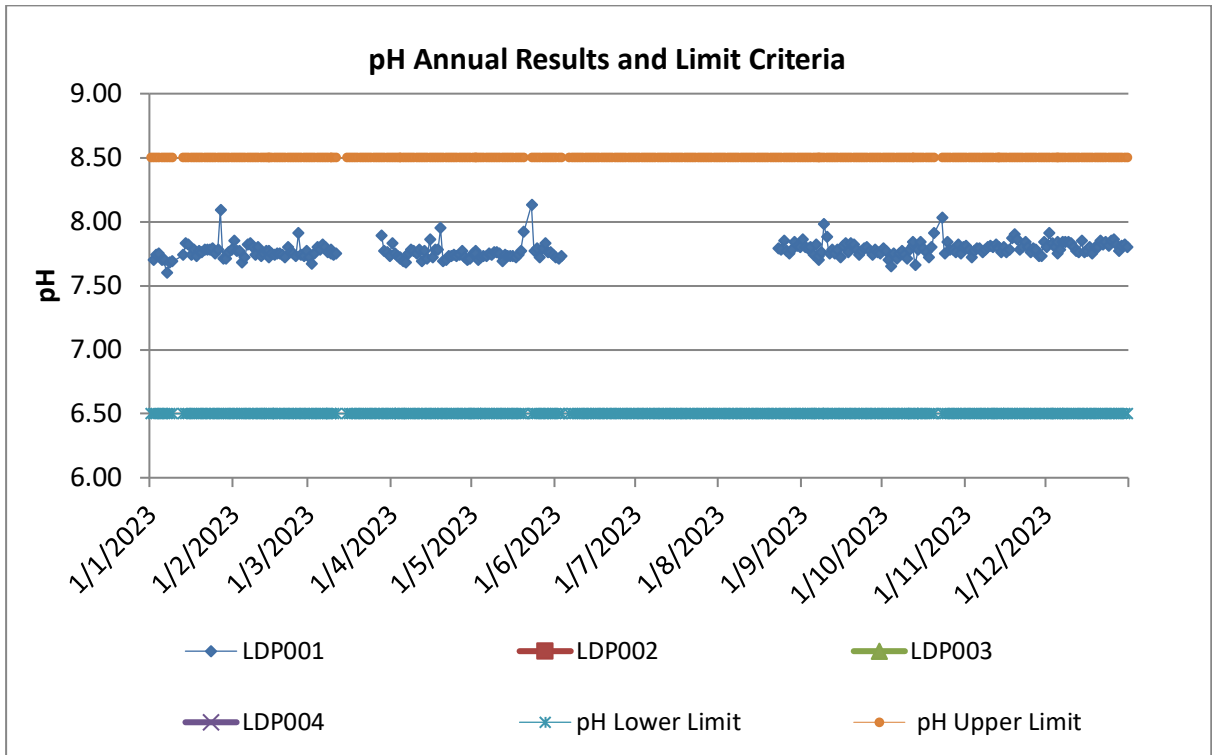
**Figure 7-2 Annual pH Monitoring Results and Limit Criteria**

data for LTA to compare against. LDP001 has a consistent discharge water quality in 2023 as can be seen from **Figure 7-2**, **Figure 7-3** and **Figure 7-4**. The water quality results for LDP001 shows little variation. LDP002, LDP003 and LDP004 discharges occur as a result of high rainfall events and have greater variability.

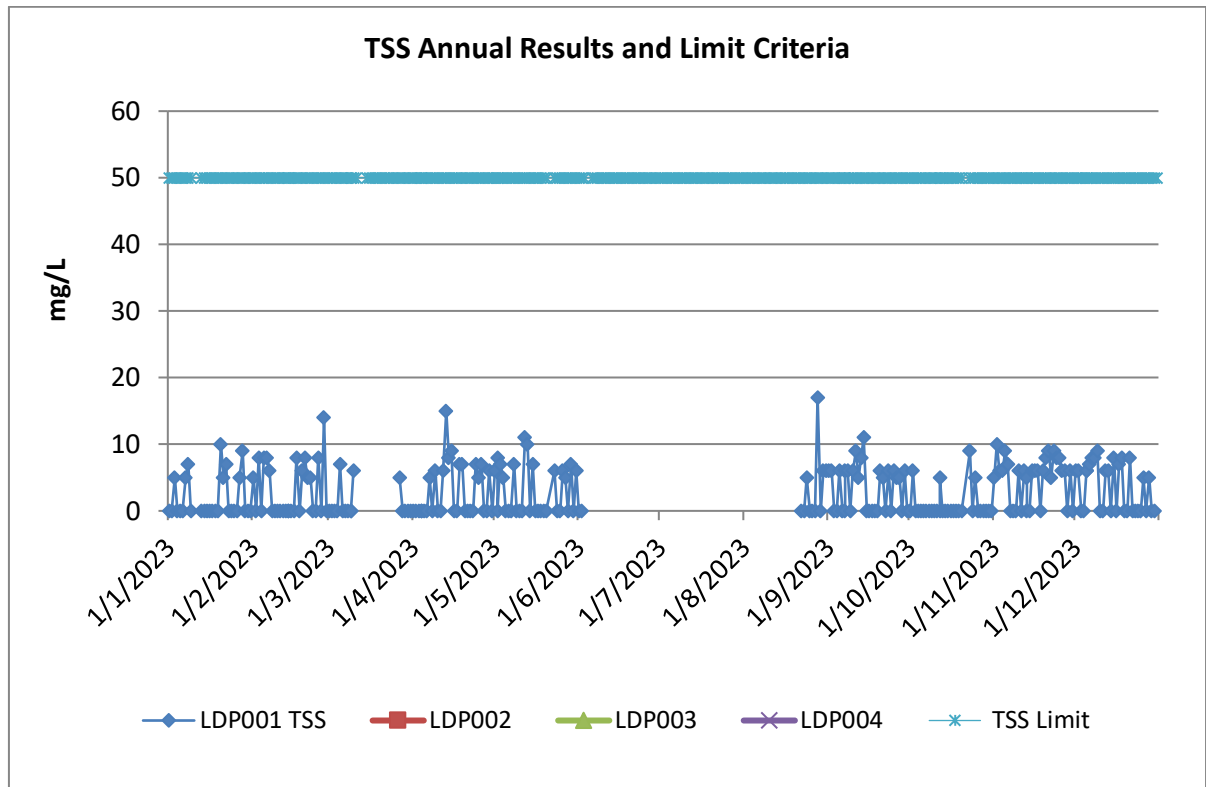
**Figure 7-3 Annual TSS Monitoring Results and Limit Criteria**

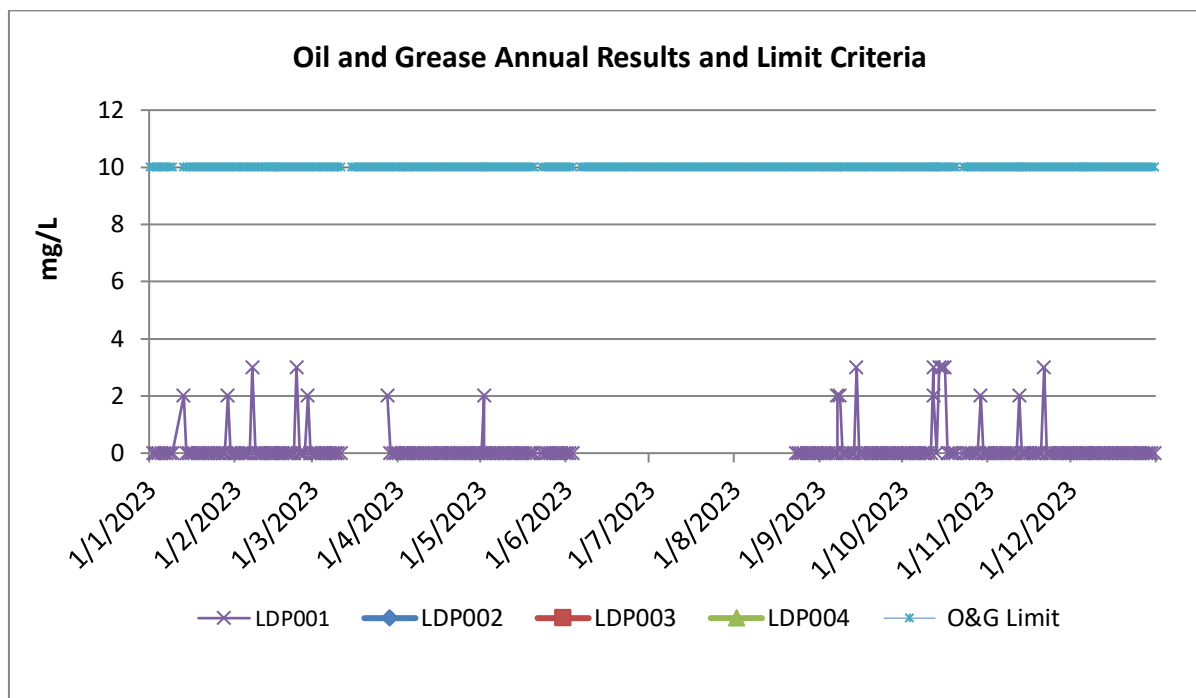
**Figure 7-4 Annual Oil & Grease Monitoring Results and Limit Criteria**
