***CENTENNIAL MANDALONG PTY LTD***  
***Mandalong Mine***  
***ANNUAL REVIEW***

**March 2024**

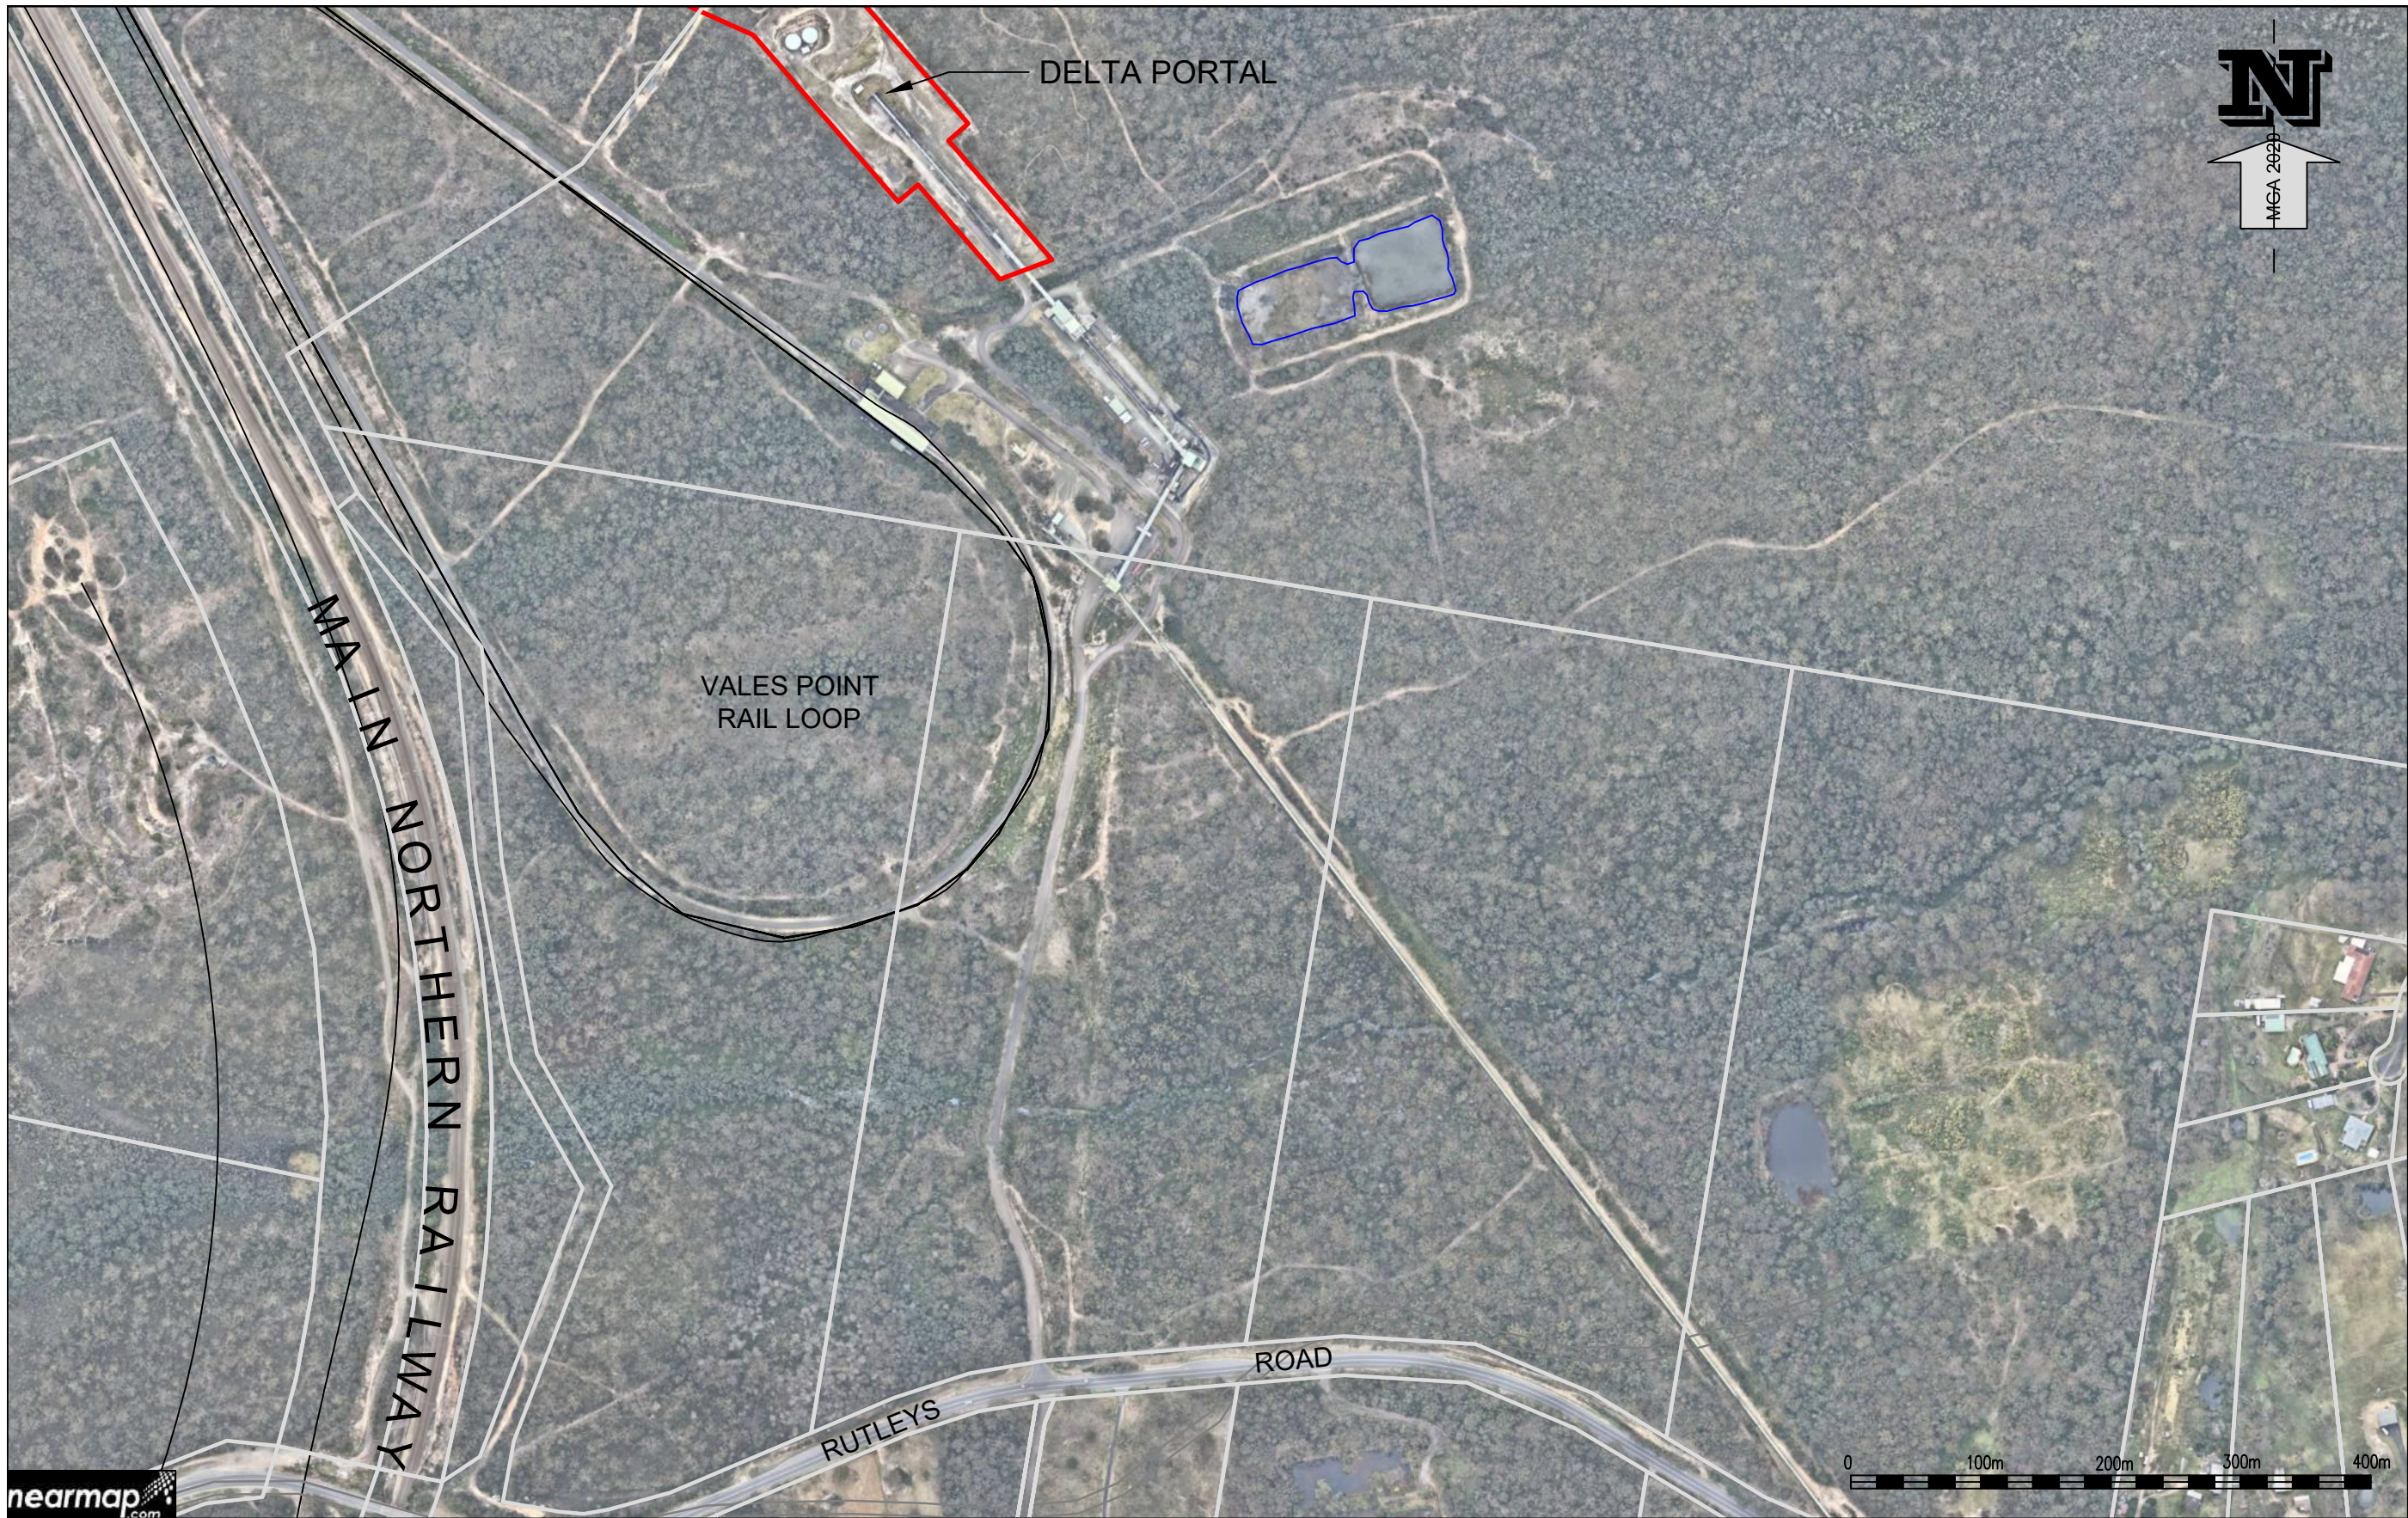
CONTRACT	
PLOTFILE: CM00315c_rev0.pdf	
<b>A3</b>	<b>CM00315c</b>
DRAWING REV.	0 - 22.02.2023

**Delta Entry Site -  
 Location of Environmental Monitoring Points**

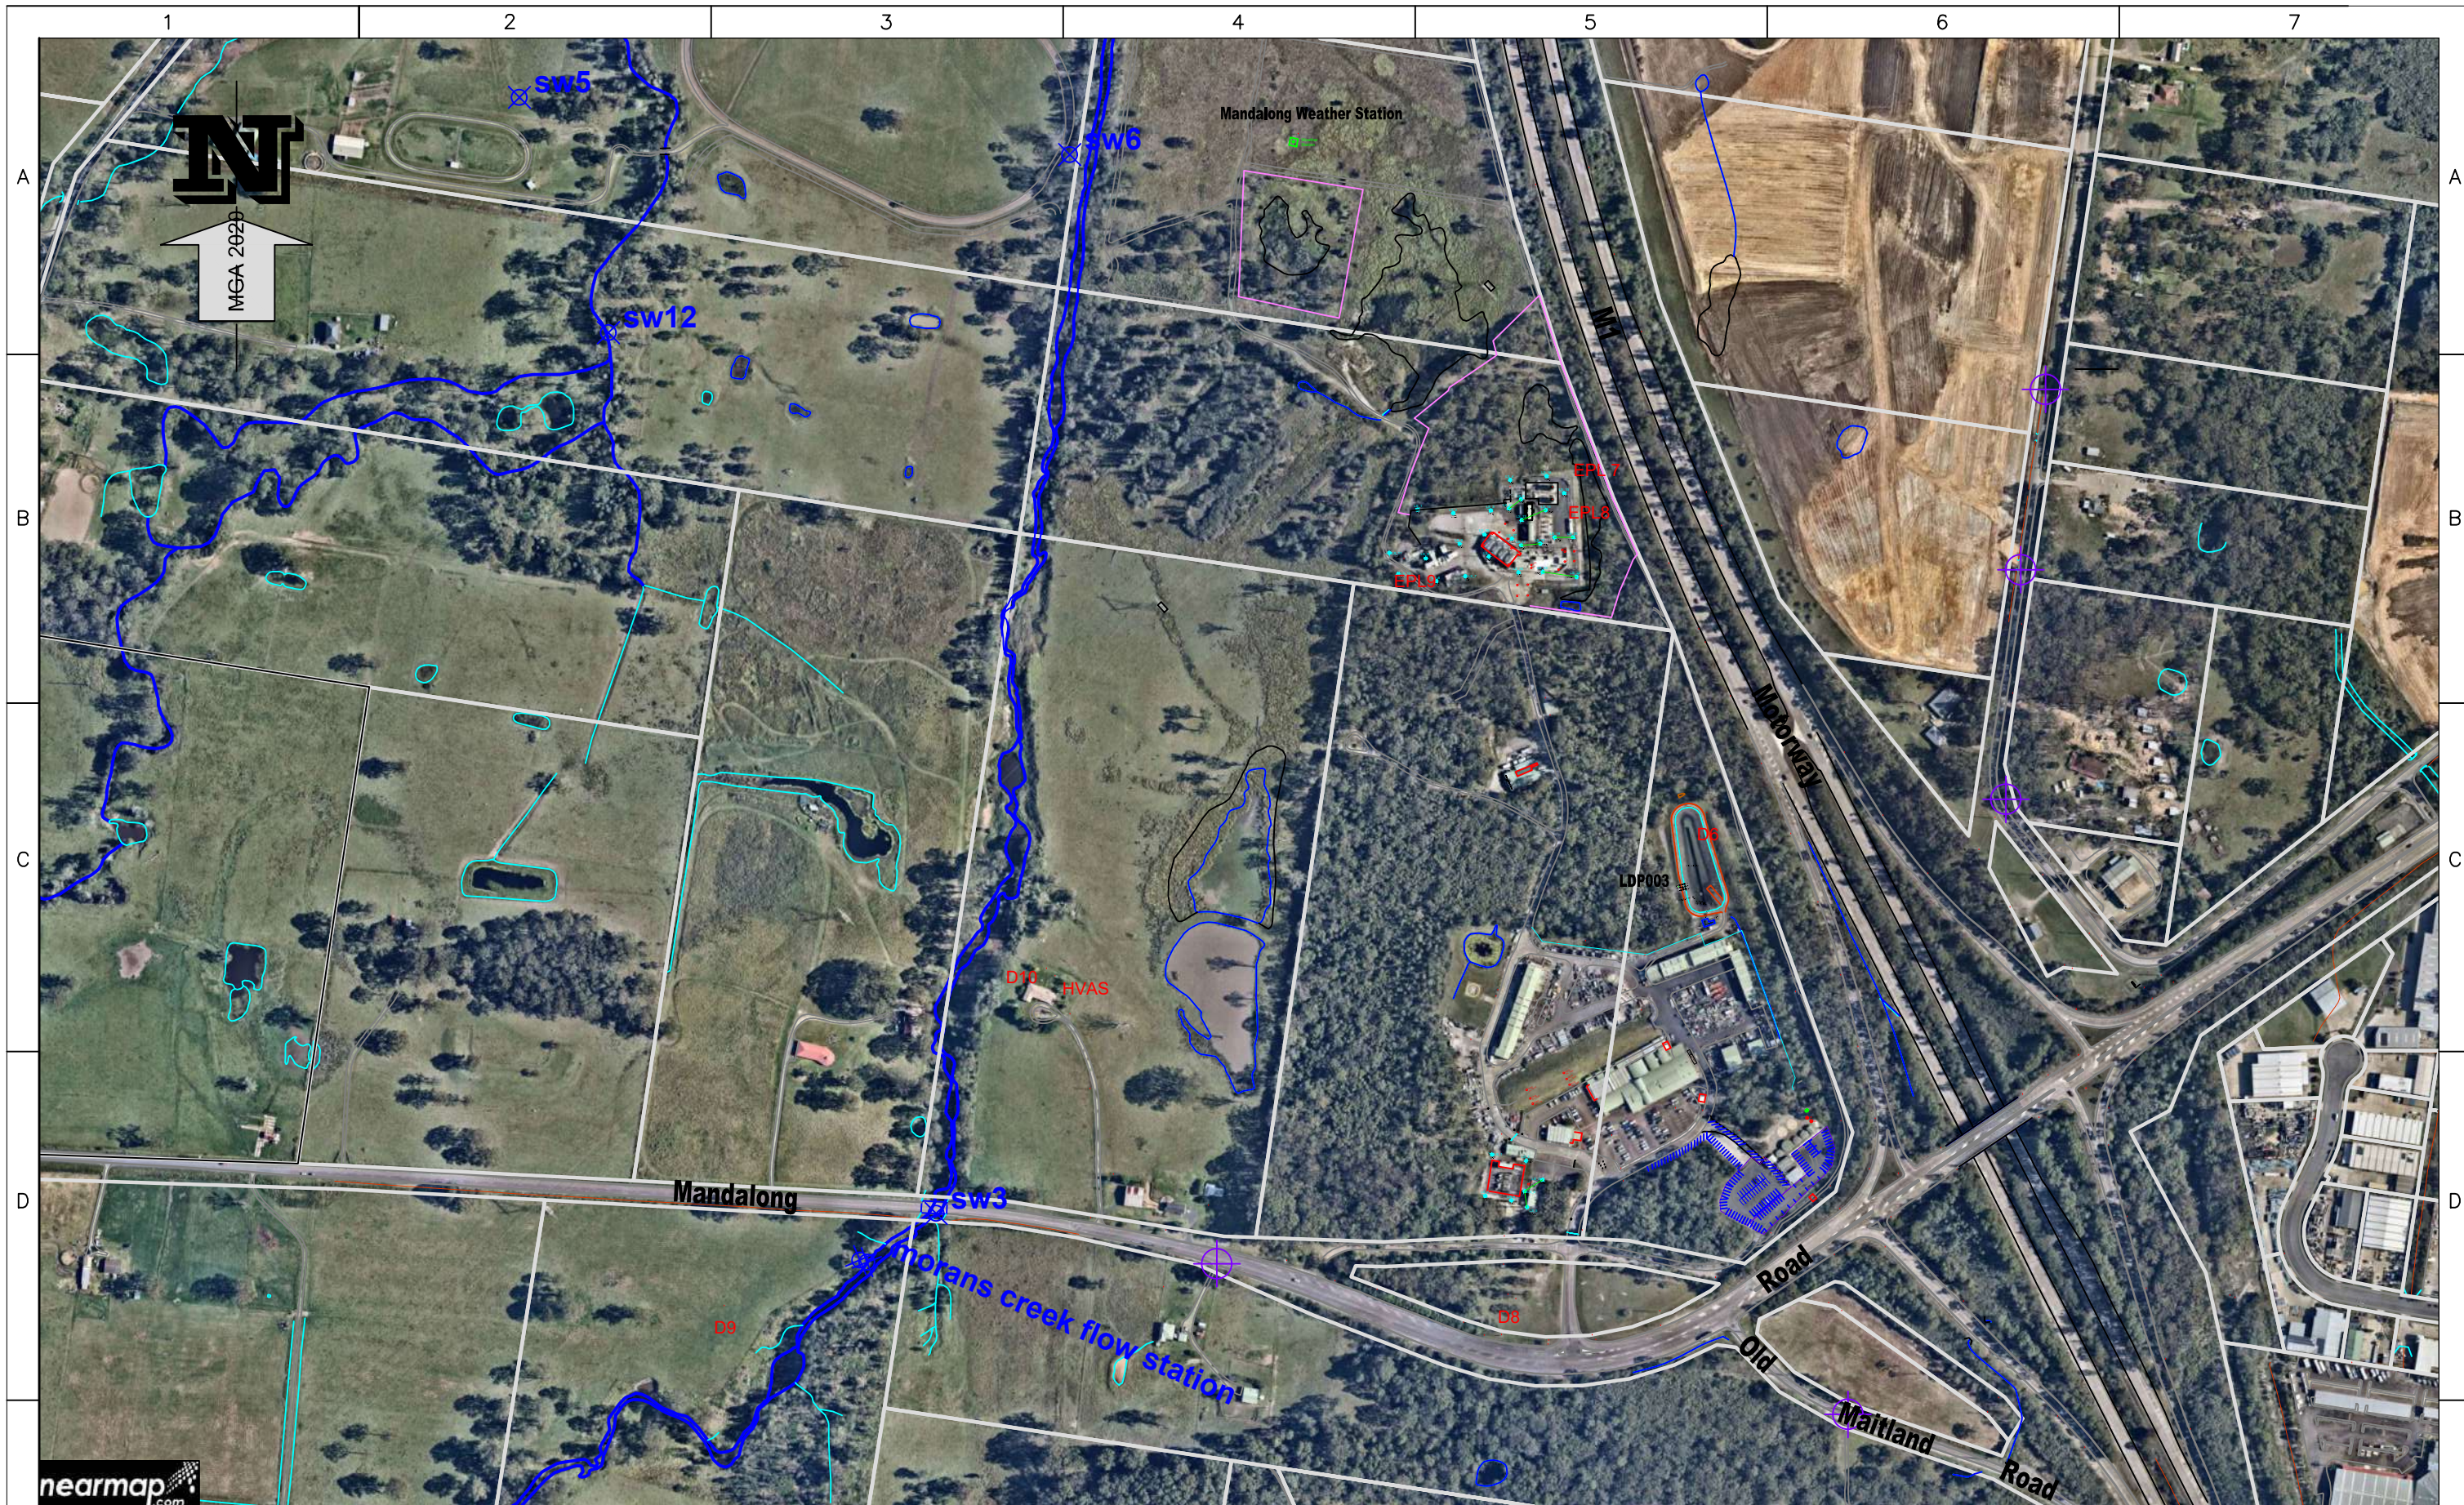
CONTRACT	
PLOTFILE CM00315_rev0.pdf	
<b>A3</b>	<b>CM00315d</b>
REVISION	Rev 1 13/03/23

**Mandalong Mine**  
**Location of Environmental Monitoring Points**
