# 2024 Annual Review

### **ANNUAL REVIEW**

1 January – 31 December 2024

Prepared by Umwelt (Australia) Pty Limited on behalf of Bulga Coal Pty Ltd

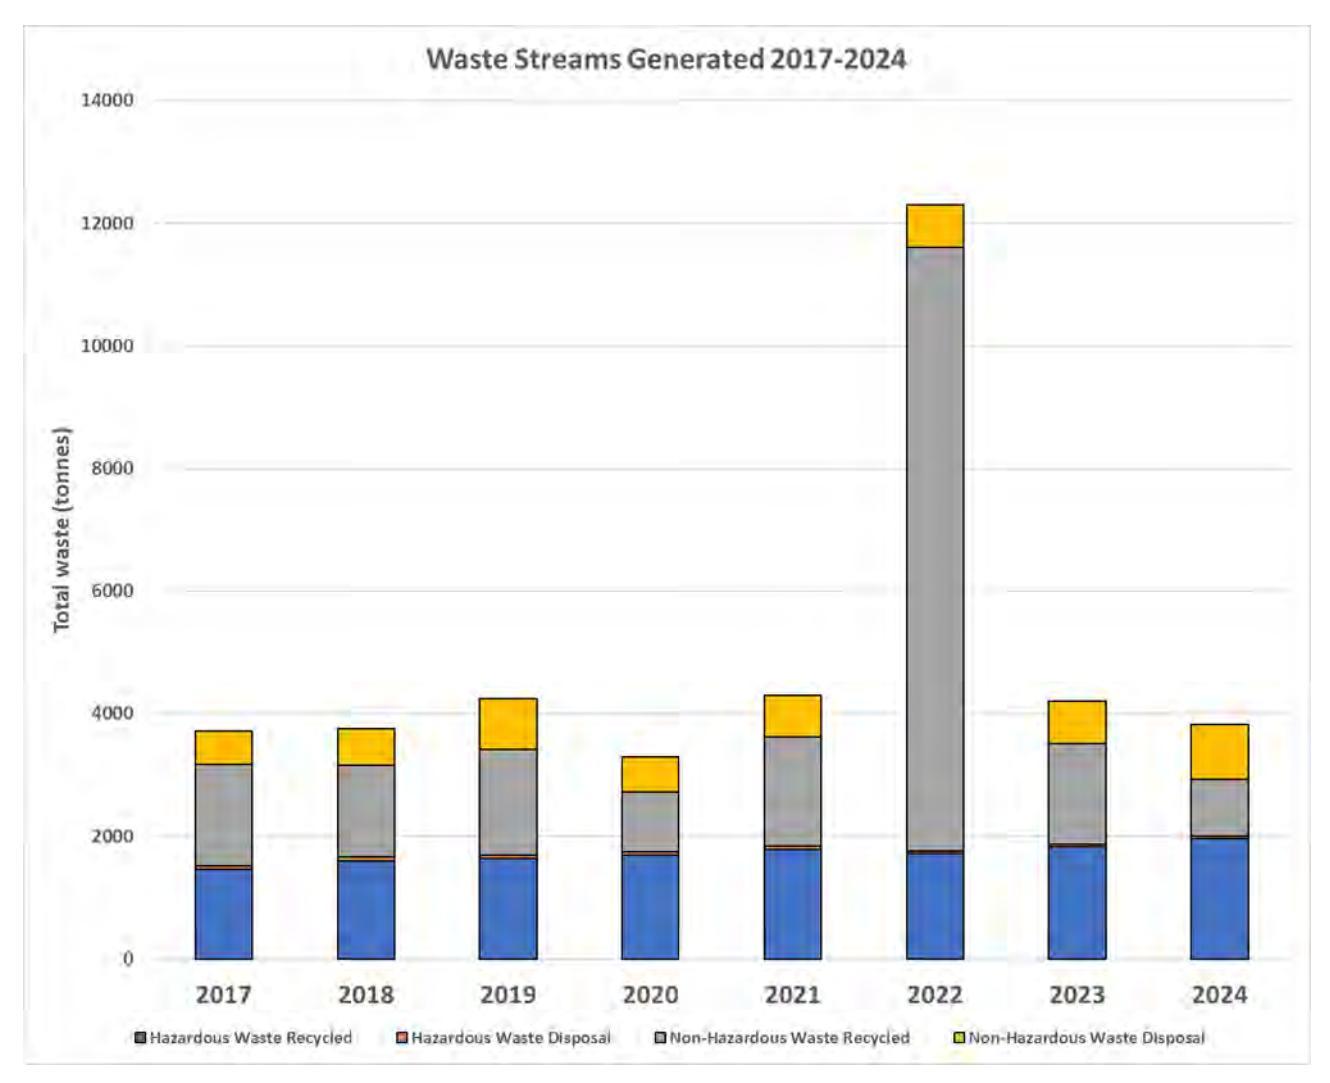
Figure 4.2 2017–2024 Waste Streams Generated

A summary of waste disposal from 2017 to 2024 is presented in **Figure 4.2**. The figure shows non-hazardous waste recycling has fluctuated significantly between 2021 to 2024. The changes in volumes and recycled material reflect the staged decommissioning of the underground laydown areas and dragline decommissioning (8,949 t) during 2022.

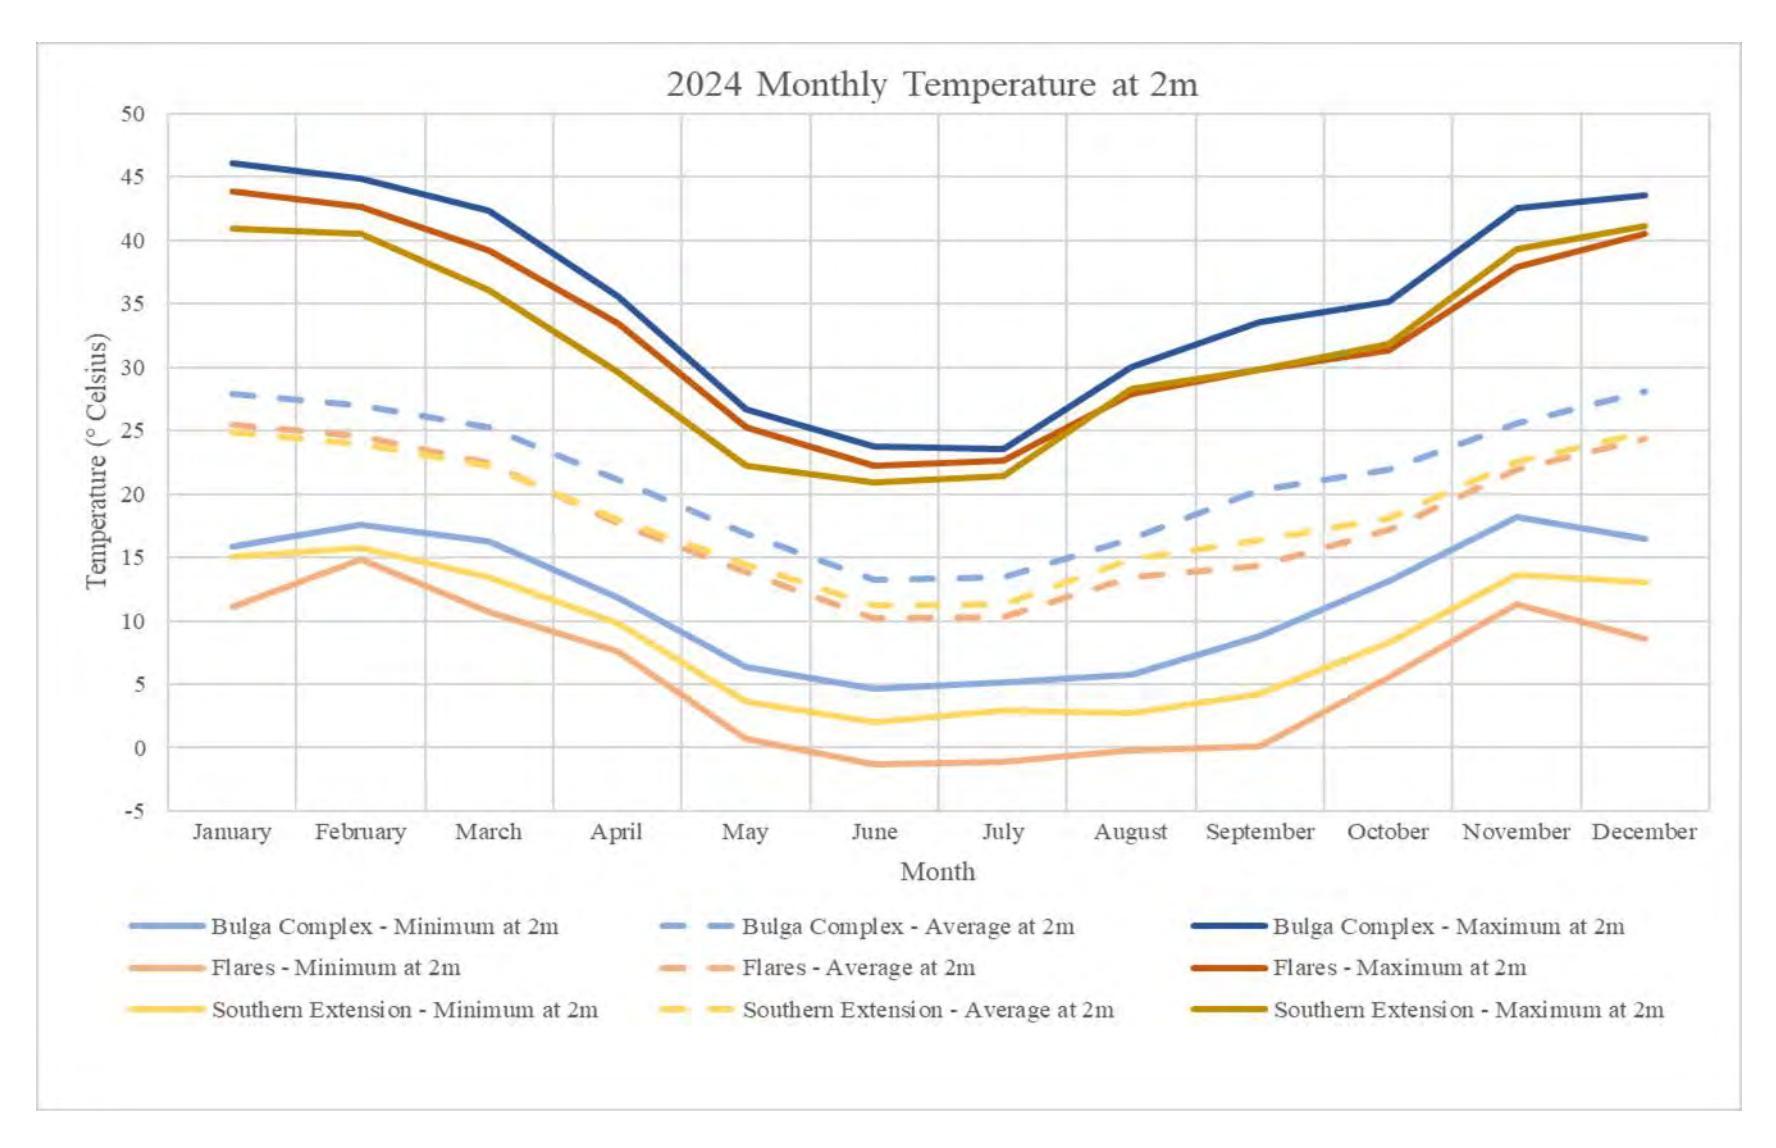
Figure 6.5 2024 Monthly Temperature 2 m (Degrees Celsius) at Representative Monitoring Stations

As shown in **Table 6.2** and **Table 6.3**, the daily minimum and maximum surface level temperatures ranged across Bulga's three monitoring stations at 2 metres and 10 metres above surface level from  $-1.32^{\circ}$ C to 46.1°C respectively. Refer to **Table 6.4** for humidity recorded over the reporting period.

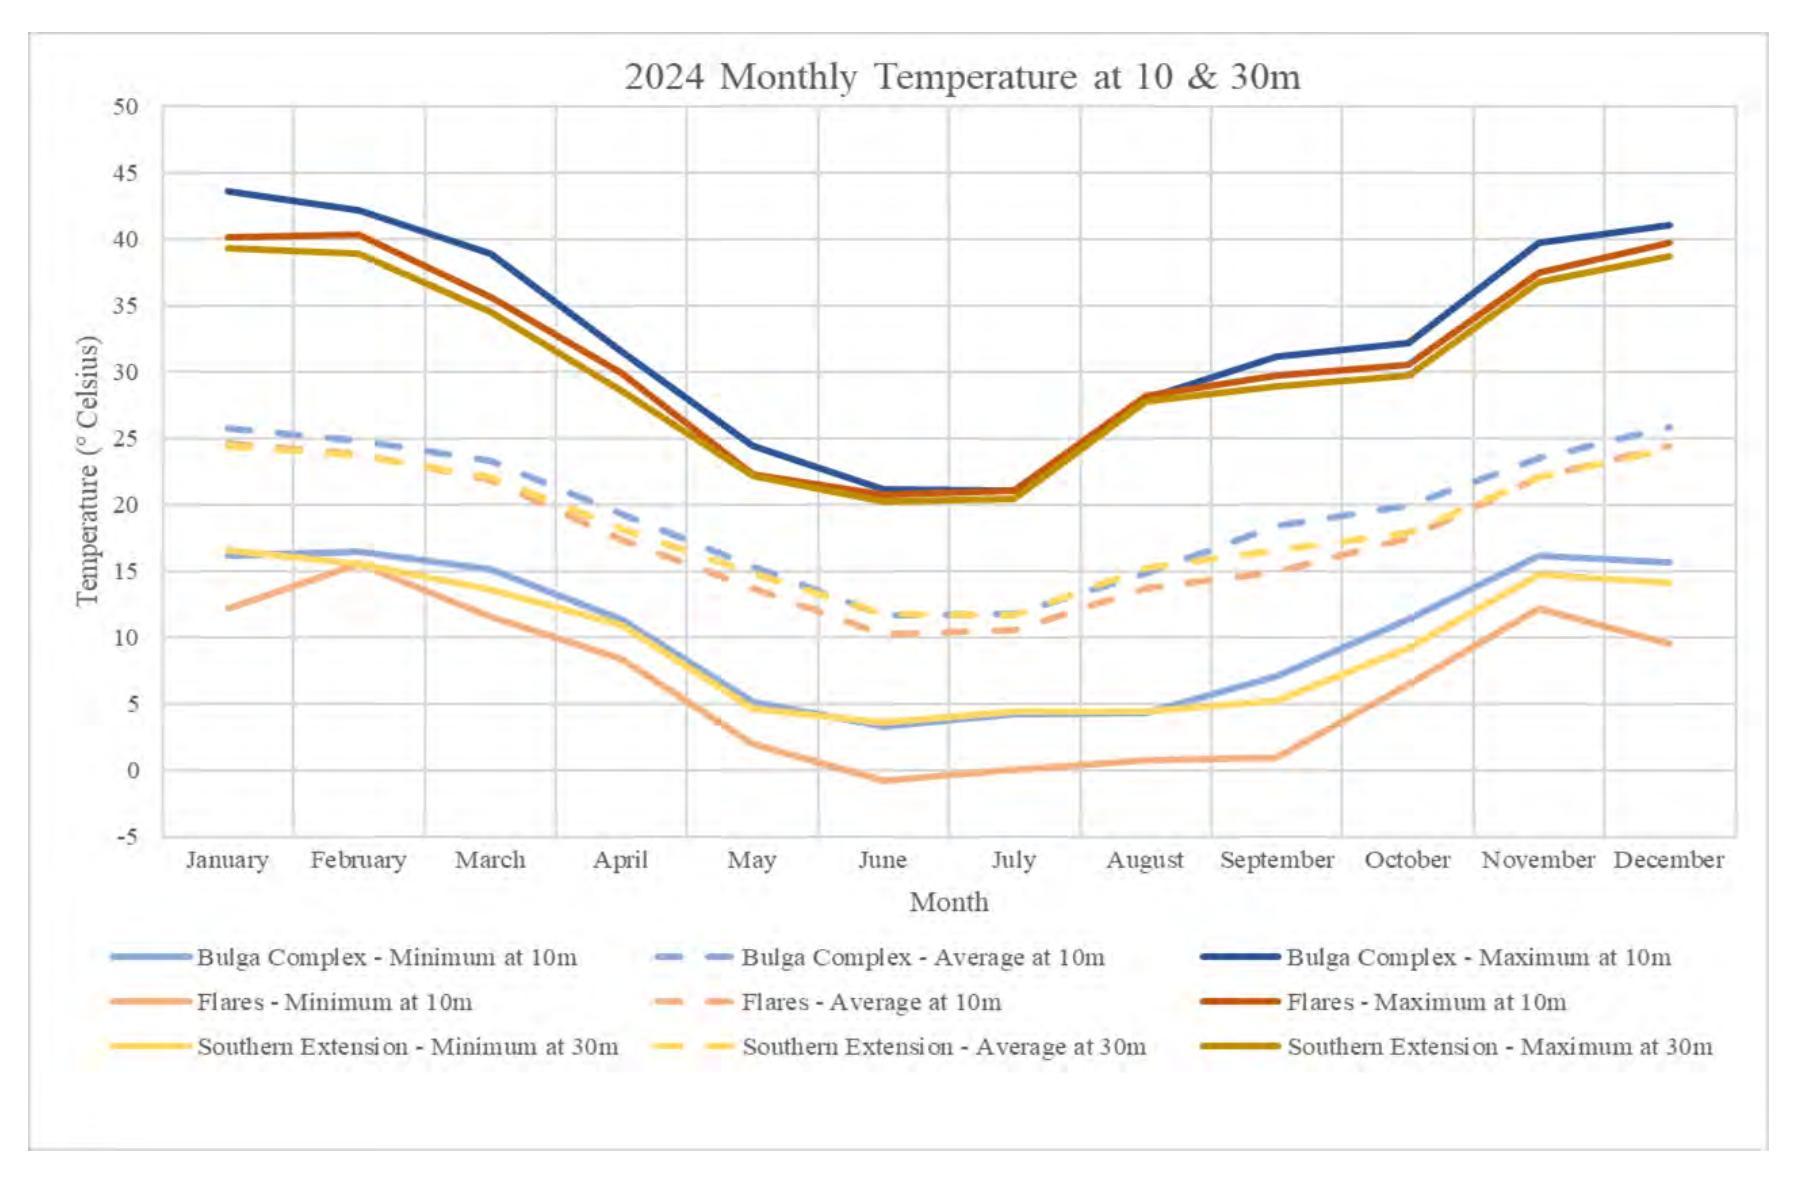
#### Figure 6.6 2024 Monthly Temperature 10 m/30 m (Degrees Celsius) at Representative Monitoring Stations

Note: Temperature at Bulga Complex and Flares stations is at 10 m. Temperature at 30 m is recorded at Southern Extension.

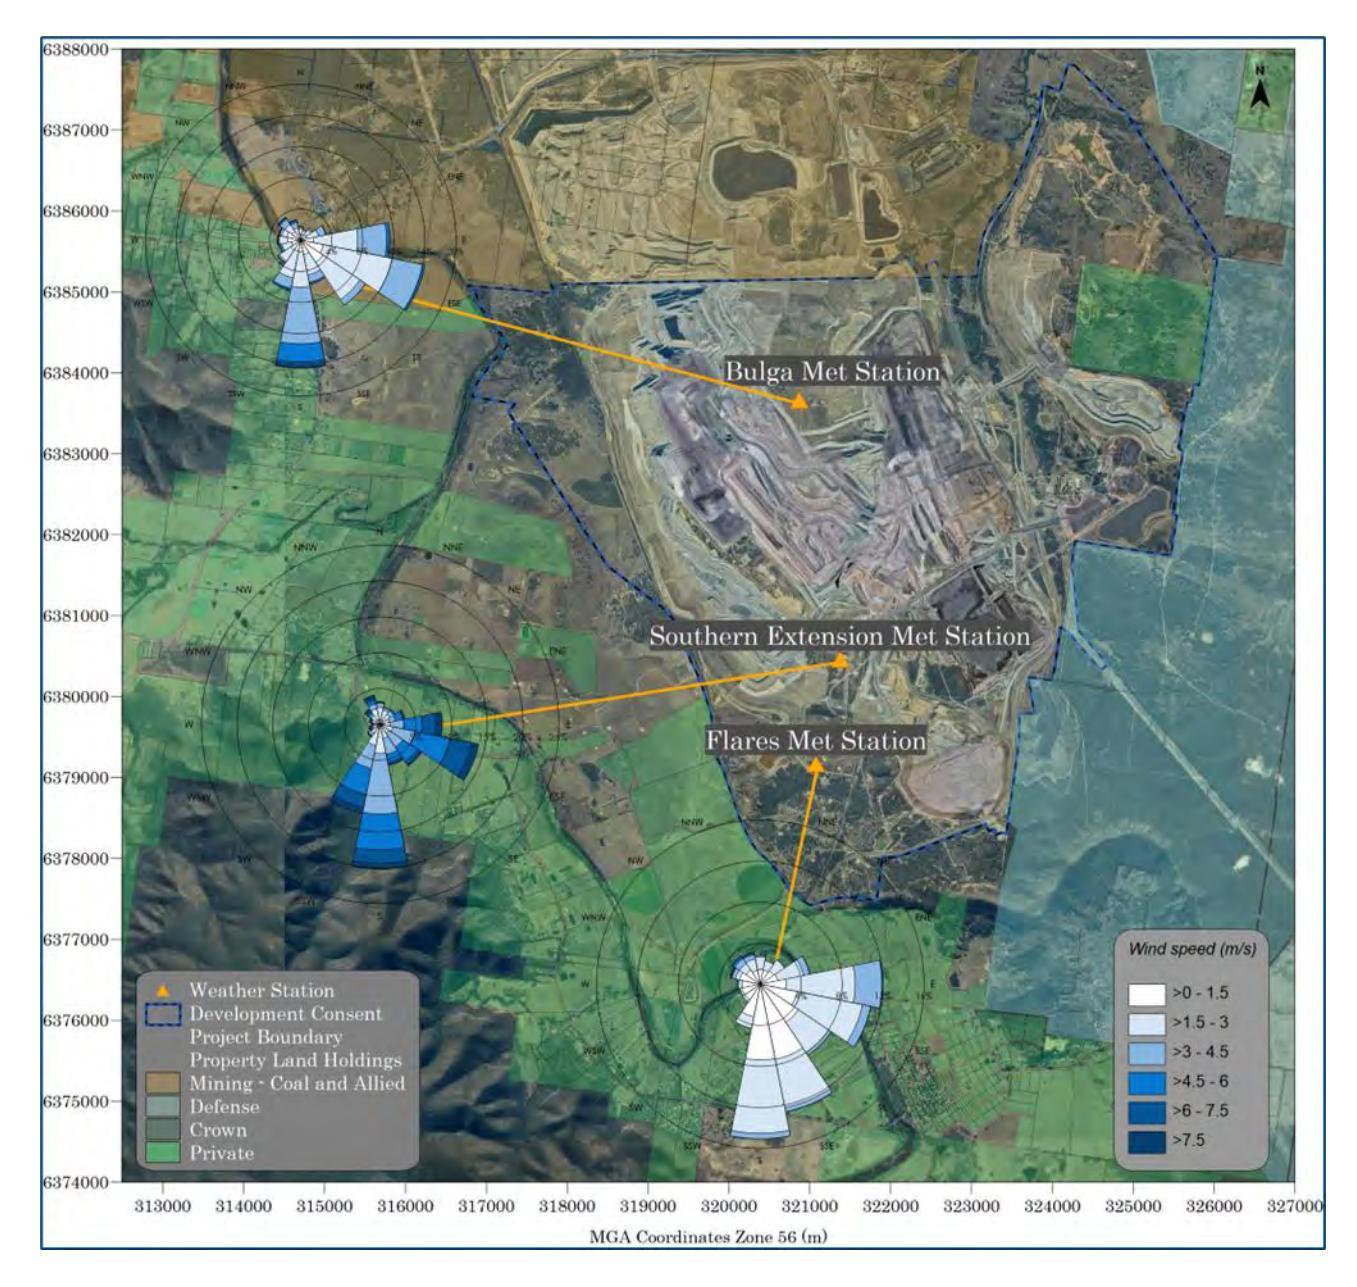
Figure 6.9 Wind Speed and Direction Quarter 1

The Bulga Complex Station, Southern Extension Station and Flares Station predominantly recorded winds originating from the south and southeast in Q1 2024. The calms recorded at the Flares Station were most likely due to sheltering from vegetation.

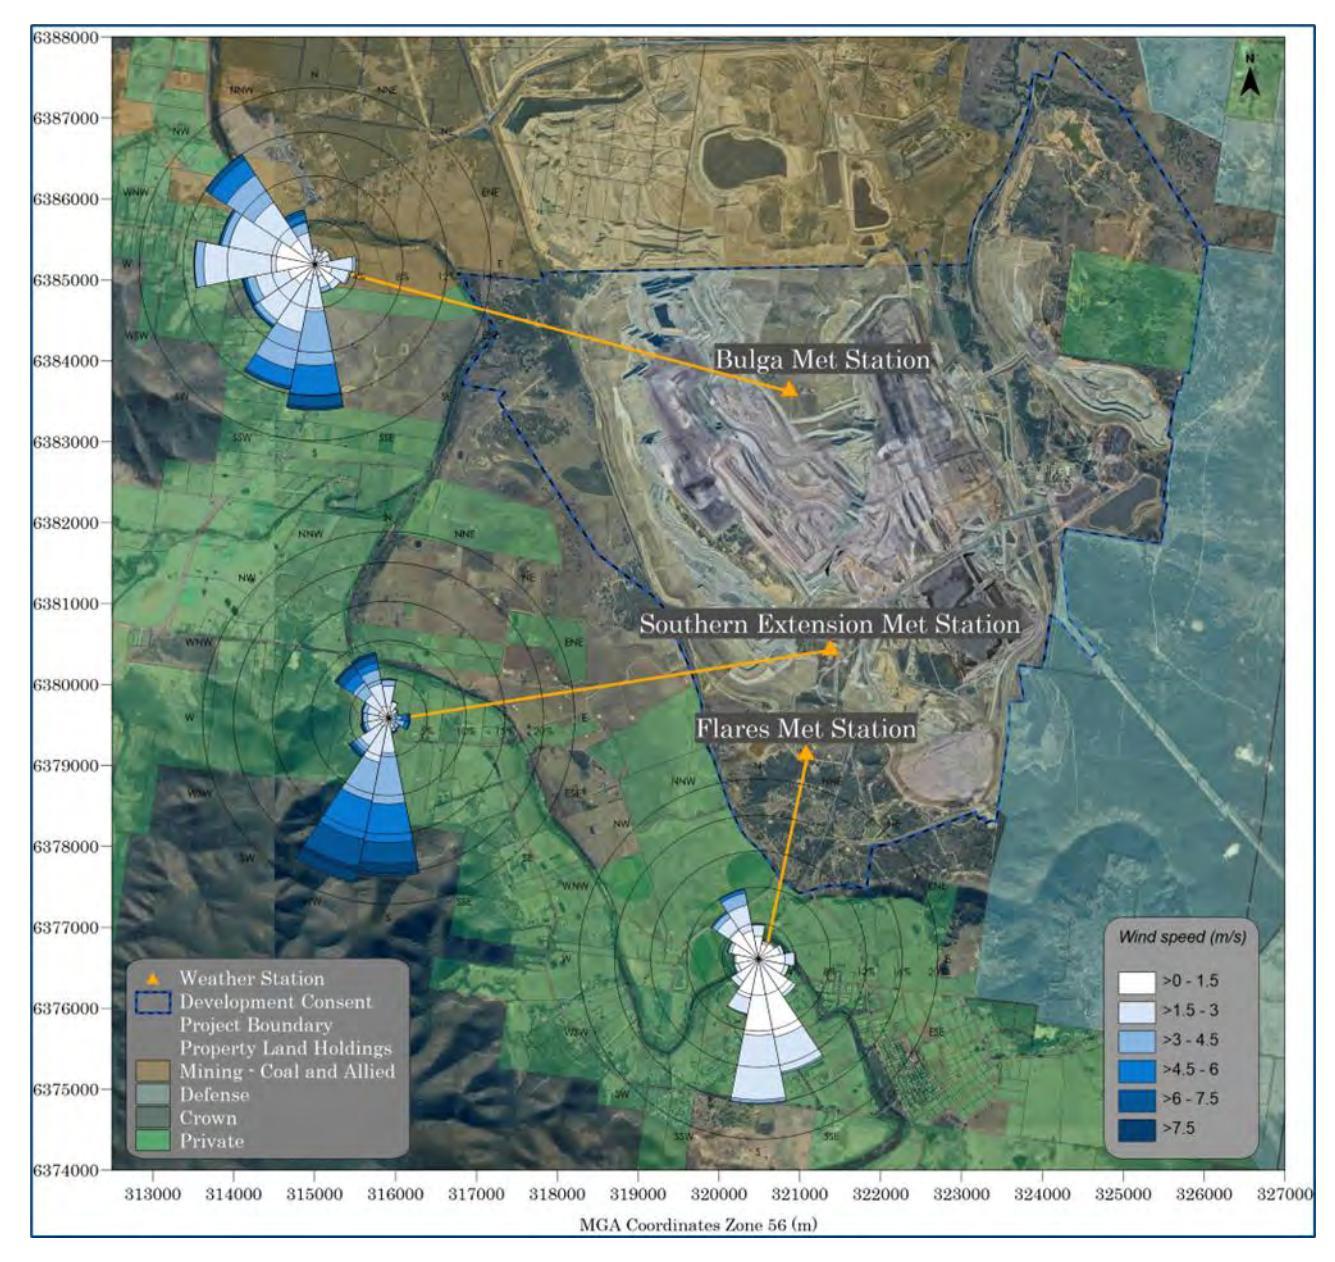
Figure 6.10 Wind Speed and Direction Quarter 2

The Bulga Complex Station, Southern Extension Station and Flares Station recorded variable wind directions with the highest proportions being from the south in Q2 2024. The calms recorded at the Flares Meteorological Station were most likely due to sheltering from vegetation.

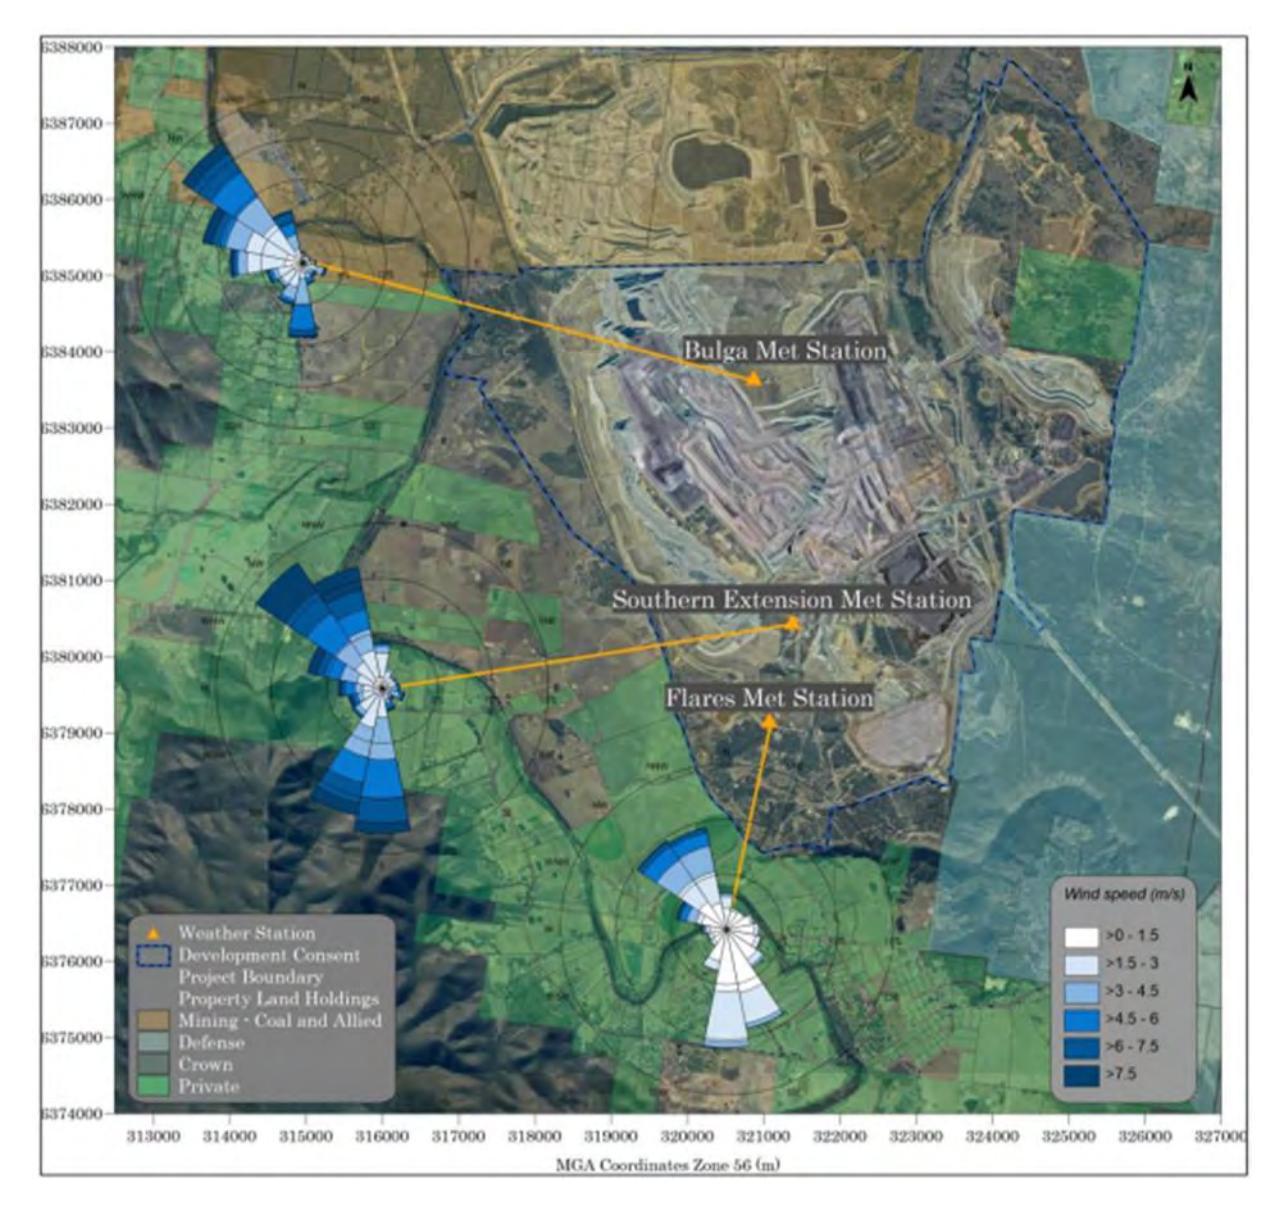
Figure 6.11 Wind Speed and Direction Quarter 3

The Bulga Complex Station, Southern Extension Station and Flares Station recorded variable wind directions, with the highest proportions being from the south quadrant and northwest quadrants in Q3 2024. The calms recorded at the Flares Station were most likely due to sheltering from vegetation.

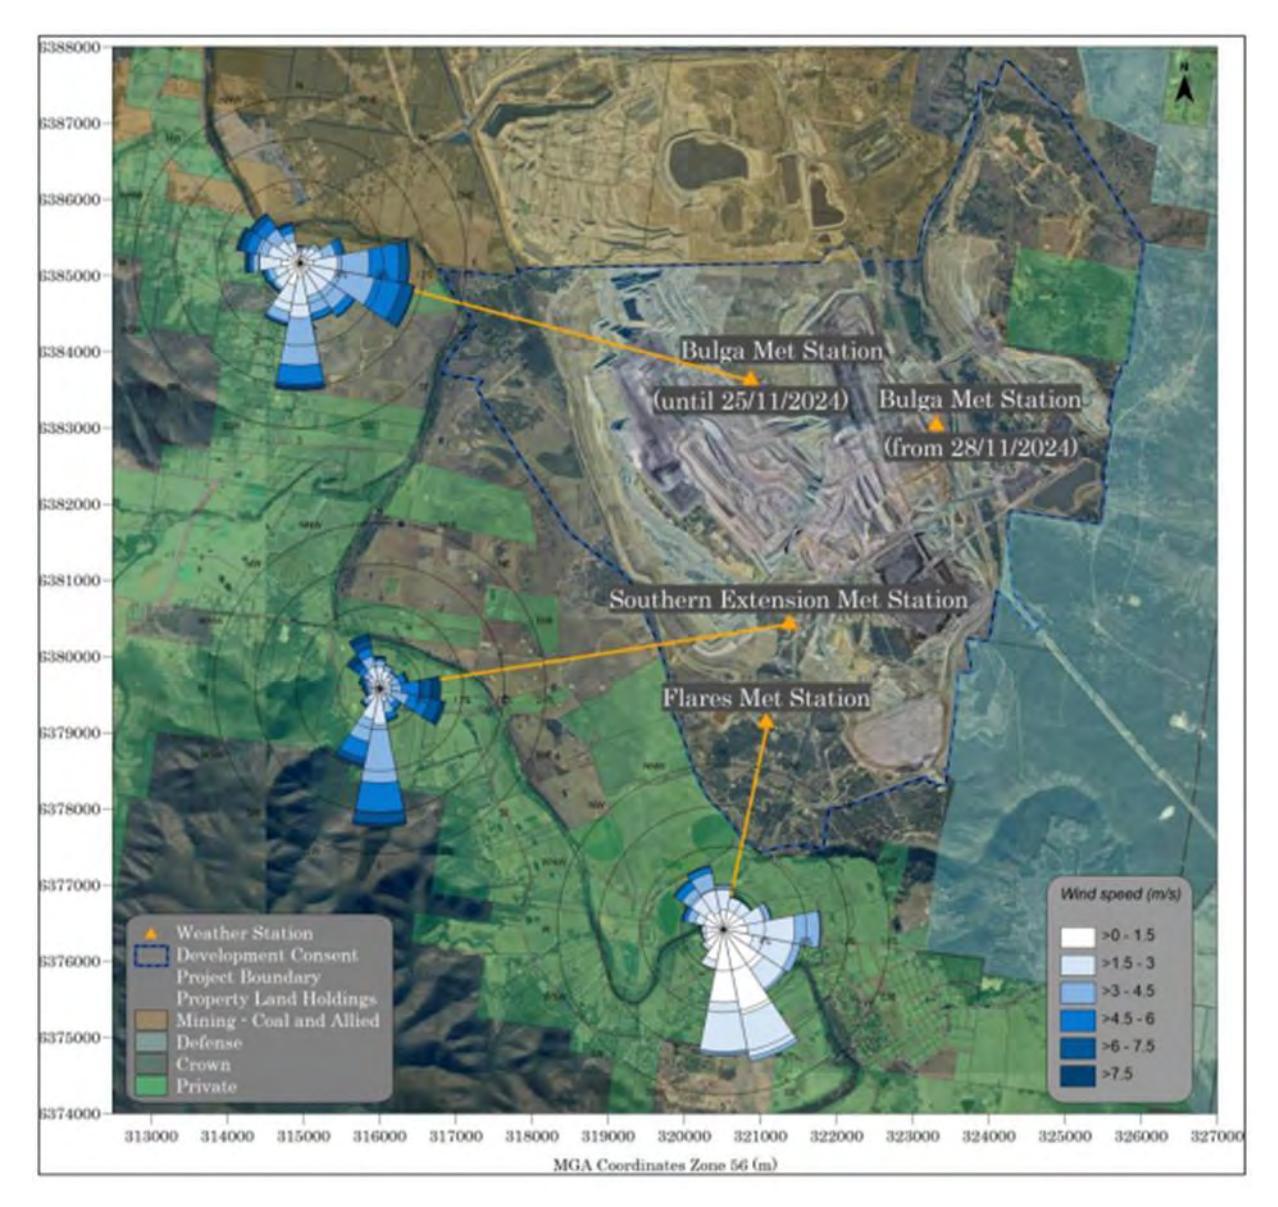
### Figure 6.12 Wind Speed and Direction Quarter 4

The Bulga Complex Station, Southern Extension Station and Flares Station recorded variable wind directions with the highest proportions being from the south in Q4 2024. It is noted that the Bulga Complex Station was temporarily offline from 25 November 2024 to 28 November 2024 to allow the system to be relocated prior to dump progression. The calms recorded at the Flares Station were most likely due to sheltering from vegetation.

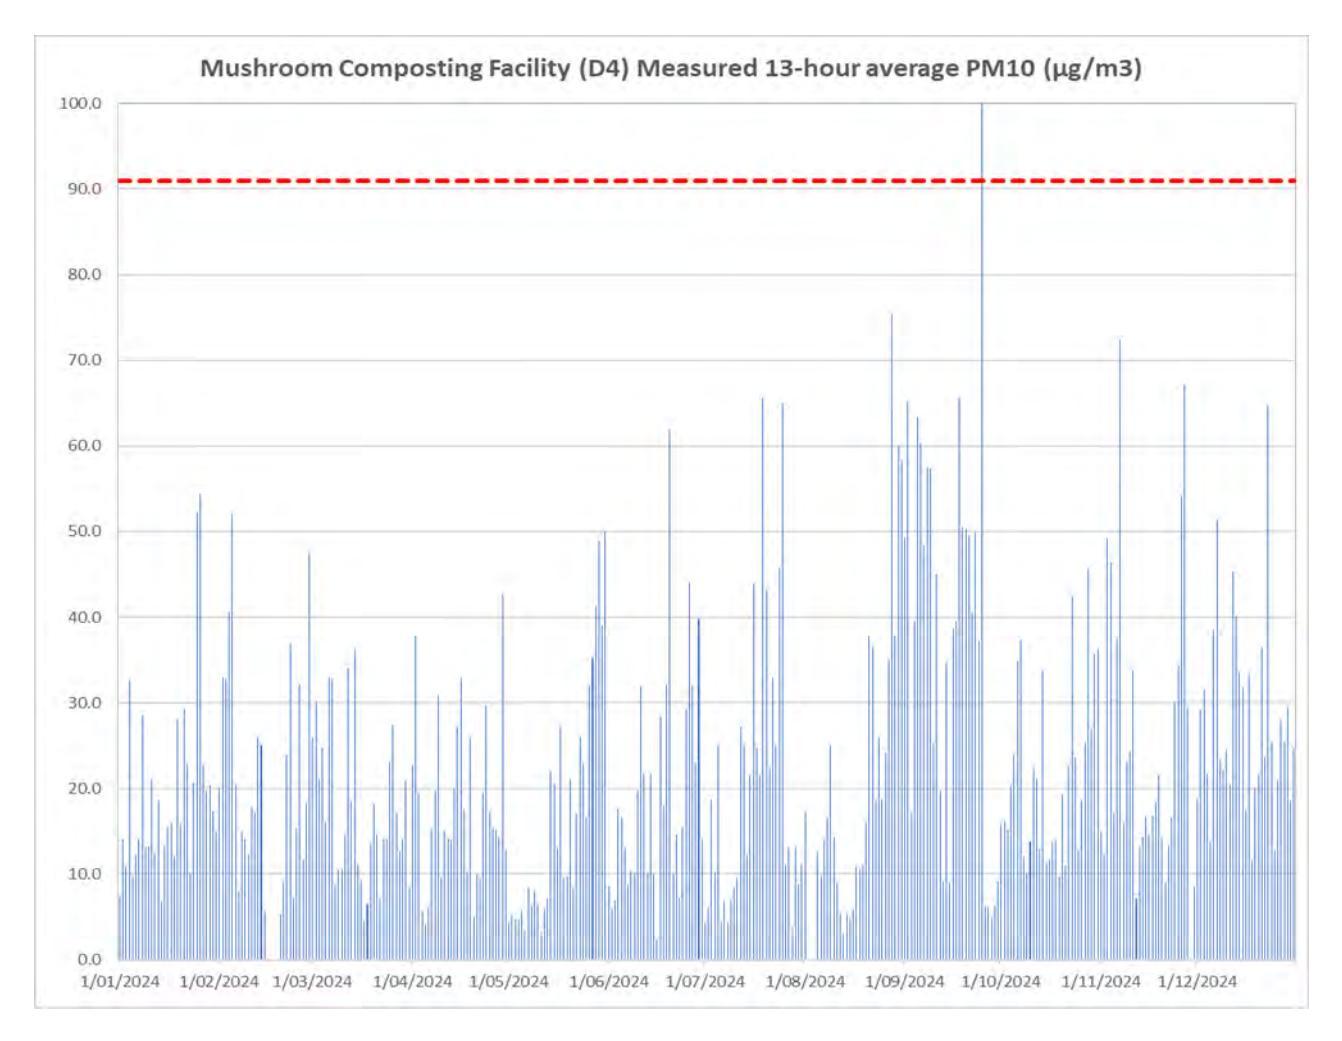
Figure 6.15 Mushroom Composting Facility (D4 Sampling Results 2024 – 13-hour PM<sub>10</sub> Averages)

As shown in **Figure 6.15**, there was one occasion where levels were above the assessment level of  $91\mu g/m^3$ . This was investigated in accordance with the *Eastern Emplacement Area Air Quality Management Framework* (EEAAQMF). In accordance with the investigation and incident reporting process in the EEAAQMF, Bulga Coal and the Mushroom Composters agreed that Bulga Coal was not the main cause of the exceedance; no dumping or loading activities were undertaken at the Eastern Emplacement Area (EEA) during the day. Only rehabilitation activities were carried out and they were not upwind of the Mushroom Composting Facility. Therefore, this was not classified as an incident or non-compliance and no notification to DPHI was required.

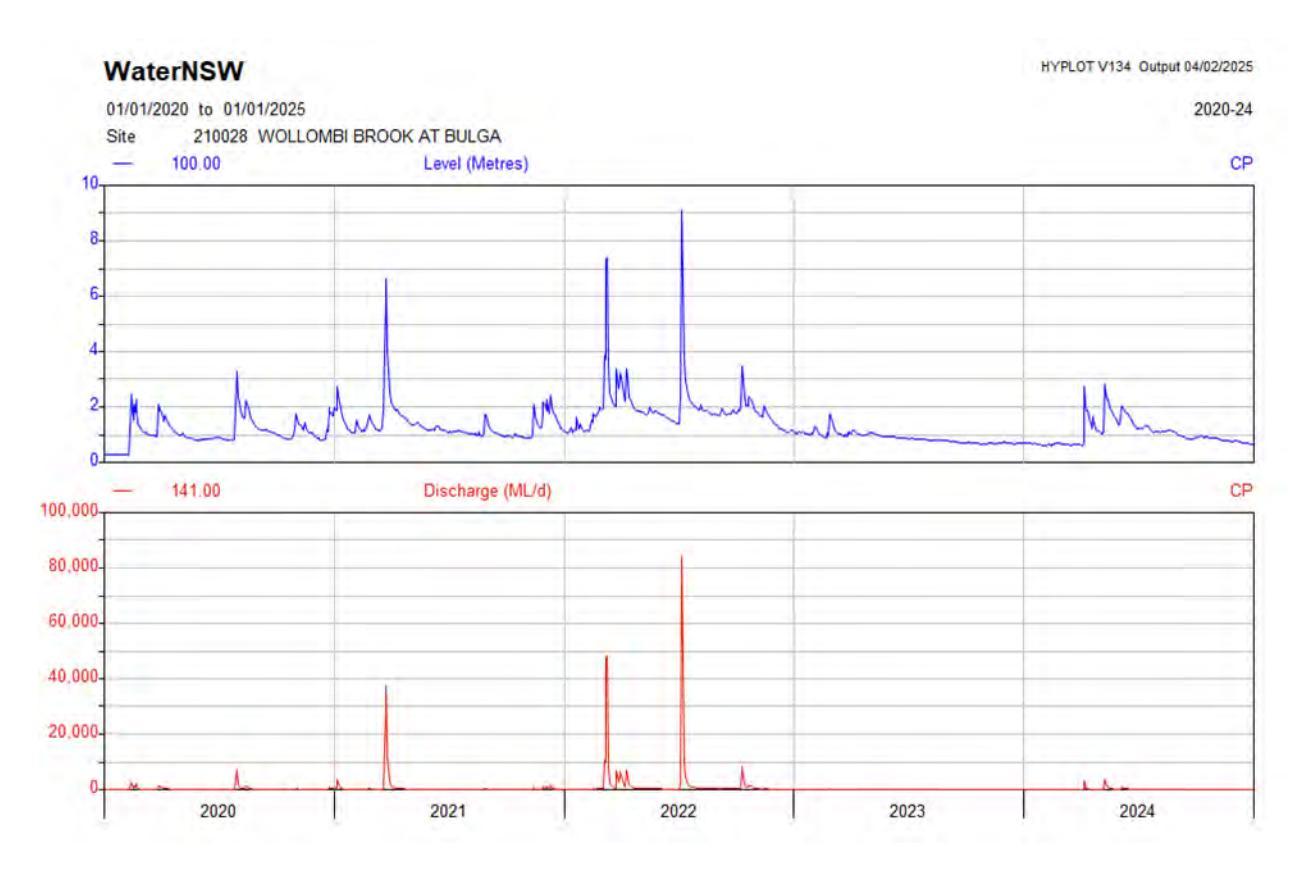
Figure 7.2 Wollombi Brook – Bulga Gauging Station 210028 (Downstream)

Stream flow impacts in Wollombi Brook from Bulga Coal are determined by comparing the Water NSW gauging station records, upstream and downstream of the site. The upstream site is the Wollombi Brook – Brickmans Bridge (Paynes Crossing) gauging station (210135), which is located approximately 20 km upstream of Bulga Coal. The downstream site is the Wollombi Brook – Bulga gauging station (210028), located approximately 5 km downstream of Bulga Coal. **Figure 7.1** and **Figure 7.2** show the gauging station records for 2020 to 2024 for the upstream and downstream sites, respectively.

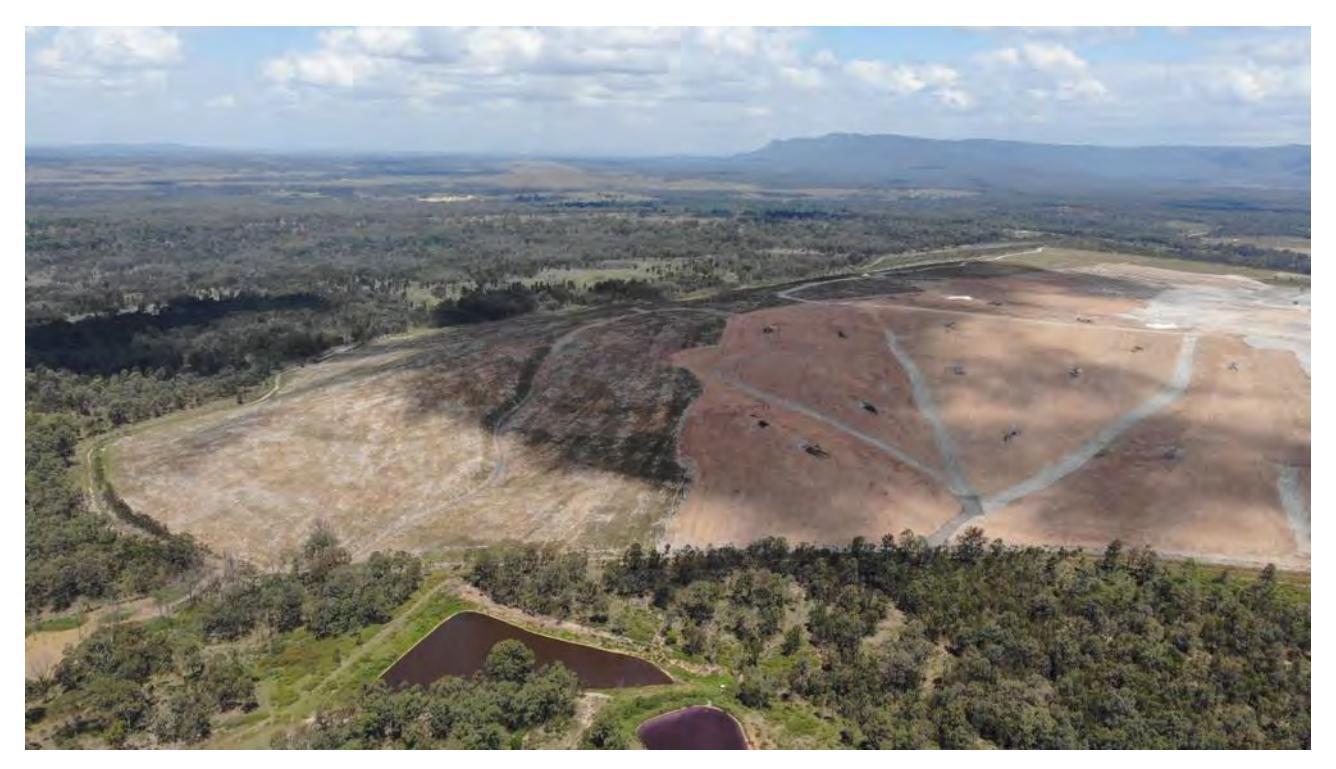
During 2024, Bulga Open Cut continued to implement a geomorphic natural landform design, as shown in **Photo 8.1**. Bulga Open Cut continued to progressively rehabilitate all available overburden emplacement areas which have reached final landform extents.

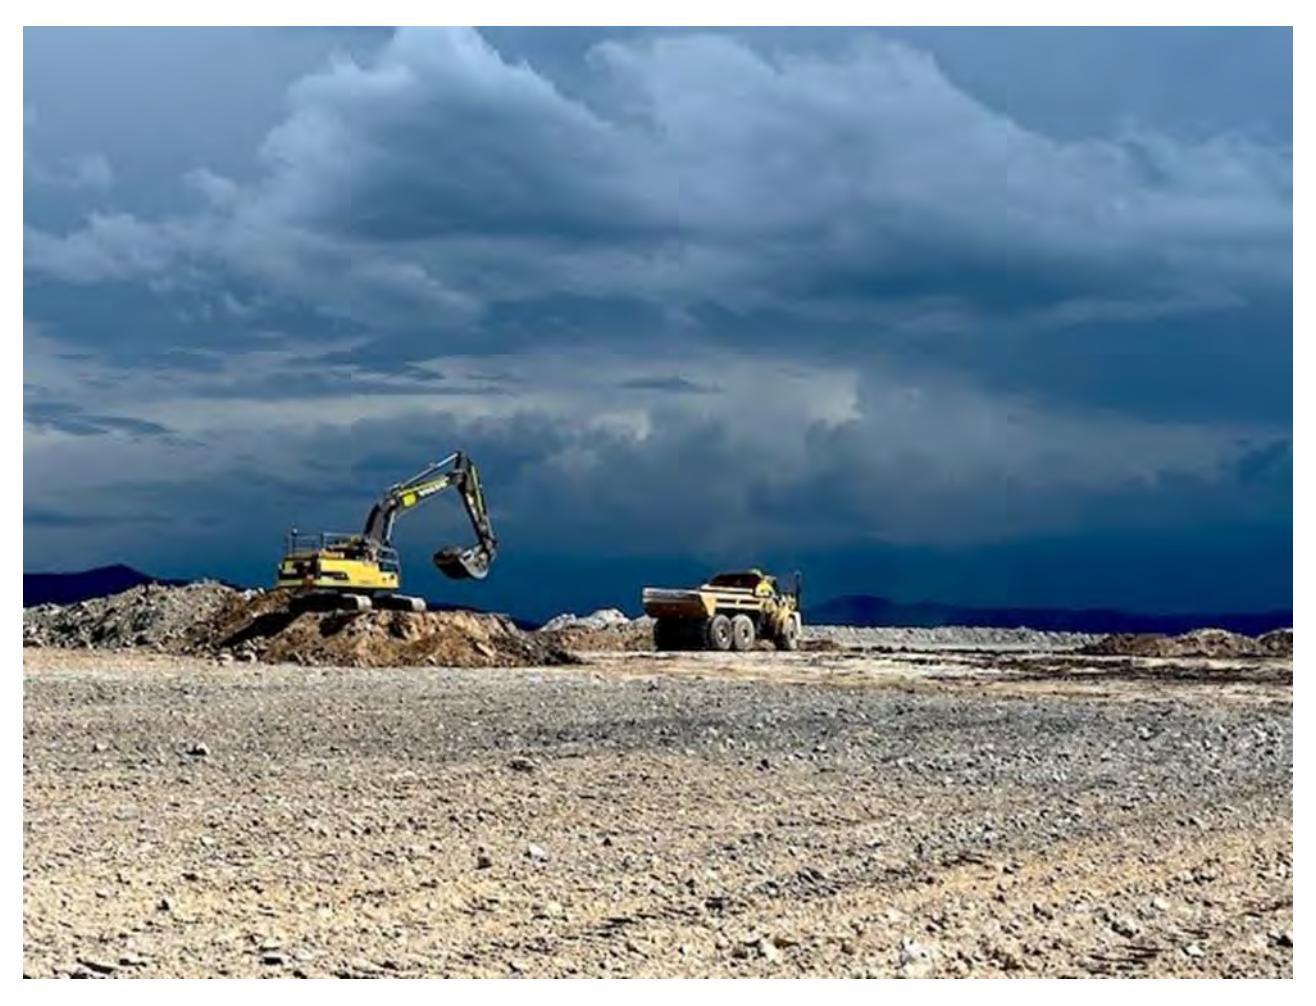
Photo 8.2 Topsoil loading at the Eastern Emplacement in 2024

Stockpiled topsoil was spread at a nominal thickness of 100 mm on the slope of the shaped landform, with approximately 50 mm applied on the flatter areas (refer **Section 8.6.2**). Topsoil was sourced directly from topsoil stripping activities and topsoil stockpiles stored onsite. Gypsum was applied immediately after topsoil application at a rate of 8 t/ha and then deep ripped to a depth of 450 mm to incorporate the topsoil into overburden material to create a suitable seed bed, as shown in **Photo 8.2**.
