**Mount Pleasant Operations (DA 92/97  
Annual Review 2019**

**MOUNT PLEASANT OPERATION**

**2019 ANNUAL REVIEW &  
ANNUAL REHABILITATION REPORT**

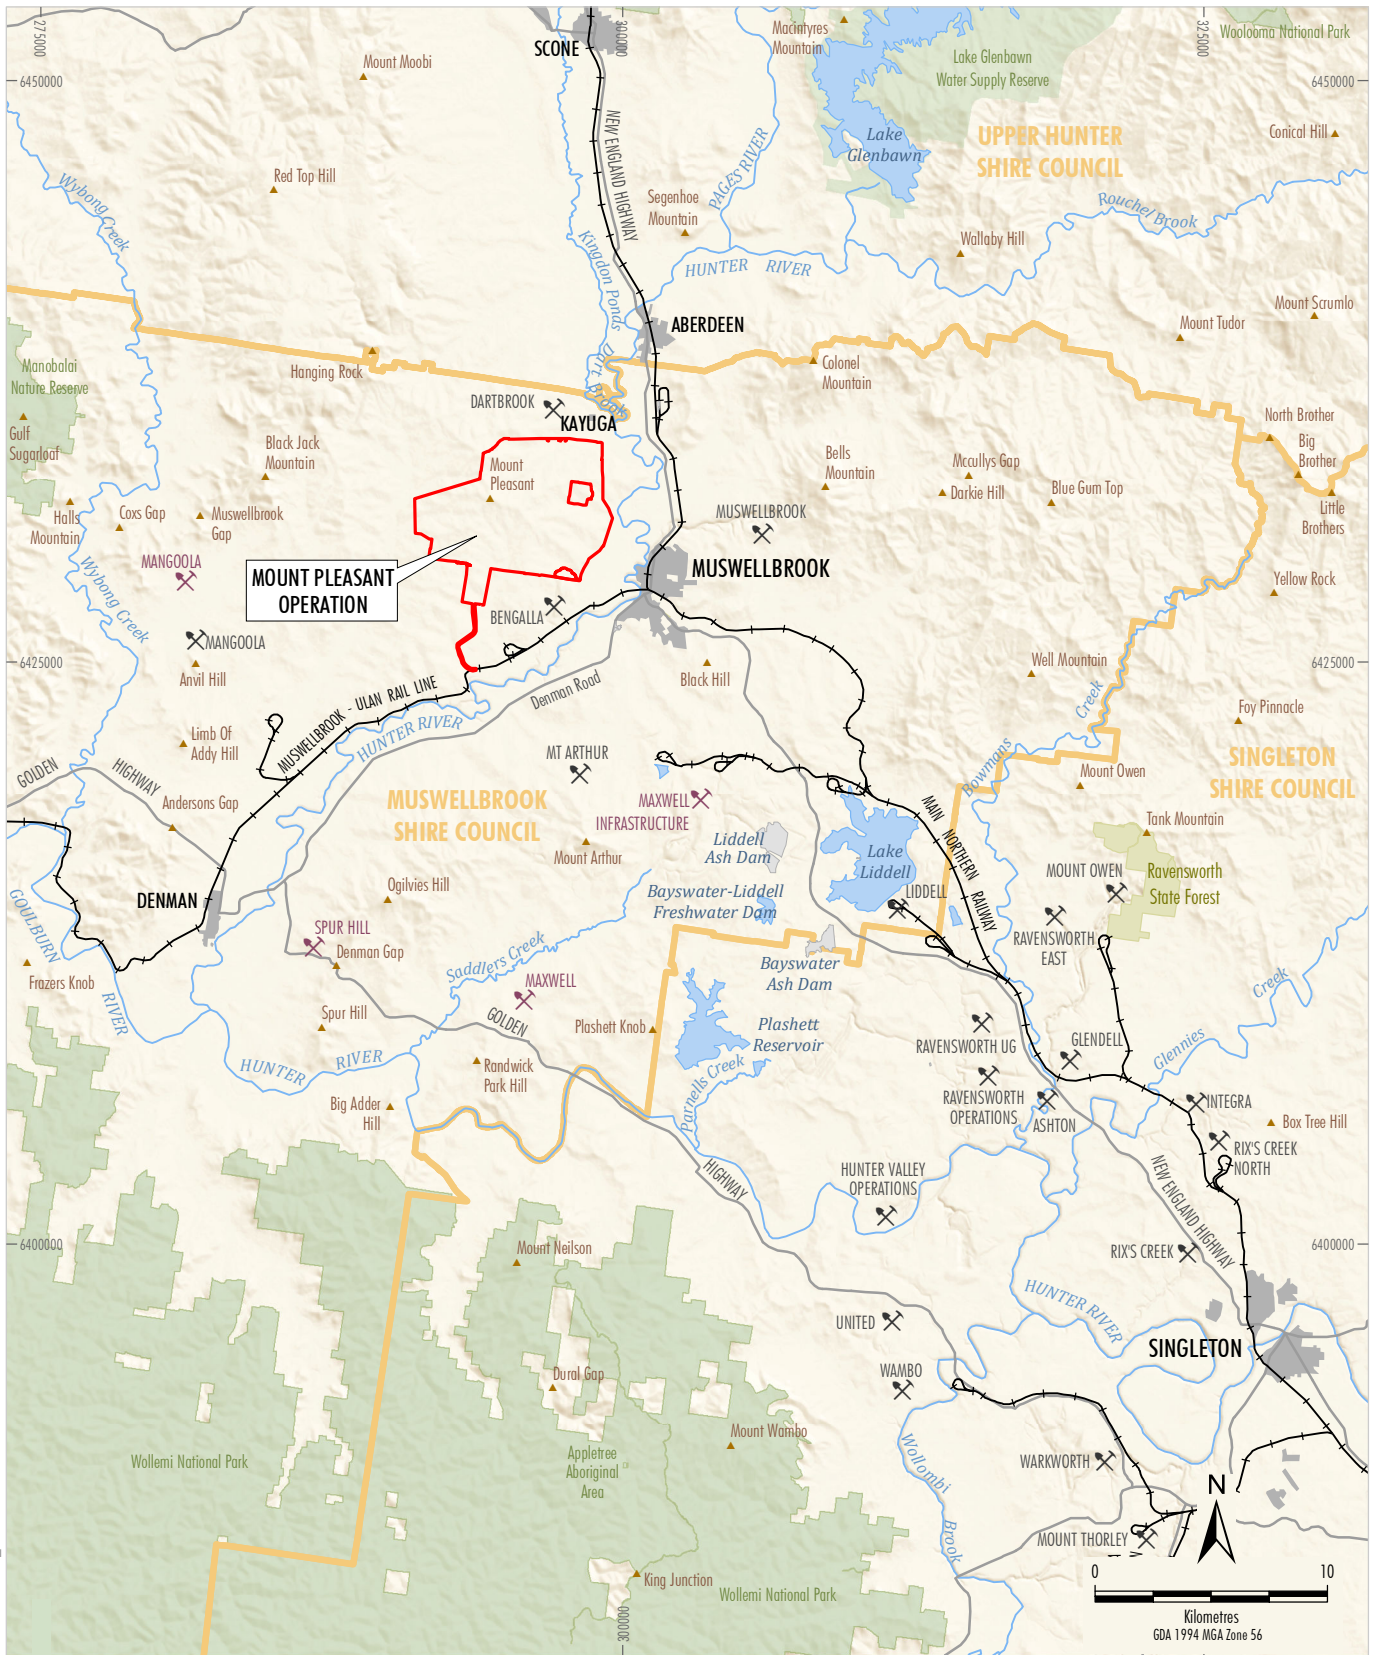
Figure 2 shows the general arrangement of the MPO, as well as the extent of disturbance and rehabilitation at the end of 2019 and the forecasted additional disturbance proposed in 2020.

Figure 2 shows the extent of active disturbance and rehabilitated areas at the end of the reporting period, as well as the forecast disturbance areas proposed in 2020.

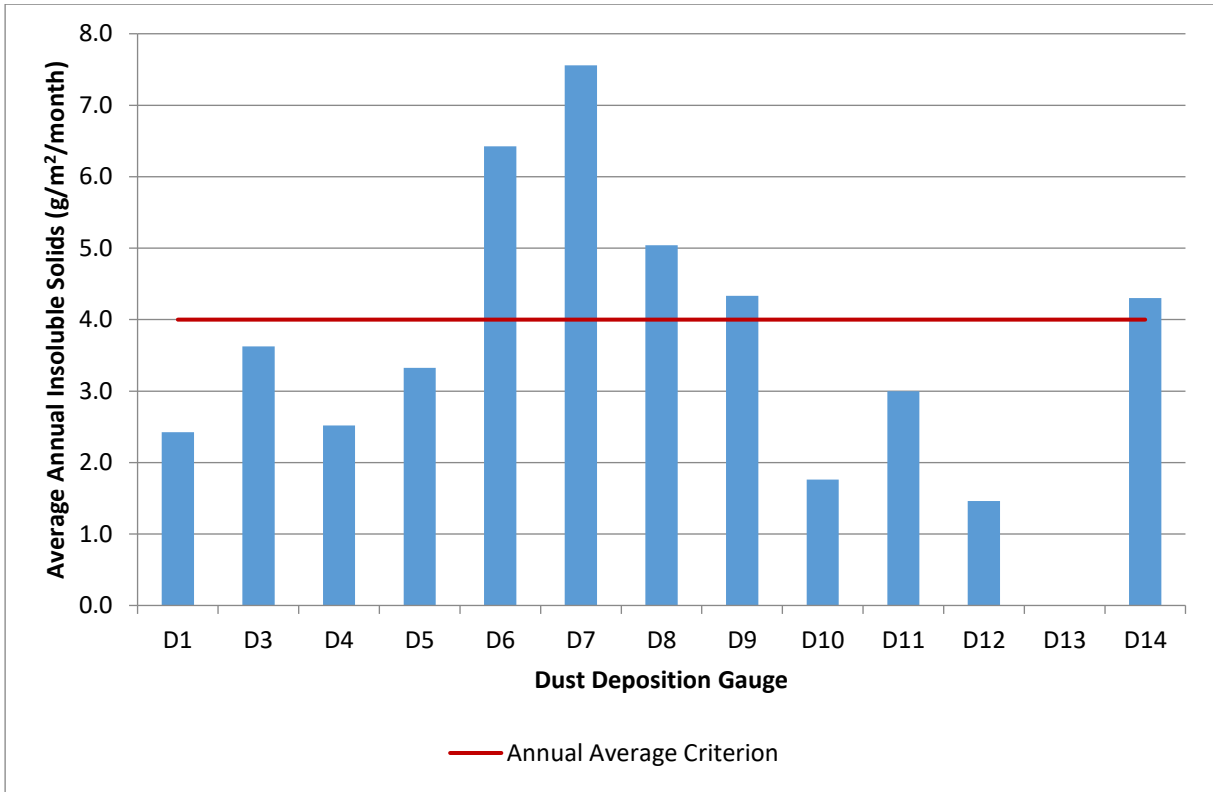
Chart 4: 2019 Annual Average Insoluble Solids

Annual average levels of insoluble solids (i.e. dust deposition) are presented in Chart 4. Chart 5 provides a comparison between annual average dust deposition levels at each of the monitoring sites from 2014 to 2019.

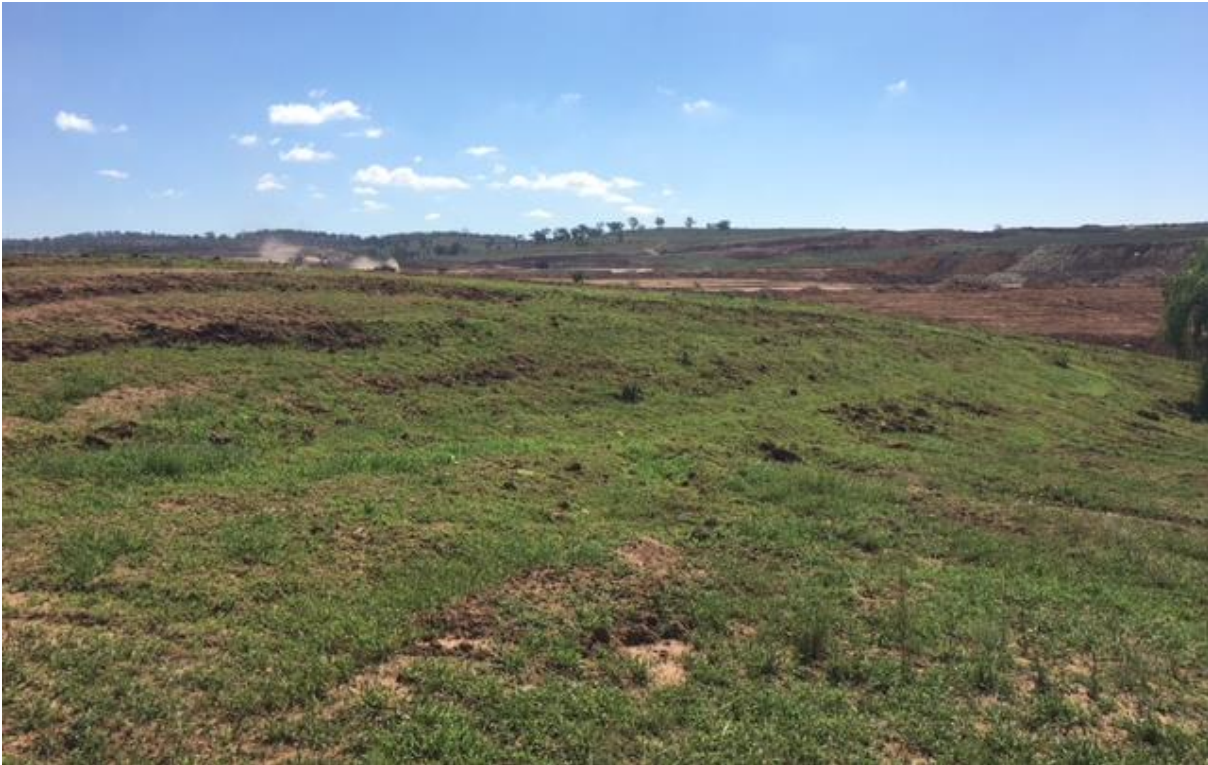
**Plate 2: Example Topsoil Stockpile**

Plate 2 provides an example topsoil stockpile at the MPO. Further descriptions of topsoil stockpile management options are outlined in the approved MOP/RMP.

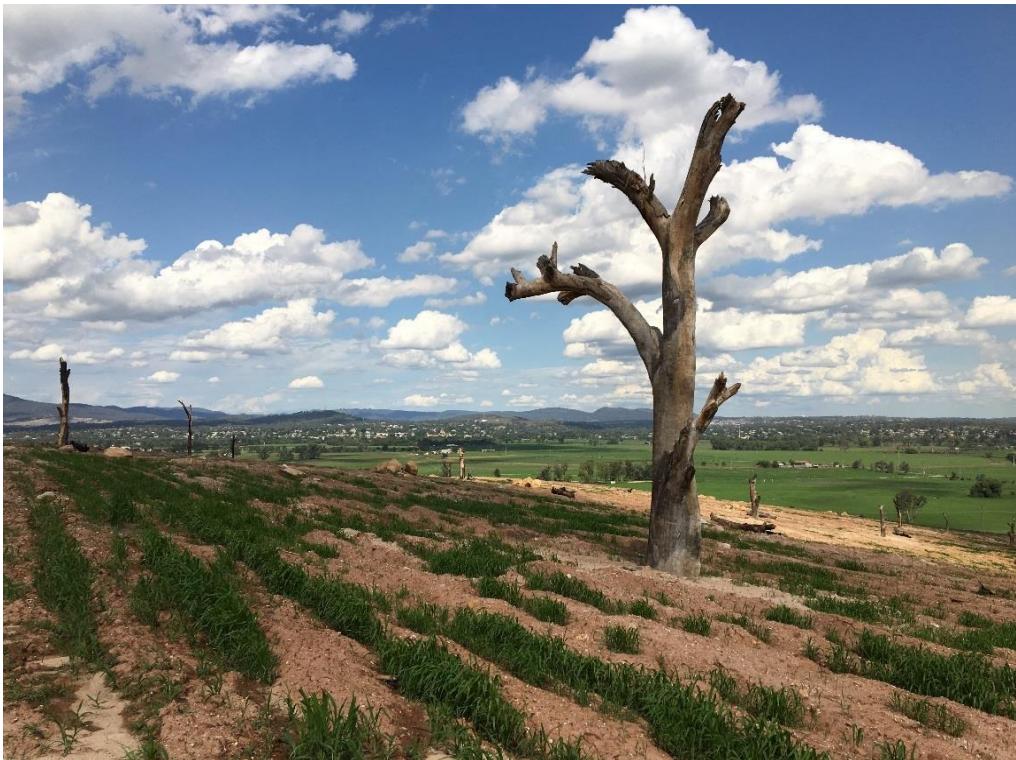
**Plate 3: Eastern Out of Pit Emplacement Rehabilitation**

- bulk and detailed re-shaping of overburden material to final landform;
- installation of habitat features such as stag trees and rock piles;
- topsoil spreading to a minimum depth of 100 mm;
- gypsum application at a rate of 10 tonnes per hectare (t/ha);
- deep ripping/tining along the contour of the final landform;
- direct/hand seeding of EEC tree/shrub/grass indicative species plus an additional grass cover crop; and
- planting of approximately 1,000 native trees per hectare.
