CHAIN VALLEY COLLIERY
Annual Review 2019
1 January 2019 – 31 December 2019

Chain Valley Colliery – Annual Review (AEMR) 2019

Name of operation	Chain Valley Colliery
Name of operator	Great Southern Energy Pty Ltd trading as Delta Coal Pty Ltd
Project Approval #	SSD 5465
Name of Project Approval holder	Delta Coal Pty Ltd
Titles/Mining Leases #	Consolidated Coal Lease 707, Consolidated Coal Lease 706 (part), Mining lease 1051, Mining lease 1052, Mining lease 1308, Mining Lease 1370, Mining lease 1632 (part sublease), Mining Purposes Lease 1349, Mining Purposes Lease 337, Mining Purposes Lease 1389, Mining Purposes Lease 1400, Consolidated Coal Lease 719 (part sublease), Consolidated Coal Lease 721 (part sublease), Consolidated Coal Lease 722.
Name of holder of mining leases	Great Southern Energy Pty Ltd
Water License #	WAL41508 / Work Approval 20MW065025
MOP Commencement Date	1 st October 2018
MOP Completion Date	31 st December 2020
Annual Review start date	1 January 2019
Annual Review end date	31 December 2019

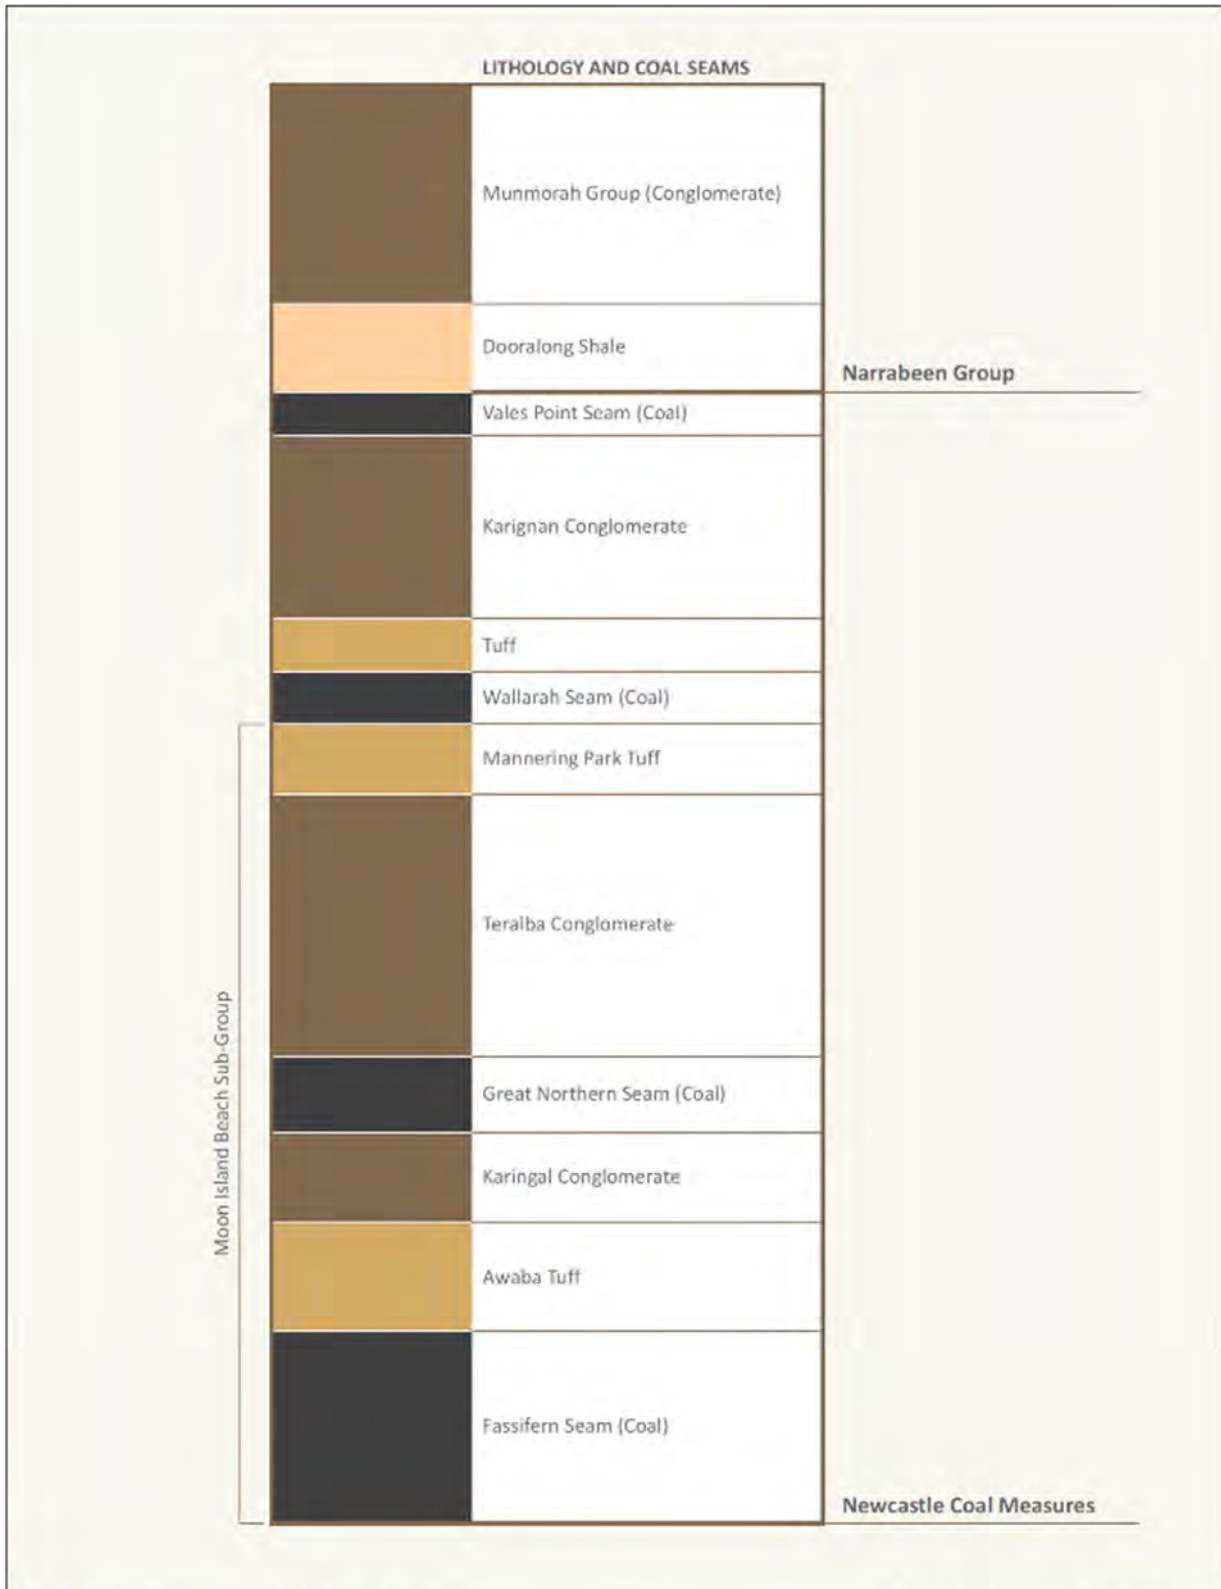
Typical stratigraphy at the Site

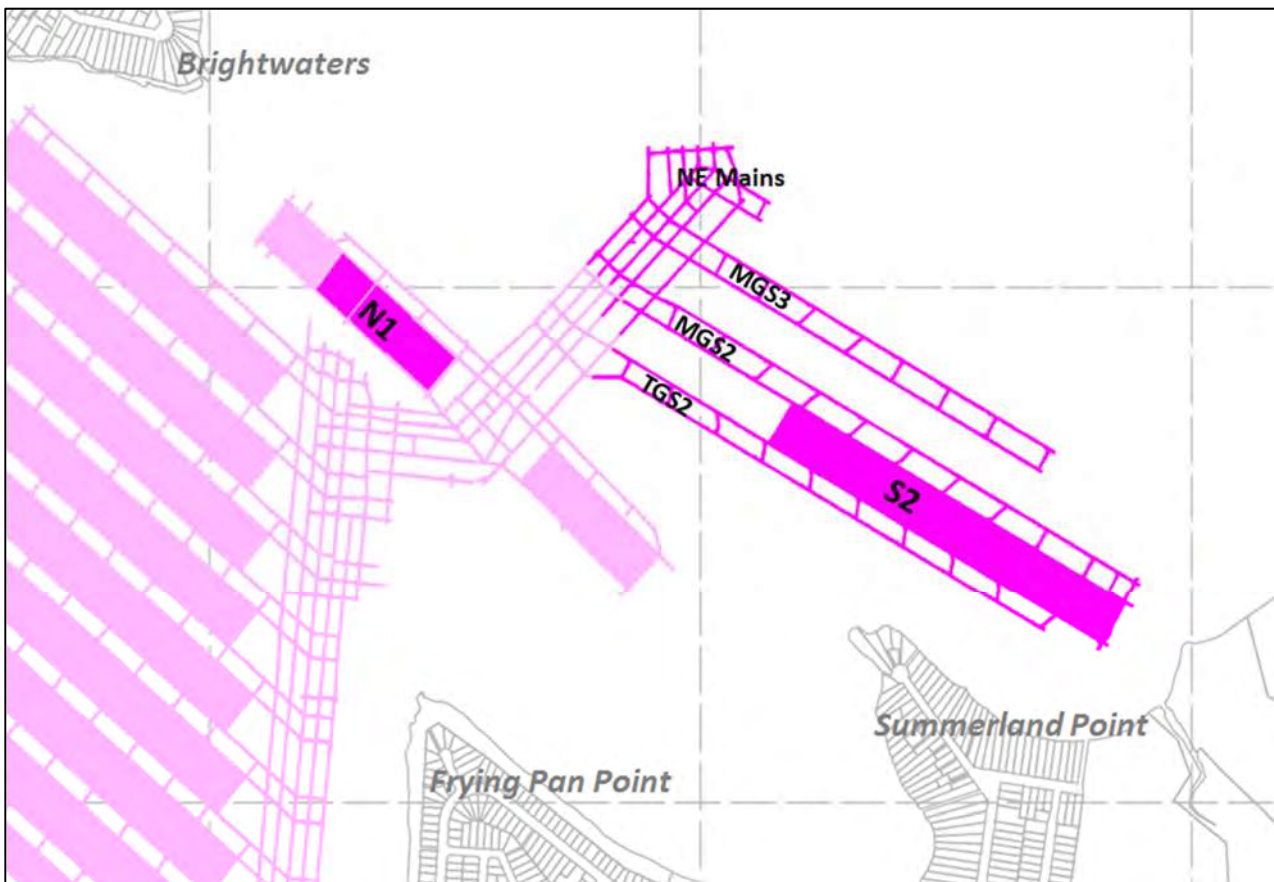
Figure 3: CVC 2019 mining area

Total production for 2019 was 0.8 Mt, which comprised 1088 m of longwall retreat and 10,330 m of development drivage which occurred in Tailgate S2, Maingate S2, Maingate S3 and the North East Mains. Miniwall mining during the reporting period consisted of parts of Miniwall N1 and Miniwall S2. Mining areas in 2019 are shown in **Figure 3**.

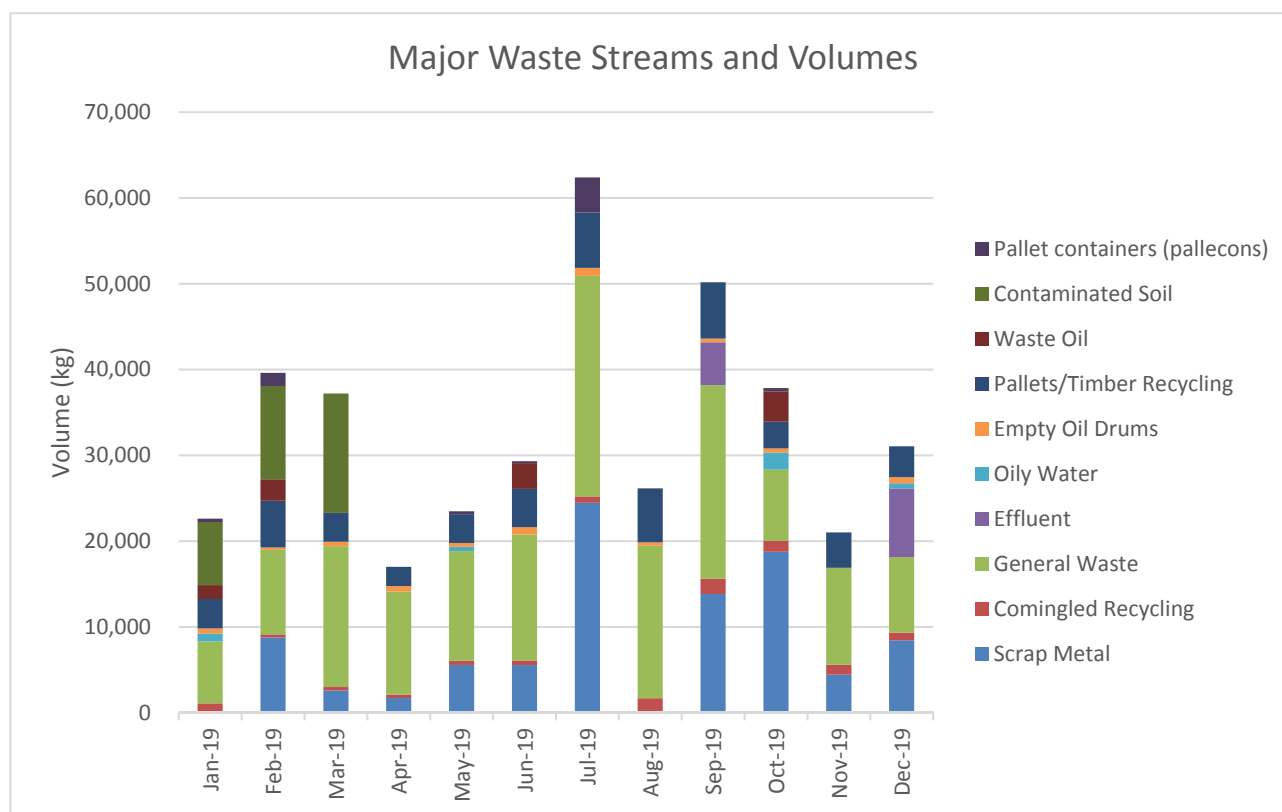
Figure 5: CVC Major Waste Streams and Volumes

The total waste management system also involves weekly site inspections by the waste management contractor to facilitate effective waste management and continual improvement along with monthly reporting, with data from key waste streams presented in **Figure 5**.

During the reporting period there was a continued focus on recycling with a large amount of scrap metal removed from site. The total waste management system will continue during the next reporting period.

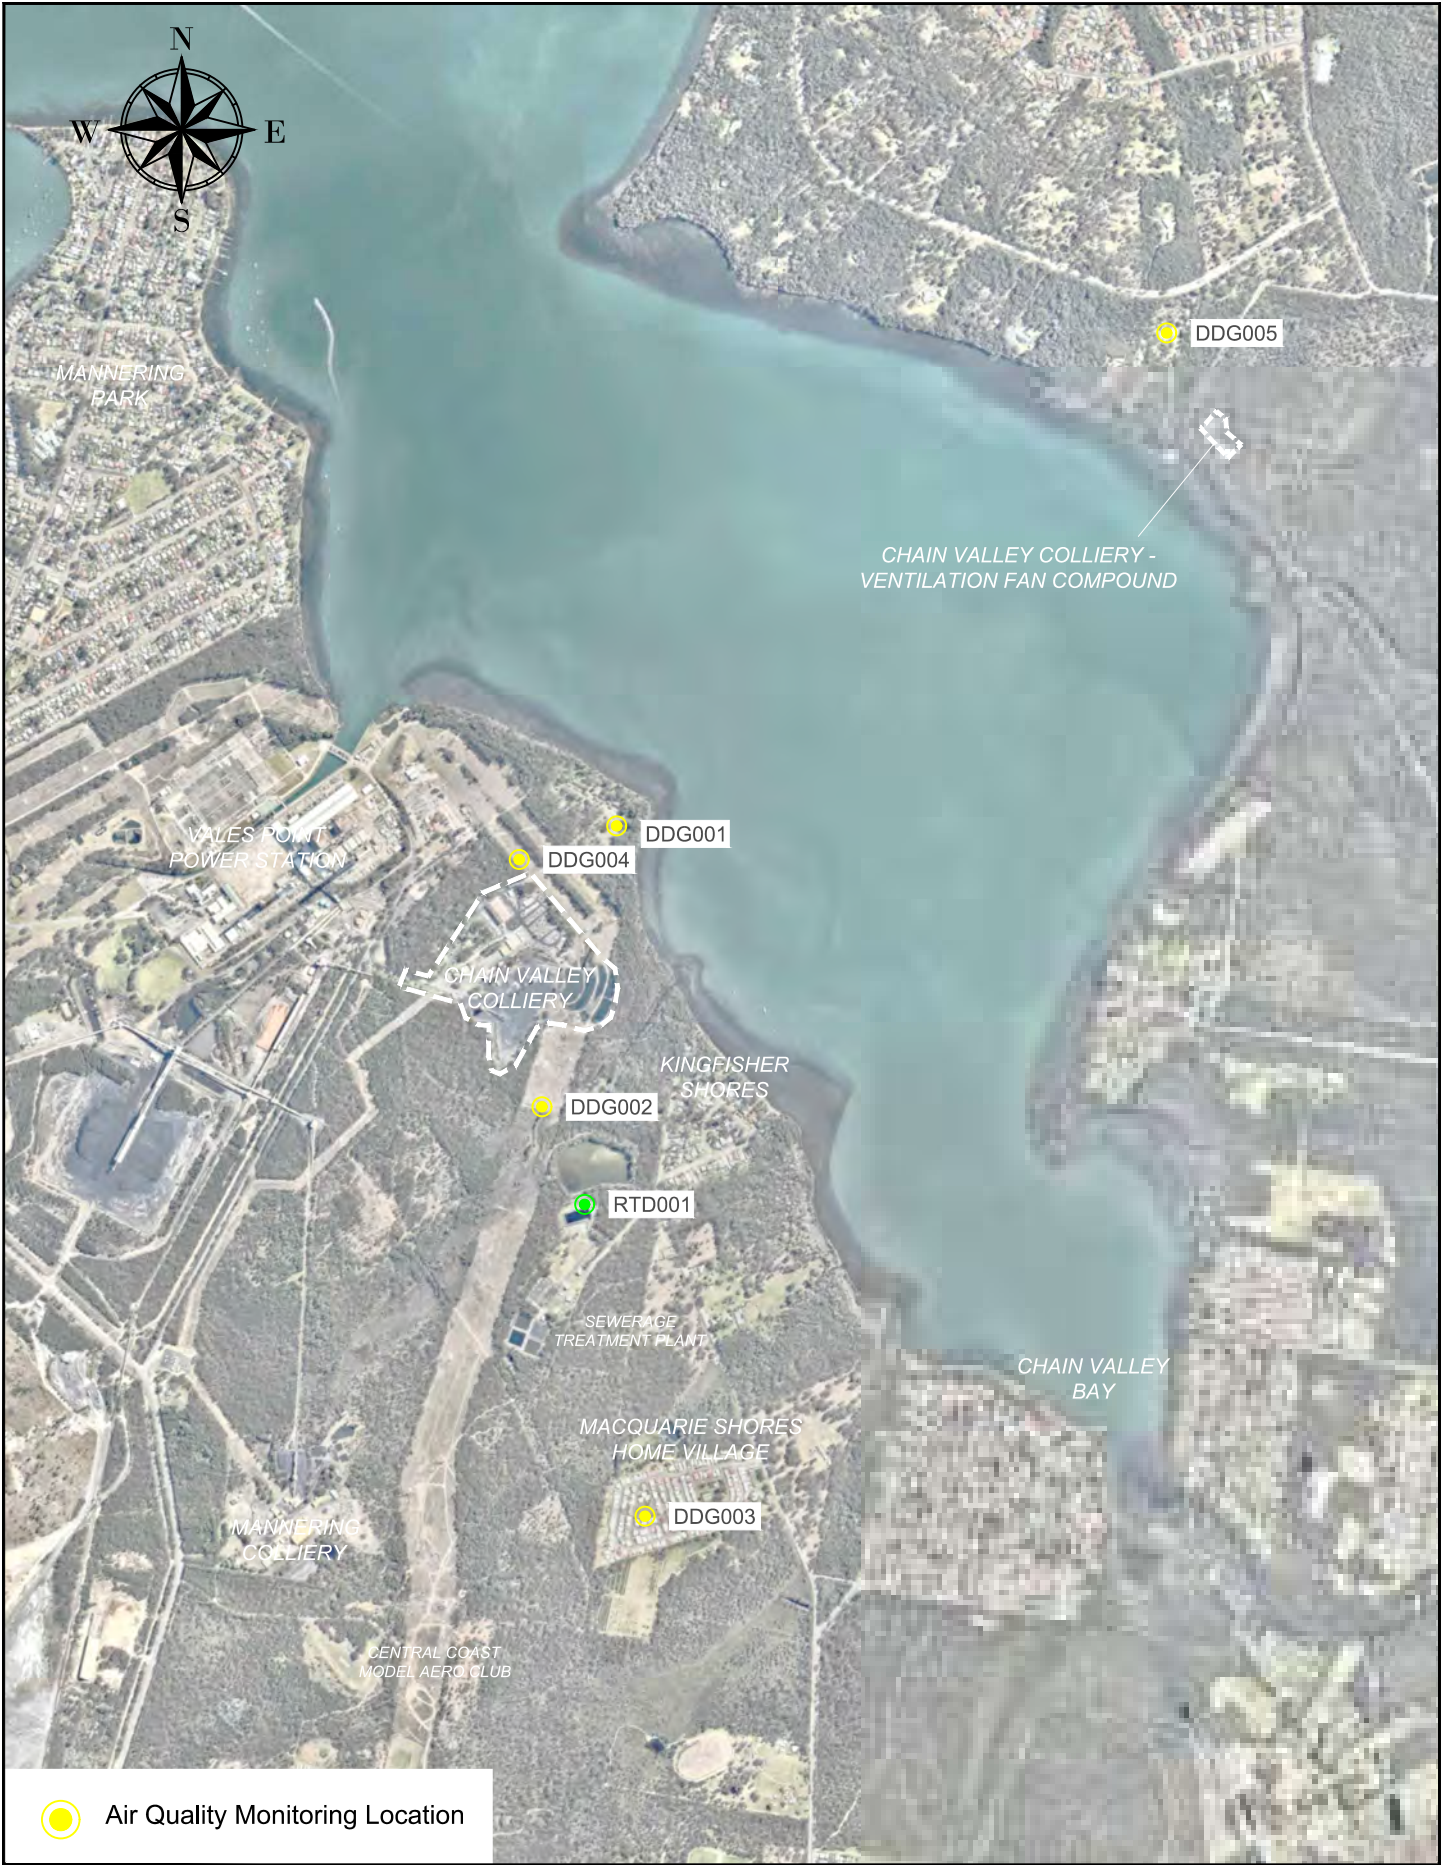
Chain Valley Colliery
 Air Quality Management Plan
 Air Quality Monitoring Locations

SCALE: 1:20 000
 DRAWN: T Chisholm
 CHECKED: K Weekes
 DATE: 8/10/2019
 DRG NO: C1S0266

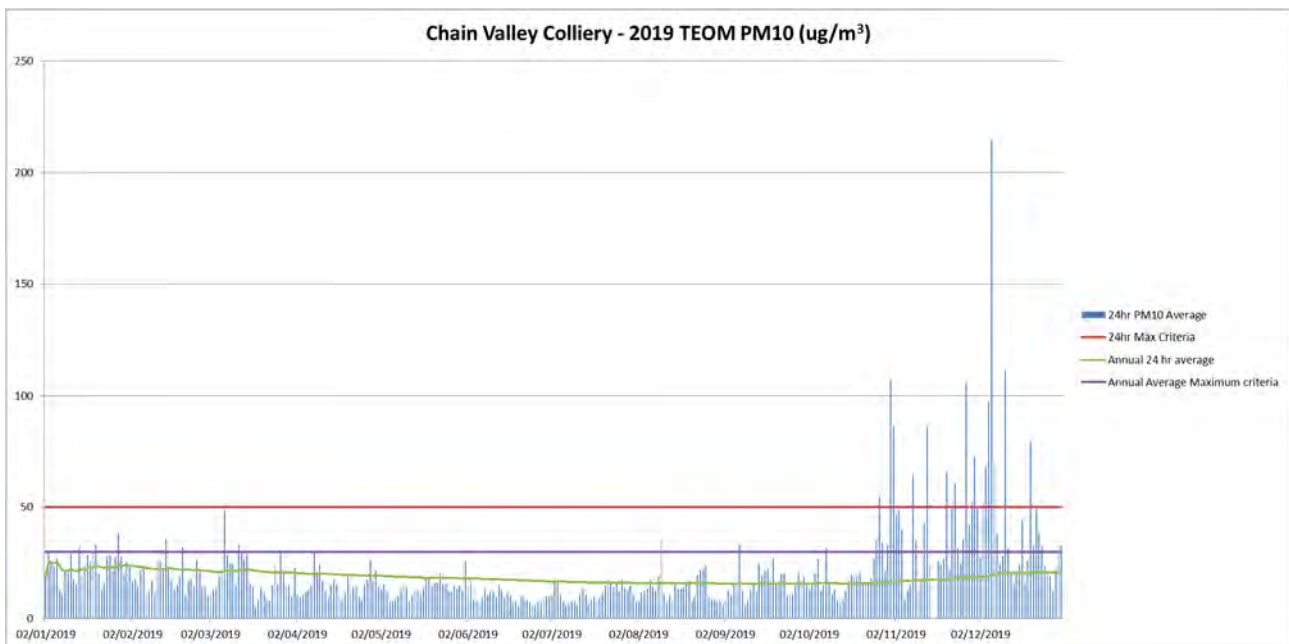
Figure 9: PM_{10} monitoring results during the reporting period

The EPA long-term annual average criterion ($30 \mu\text{g}/\text{m}^3$) was not exceeded during the 2019 period. Daily results, the rolling average and relevant limits are shown on **Figure 9**.

Daily (24-hour) results ranged from a minimum of $5.0 \mu\text{g}/\text{m}^3$ to a maximum of $214.8 \mu\text{g}/\text{m}^3$ during 2019. The 2019 annual average of 24hr PM_{10} results was $20.9 \mu\text{g}/\text{m}^3$. The most comparative locations from the EIS where PM_{10} air quality modeling was completed relate to receptors R12 and R15, with cumulative PM_{10} annual average predictions of $22 \mu\text{g}/\text{m}^3$ and $20 \mu\text{g}/\text{m}^3$ respectively. The actual location of real time PM_{10} monitoring is in between these two receivers, so a result of $20.9 \mu\text{g}/\text{m}^3$ is consistent with the modeled values.

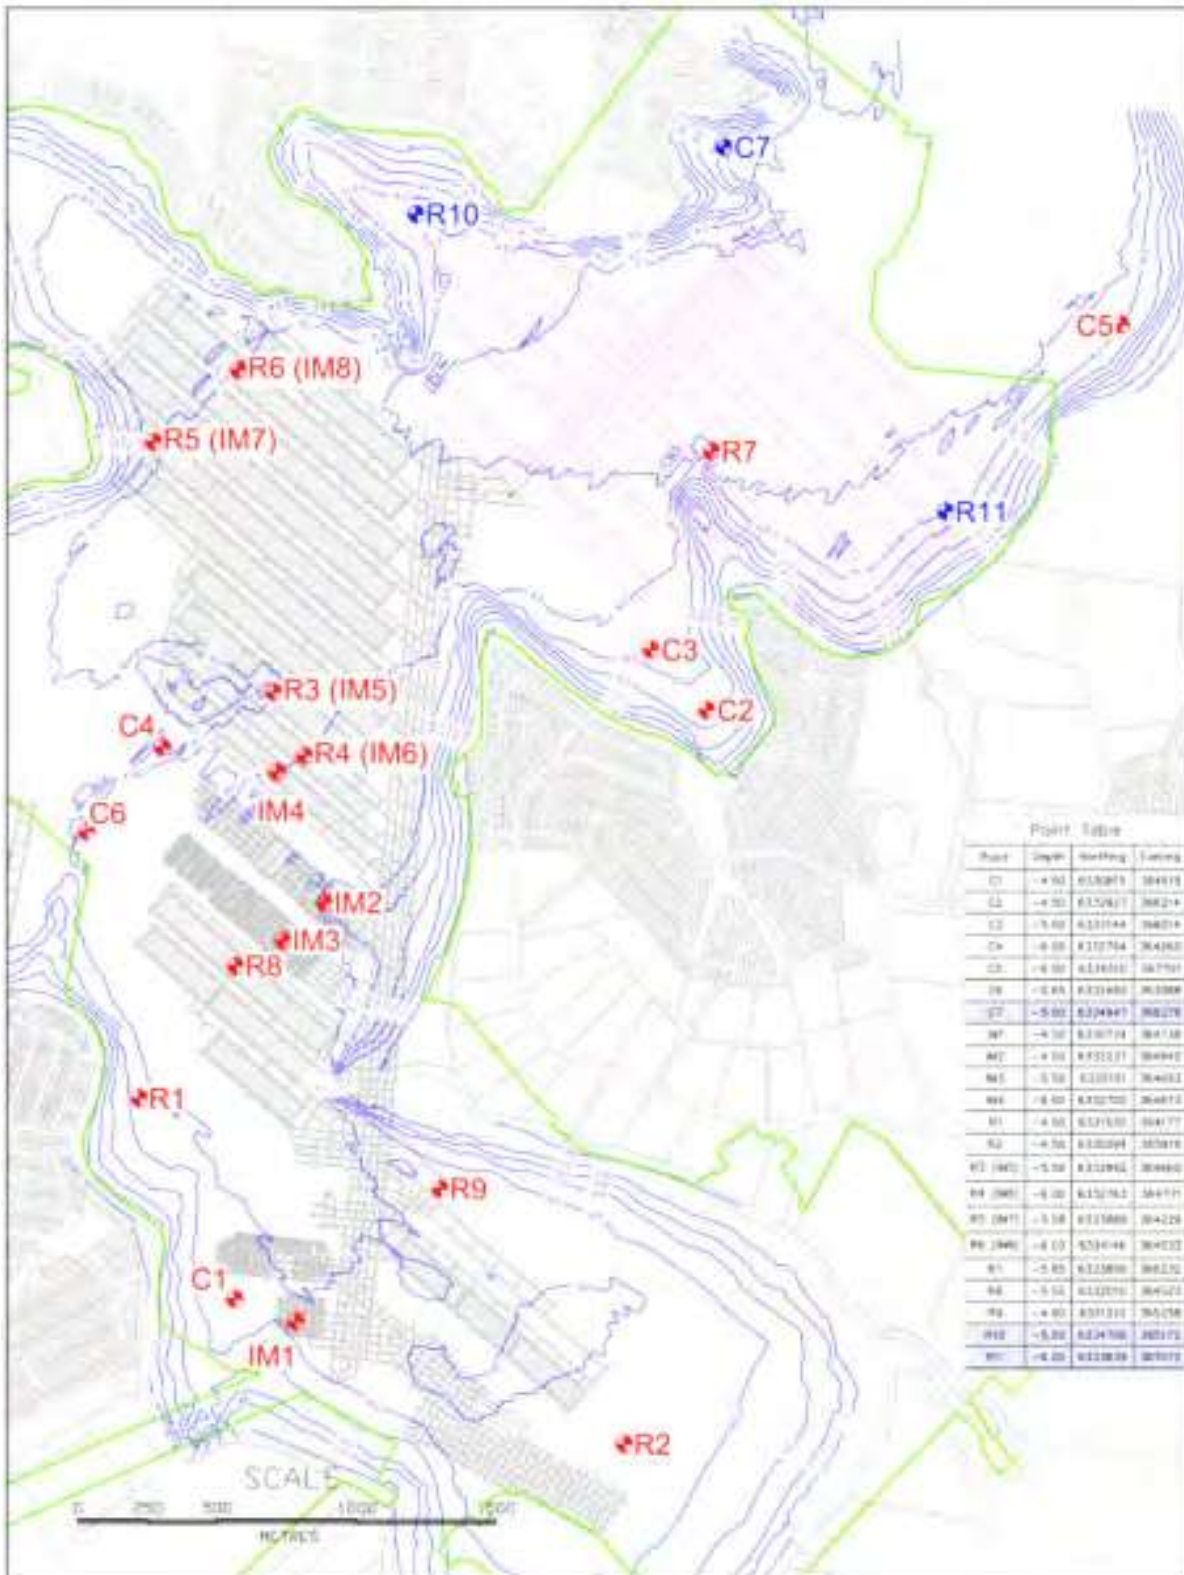
Figure 15: Benthic Sampling Locations

In summary, the mud basin off Summerland Point and in Chain Valley between February 2012 and September 2019 was found to be inhabited by 24 species of organisms greater than 1 mm in size. Polychaete worms and bivalve molluscs were the most frequently encountered animals. Benthic sampling locations are shown in **Figure 15**.

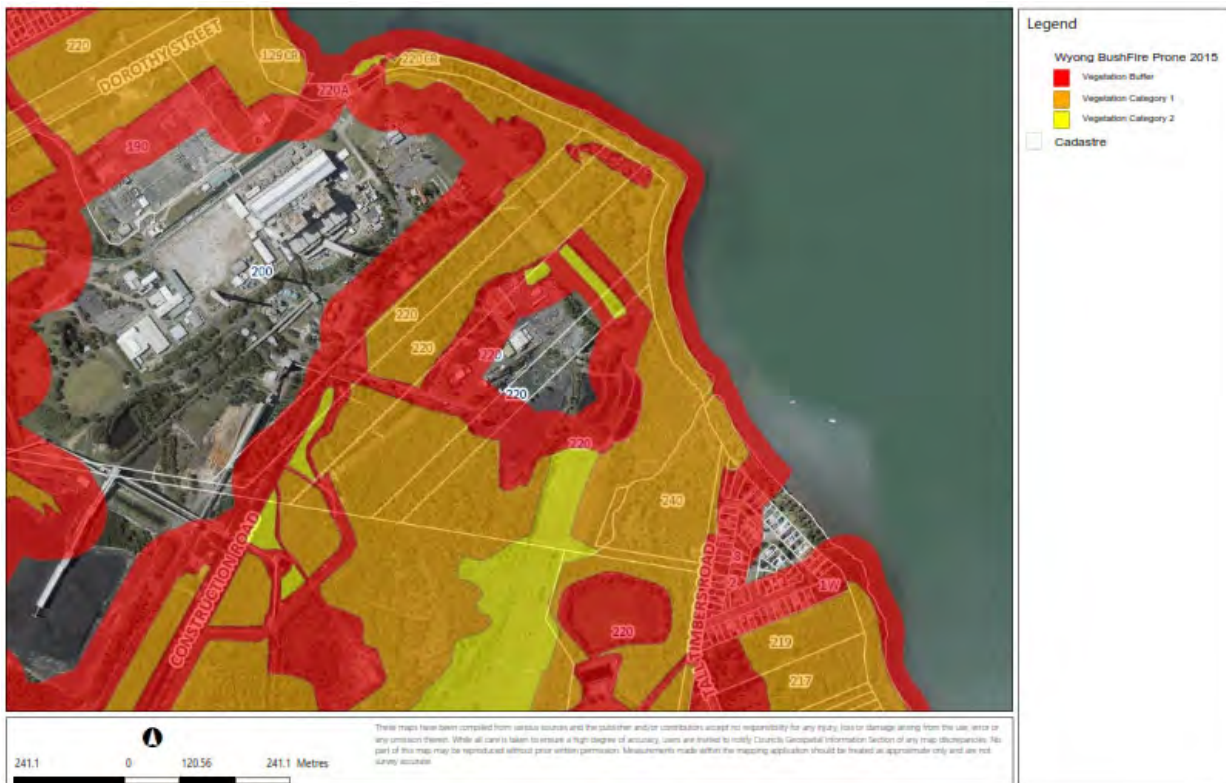
Figure 17: Bushfire Prone Land Map for CVC Pit Top Area (Source: Wyong Council, 2015)

The pit top area contains vegetation which is considered to be bushfire prone land (Category 1) as shown on **Figure 17**. The ventilation shaft area has also been identified as containing Category 1 vegetation as shown on **Figure 18**.

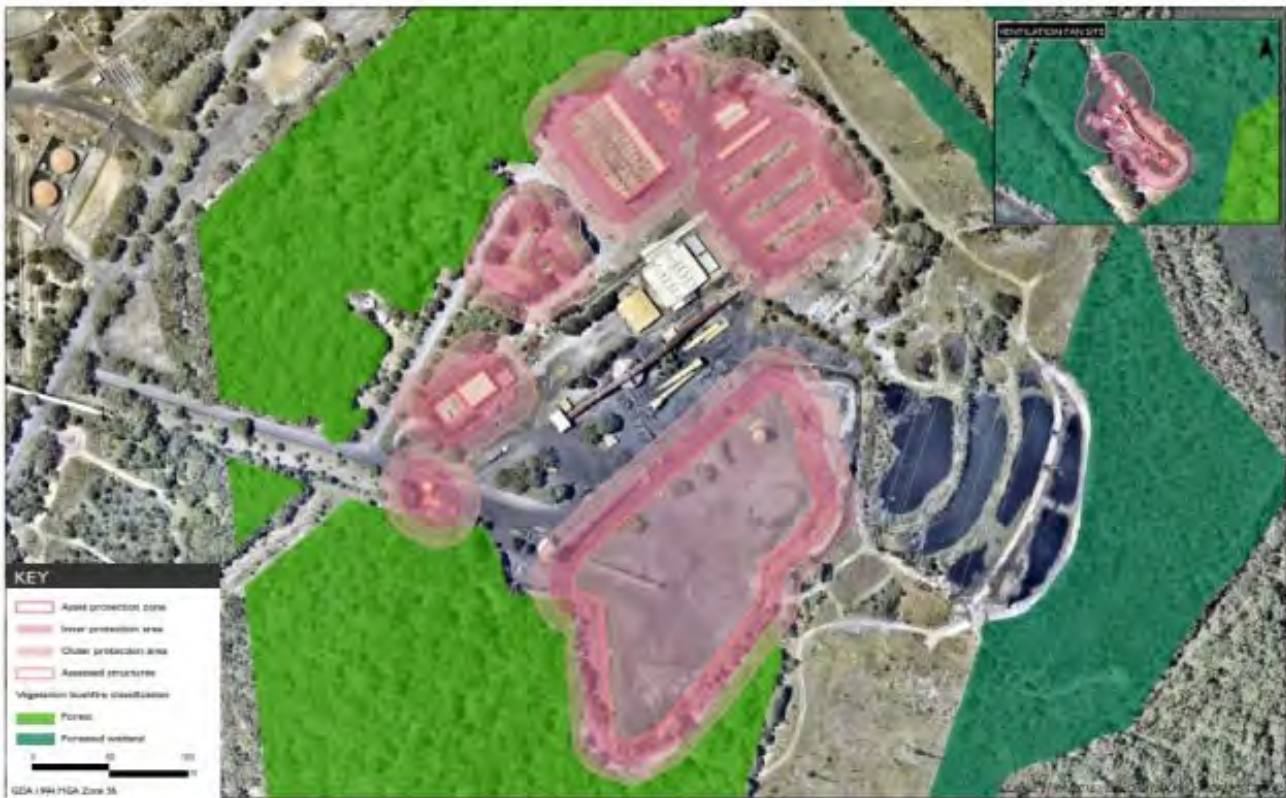
Figure 19: Approved APZ's for CVC

A risk assessment and review was undertaken following this event which determined additional asset protection zones (APZ's) would be required. Approval was subsequently sought and approved during the reporting period for the establishment of the proposed APZ's. Figure 19 shows the approved APZ area. The establishment of the APZ's was undertaken during the 2017 reporting period to improve its bushfire protection zones. As detailed in the Biodiversity Management Plan, fire trails will be inspected annually prior to the start of the Bushfire Danger Period. This inspection is scheduled via the Work Order system. An inspection was undertaken in August 2019 with follow-up slashing and clearing as required.

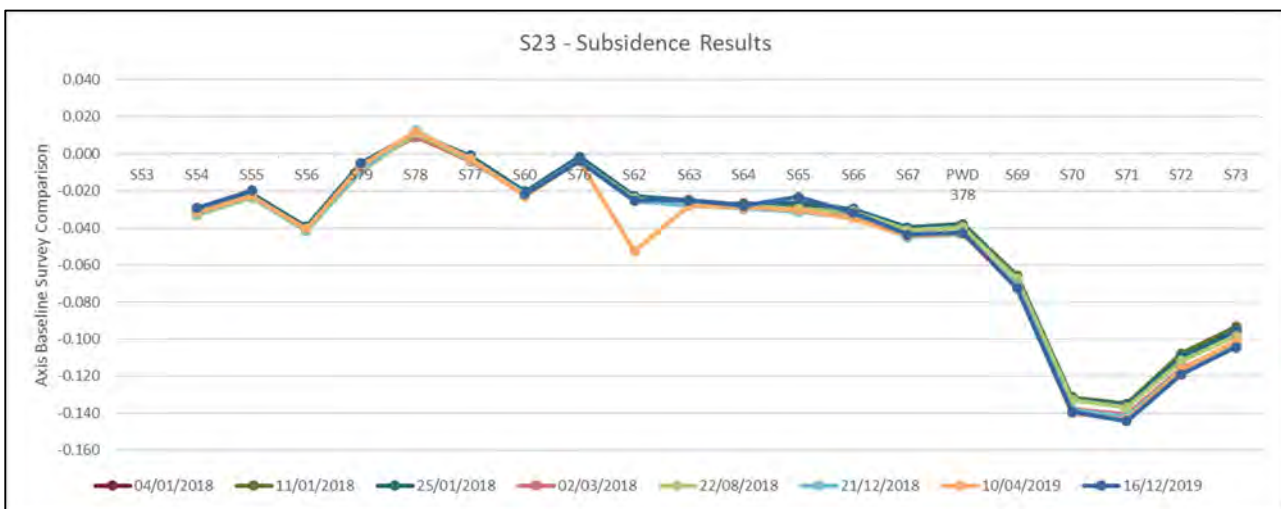
Figure 23: Line 23 Subsidence Results

It is noted this point, along with points #63-75 have all experienced more than negligible amounts of subsidence (20 mm) since June 2008. Since 2008, when Fassifern first workings were completed, subsidence movement has ranged between 20-40 mm, primarily due to the impact of multi-seam extraction in the Wallarah and Great Northern seams. Ongoing subsidence appears to have slowed in recent years, with approximately 10 mm of movement (Point S71) during the 2018 and 2019 reporting periods as detailed in **Figure 23**.

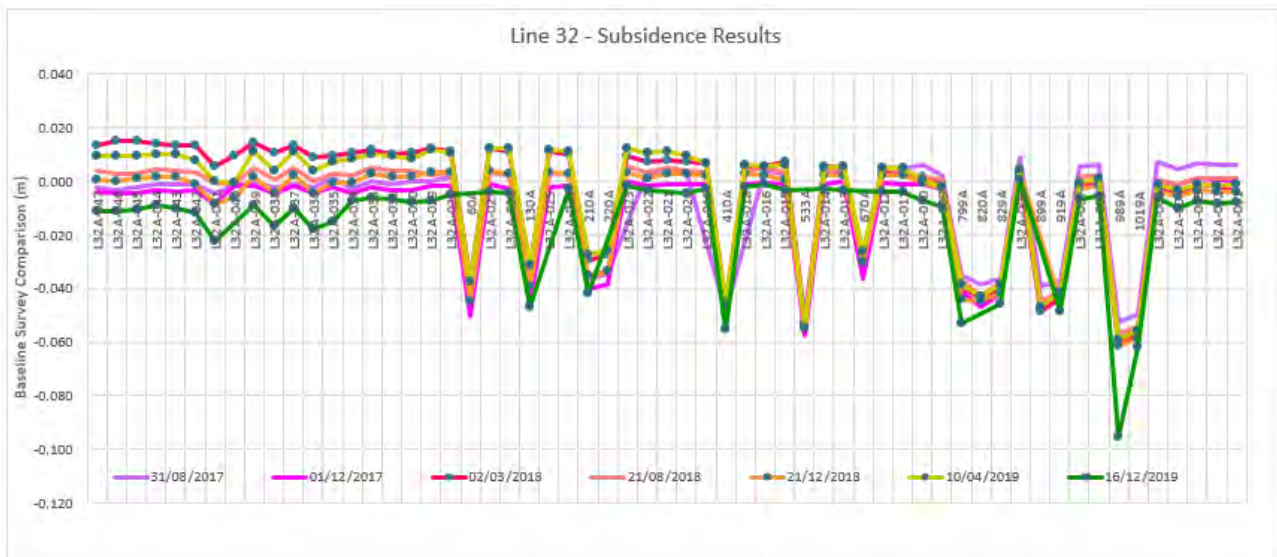
Figure 24: Line 32 Subsidence Results

A specific point (989A) measured approximately 40 mm of movement during the report period. As the adjacent monitoring points are stable this is assumed to be related to damage / movement of the specific monitoring point rather than mine-subsidence related.

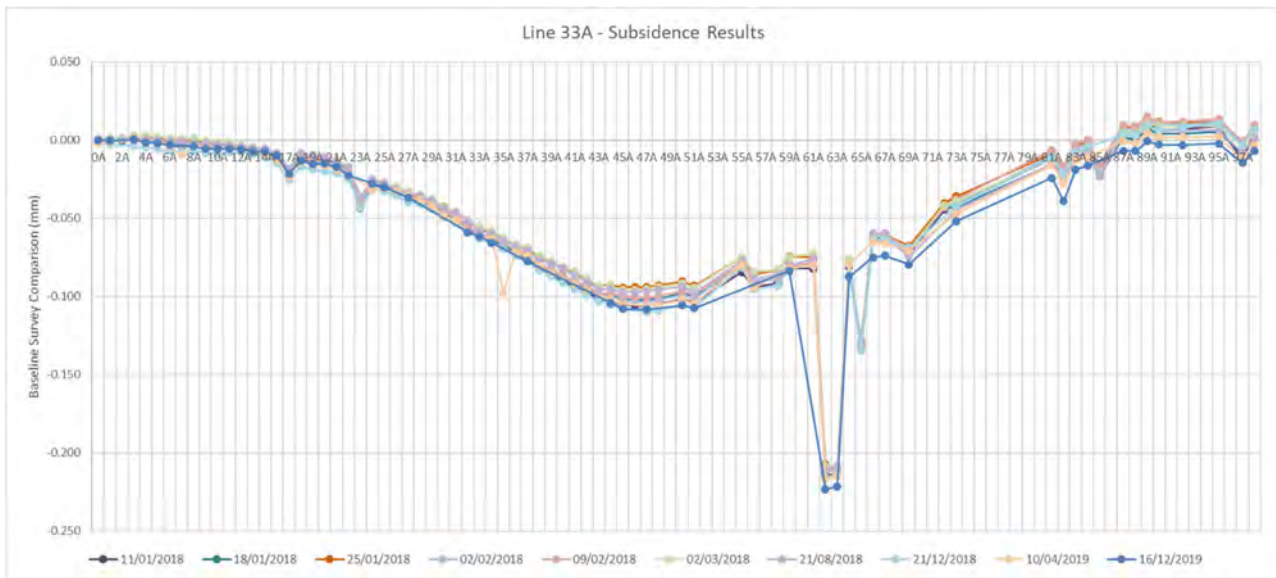
Figure 25: Line 33A Subsidence Results

Similarly to the Summerland Point monitoring, many of the historically monitored subsidence marks have experienced greater than negligible subsidence (20 mm). However, no additional subsidence movement was detected during the miniwall extraction in CVB. **Figure 24, Figure 25 and Figure 26** show the subsidence monitoring results for the reporting period.

As the area where Line 33A monitoring marks are located is along a public reserve where regular slashing / brush cutting activities are carried out, a number of monitoring points have been disturbed / moved over time. Where this type of movement occurs, the new RL point is adopted and monitoring continues.

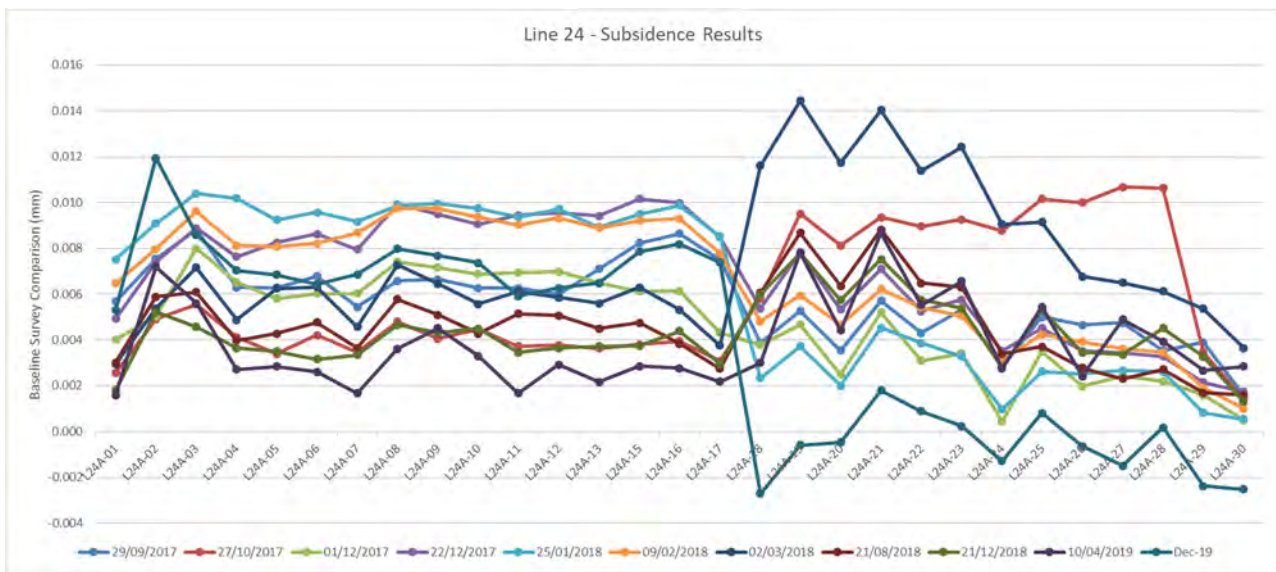
Figure 26: Line 24 Subsidence Results

The survey accuracy, combined with ground movement, is generally responsible for most movement <10 mm. Occasionally there will be disturbance or deterioration to survey marks, particularly given they are in publicly accessed areas.

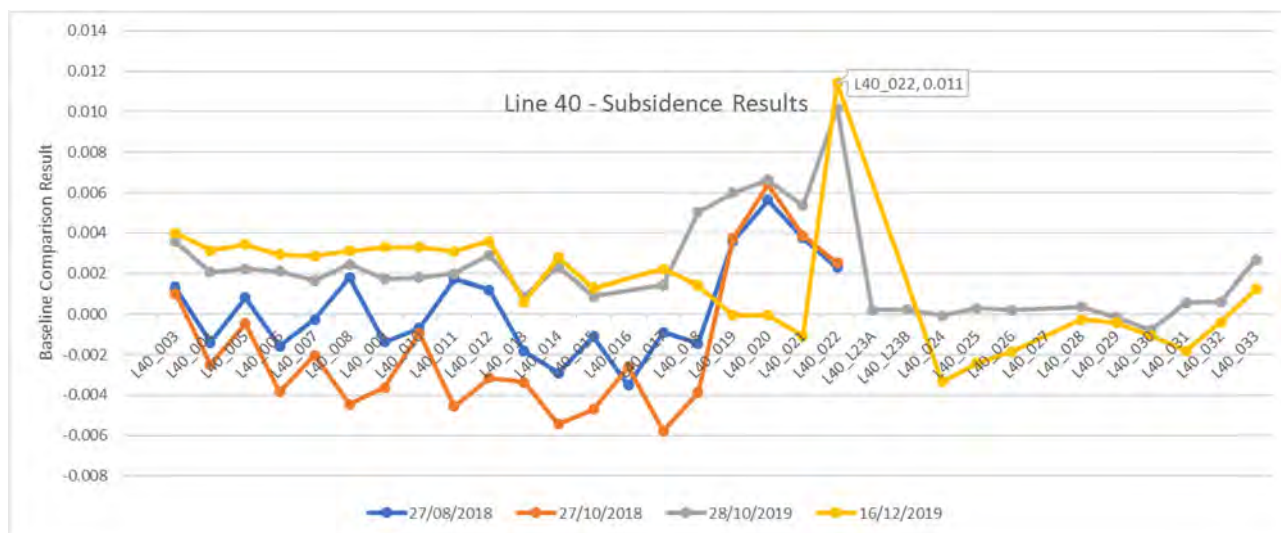
Figure 27: Line 40 Subsidence Results

Monitoring points along Line 40 were established in 2018 to monitor the shoreline adjacent to Miniwall S1. This line was extended in 2019 as part of the subsidence monitoring program for Miniwalls S2 and S3. Minor ground movement along the line is limited to ± 5 mm and appears seasonal. **Figure 27** shows the reporting period subsidence results for Line 40.

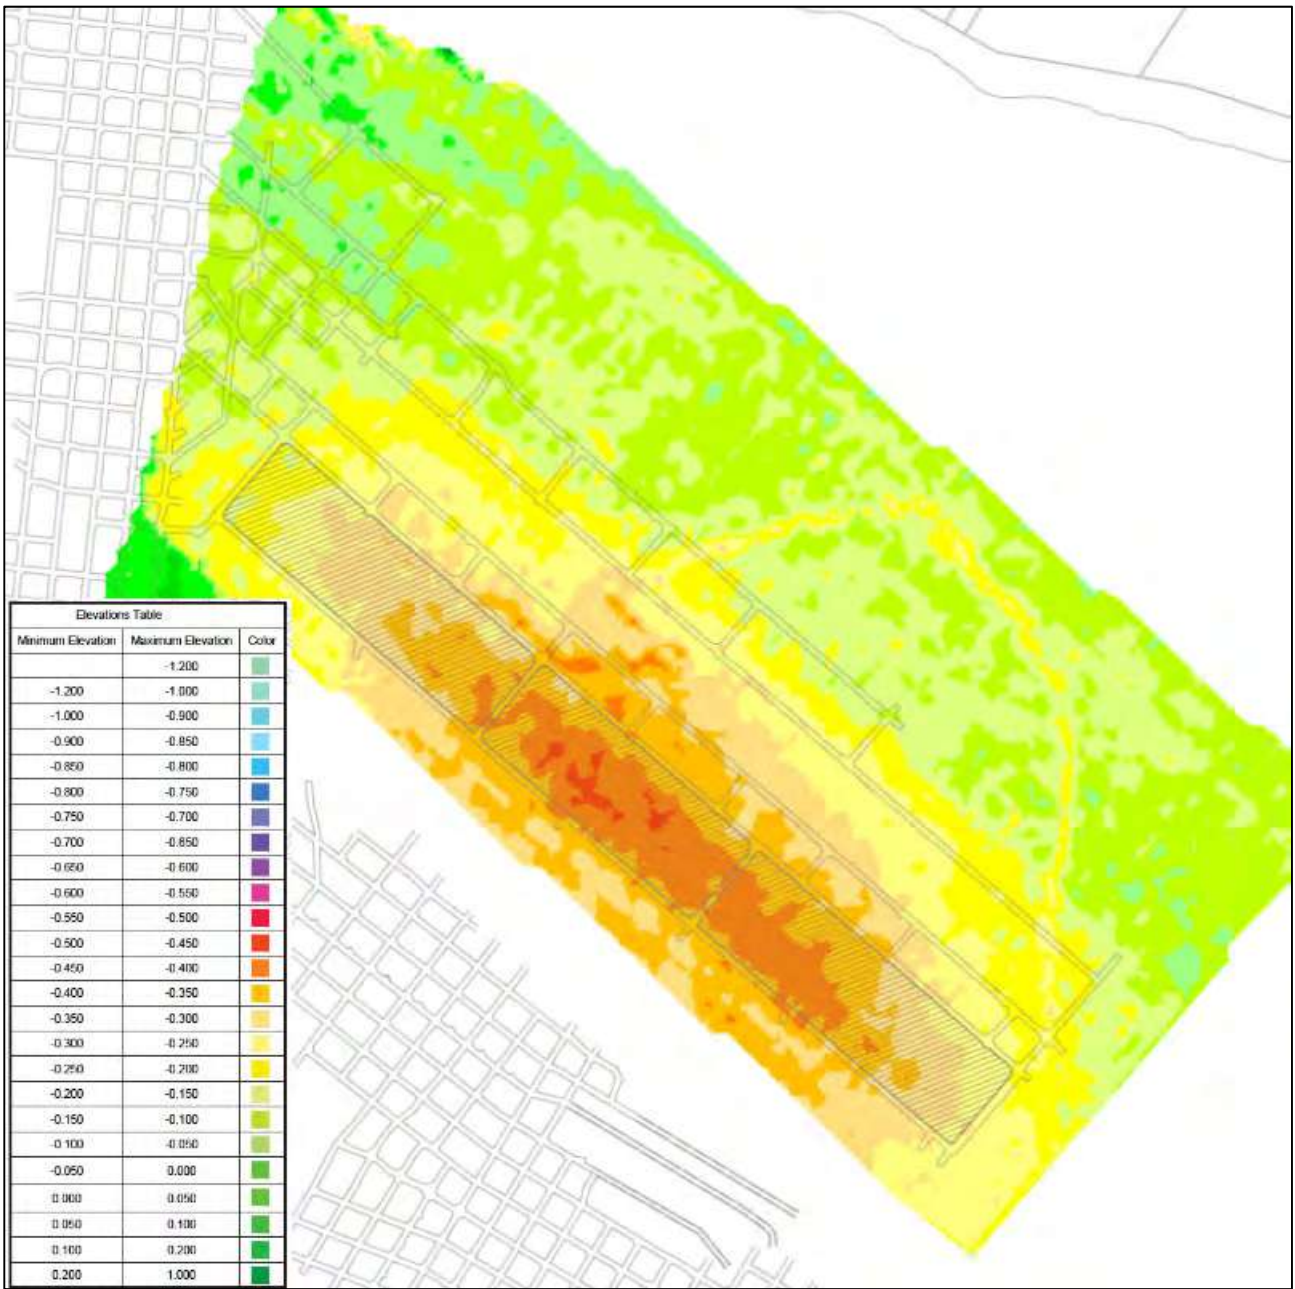
Figure 30: Lake Bed Subsidence Results, Chain Valley Bay Miniwall CVB1, July 2019

Bathymetric surveys over the Chain Valley Bay mining area (**Figure 30**) have indicated subsidence of up to 400 mm directly over the extracted area. An increased angle of draw of surface subsidence has been detected, but no impacts to the shoreline were observed. Minimal subsidence movement was detected from the previous survey in the area (January 2018).

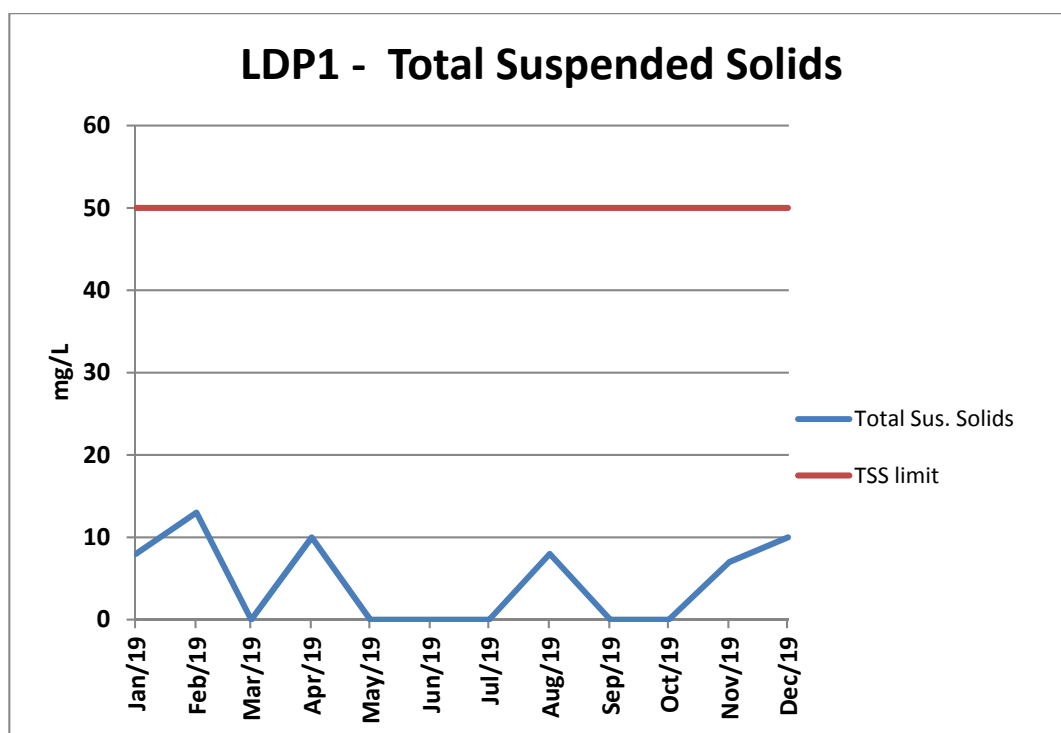
Figure 35: Total suspended solids monitoring results at LDP1

Notes: 1. TSS results shown as zero were below the limit of reporting (<5mg/L)

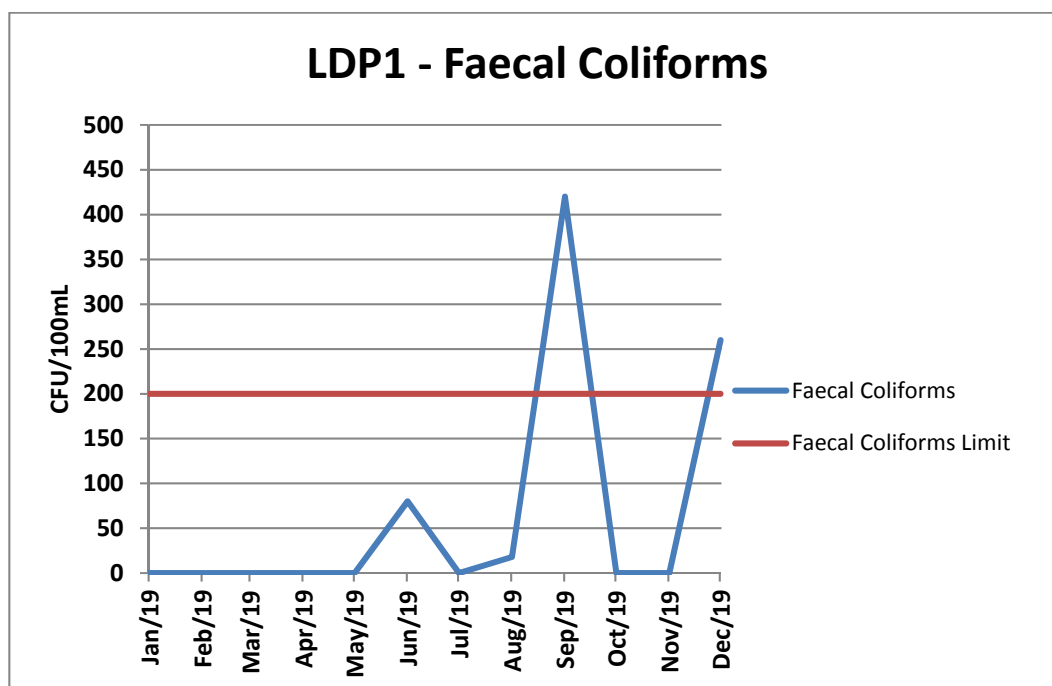
Figure 36: Faecal coliform results at LDP1

As detailed in **Figure 36**, there were two exceedances of the faecal coliform limit during the reporting period. Further information is provided in **Section 6.3**.

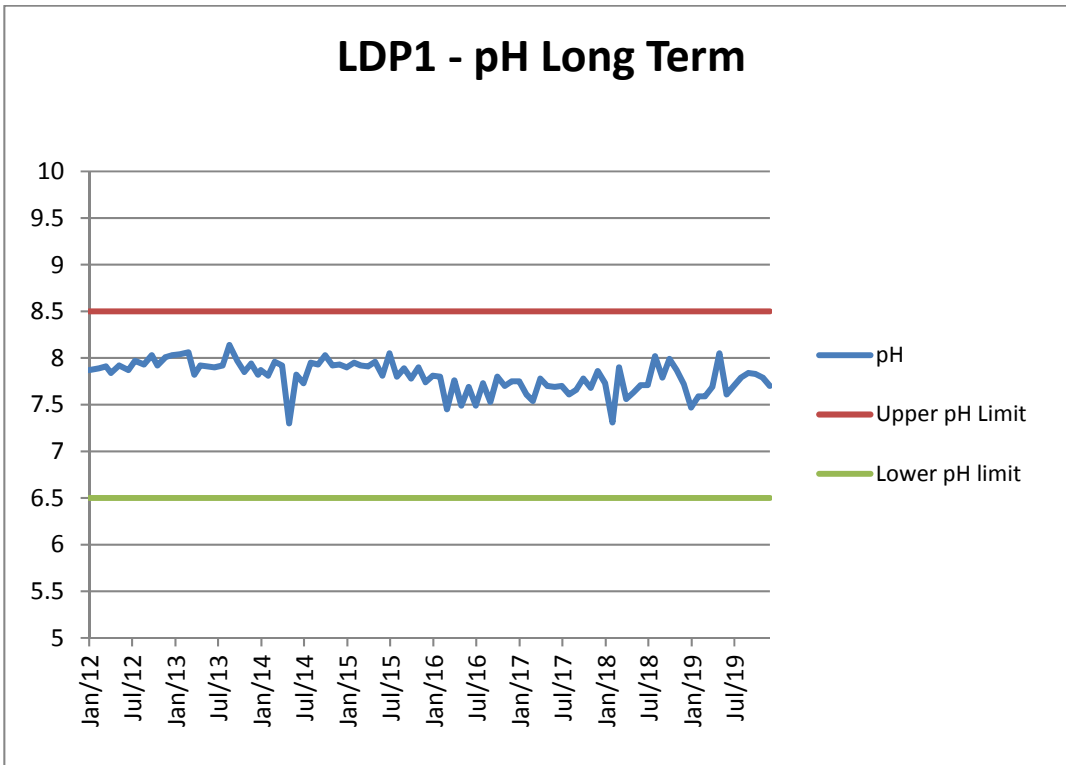
Figure 37: Long term pH results from LDP1

To assess any long-term trends in both water quality and quantity, eight years of data is presented for pH (**Figure 37**), electrical conductivity (**Figure 38**), total suspended solids (**Figure 39**) and faecal coliforms from LDP1 (**Figure 40**).

From the below figures it is evident that despite some infrequent higher results of faecal coliforms and one TSS result over 50 mg/L, there are no significant trends or changes in the water quality parameters. There is no obvious increase in mine dewatering volumes over the last six or seven years, however, it is expected that this will occur over time consistent with the groundwater modelling within the Chain Valley Colliery EIS that predicts an increase in groundwater make will occur to an annual average of 10.5 ML/day (at the end of mine life). The current mine dewatering levels (approximately 5.7 ML/day during 2019) are still significantly below this level.
