CHAIN VALLEY COLLIERY
Annual Review 2019
1 January 2019 – 31 December 2019

Chain Valley Colliery – Annual Review (AEMR) 2019

Name of operation	Chain Valley Colliery
Name of operator	Great Southern Energy Pty Ltd trading as Delta Coal Pty Ltd
Project Approval #	SSD 5465
Name of Project Approval holder	Delta Coal Pty Ltd
Titles/Mining Leases #	Consolidated Coal Lease 707, Consolidated Coal Lease 706 (part), Mining lease 1051, Mining lease 1052, Mining lease 1308, Mining Lease 1370, Mining lease 1632 (part sublease), Mining Purposes Lease 1349, Mining Purposes Lease 337, Mining Purposes Lease 1389, Mining Purposes Lease 1400, Consolidated Coal Lease 719 (part sublease), Consolidated Coal Lease 721 (part sublease), Consolidated Coal Lease 722.
Name of holder of mining leases	Great Southern Energy Pty Ltd
Water License #	WAL41508 / Work Approval 20MW065025
MOP Commencement Date	1 st October 2018
MOP Completion Date	31 st December 2020
Annual Review start date	1 January 2019
Annual Review end date	31 December 2019

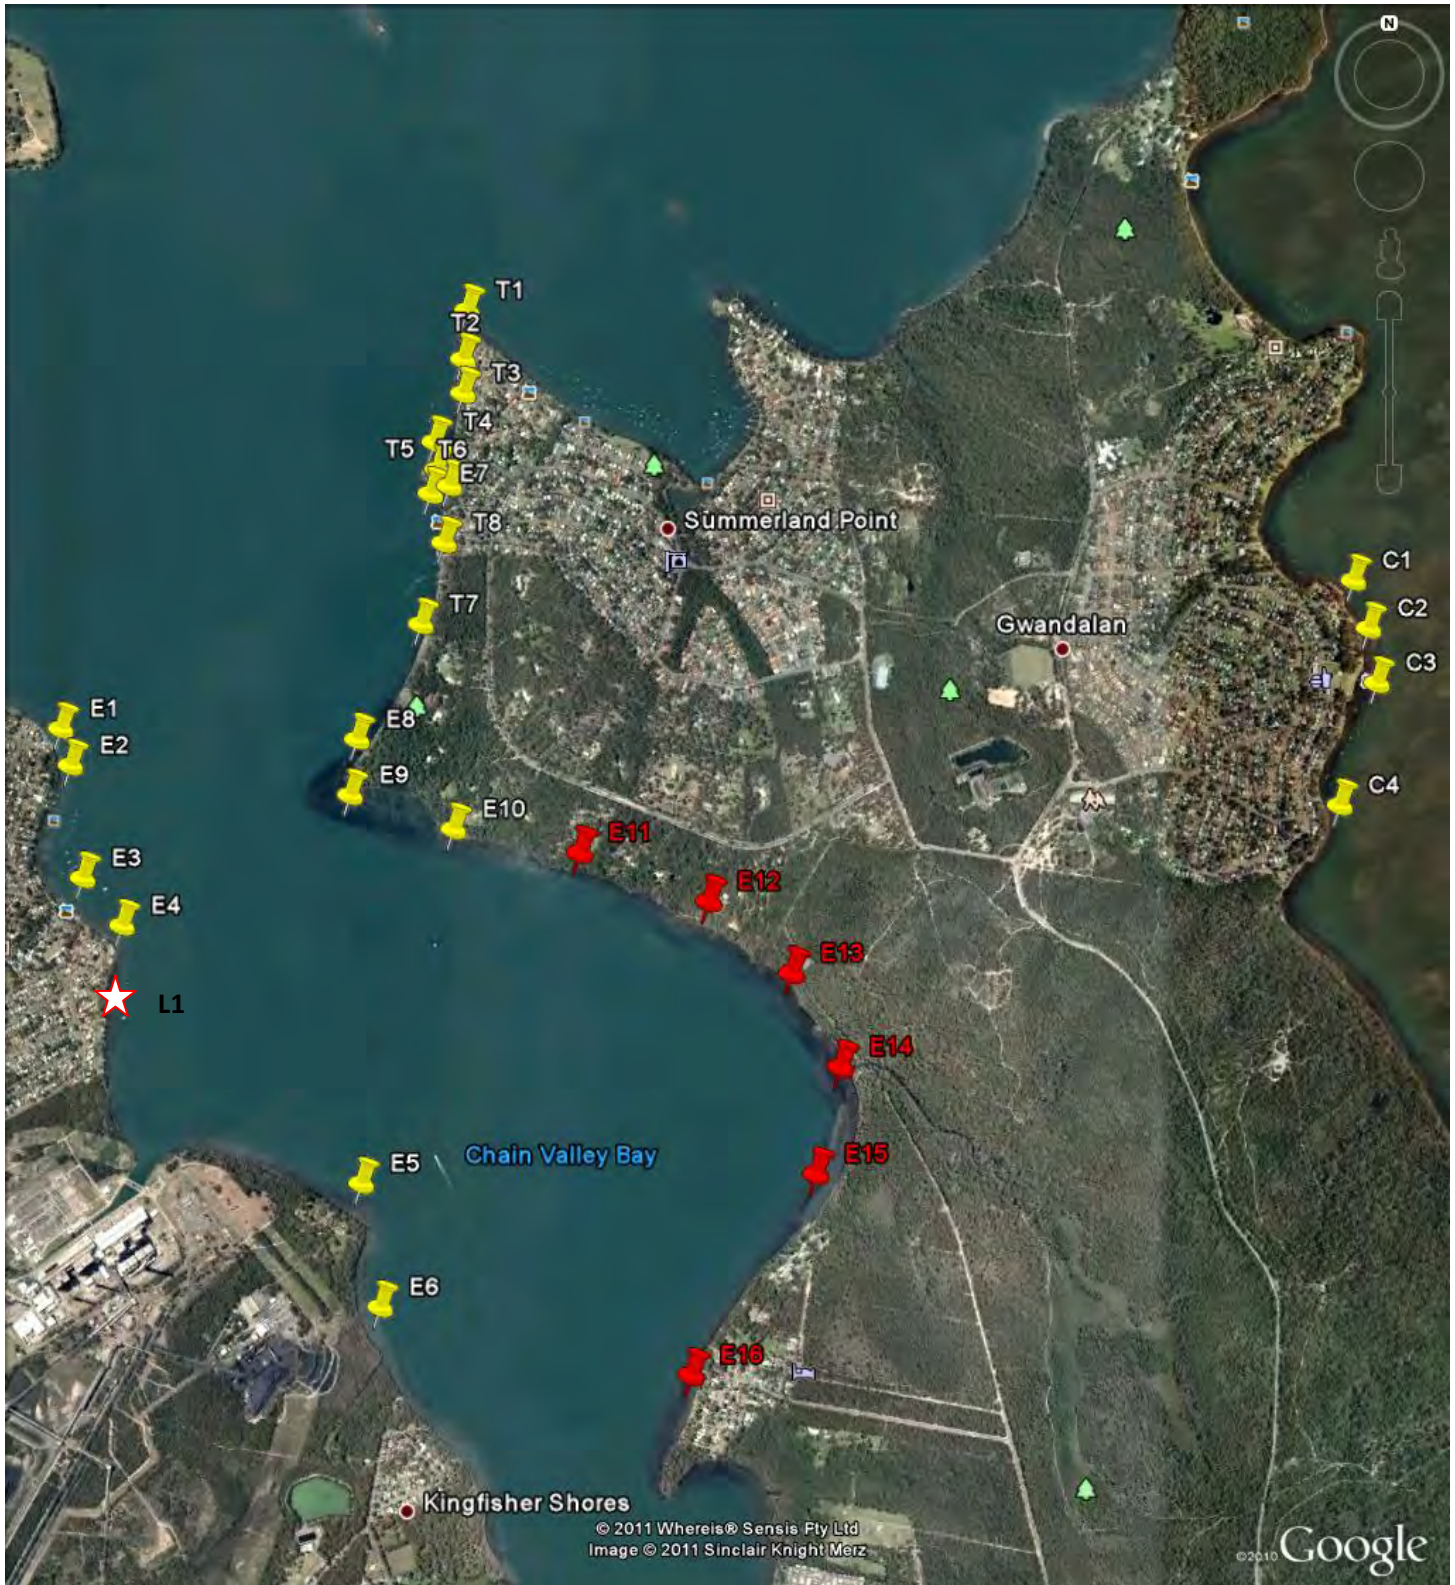
Figure 4.1. Locations of Transects in Chain Valley Bay, Summerland Point and Crangan Bay, Lake Macquarie.

Figures 4.1, 4.2 and 4.3 shows the area of Chain Valley Bay, Summerland Point, Bardens Bay, Brightwaters and Crangan Bay where the seagrass transects are located. In 2018 and 2019, a total of 50 transects were photographed.

Transects E1 to E16	Established experimental transects in Chain Valley Bay and Summerland Point.
Transects T1 to T8	Established experimental transects along Summerland Point.
Transects C1 to C4	Established control stations in Crangan Bay.
Transects A1 to A6	Established experimental stations in Bardens Bay in 2014.
Transect L1	Established in Chain Valley Bay in 2015.
Transects C5 to C6	Established in 2018.
Transects F1 to F7	Established in 2018.
Transects S1 to S6	Established in 2018.

In June 2011 a further photographic resurvey of the 22 permanent seagrass transects was carried out, including determination of the elevation of the inner and outer ends of each transect using differential GPS (Pearson and Associates Pty. Ltd). A further 6 transects through the seagrass beds were added to the schedule. These new transects were located along the eastern shoreline of Chain Valley Bay (Figure 4.1).

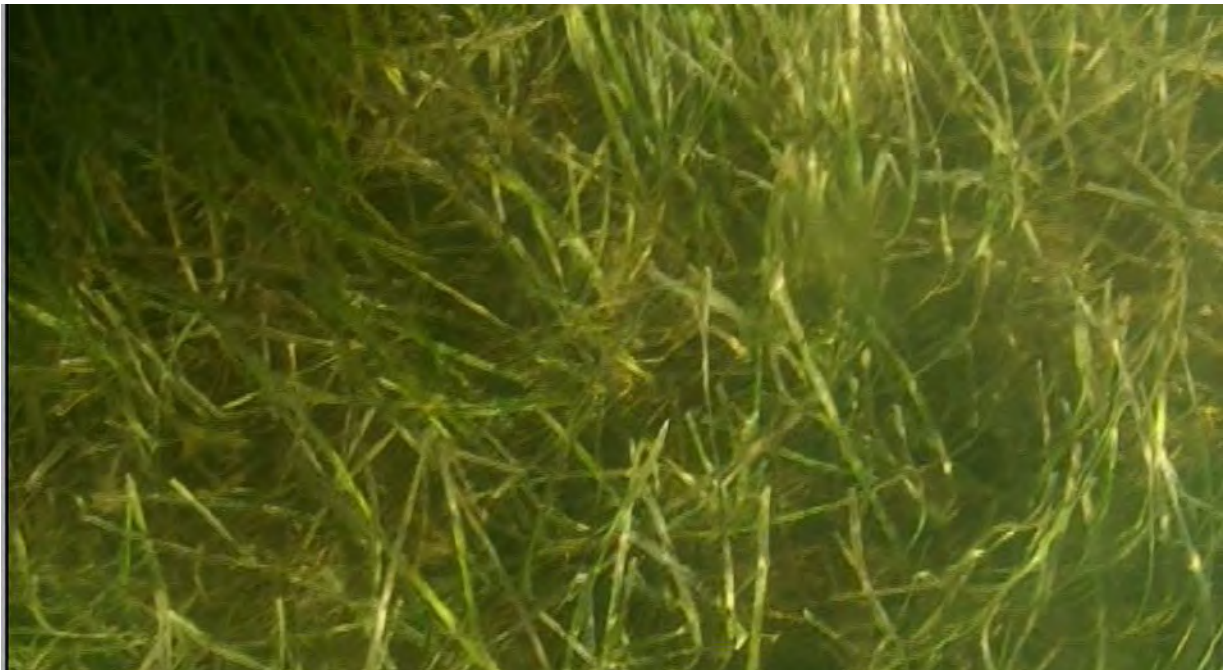
Plate 4. Dense long leaved seagrass with level 1 fouling (no fouling).

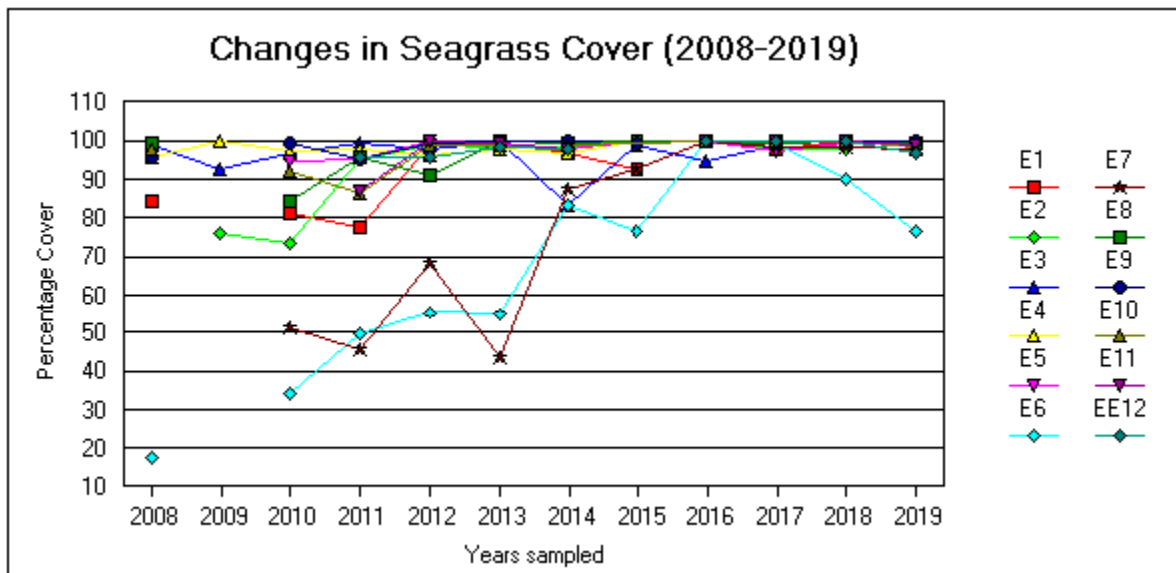
Figure 7.1. Changes in percentage area of seagrasses at Transects E1 to E12 that had been sampled for 11 years.

In June 2019, seagrass cover at the transects ranged from 24.71 to 100 percent in the study area (Table 7.1). The health and condition of the seagrass was good generally but, at some stations, the percentage cover was much lower than it was 2018 (Figure 7.2) particularly at Transects T1 to T8. Some seagrasses were lightly fouled with epiphytic algae while others were clear of epiphytic algae. The brown seaweed *Cystophyllum onustum* was present on shells and pebbles protruding through the seagrass, almost reaching the surface at Transects E1 to E4.

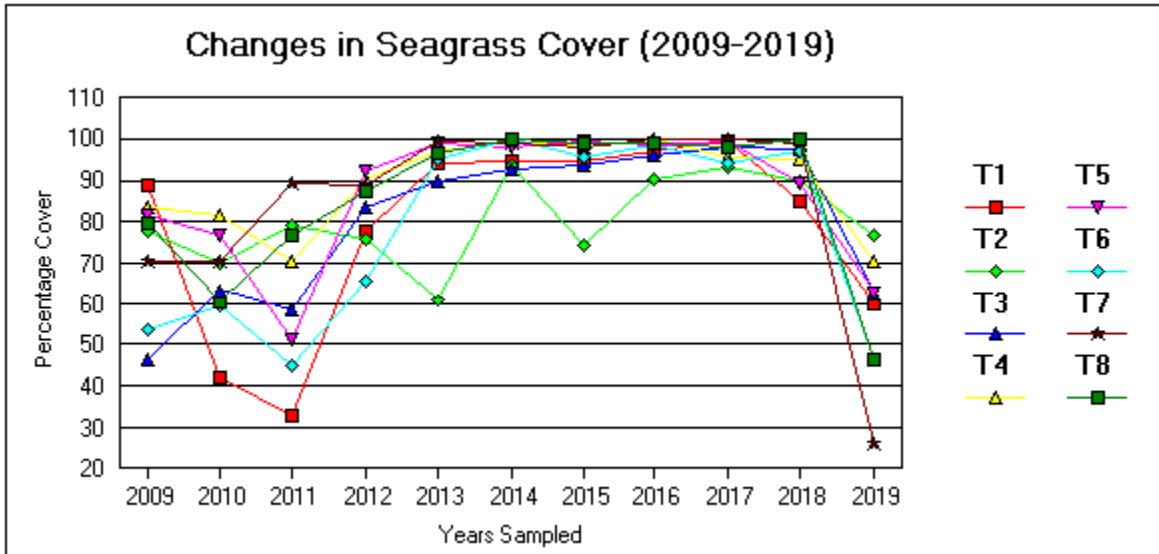
Figure 7.2 Changes in percentage area of seagrasses at Transects T1 to T8 that had been sampled for 10 years.

In 2019, however, at a time of very low rainfall and a very long lived high atmospheric pressure over the lake, there was some reductions in seagrass cover at some transects. This reduction in seagrass cover in 2019 was most noticeable along the shore of Summerland Point. Water level in the lake was depressed for long periods by around 0.3m. This lowered lake level caused increased water temperature over the seagrass beds and increased damaging wave attack during periods of strong westerly winds. Less water over the seagrass beds also increased the likelihood of damage by boats, waders and swimmers.

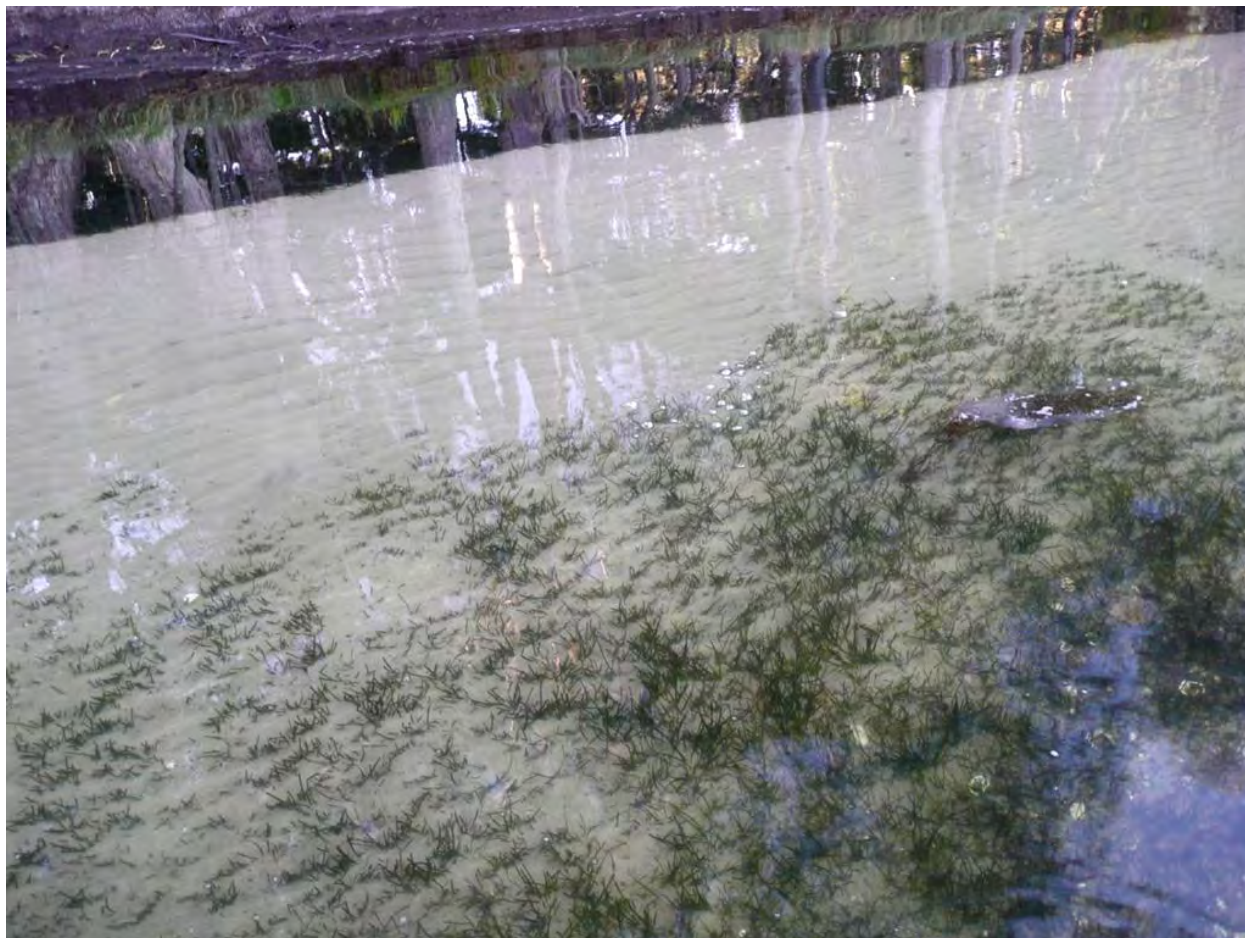
Plate 15. *Zostera capricorni* covered by sand along Summerland Point after strong southwesterly winds

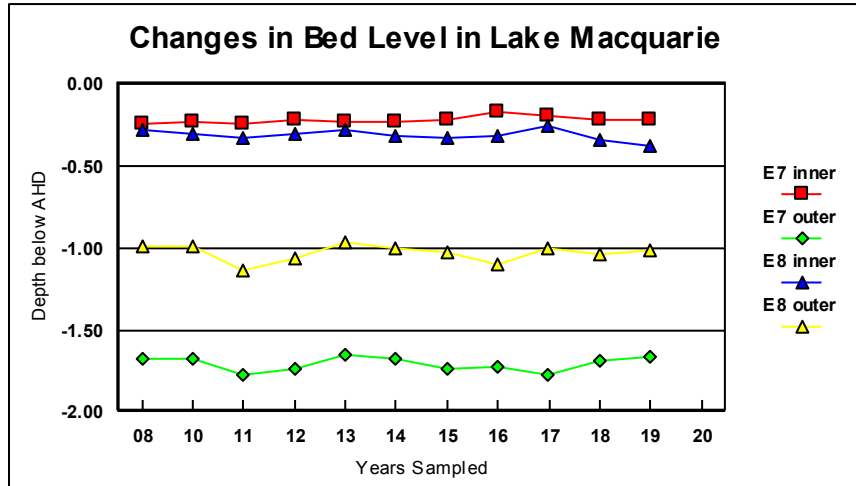
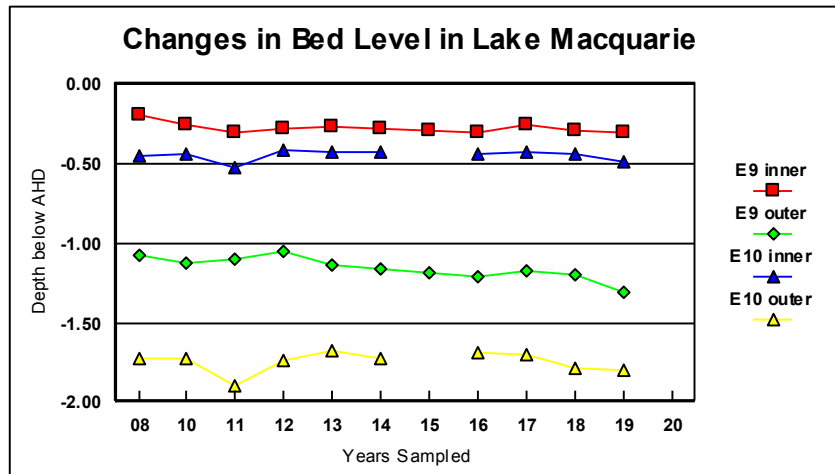
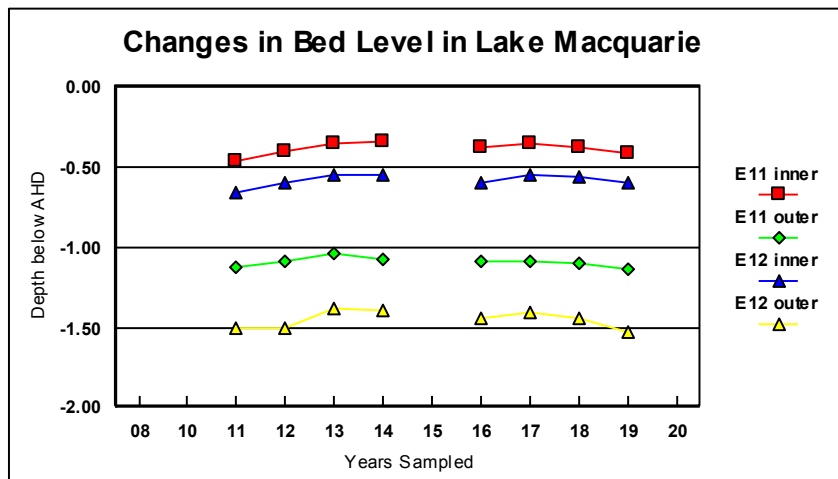
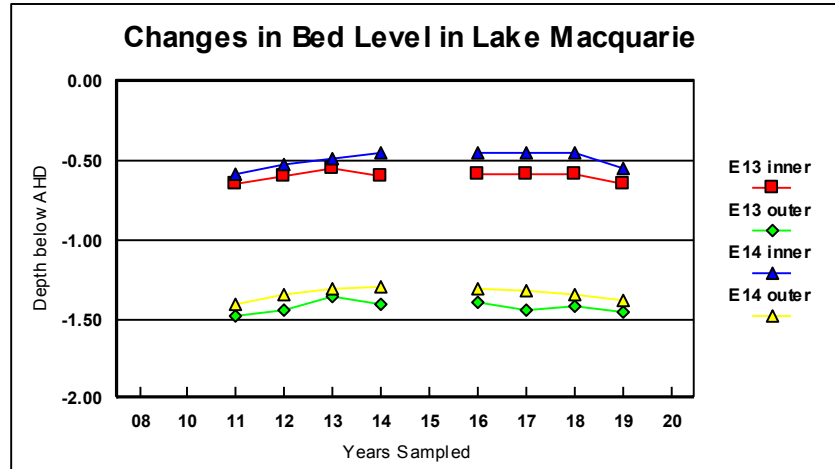
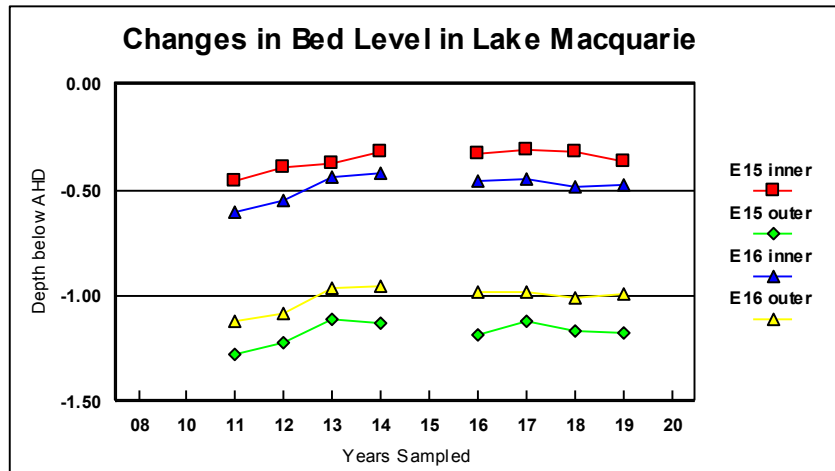
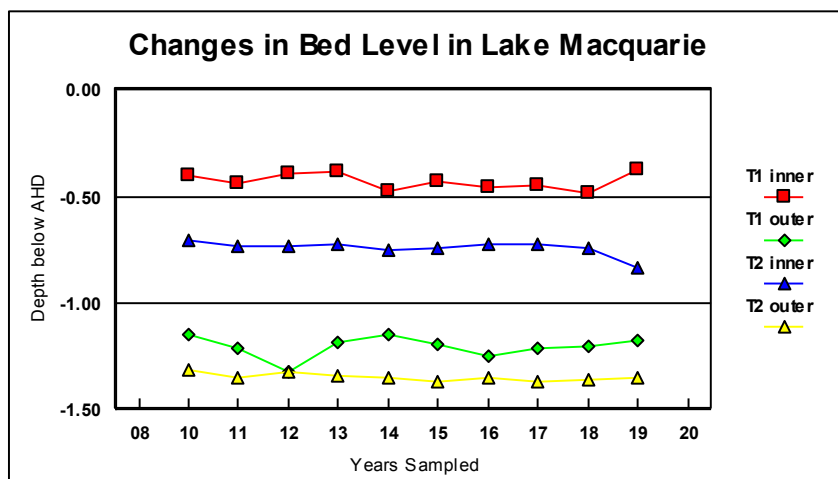
Figure 8.1 shows changes to the level of the lake bed at the inner and outer ends of Transects that have been sampled for eleven years. Table 8.1 compares the elevation of the lake bed at the inner and outer ends of each transect for the years 2013 to 2019 compared with 2008.

Figure 8.1. Changes in lake bed level at the inner and outer ends of each transect.

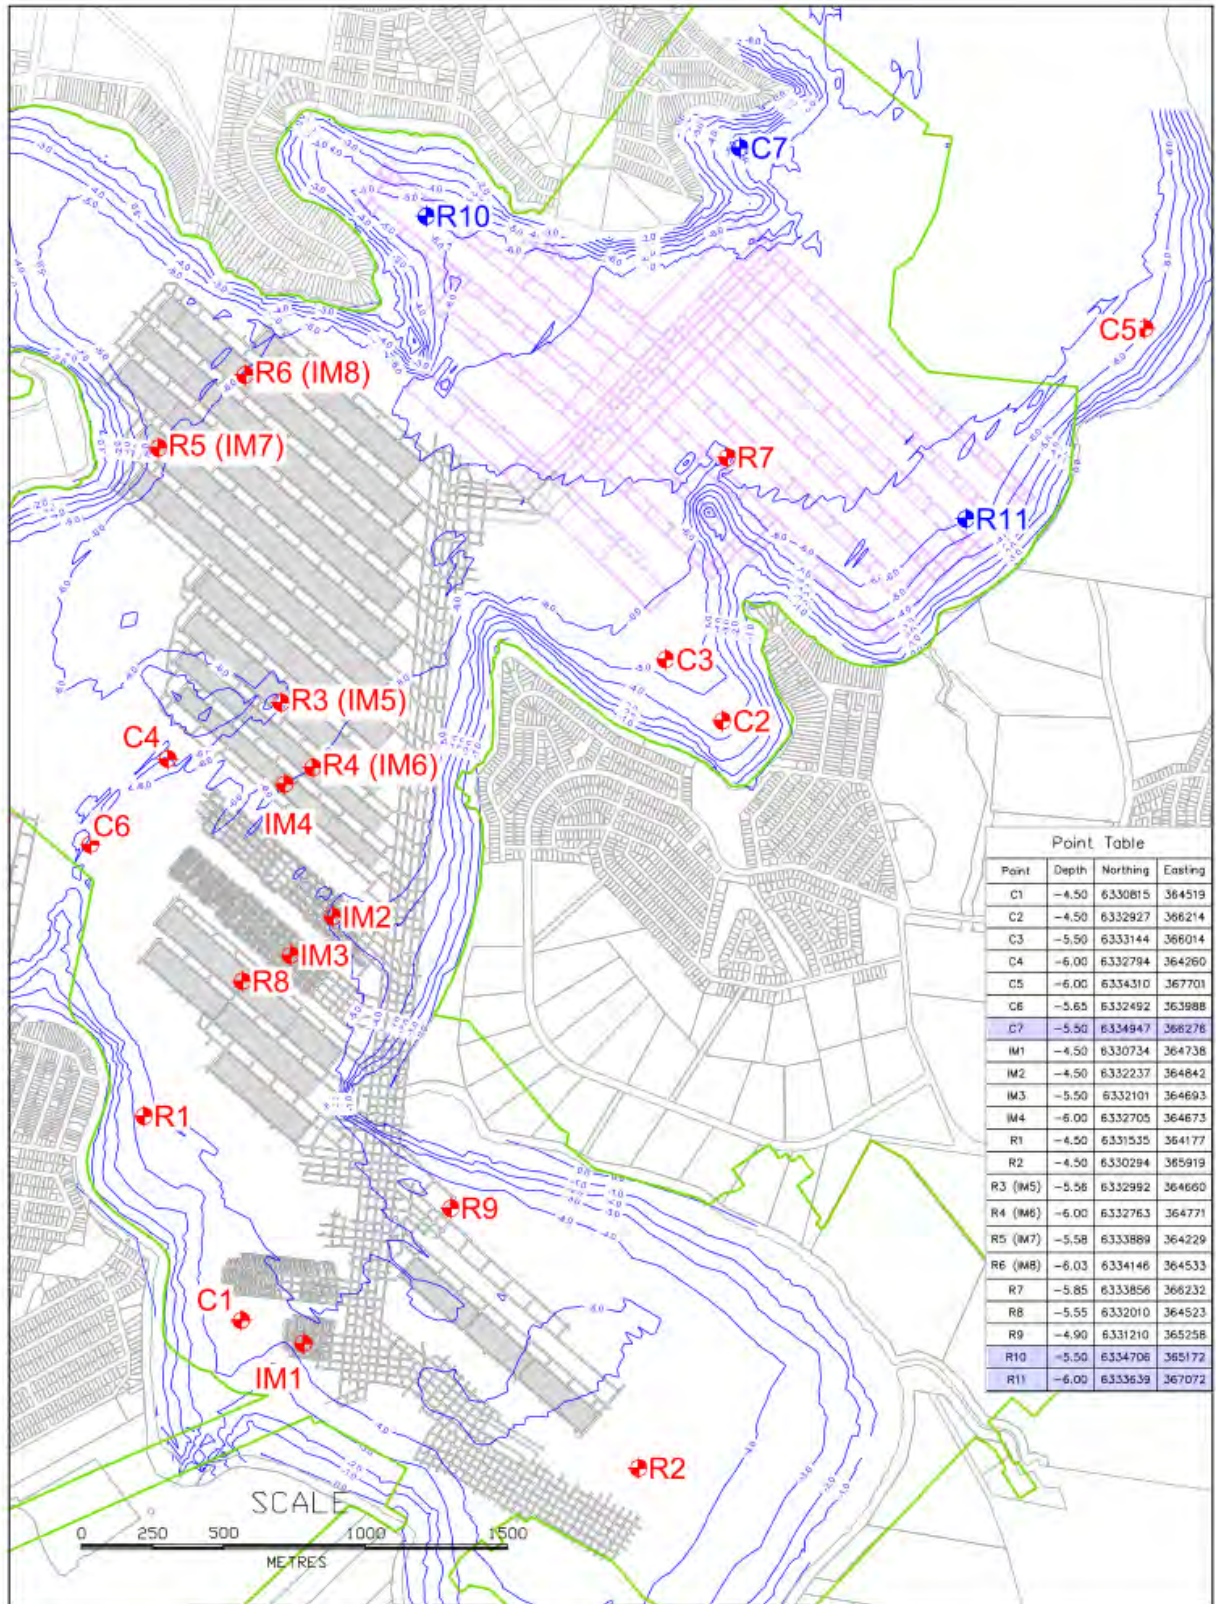
Figure 9.1 shows the extent of mining up to June 2019.

Figure 9.1. Extent of Underground Mining up to June 2019.

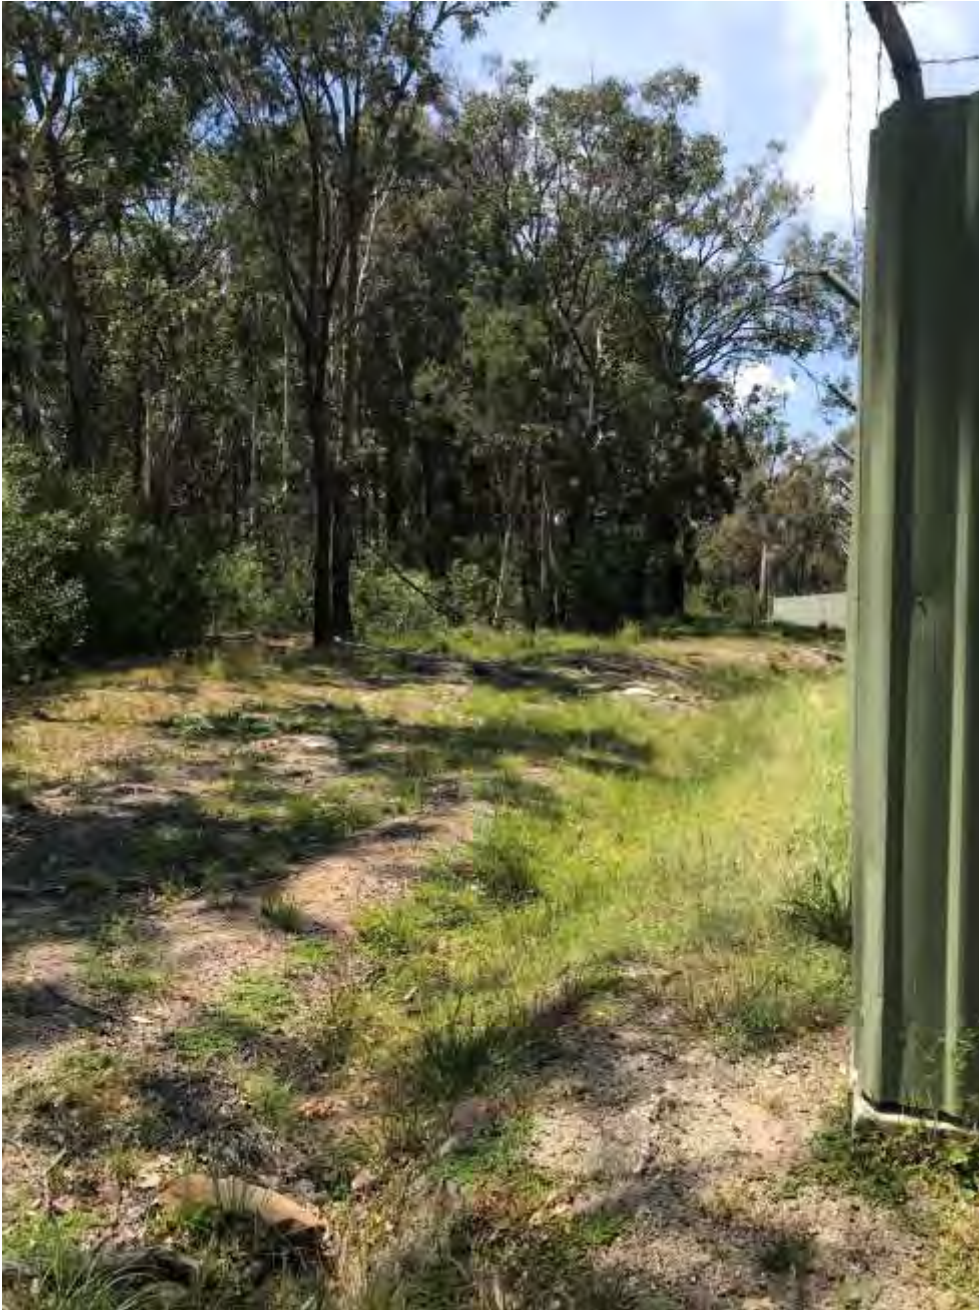
Monitoring point	2019 monitoring observations
1	Vegetation appears healthy with observable growth of canopy species and midstorey species. Not comparable with the 2016 monitoring given the clearing for an asset protection zones (APZ).
2	Vegetation appears healthy with observable growth of canopy species and midstorey species compared, to previous monitoring events. Isolated dieback of individual branchlets observed, however on balance, canopy crown density has is similar or demonstrates a net increase.
3	Vegetation has increased in height and density with native midstorey species growth particularly prevalent.
4	Vegetation appears healthy with observable growth of canopy species and midstorey species. Not comparable with the 2016 monitoring given the clearing for an asset protection zones (APZ).
Tree 1	Tree appears healthy, with new growth, dense foliage within the crown and no dieback observed.

Photograph B.1 Photo point 1

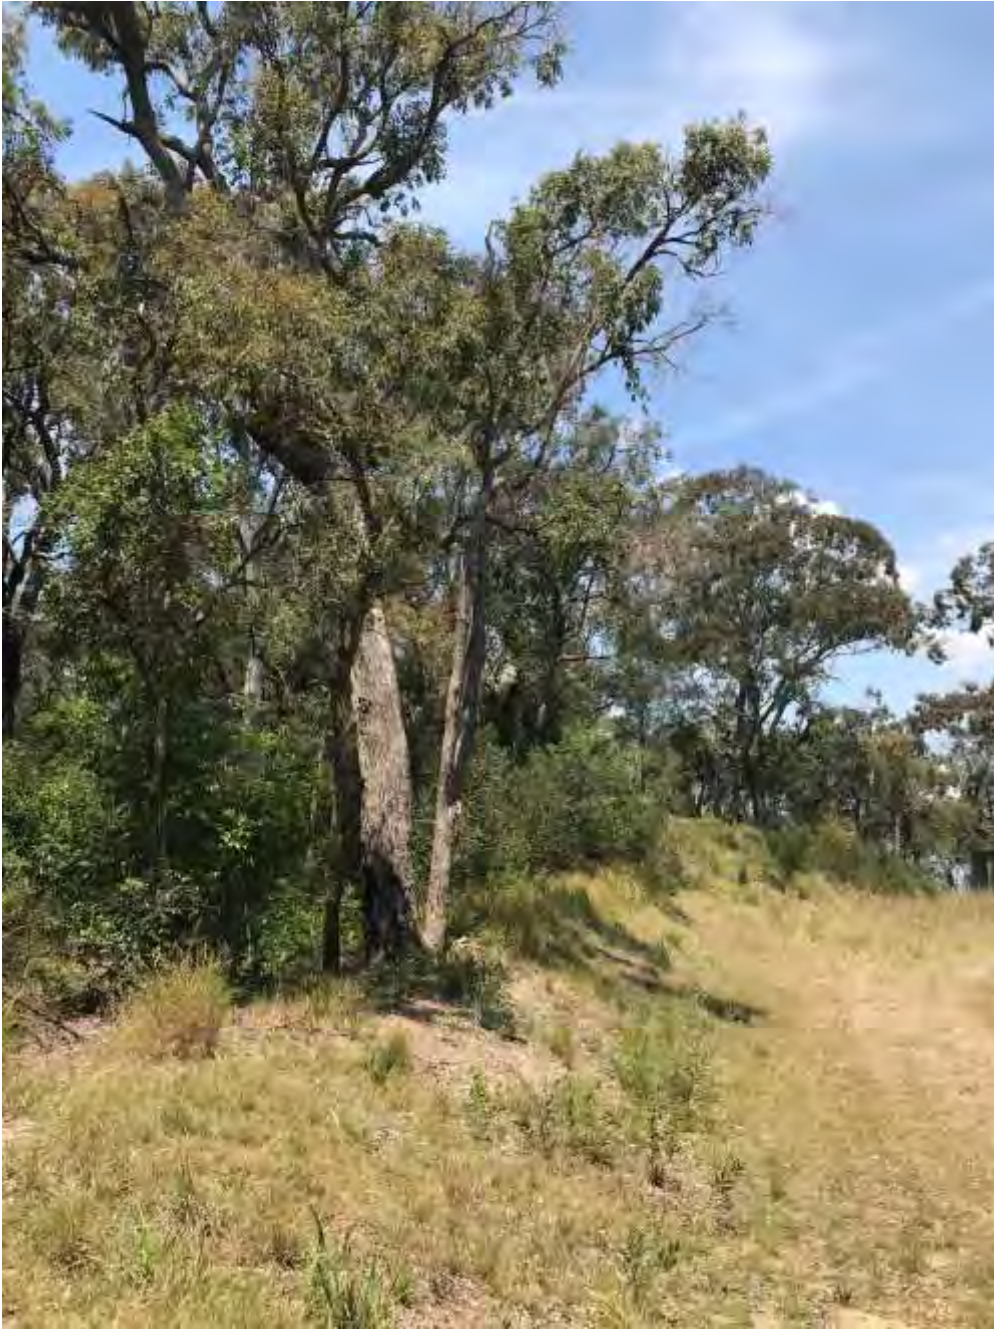
Photograph B.2 Photo point 2

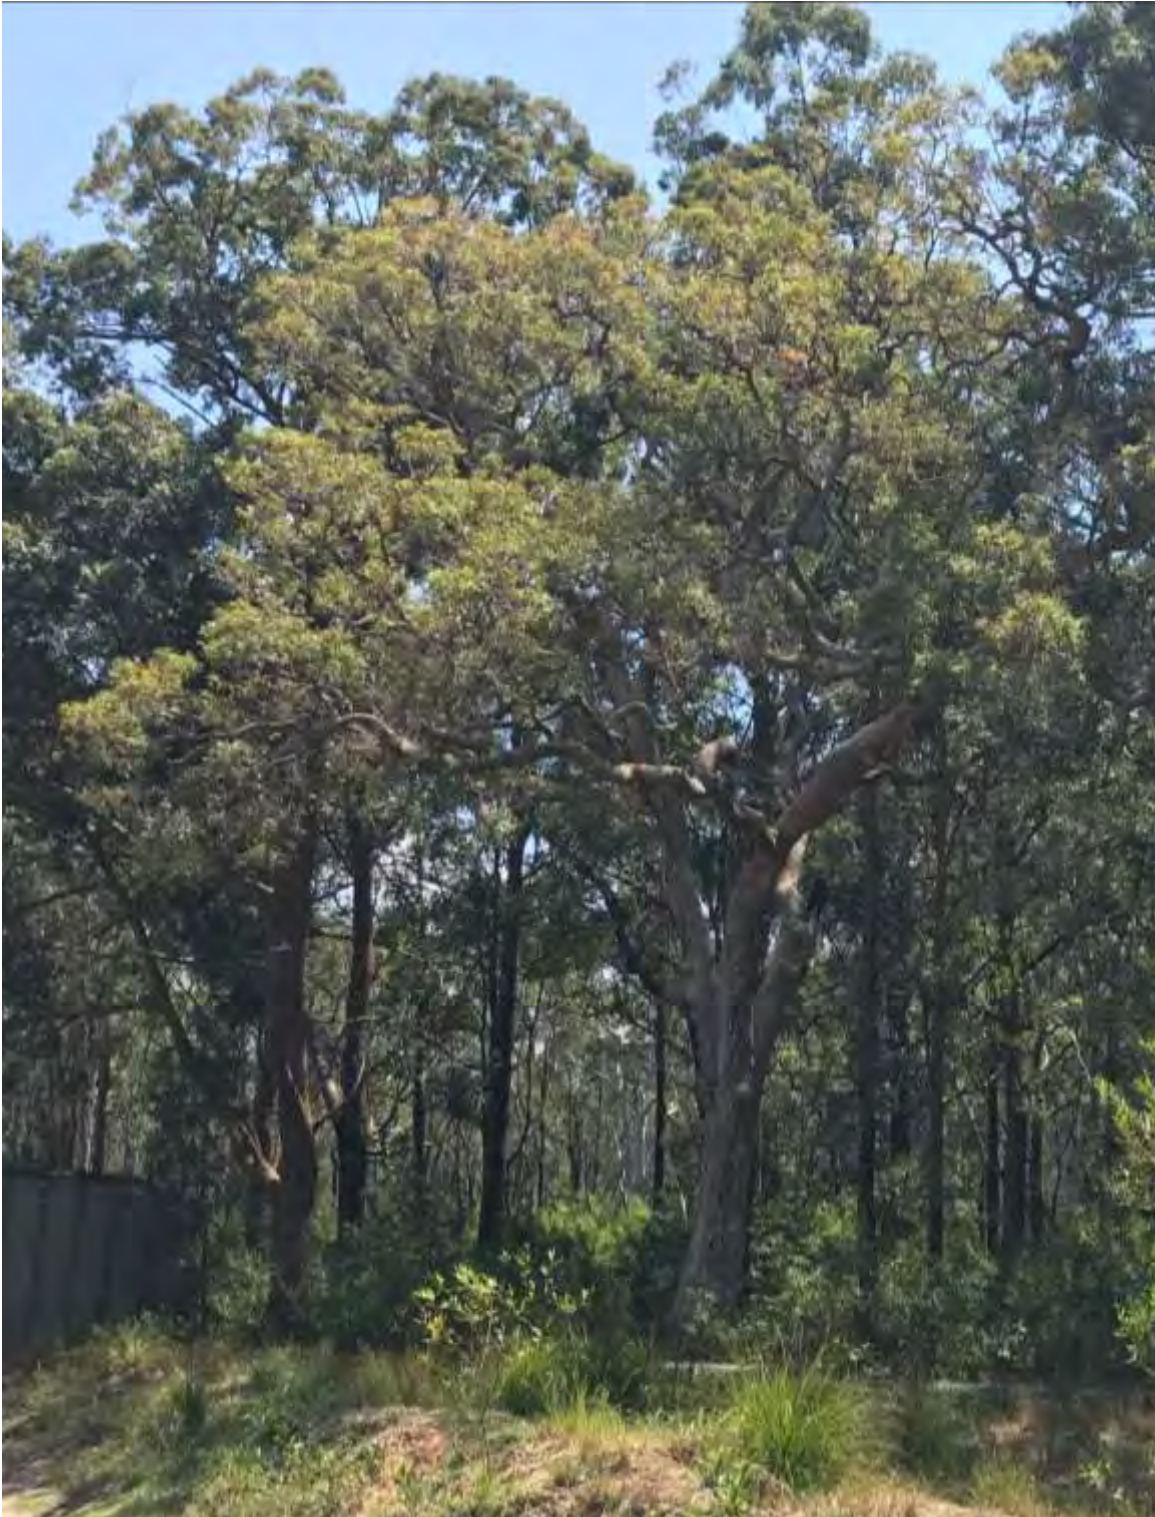
Photograph B.5 **Tree monitoring point 1**

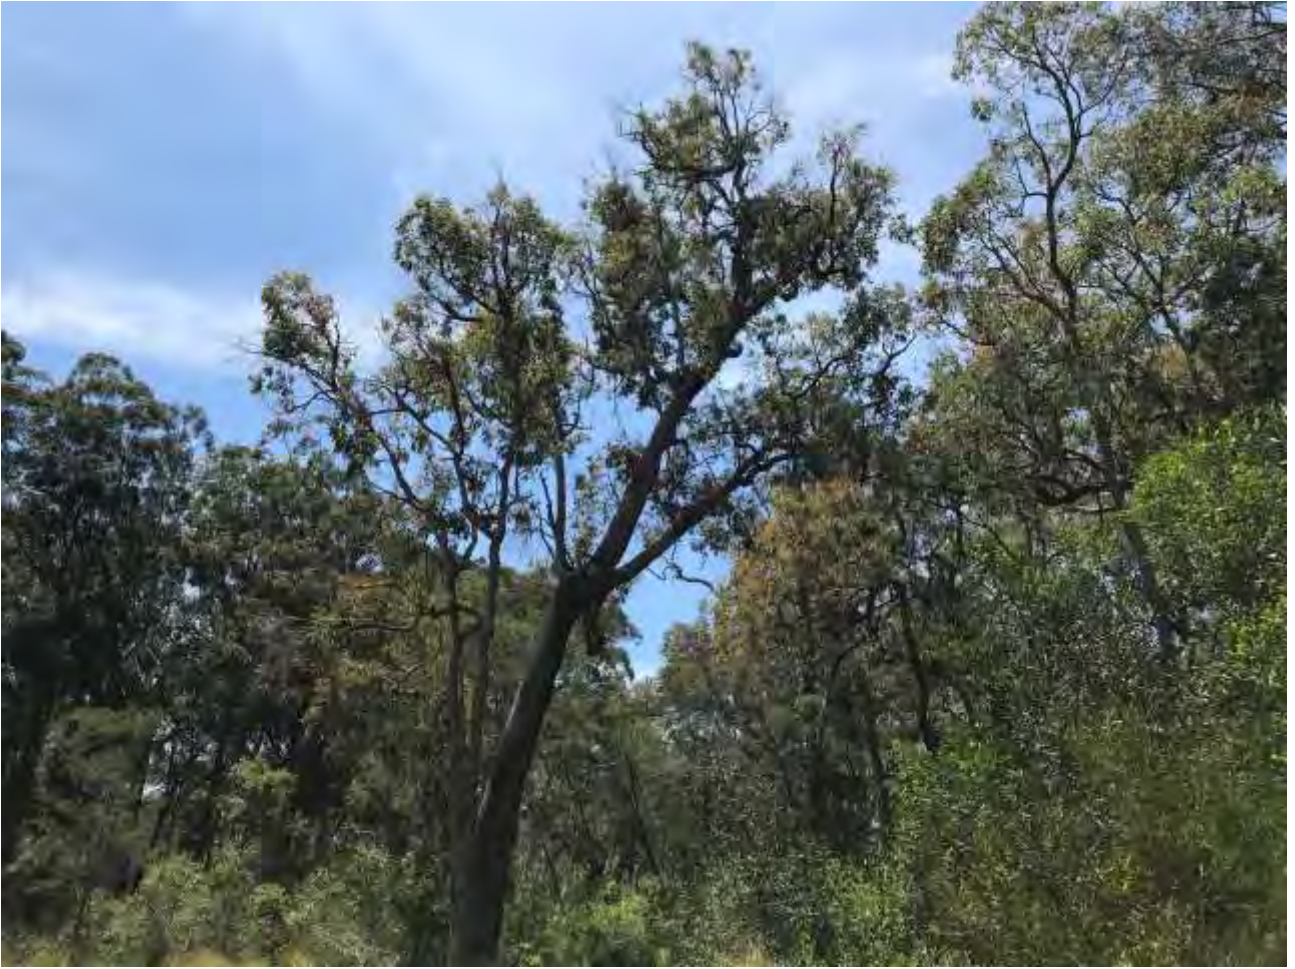
Tree 2	Tree appears healthy, with new growth and dense foliage within the crown. Small areas of dieback observed on small and isolated limbs, however this is less noticeable than observed in previous years. The tree has increase foliage cover compared to the 2016 BMP photograph.

Photograph B.6 **Tree monitoring point 2**

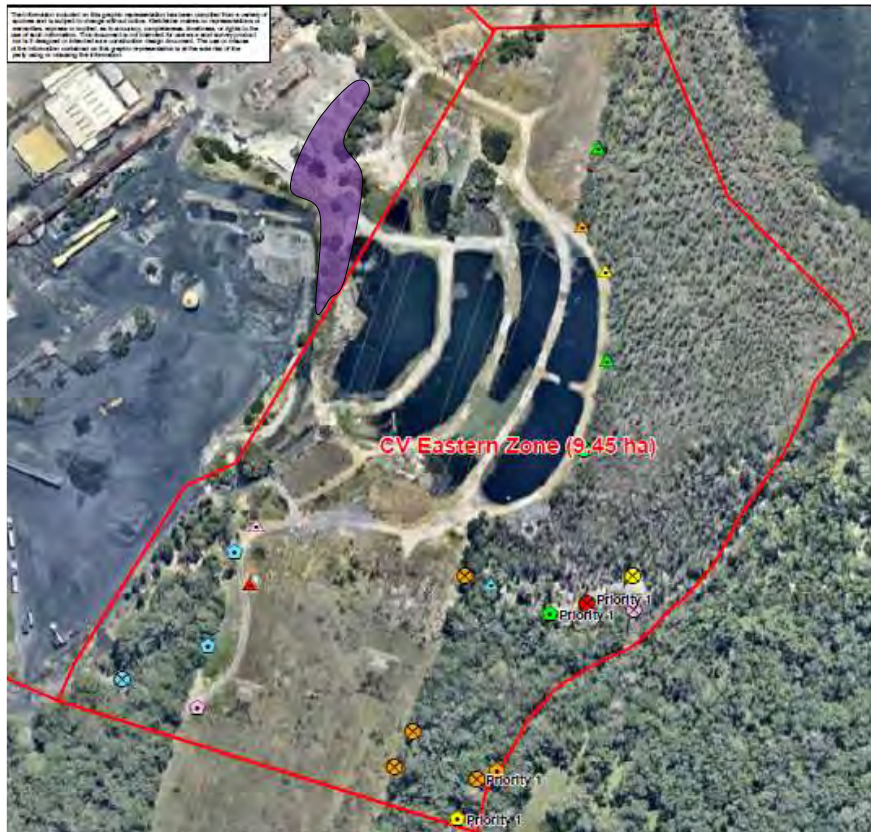
3.2 CV Central and CV East

- Minimal works were completed here due to other client priorities
- Targeting some Lantana, Pampas Grass, Castor Oil & Crofton
- Spot sprayed some Crofton weed when conditions were appropriate.
- Target Noxious, WoNS and environmental weeds using industry approved methods
- Some weed propagules/seed were bagged and removed from site

- Treat plumes of Lantana, Pampas Grass, Castor Oil, Crofton Weed using a combination of cut/paint, hand removal and spraying techniques.
- Considerable areas of *Juncus acutus* and Pampas that need works around CVC and ponds
- Priority weeds in southern half of CV East to be worked before xmas 2019.
- Carefully treat weeds around ponds where there is active bird/reptile life

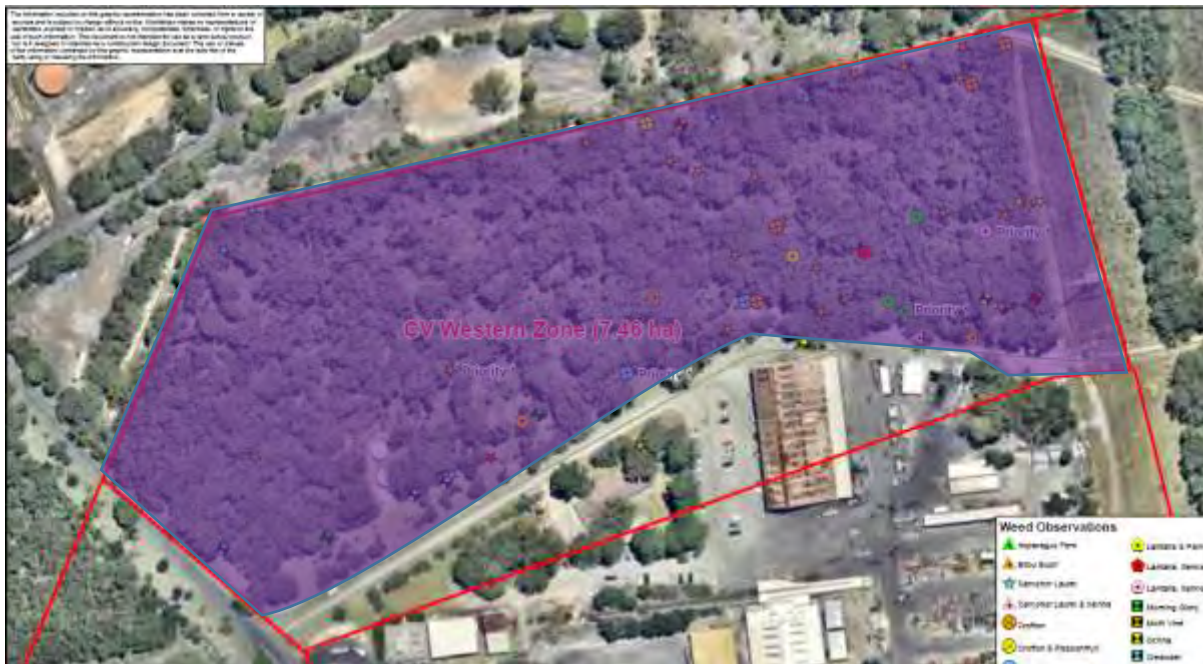
3.3 CV West

- Considerable time was spent in CV West due to the nature of weed/native ratio and the weeds returning rampantly after works completed some time ago.
- After preliminary inspection, the southern half of CV west contained the majority of the weeds. Primary weeding along the southern edges of CV West. Targeted Lantana, Senna, Bitou Bush, Pine Trees, Crofton Weed, Pampas Grass and other problematic weeds.

- Follow up works should be scheduled soon as weeds will return in large densities during the upcoming the summer months. A 12-24 month contract is suggested so any saplings regrowth can be secondary weeded and maintained to reduce numbers for next season
- Regular observation for weeds on edges, fire trails and road verges.
- Systematic sweeps to effectively cover large areas will be utilised.
- Focus on Lantana, Pampas, Crofton, Camphor laurel, Senna and Pine Trees

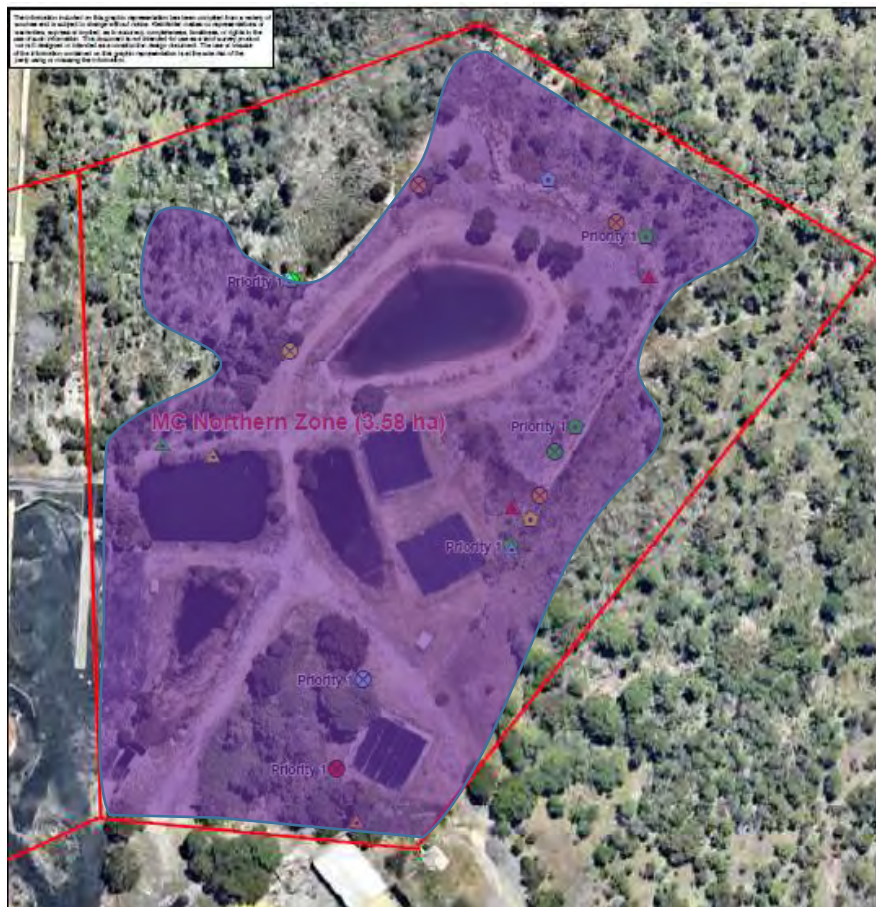
3.4 MC North

- Selective works were completed here due to other priorities. The main focus was the southern remnant bushland pocket and any obvious weeds around wetlands/ponds
- Targeting some Lantana, Pine Tree, Pampas Grass, Castor Oil & Crofton
- Numerous *Acacia saligna* were cut and painted
- Spot sprayed some Crofton weed, Thistle and Pampas when conditions were appropriate.
- Target Noxious, WoNS and environmental weeds using industry approved methods
- Some weed propagules/seed were bagged and removed from site

- Immediate works in the southern remnant bushland to consolidate primary weeding completed in August/September 2019.
- Treat plumes of Lantana, Pampas Grass, Castor Oil, Crofton Weed using a combination of cut/paint, hand removal and spraying techniques.
- Continue the treatment of remaining *Acacia saligna* around the northern retention pond.
- Considerable areas of *Juncus acutus* and Pampas need works
- Carefully treat weeds around ponds where there is active bird/reptile life

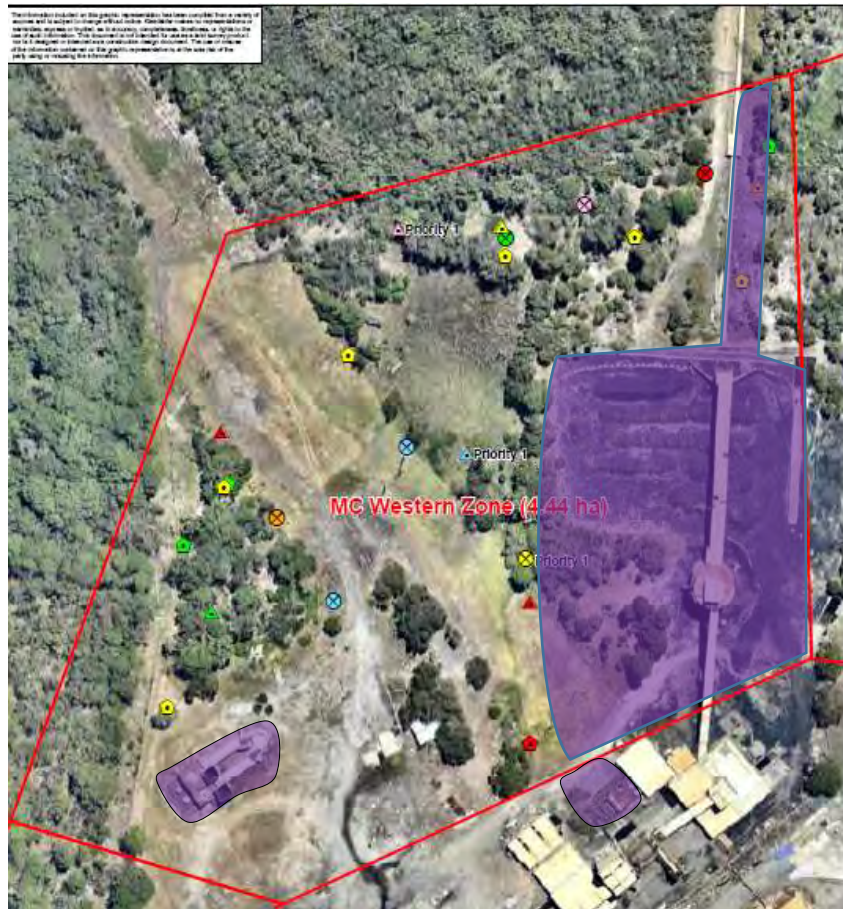
3.5 MC West

- Most of the works in MC West were around the coal loading/storage area
- Chris Armit requested a day for complete some APZ works along the northern coal conveyor belt where the native vegetation was growing near/over causing a fire risk especially coming into summer.
- Another request by Chris Armit was completed on Day 1 of our work schedule. This was to clear low lying grasses/weeds from 2 x fenced areas manned for routine maintenance. This involved spraying grass weeds and herbaceous weeds from 2 separate caged areas
- Targeting some Lantana, Bitou Bush, Pampas Grass, Castor Oil & Crofton
- Spot sprayed some Crofton weed when conditions were appropriate.
- Target Noxious, WoNS and environmental weeds using industry approved methods
- Several bags of weed propagules/seed were removed from site

- A large pocket of Bamboo and Lantana require immediate treatment before spreading through more native bushland.
- Treat plumes of Lantana, Pampas Grass, Castor Oil, Crofton Weed using a combination of cut/paint, hand removal and spraying techniques.
- Numerous large Pine Trees are spread across this zone and over Delta fencelines.
- Considerable areas of *Juncus acutus* and Pampas that need works
