CHAIN VALLEY COLLIERY
Annual Review 2019
1 January 2019 – 31 December 2019

Chain Valley Colliery – Annual Review (AEMR) 2019

Name of operation	Chain Valley Colliery
Name of operator	Great Southern Energy Pty Ltd trading as Delta Coal Pty Ltd
Project Approval #	SSD 5465
Name of Project Approval holder	Delta Coal Pty Ltd
Titles/Mining Leases #	Consolidated Coal Lease 707, Consolidated Coal Lease 706 (part), Mining lease 1051, Mining lease 1052, Mining lease 1308, Mining Lease 1370, Mining lease 1632 (part sublease), Mining Purposes Lease 1349, Mining Purposes Lease 337, Mining Purposes Lease 1389, Mining Purposes Lease 1400, Consolidated Coal Lease 719 (part sublease), Consolidated Coal Lease 721 (part sublease), Consolidated Coal Lease 722.
Name of holder of mining leases	Great Southern Energy Pty Ltd
Water License #	WAL41508 / Work Approval 20MW065025
MOP Commencement Date	1 st October 2018
MOP Completion Date	31 st December 2020
Annual Review start date	1 January 2019
Annual Review end date	31 December 2019

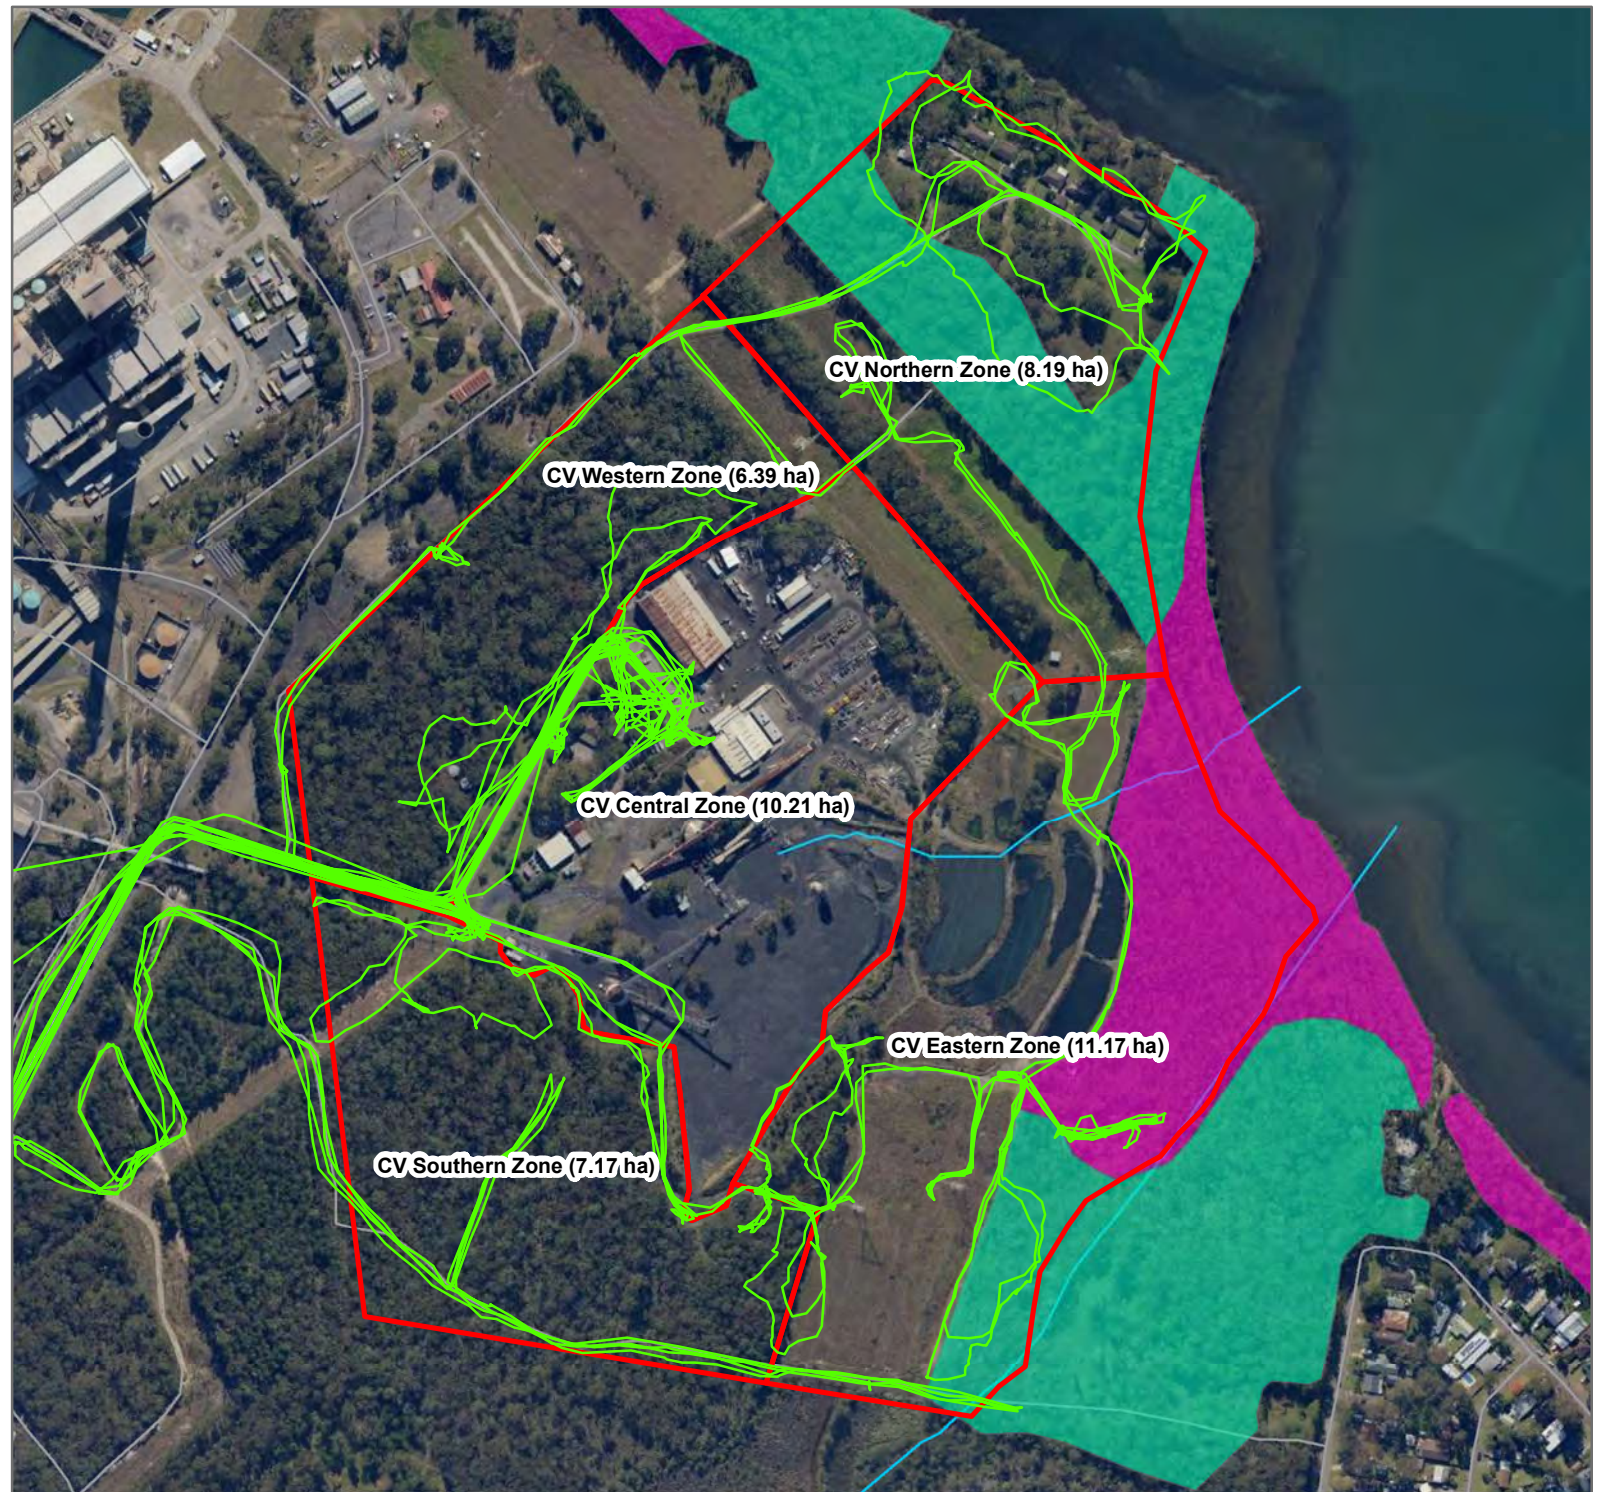
Map No: 2

Title: Mannering Colliery:
Subject Site & Survey Effort

A site survey was conducted over two (2) days on the 15th and 16th October 2019. Weather conditions were clear with maximum temperatures of approximately 25°C on the 15th and 24°C on the 16th. See Maps 1, 2 and 3 for survey effort.

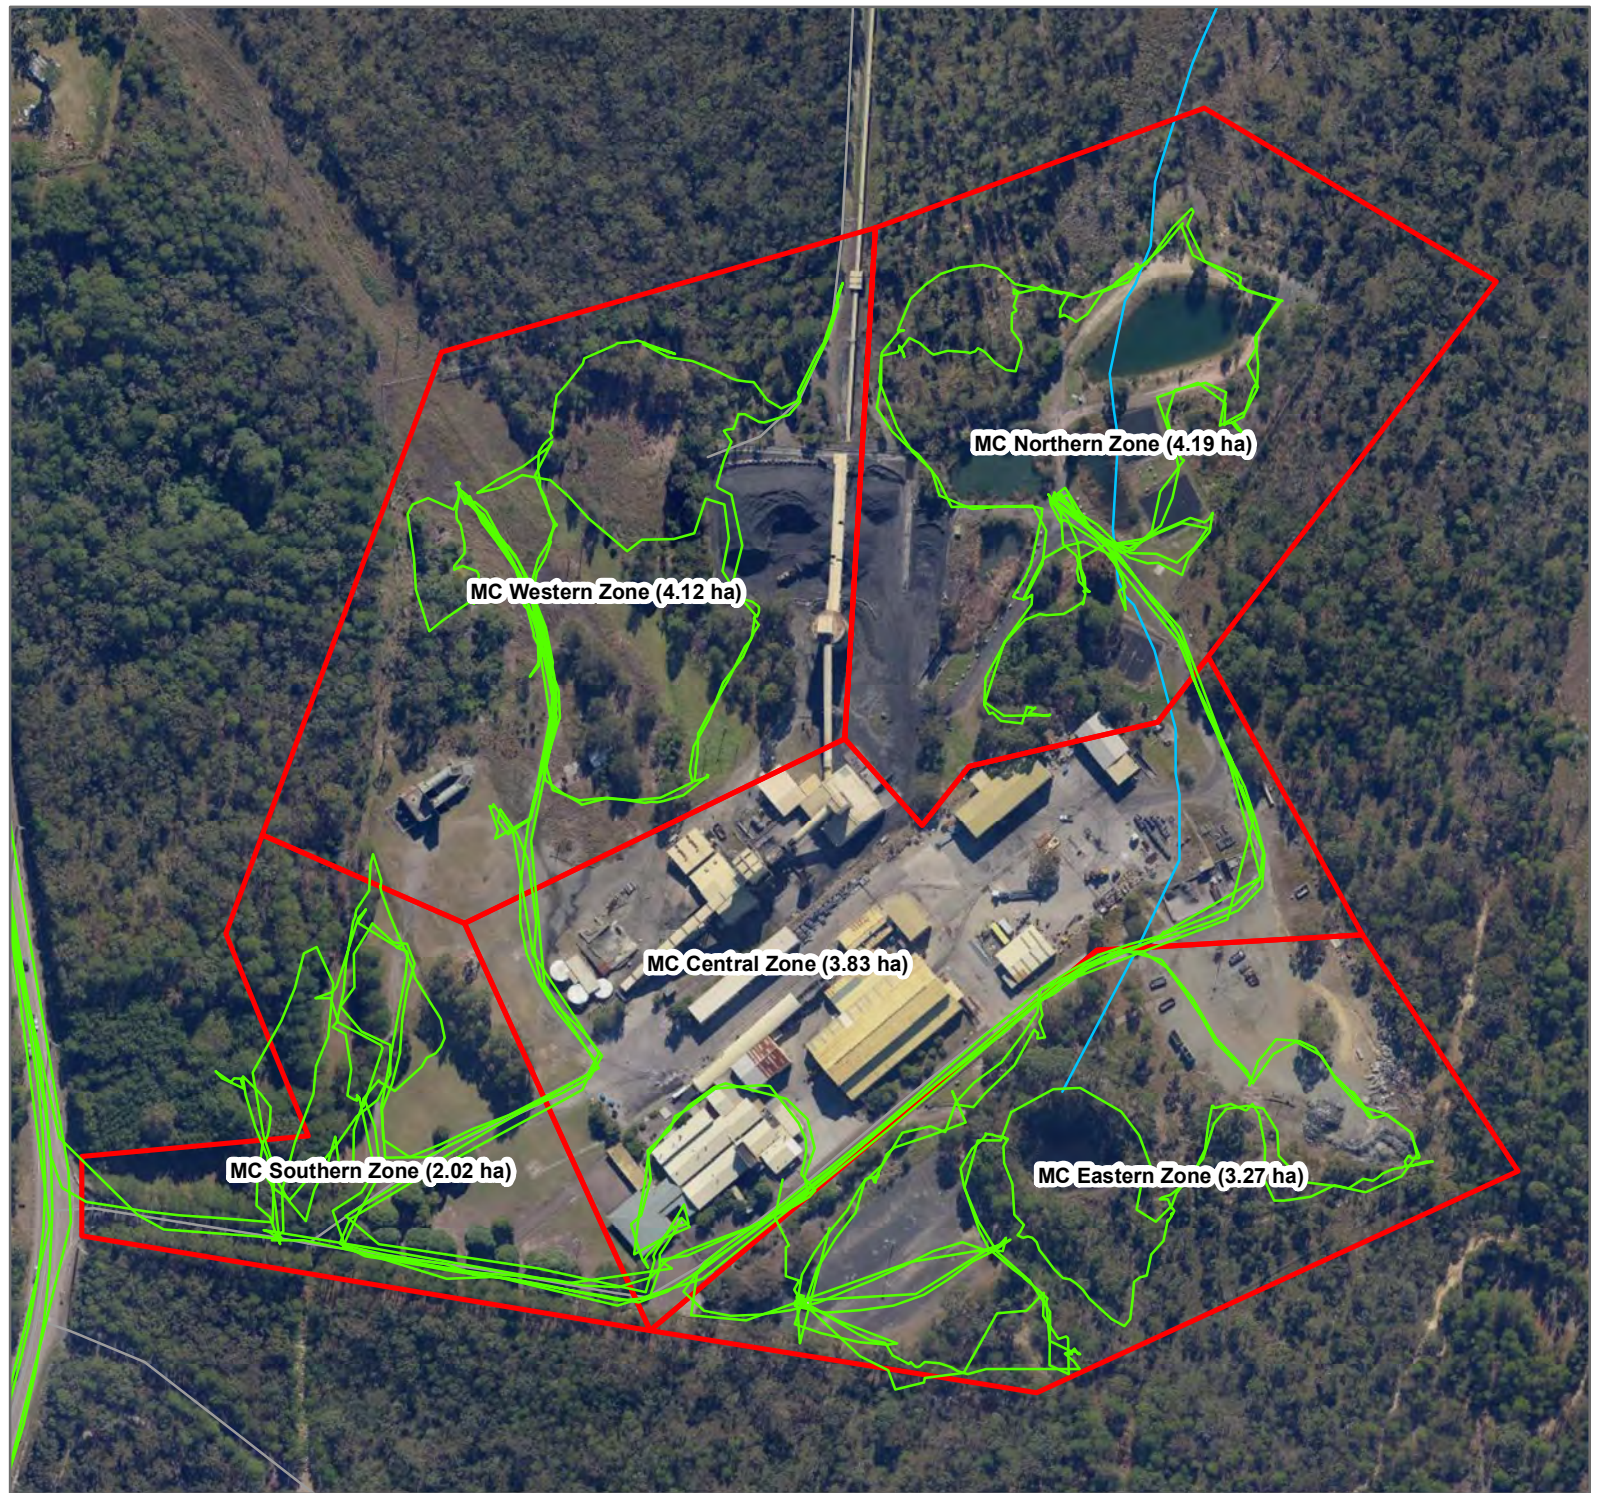
Map No: 3

Title: Summerland Point Ventilation
Shaft: Subject Site, EECs &
Survey Effort

See Map 3 for EEC locations.

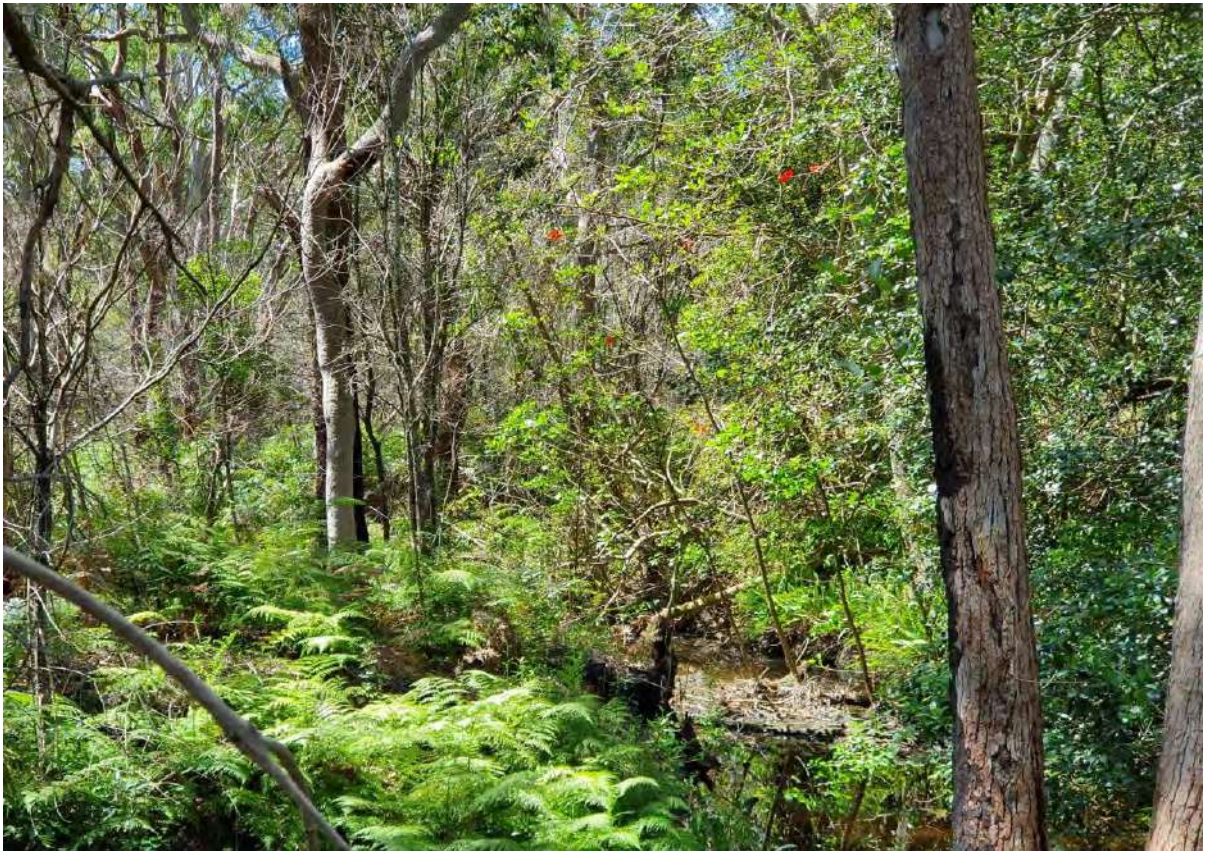
Figure 1. Eastern Zone of Chain Valley Colliery along creek line.

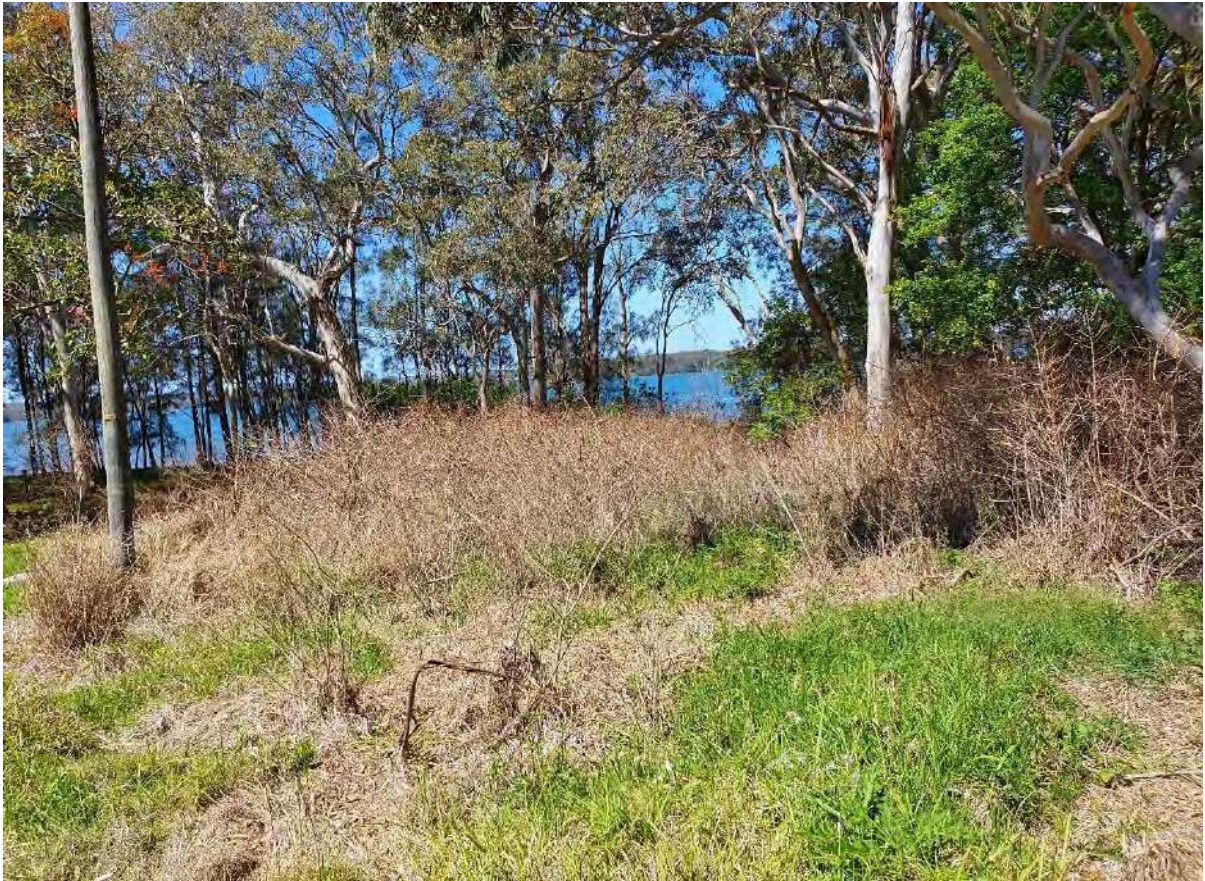
Figure 2. Treated Lantana and Blackberry in Northern Zone of Chain Valley Colliery near cottages.

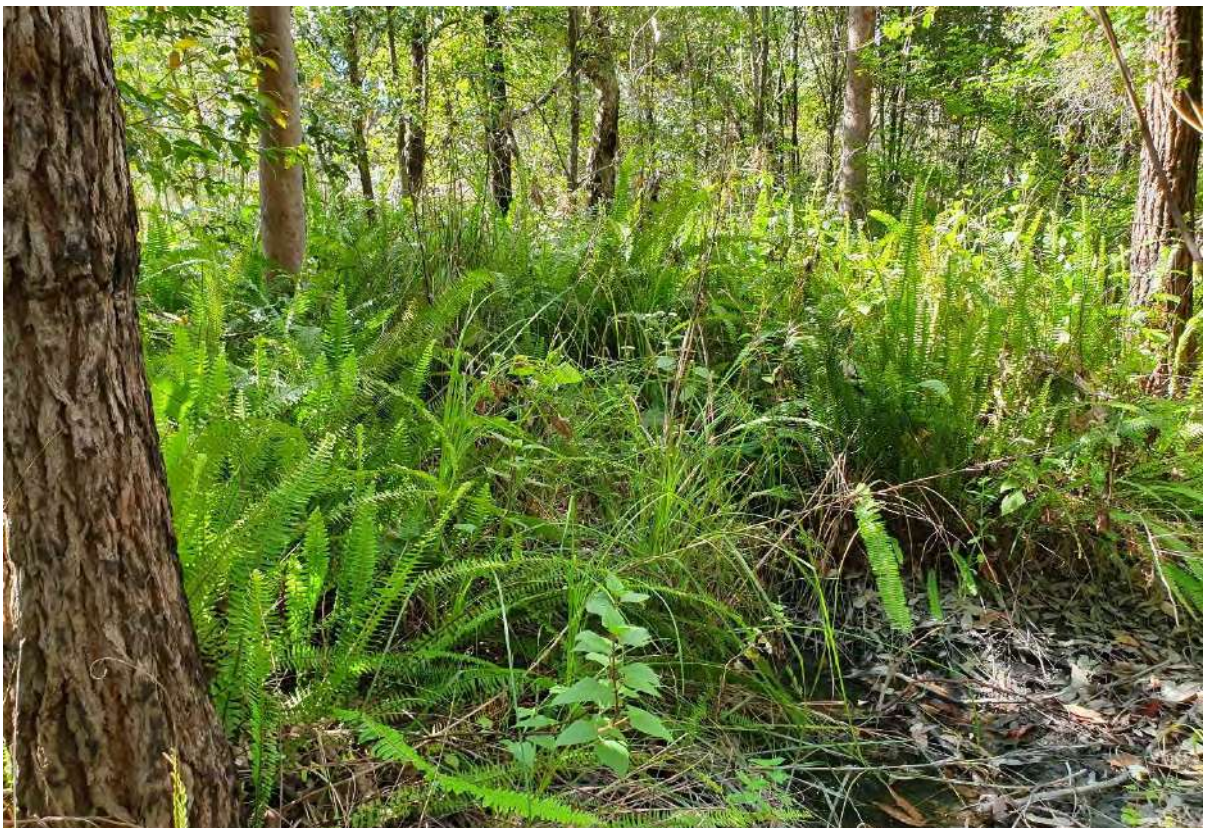
Figure 3. Fishbone Fern and Crofton Weed in Western Zone Area B of Chain Valley Colliery along drainage area.

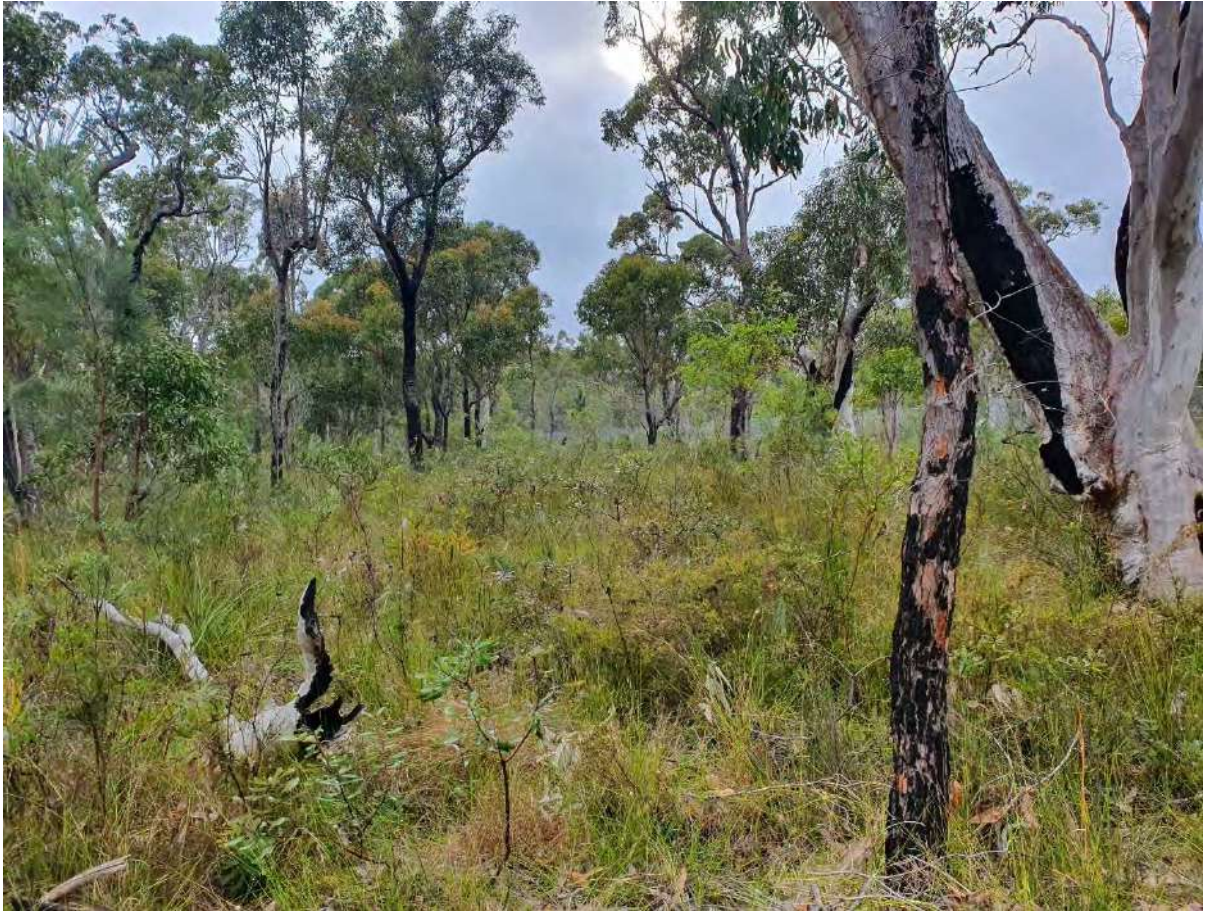
Figure 4. Resilient bushland in Eastern Zone Area D of Mannering Colliery.

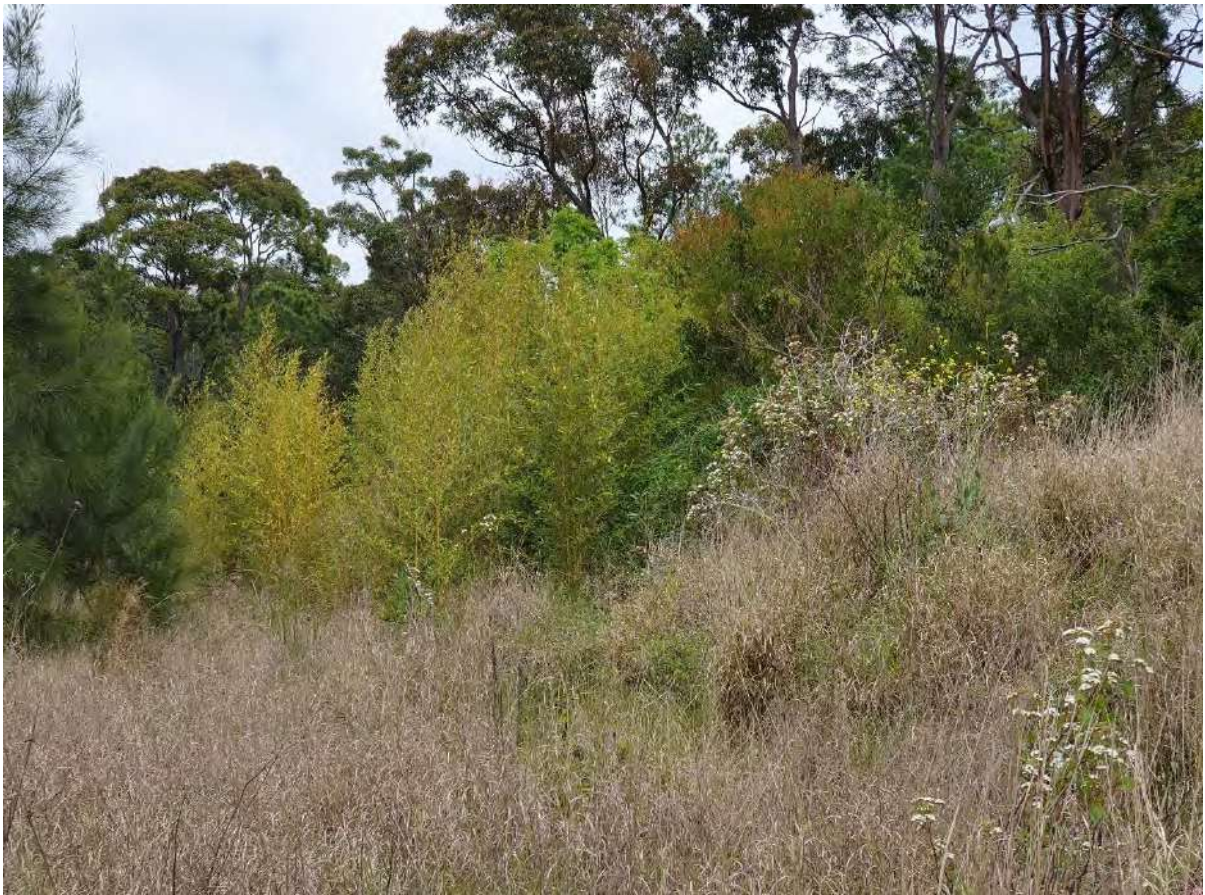
Figure 5. Bamboo and Crofton Weed in Western Zone Area F of Mannering Colliery.

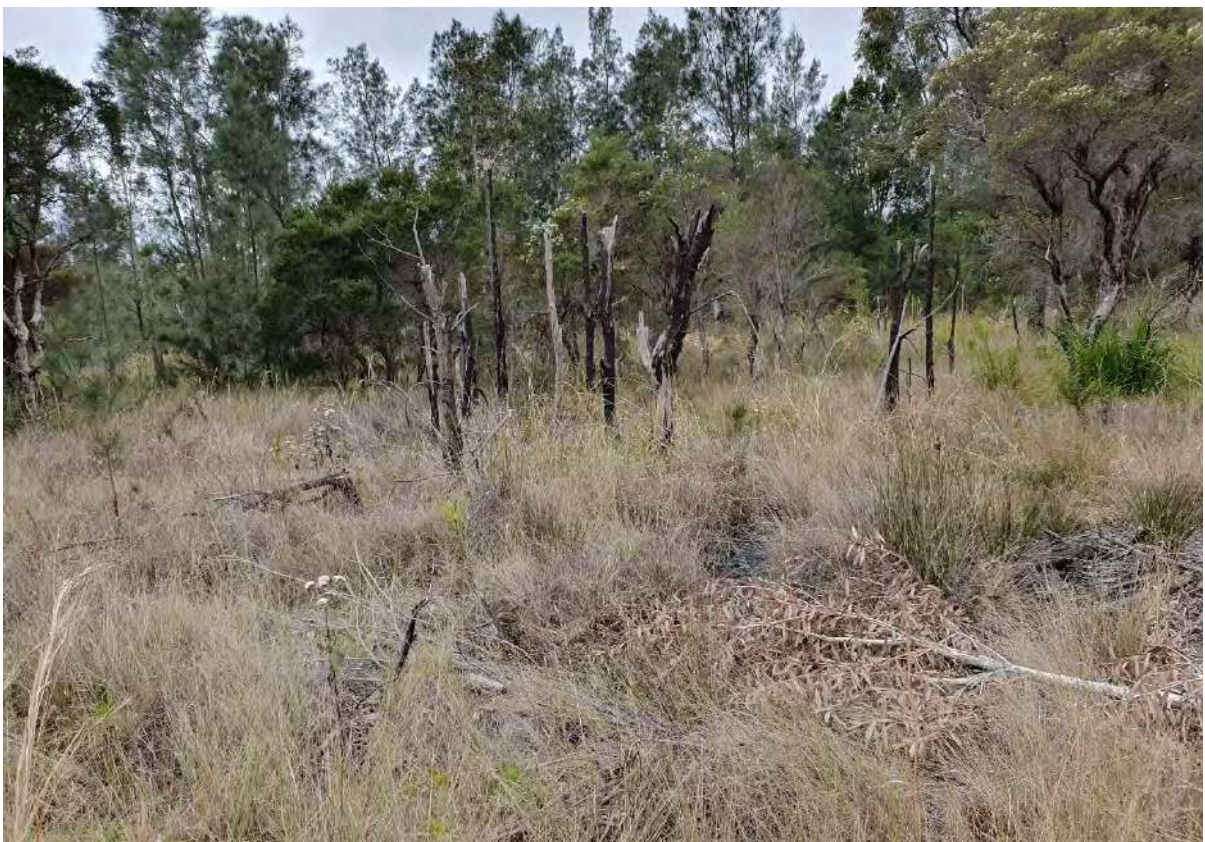
Figure 6. Crofton Weed and *Juncus acutus* in wetland area of Northern Zone Area B of Mannering Colliery.

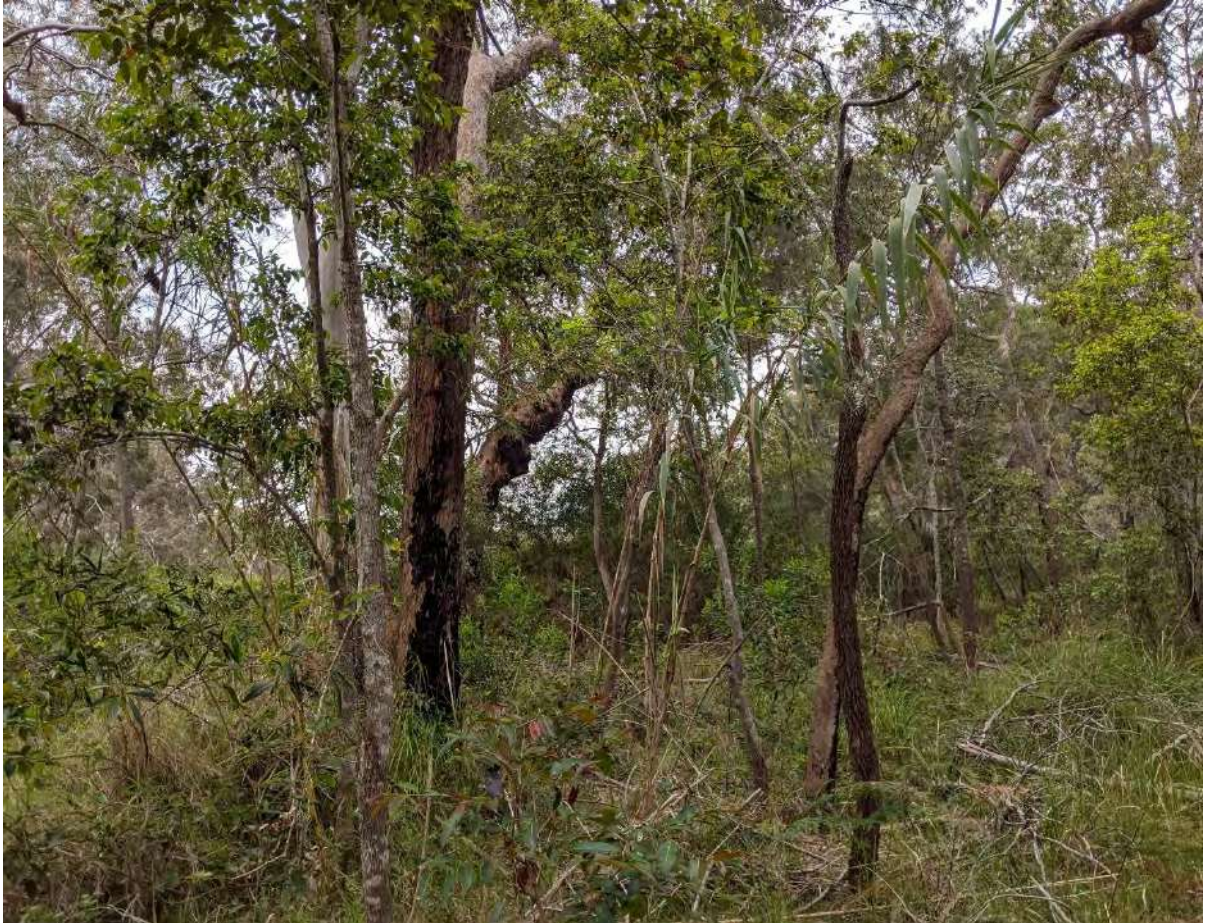
Figure 7. Giant Reed within bushland at the Summerland Ventilation Shaft site. .

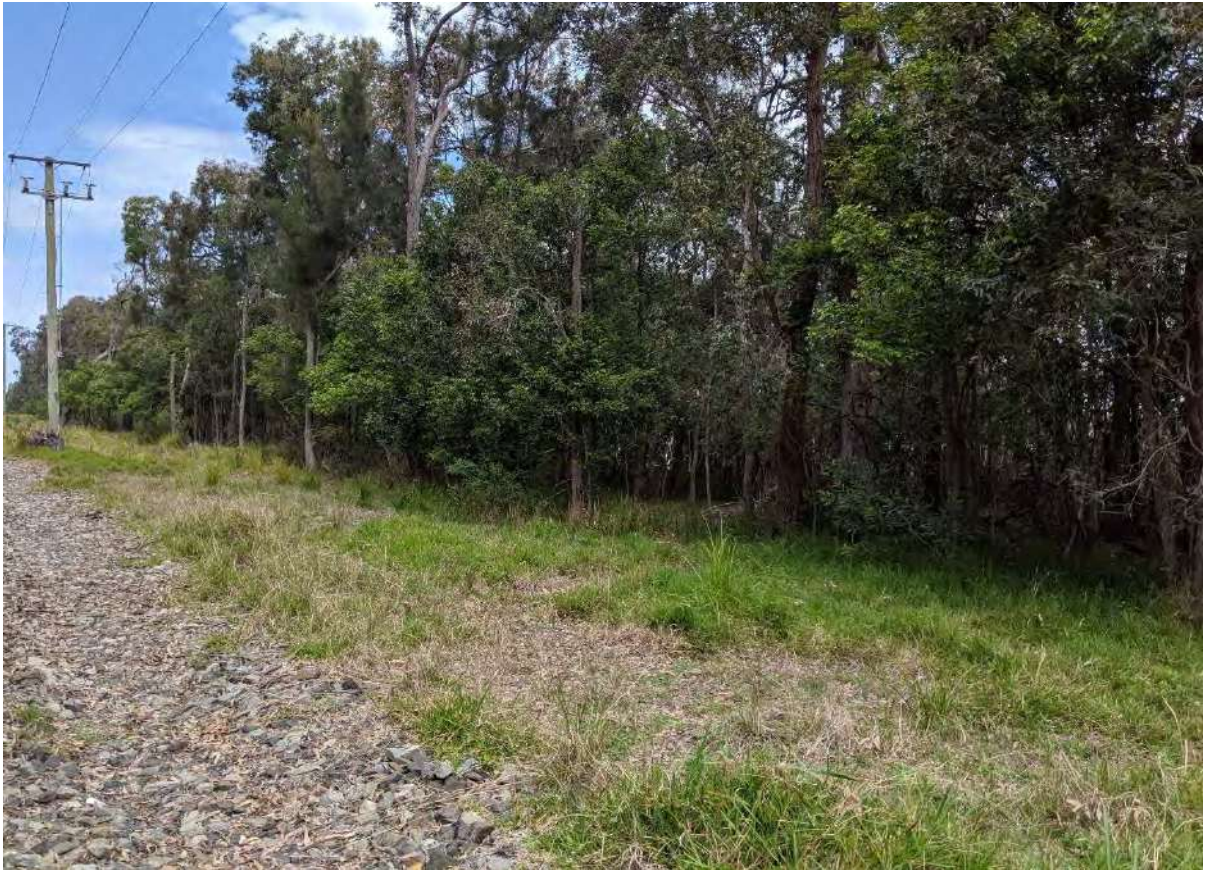
Figure 8. Unsealed road and easement within the Summerland Ventilation Shaft site.

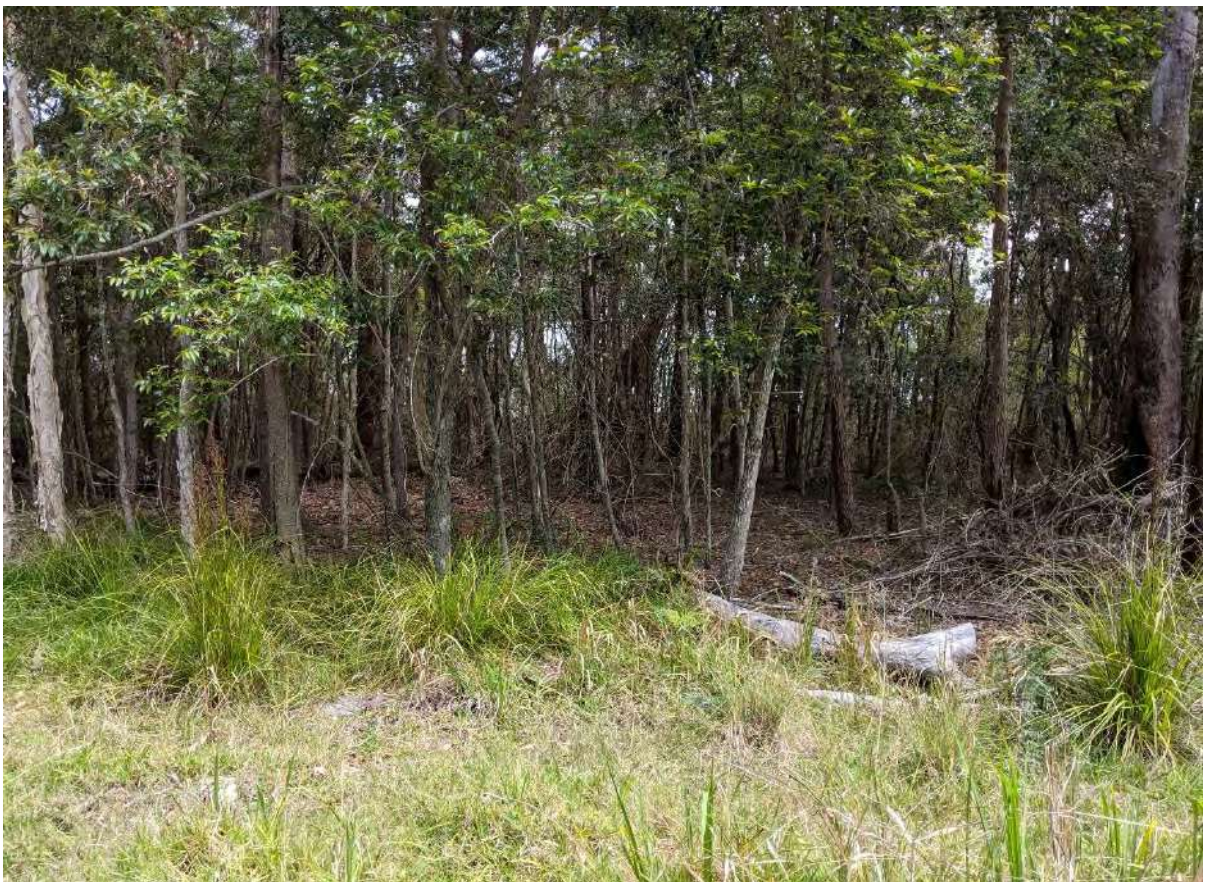
Figure 9. Vegetation adjacent to road on the Summerland Ventilation Shaft site.

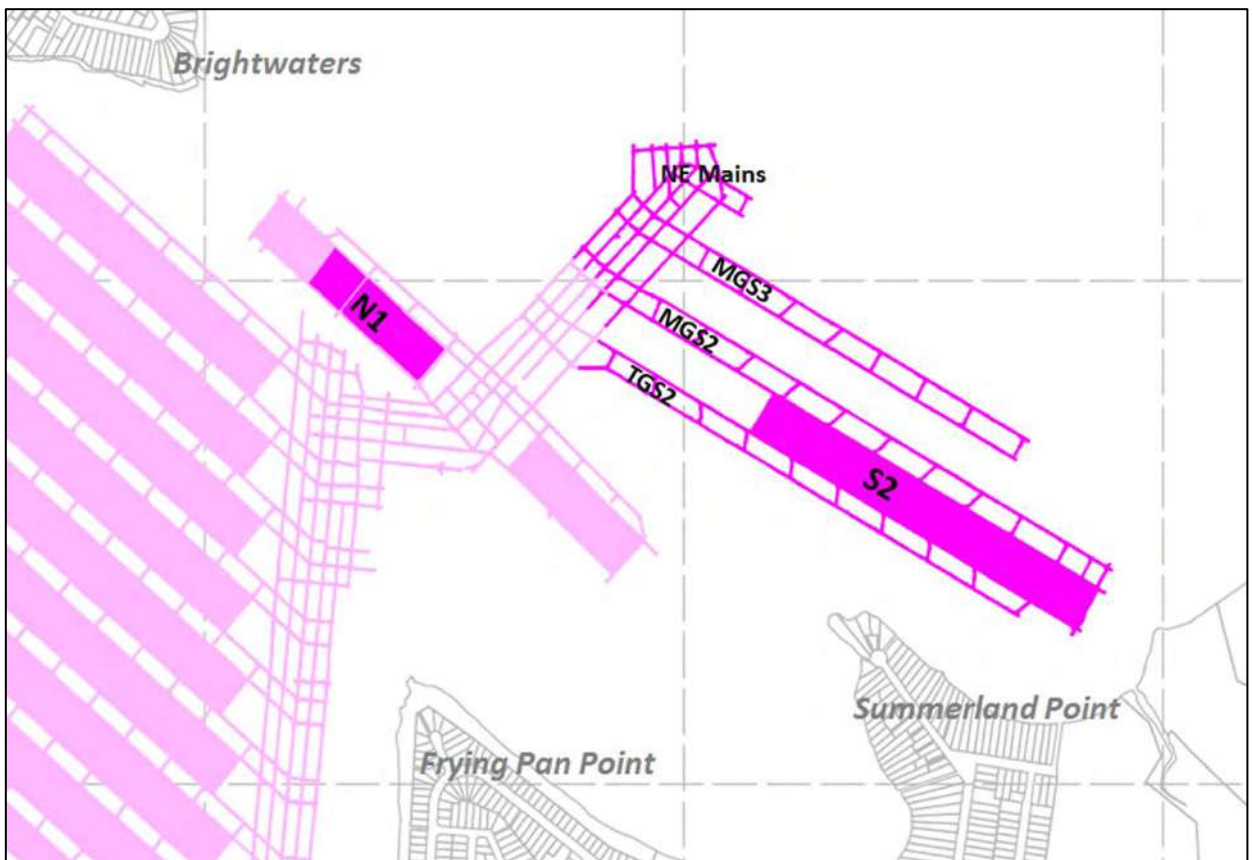
This ASR relates specifically to underground mining undertaken at CVC and MC in the period 1 January 2019 to 31 December 2019. Within this period, no mining was undertaken at MC. First workings and secondary extraction were undertaken at CVC and included:

- first workings:
 - Tailgate S2;
 - Maingate S2;
 - Maingate S3; and
 - part of the North-East Mains;
- secondary extraction:
 - Miniwall N1; and
 - Miniwall S2

Figure 1 – Chain Valley Colliery 2019 Mining Area

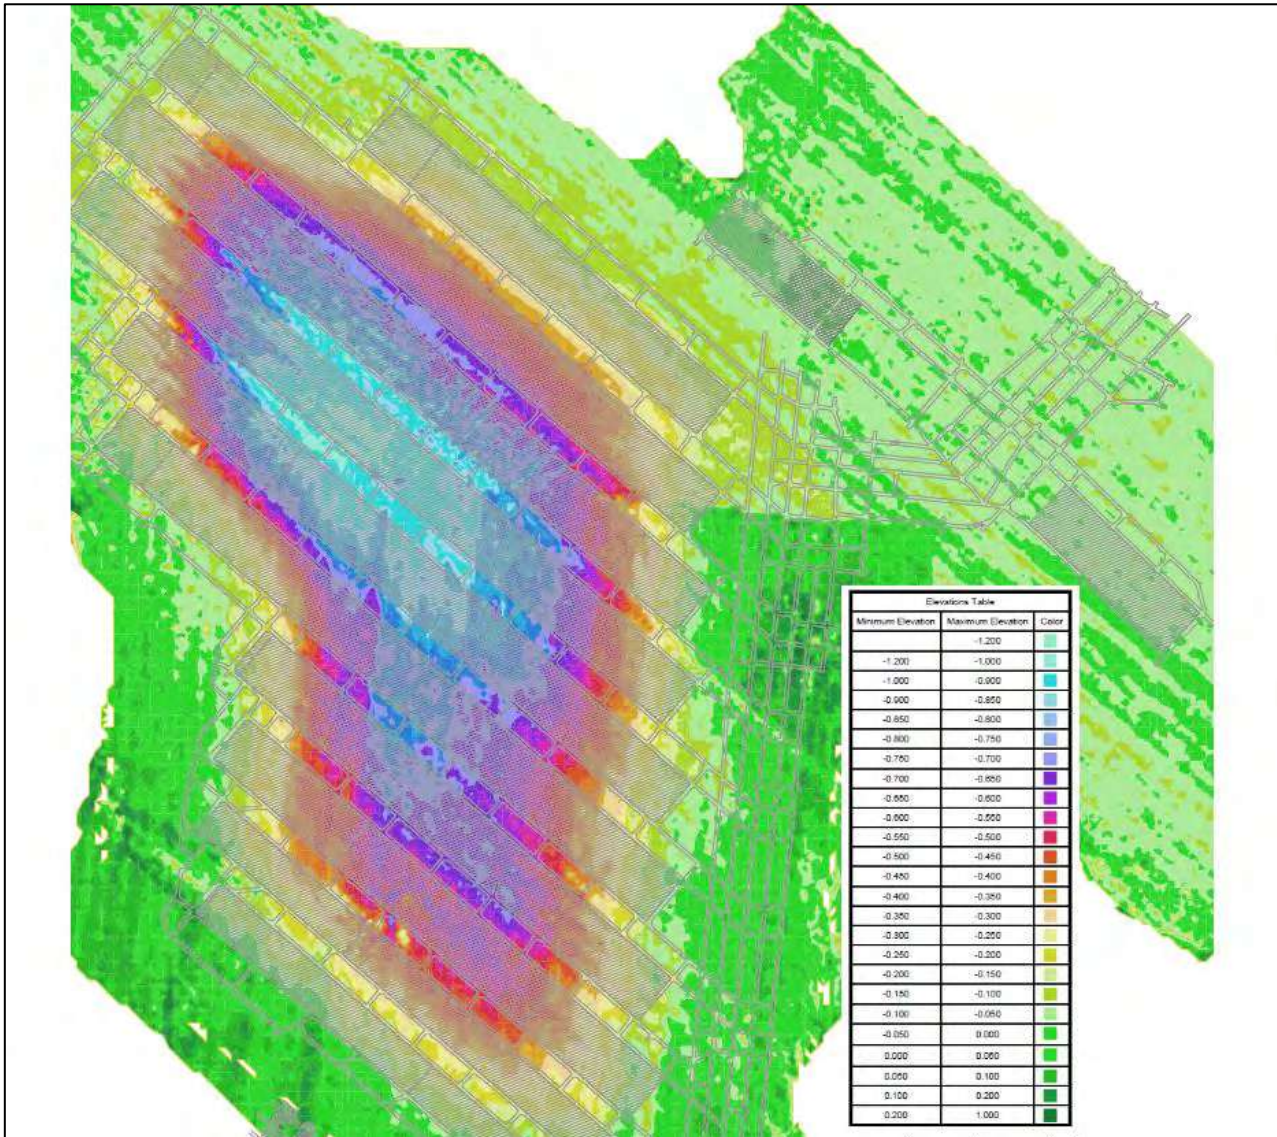
Figure 2 – Miniwalls 7-12, N1 and S1 (Jan-19 Survey)

Figure -Figure shows the 2019 scan results over Miniwalls 7-12 and N1, S1 comparative to the initial bathymetric surveys. Approximately 1200mm of subsidence has developed over the Miniwall 7-12 domain (above predictions of 780mm), but no further subsidence have been detected since the 2017 surveys.

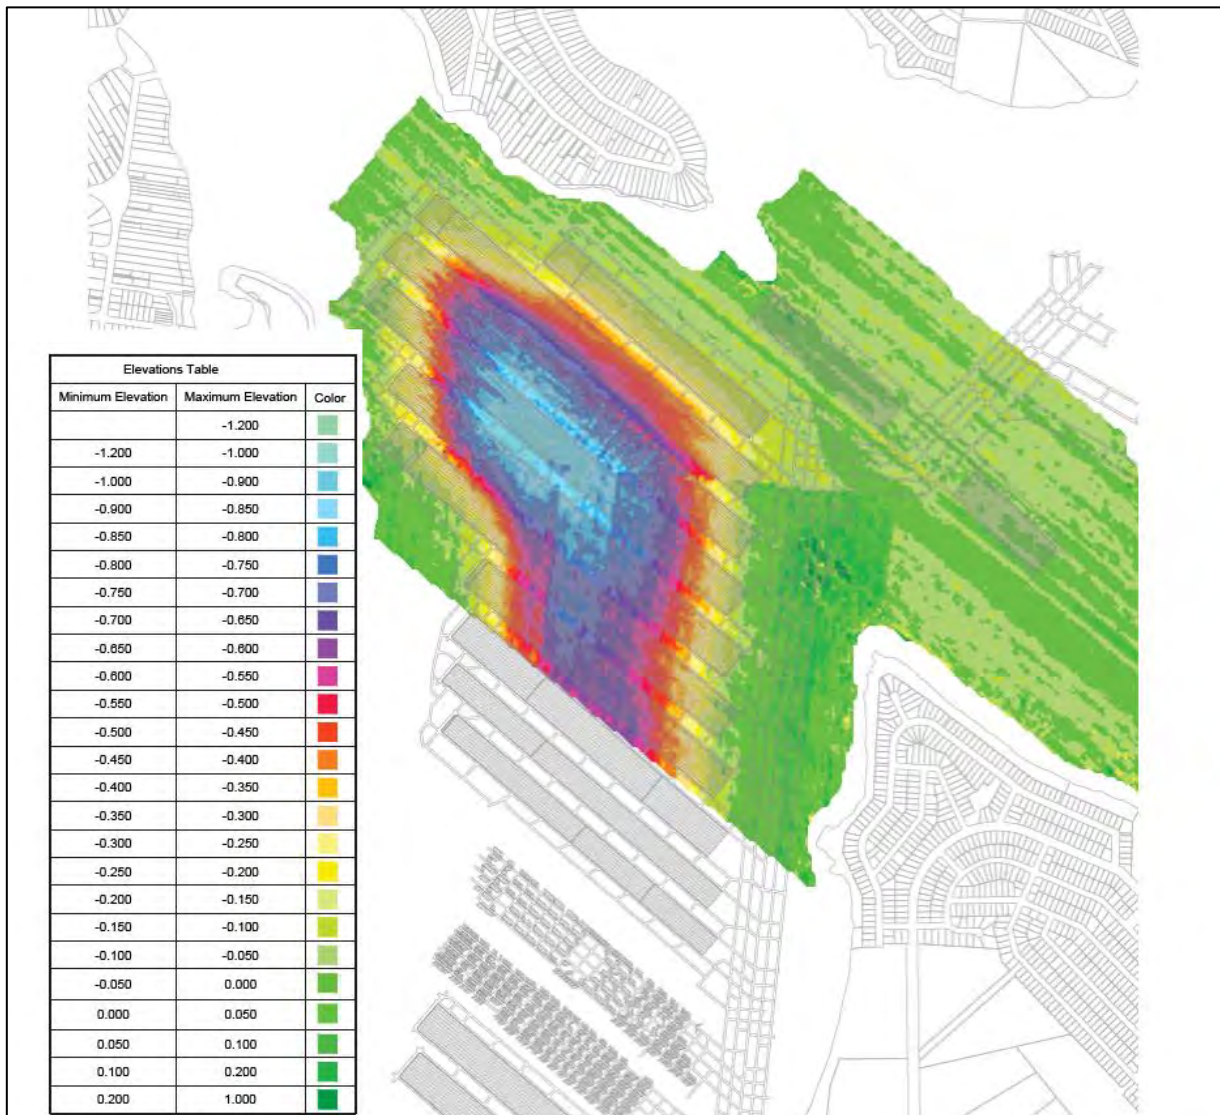
Figure 3 – Miniwalls 7-12, S1 and N1 (July-19)

Bathymetric surveys over the Chain Valley Bay mining area (Figure) have indicated subsidence of up to 400mm directly over the extracted area. An increased angle of draw of surface subsidence has been detected, but no impacts to the shoreline were observed. Minimal subsidence movement was detected from the previous survey in the area (January 2018).

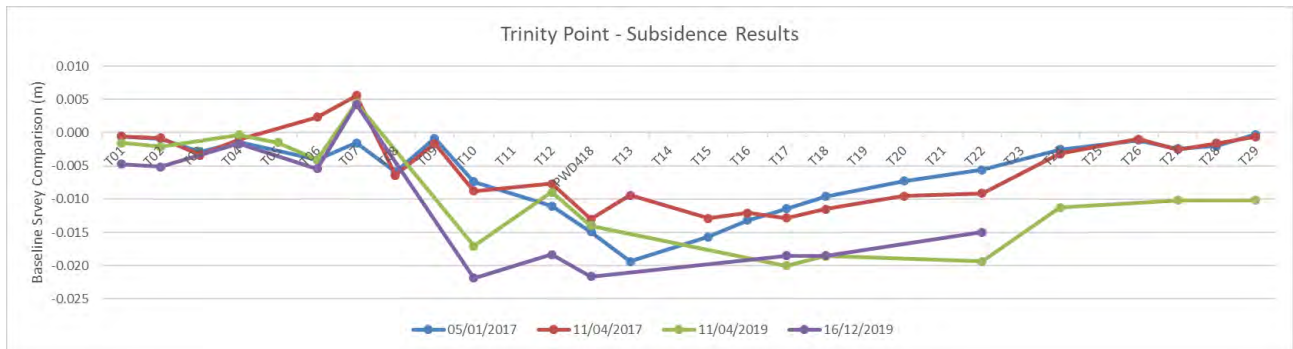
Figure Figure shows the subsidence monitoring results for the reporting period at Trinity Point. Monitoring points were installed in the area in 2014 for shoreline monitoring during extraction of Miniwalls 7-12 panels. A number of marks have been disturbed / destroyed due to development / construction works along the foreshore in the area, however nil movement attributable to subsidence has been detected.

Figure 6 - Trinity Point Subsidence Results

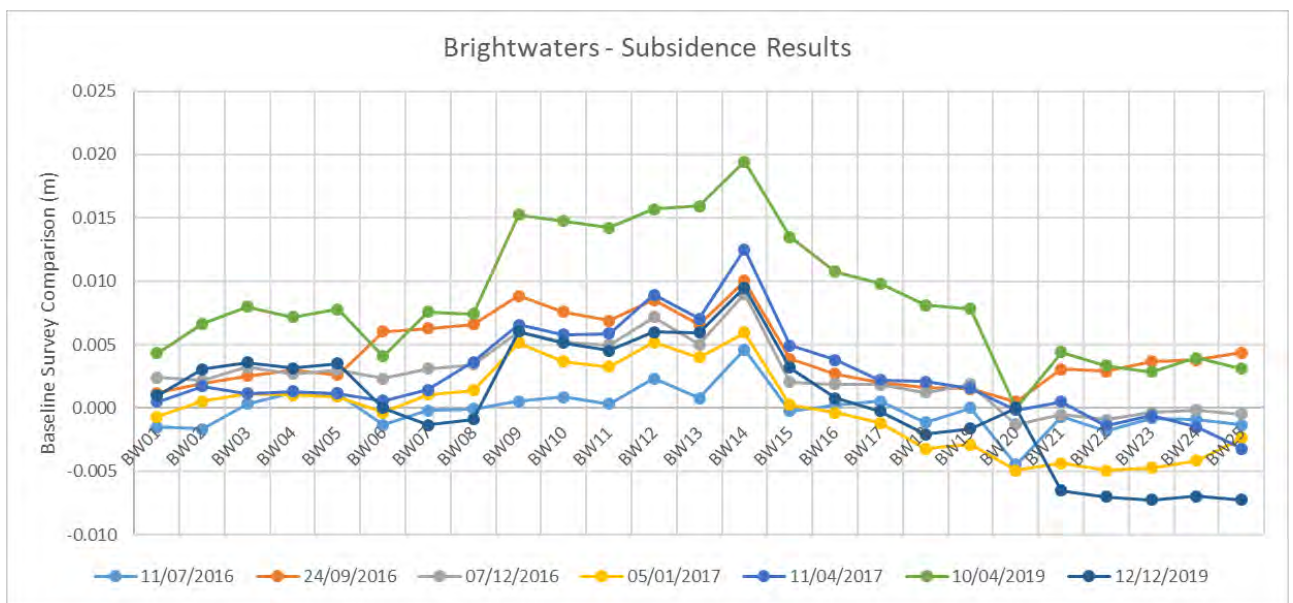
Monitoring points were installed along the Brightwaters peninsula in June 2016 to monitor the effects of Miniwall 11 and 12 extraction. Results for the reporting period are shown in **Figure** . Nil subsidence movement has been detected along the monitoring line.

Figure 7 - Brightwaters Subsidence Results

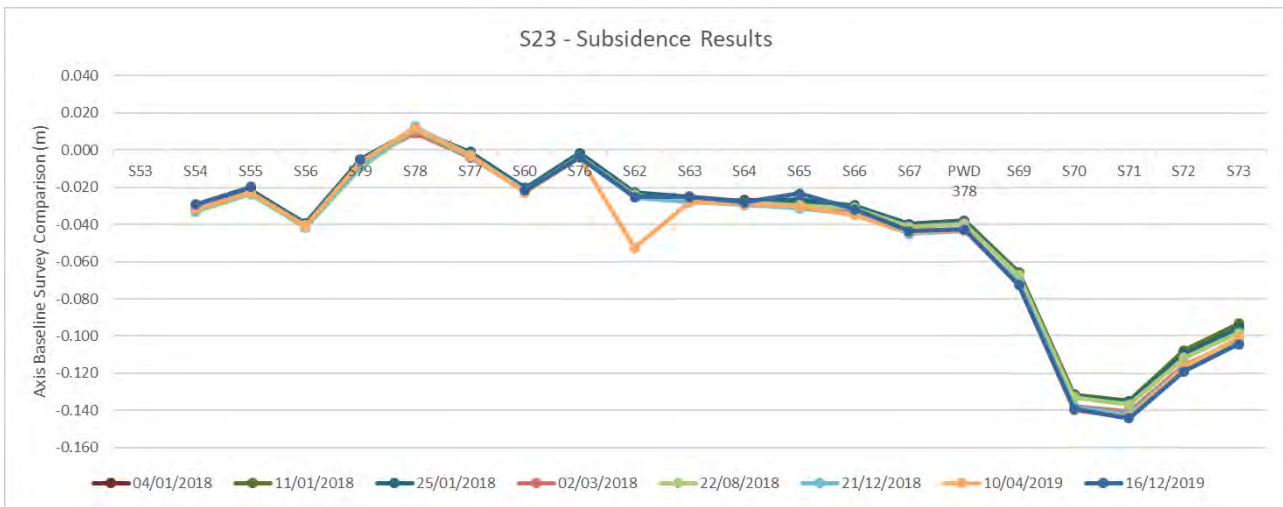
Figure 8 - Line 23 Subsidence Results

It is noted this point, along with points #63-75 have all experienced more than negligible amounts of subsidence (20mm) since June 2008. Since 2008, when Fassifern first workings were completed, subsidence has ranged between 20-40mm, primarily due to the impact of multi-seam extraction in the Wallarah and Great Northern Seams. Ongoing subsidence movement appears to have slowed in recent years, with approximately 10mm of movement (Point S71) during the 2018 and 2019 reporting periods.

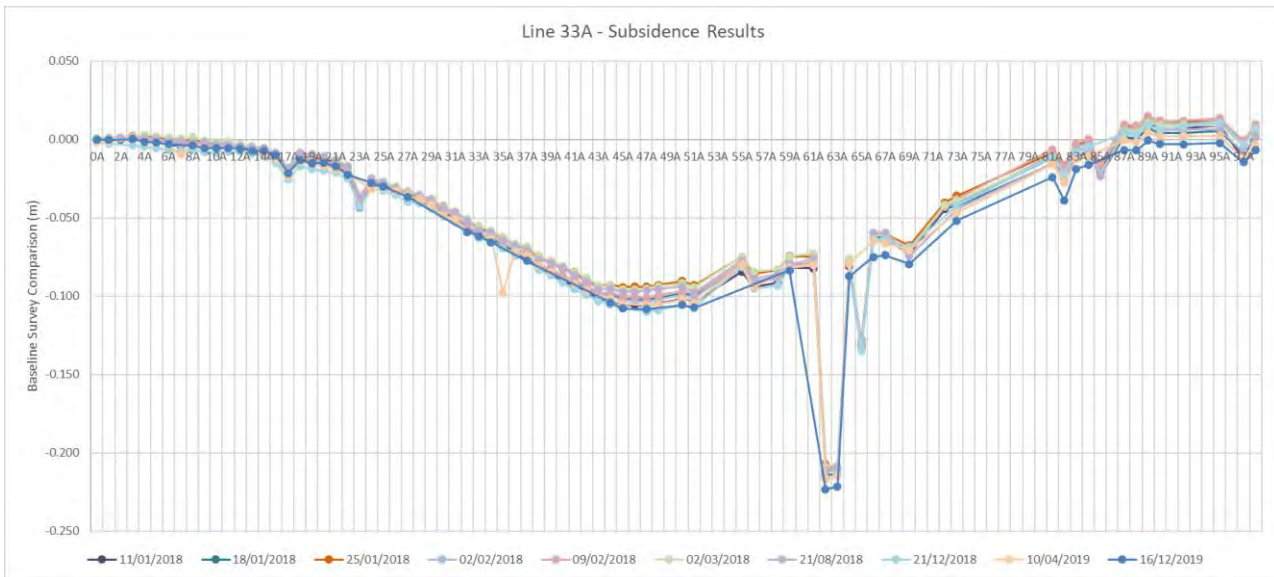
Figure 10 - Line 33A Subsidence Results

As the area where Line 33A monitoring marks are located is along a public reserve where regular slashing / brushcutting activities are carried out, a number of monitoring points have been disturbed / moved over time. Where this type of movement occurs, the new RL point is adopted and monitoring continues.

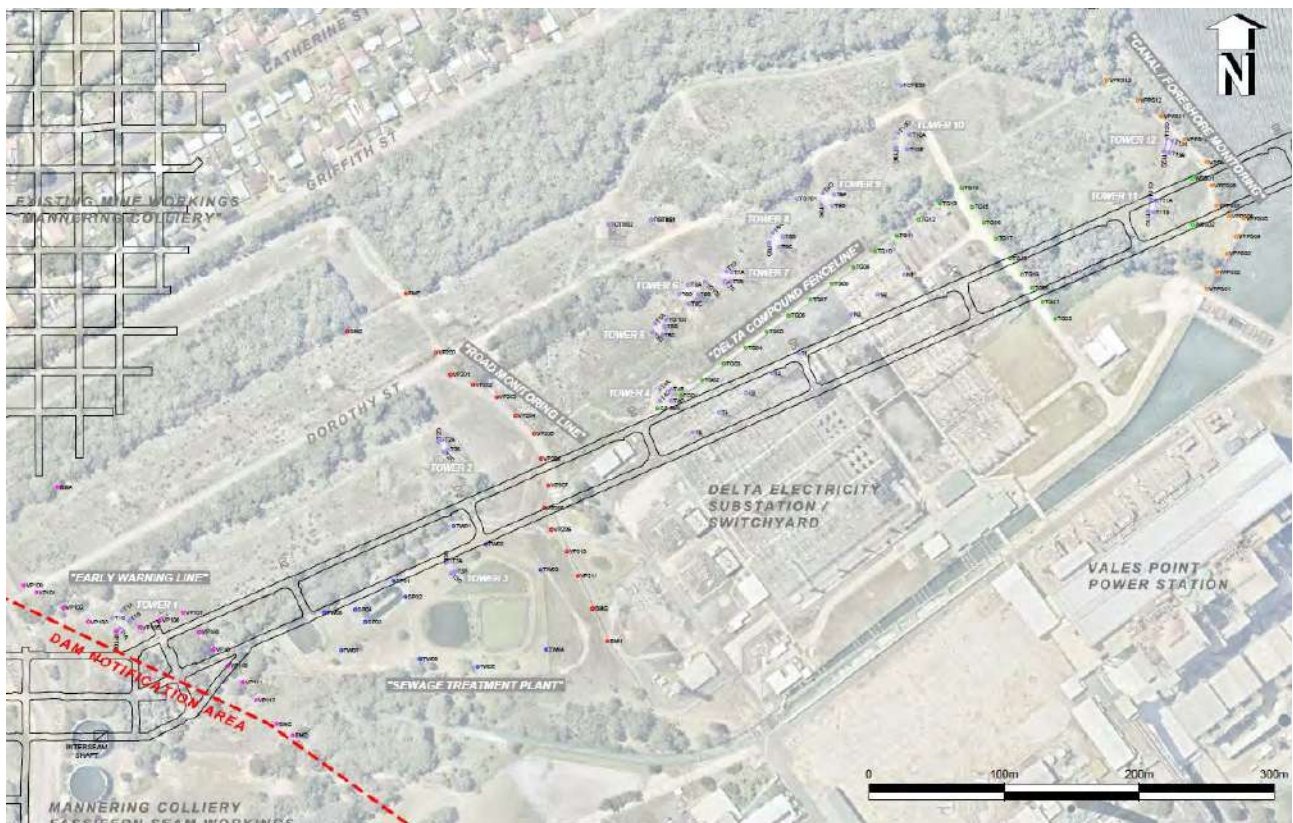
Figure 13 - Vales Point Power Station Monitoring Locations

As noted previously, at the commencement of mining operations associated with the Link Road Project, a subsidence monitoring program was implemented with monitoring points installed around VPPS (Figure 13).
