CHAIN VALLEY COLLIERY
Annual Review 2019
1 January 2019 – 31 December 2019

Chain Valley Colliery – Annual Review (AEMR) 2019

Name of operation	Chain Valley Colliery
Name of operator	Great Southern Energy Pty Ltd trading as Delta Coal Pty Ltd
Project Approval #	SSD 5465
Name of Project Approval holder	Delta Coal Pty Ltd
Titles/Mining Leases #	Consolidated Coal Lease 707, Consolidated Coal Lease 706 (part), Mining lease 1051, Mining lease 1052, Mining lease 1308, Mining Lease 1370, Mining lease 1632 (part sublease), Mining Purposes Lease 1349, Mining Purposes Lease 337, Mining Purposes Lease 1389, Mining Purposes Lease 1400, Consolidated Coal Lease 719 (part sublease), Consolidated Coal Lease 721 (part sublease), Consolidated Coal Lease 722.
Name of holder of mining leases	Great Southern Energy Pty Ltd
Water License #	WAL41508 / Work Approval 20MW065025
MOP Commencement Date	1 st October 2018
MOP Completion Date	31 st December 2020
Annual Review start date	1 January 2019
Annual Review end date	31 December 2019

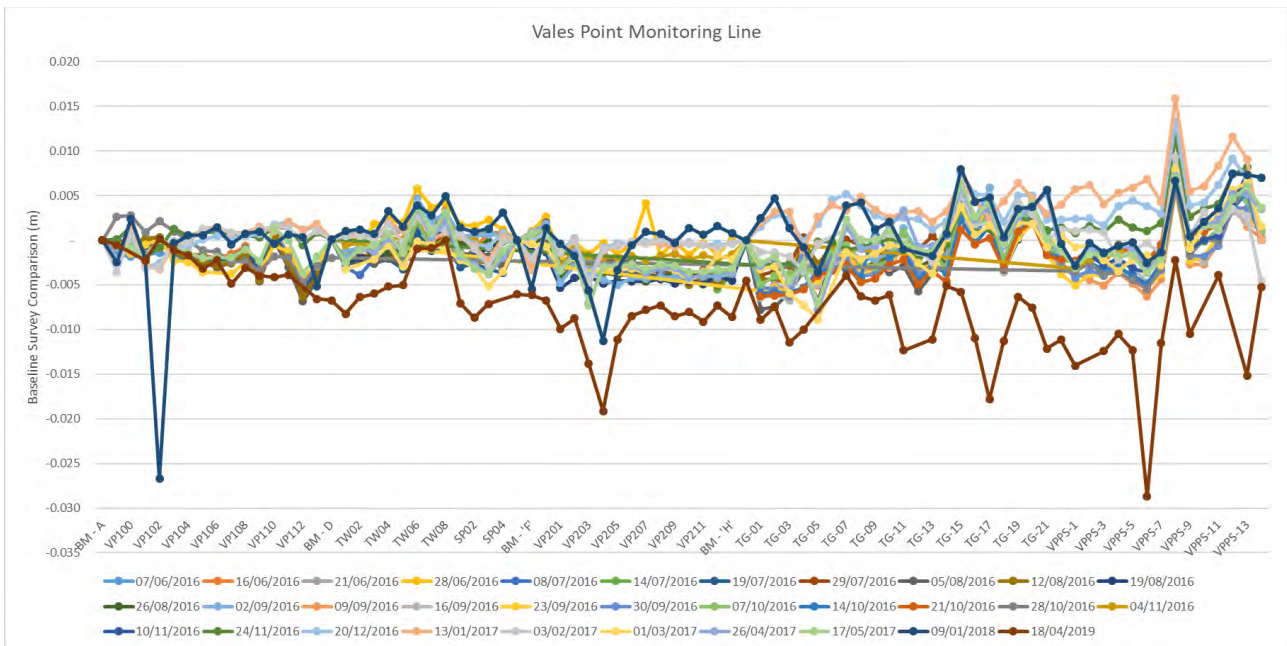
Figure 14 - Vales Point Monitoring Line Subsidence Results

No discernible subsidence impact from the Linkage Road Project workings was observed in 2019.

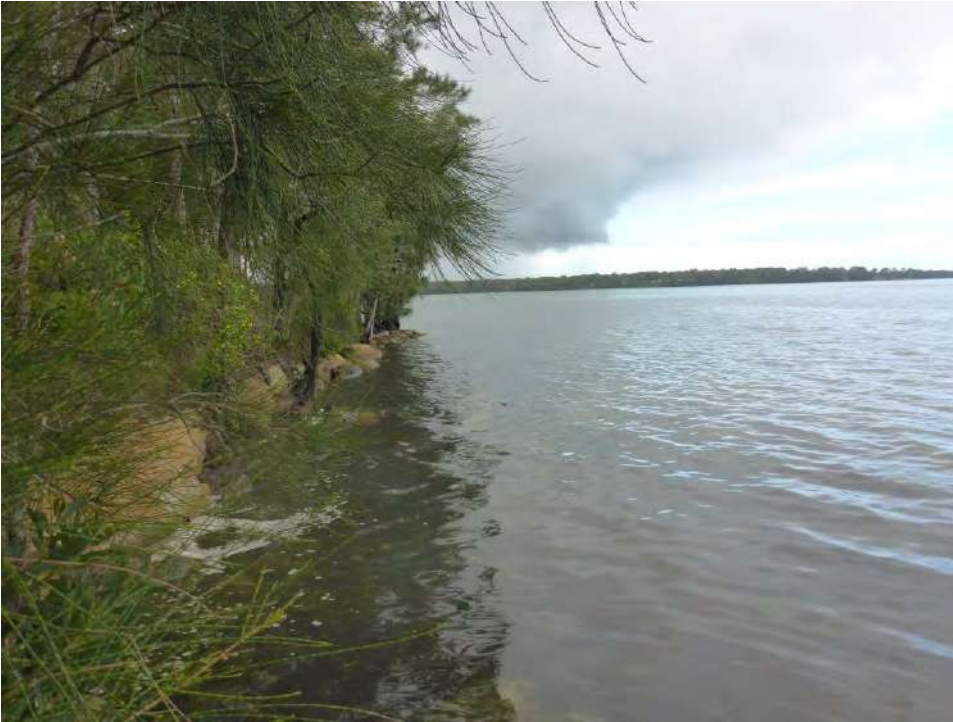
Photo 1 Previous Underground Mining Area – Lake Macquarie Shoreline

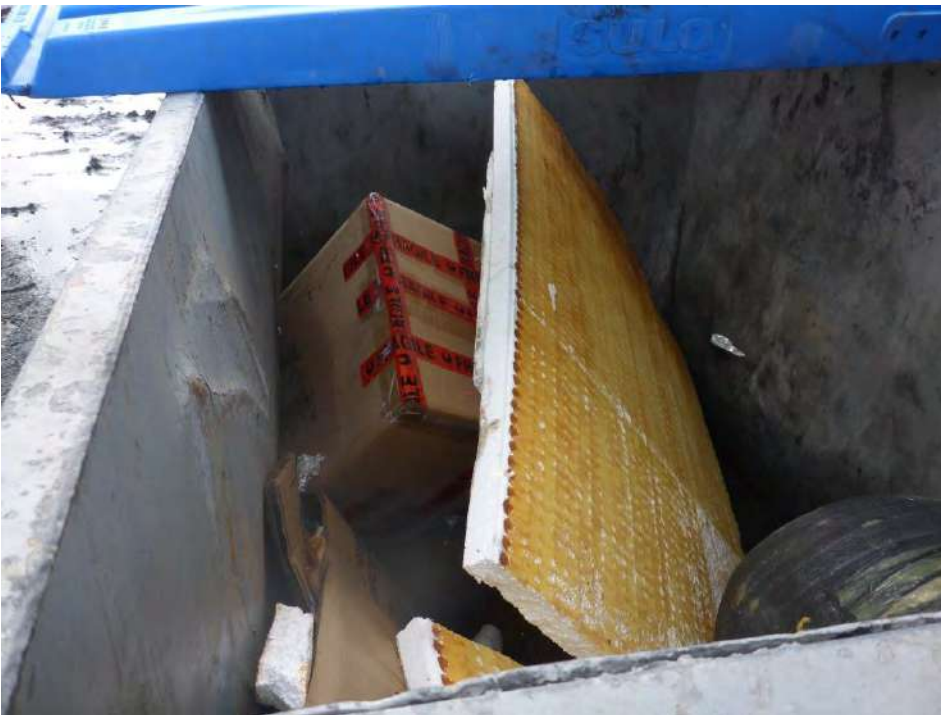
Photo 2 Cardboard included in general waste bin. Improvement Required.

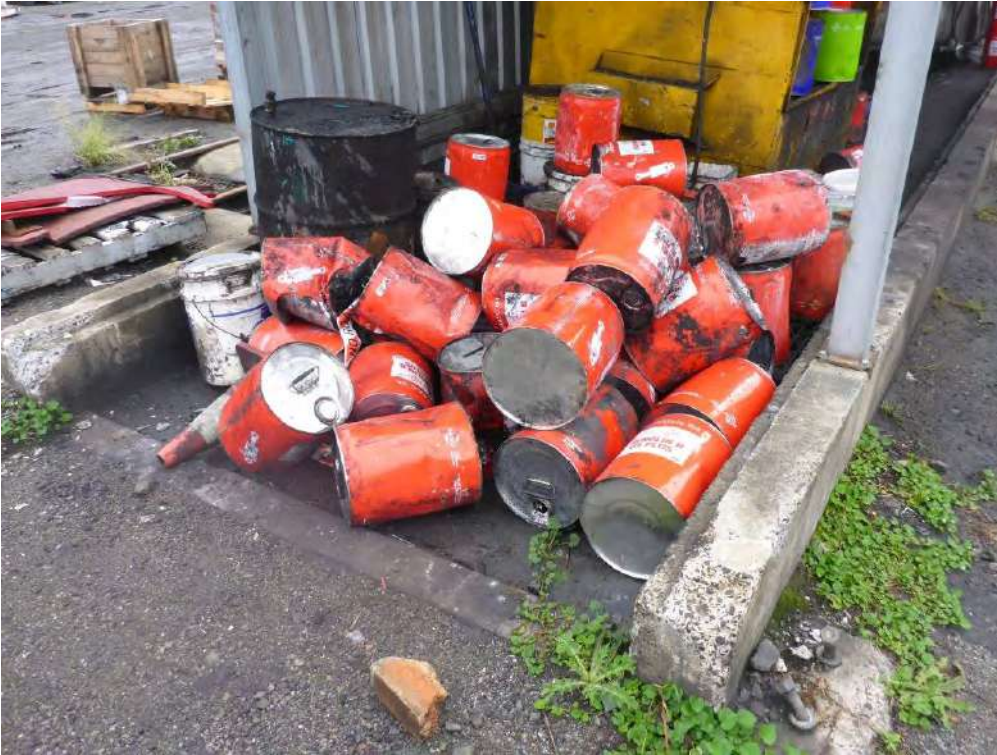
Photo 3 Hydraulic oil container stored on the side within bunded area. Improvement Required.

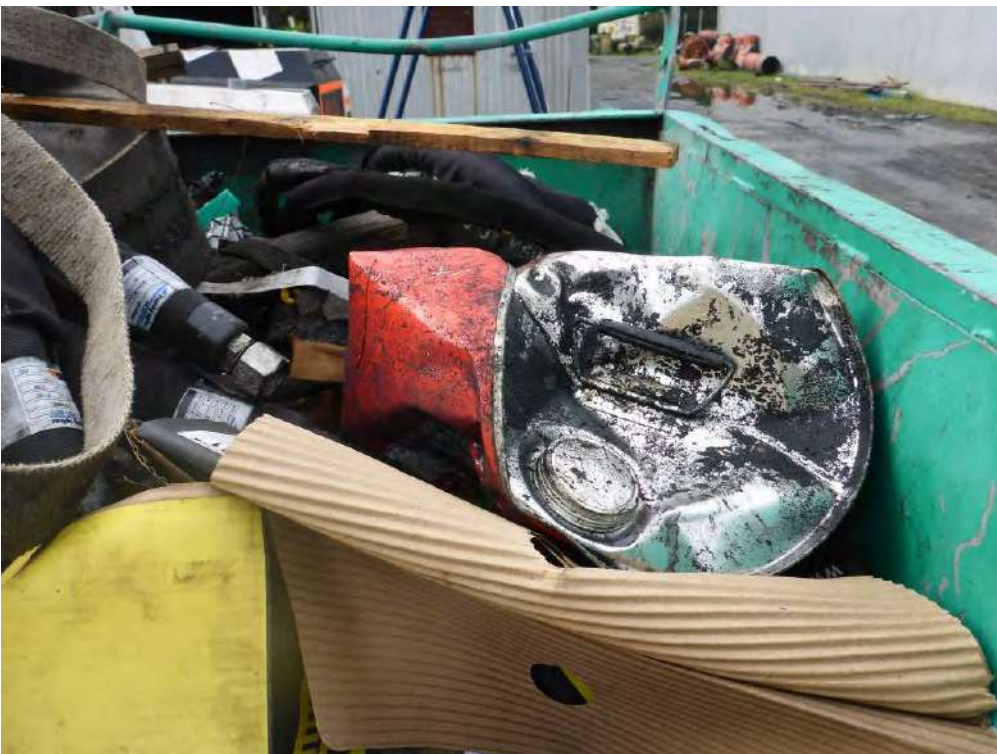
Photo 4 Hydraulic oil container should not be stored in general waste

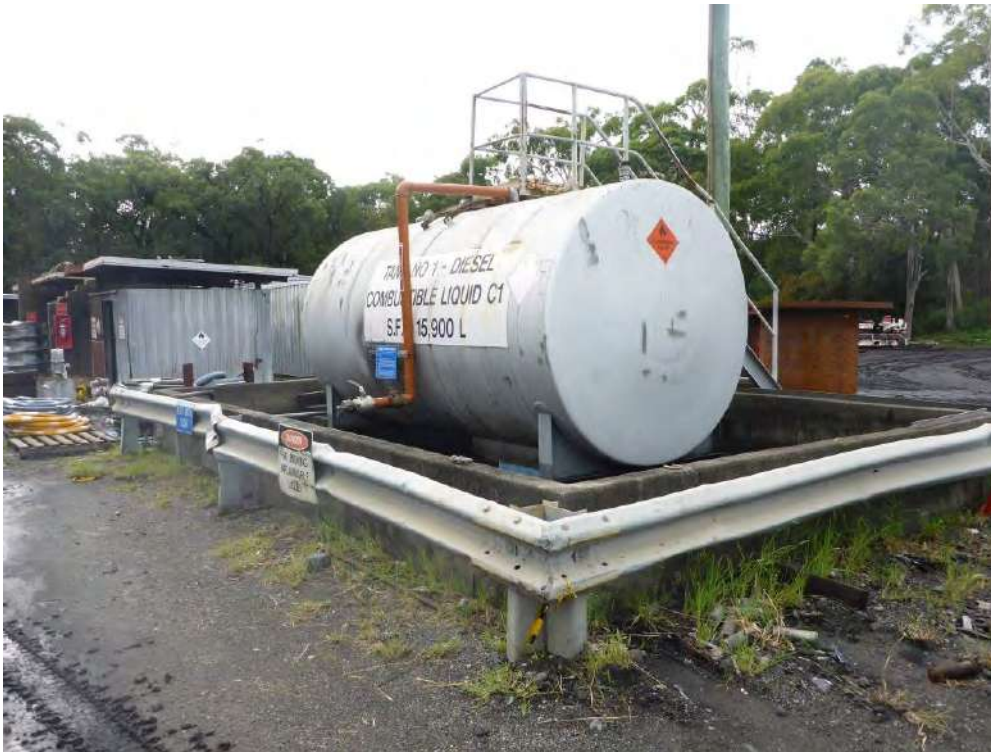
Photo 5 Diesel Tank stored within Bund

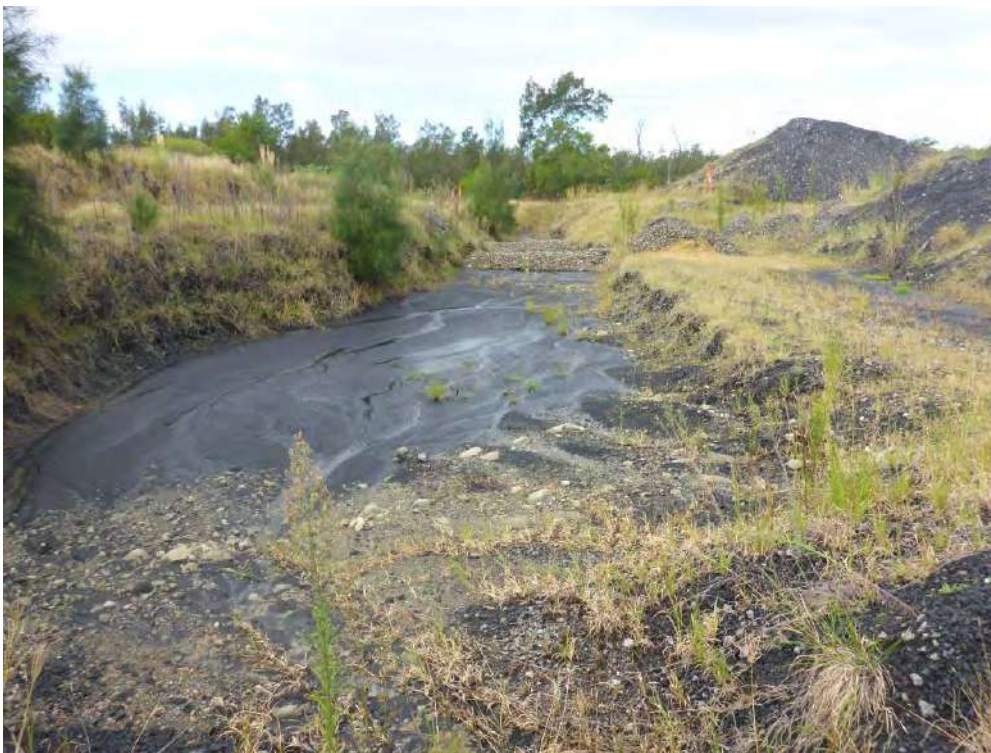
Photo 6 Coal Material in drain should be removed

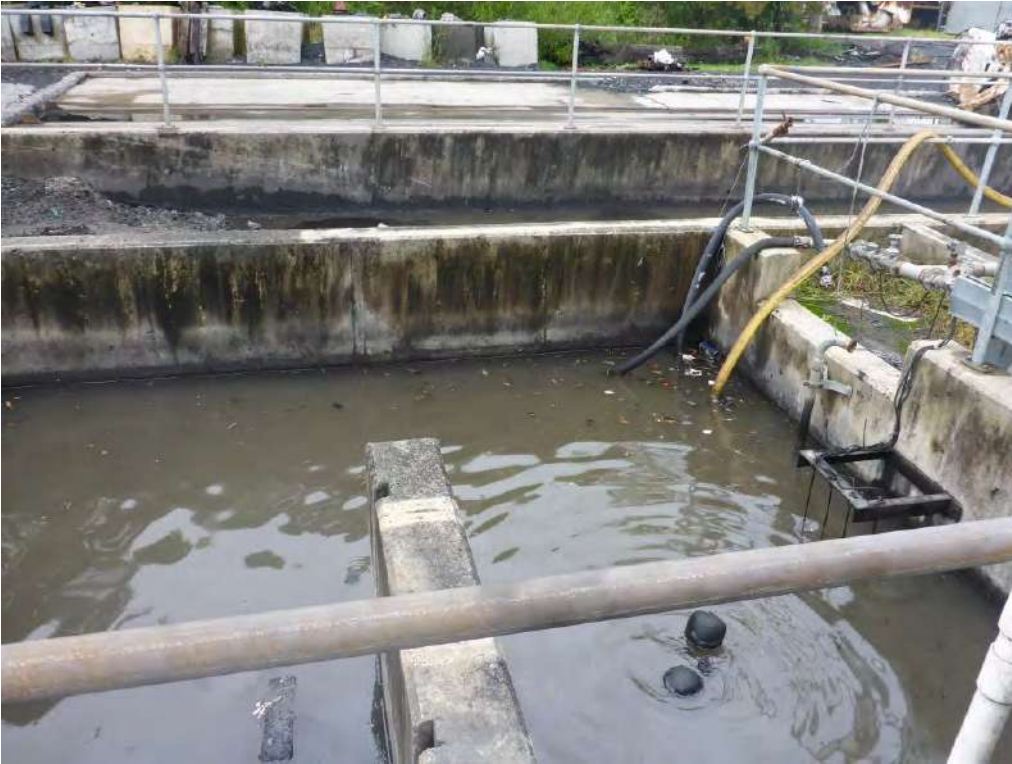
Photo 7 The Oily water separator worked effectively during the audit period

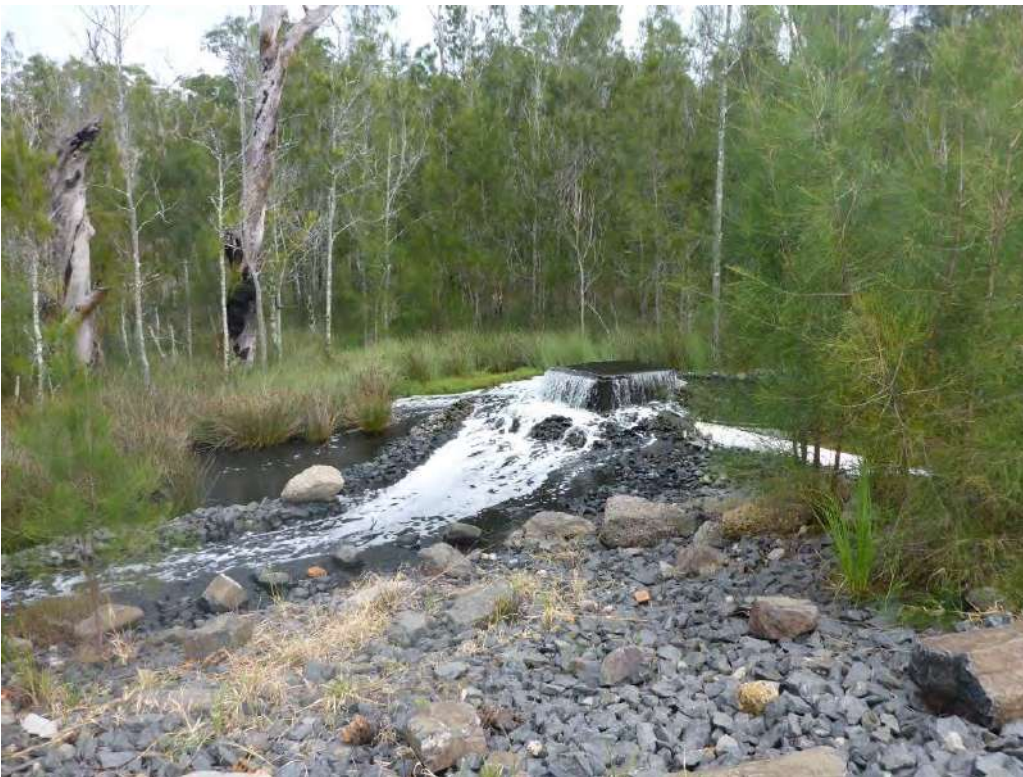
Photo 8 Licenced discharge point in operation
