Boggabri Coal Operations Pty Ltd
Boggabri Coal Mine
2021 Annual Review
5 December 2022

Annual Review Title Block

Name of Operation	Boggabri Coal Mine
Name of Operator	Boggabri Coal Operations Pty Ltd
Development Consent/Project Approval #	09_0182
Name of Holder of Project Approval	<ul style="list-style-type: none"> • Idemitsu Australia Pty Limited via its subsidiary company, Boggabri Coal Pty Ltd – 80%; • Chugoku Electric Power Australia Resources Pty Ltd – 10%; and • NS Boggabri Pty Limited – 10%.
Mining Lease #	CL 368, ML 1755
Name of Holder of Mining Leases	<ul style="list-style-type: none"> • Idemitsu Australia Pty Limited via its subsidiary company, Boggabri Coal Pty Ltd – 80%; • Chugoku Electric Power Australia Resources Pty Ltd – 10%; and • NS Boggabri Pty Limited – 10%.
Water Licence #	See Table 2-2 below for details
Name of Holder of Water Access Licences	<ul style="list-style-type: none"> • Idemitsu Australia Pty Limited via its subsidiary company, Boggabri Coal Pty Ltd – 80%; • Chugoku Electric Power Australia Resources Pty Ltd – 10%; and • NS Boggabri Pty Limited – 10%.

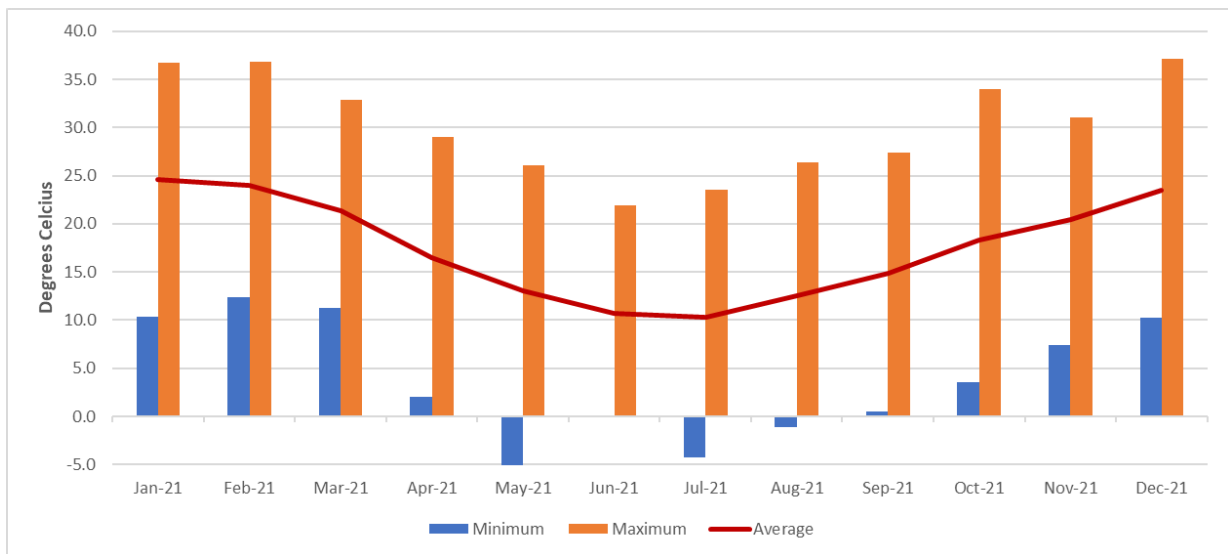
Figure 6-1 2021 Monthly Temperature Records

Maximum, minimum and average temperatures are calculated daily from the 15 min recordings. Figure 6-1 shows average monthly temperature records for the reporting period (2m MET recordings). Compared to the previous reporting period, the average minimum and maximum temperatures are notably higher in summer.

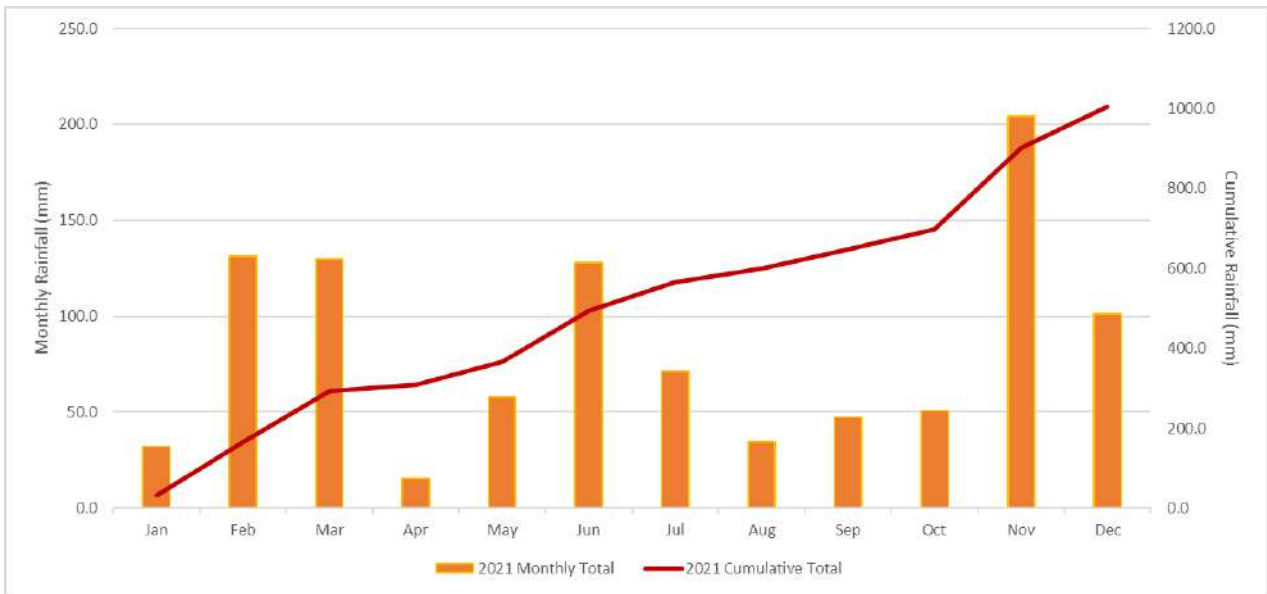
Figure 6-2 Monthly Rainfall

Rainfall is measured using an RG5 type flow-through monitor, with a 15-minute recording interval. Monthly rainfall totals for the 2021 reporting period are presented in Figure 6-2. Extreme rainfall conditions were experienced in November which resulted in extensive flooding in the local area which lead to 16 days operation shutdowns during November and December as is presented in Figure 6-3. A comparison of 2020-2021 rainfall is shown in Figure 6-3.

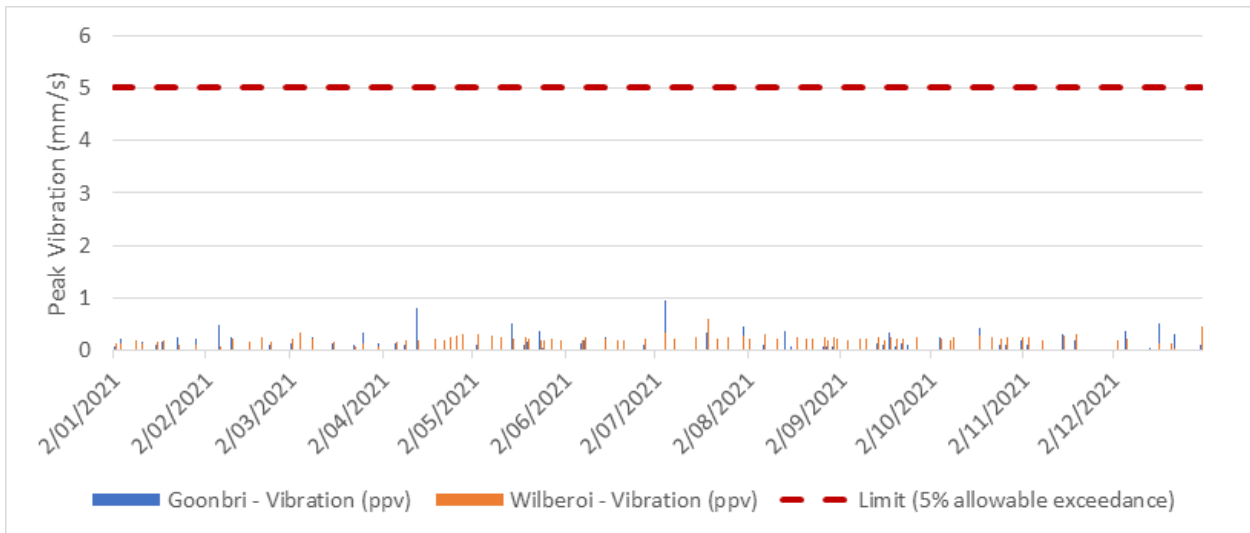
Figure 6-7 Summary of Peak Vibration Monitoring Results

Blast monitoring results indicate all blasts complied with the vibration limits of 5 mm/sec (and peak vibration of 10 mm/sec) (refer to Figure 6-7). Blast vibration monitoring results for the 2021 reporting period were on average higher than those reported for the previous 2020 reporting period. Blast vibration for the past few years has consistently remained well below the relevant limits.

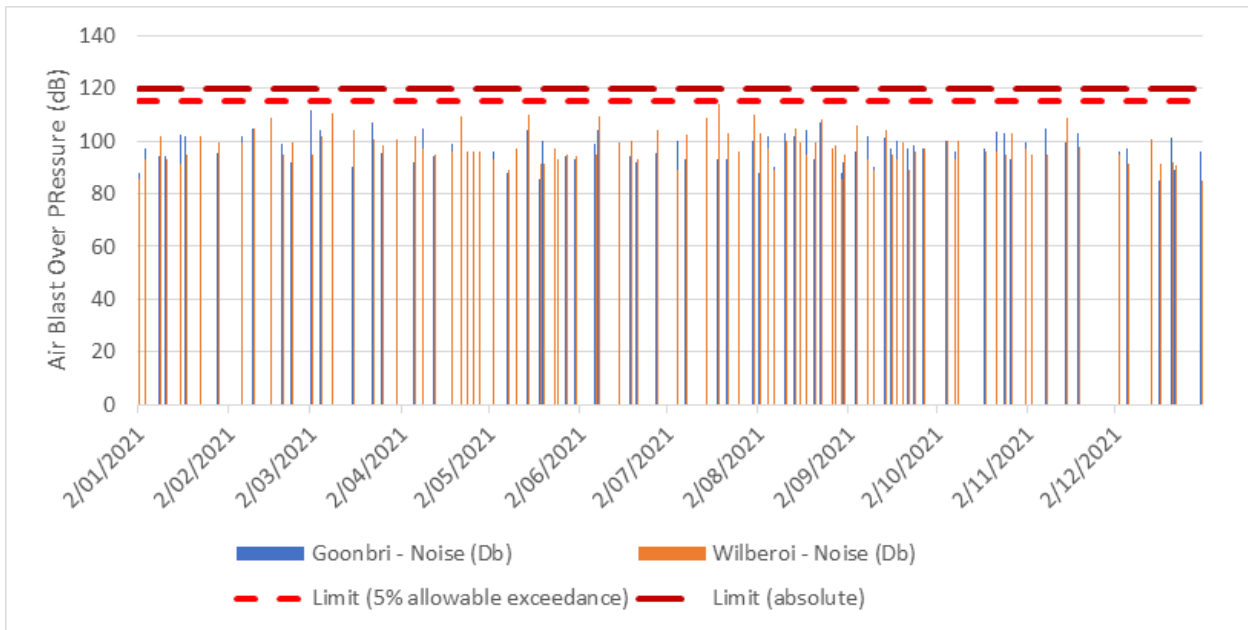
Figure 6-8 Blast Overpressure Results

BCOPL complied with all its blast overpressure criteria during the 2015, 2016, 2017, 2018 and 2020 reporting periods. One exceedance of the 120 dB(A) criteria occurred in the 2019 reporting period.

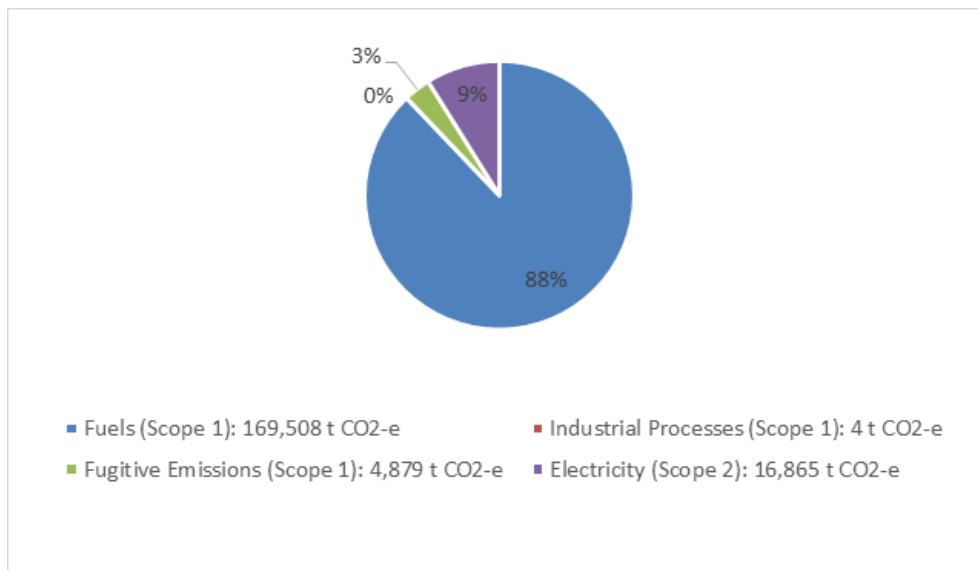
Figure 6-9 Sources of BCM Scope 1 and Scope 2 Emissions

Sources of Scope 1 and Scope 2 emissions for 2020-2021 are illustrated in Figure 6-9. The main contributor to Scope 1 emissions was the combustion of diesel oil. Scope 2 emissions are attributed to the purchase of 20,821,125 kWh of electricity from the state grid.

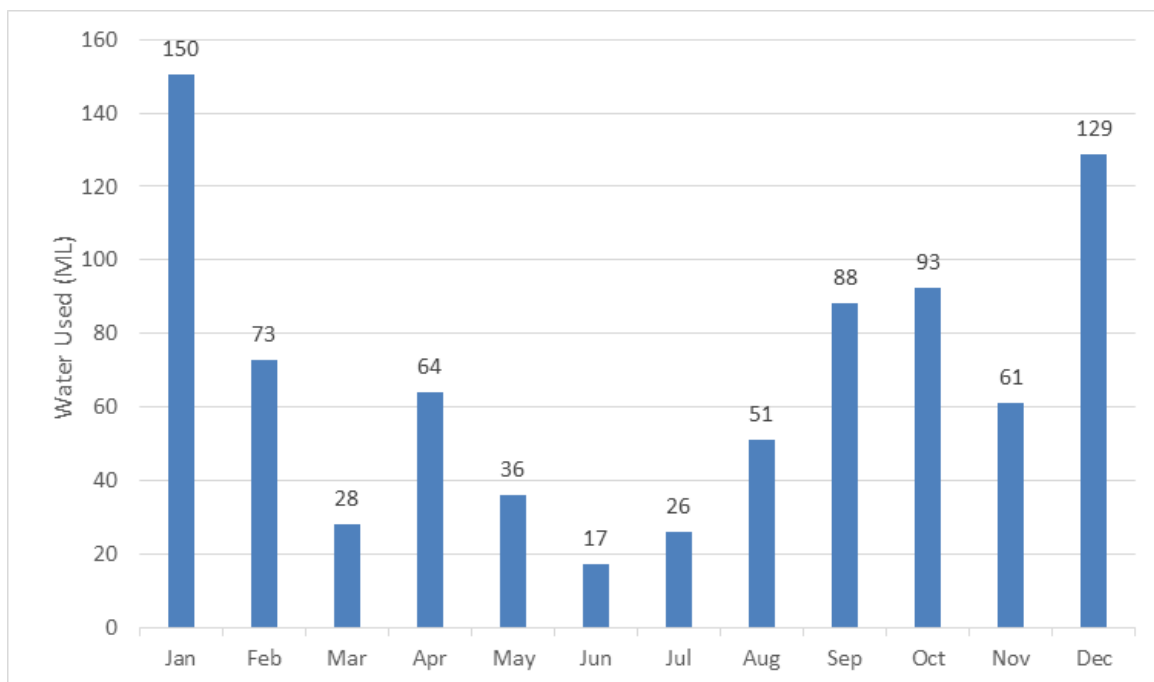
Figure 7-1 Monthly Dust Suppression Water Usage (ML)

In addition, a total of 424.67 ML of water was used in the CHPP & MIA during the reporting period. This includes water used in the coal bypass, processing plant and train load out. The total water usage for dust suppression and the CHPP is below the predicted demand as detailed in Table 7-6.

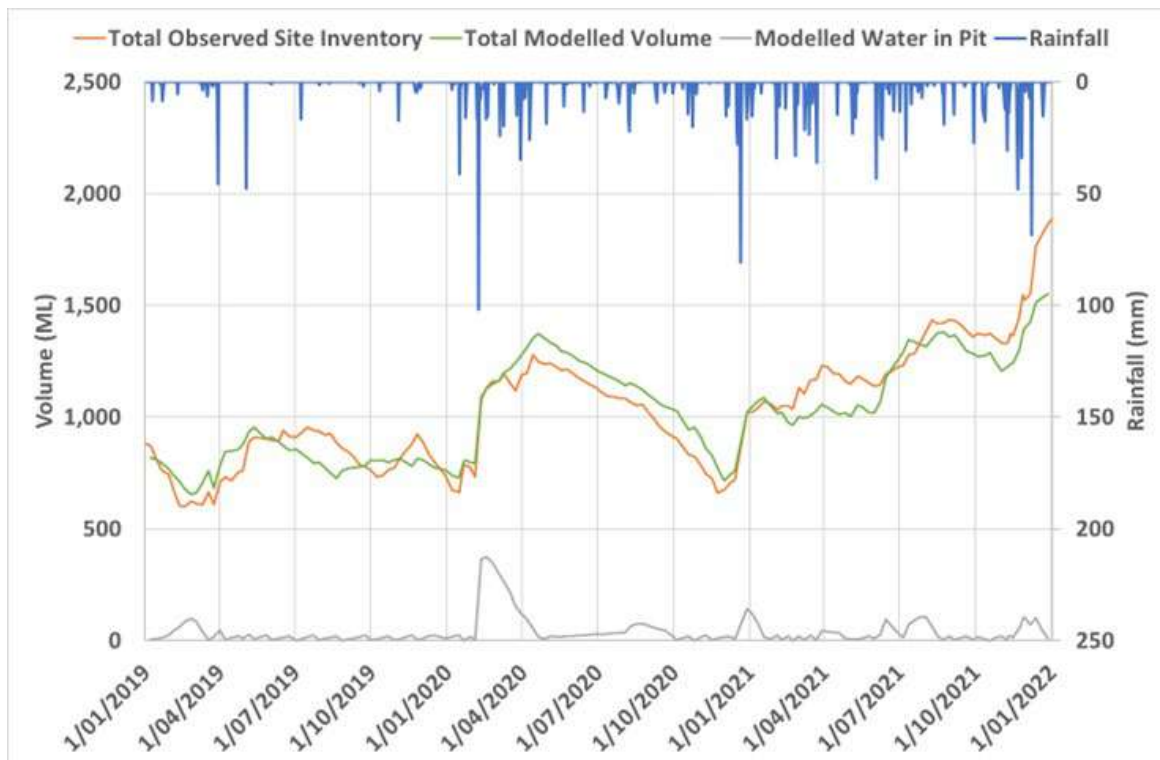
Figure 7-2 Modelled vs Observed Site Water Inventory

The site water balance model was reviewed and recalibrated for 2021 (Appendix H BCOPL 2022) by comparing the observed and modelled site water inventory (Figure 7-2). The calibrated site water balance model is considered to provide a reasonable fit to the observed site water inventory and is therefore expected to continue to provide reasonable estimates of future water demands, inventories, and discharges.

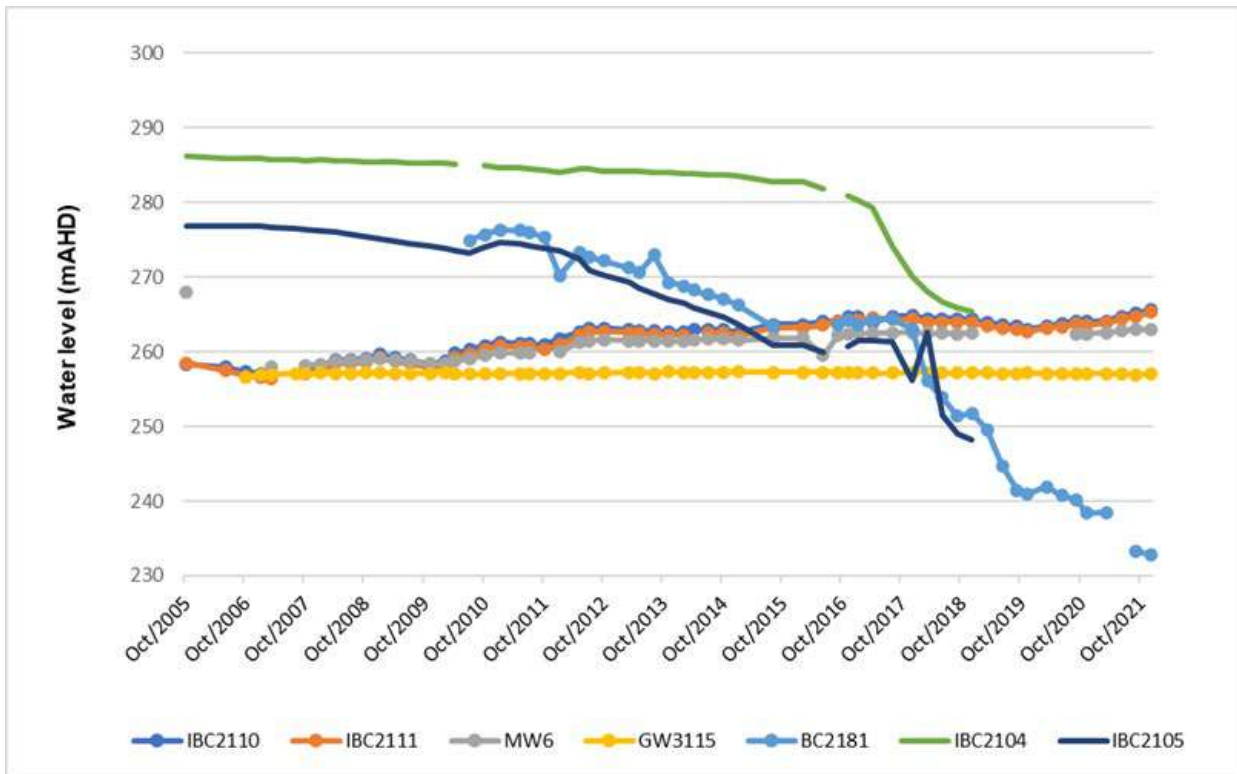
Figure 7-3 Long Term Groundwater Levels for all Bores

The groundwater level monitoring results obtained during the reporting period have been added to the long-term hydrographs presented annually for BCM, as shown in Figure 7-3. Figure 7-3 also includes monitoring data from the discontinued bores.

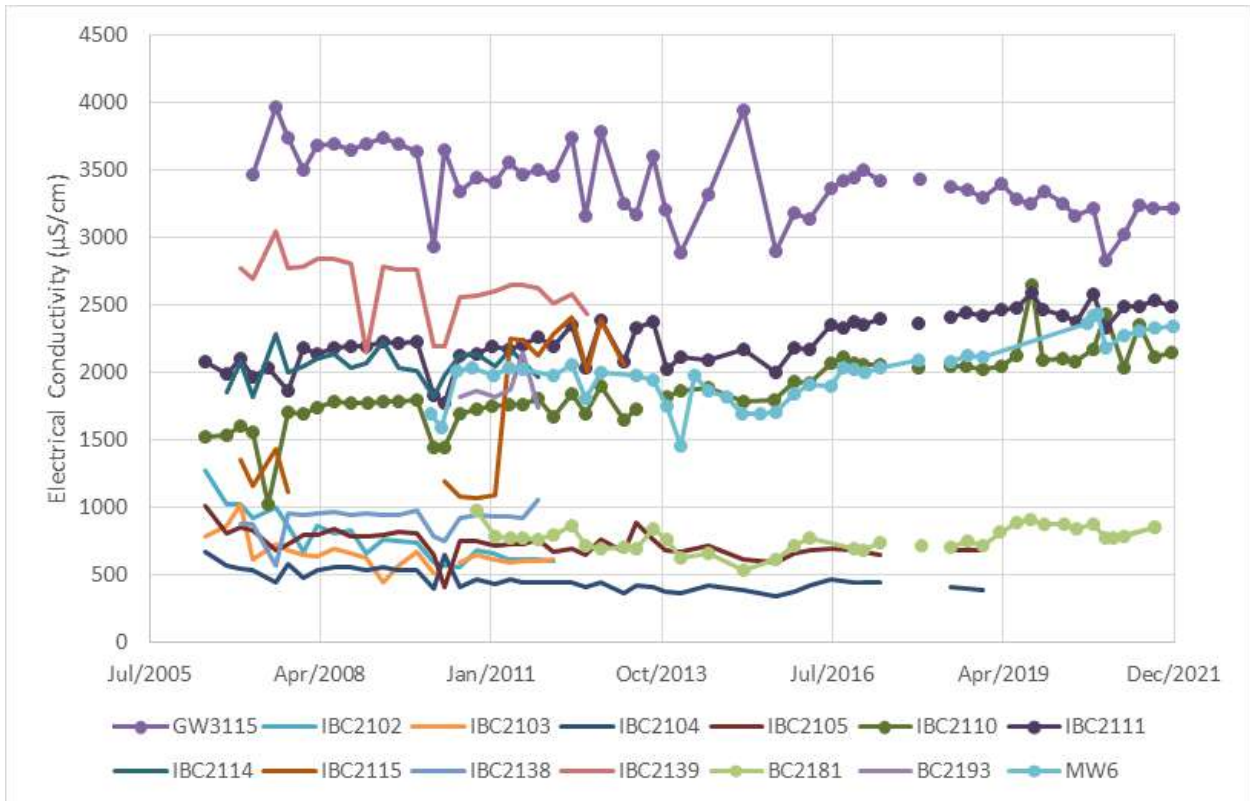
Figure 7-5 Groundwater Trends in Electrical Conductivity

EC was within trigger values throughout 2021 at all monitoring locations except for IBC2110 and IBC2111 which are installed in the Boggabri Volcanics. The exceedance of the EC trigger values at IBC2110 in June 2021 (Table 7-12) is considered an outlier. However, there is a gradual increasing trend in EC at IBC2110. The exceedance of EC trigger values at IBC2111 is associated with an increasing trend in EC at this monitoring location. The increasing trend at both IBC2110 and IBC2111 may be related to the observed historical trends in groundwater level in alluvium and Boggabri Volcanics monitoring bores.

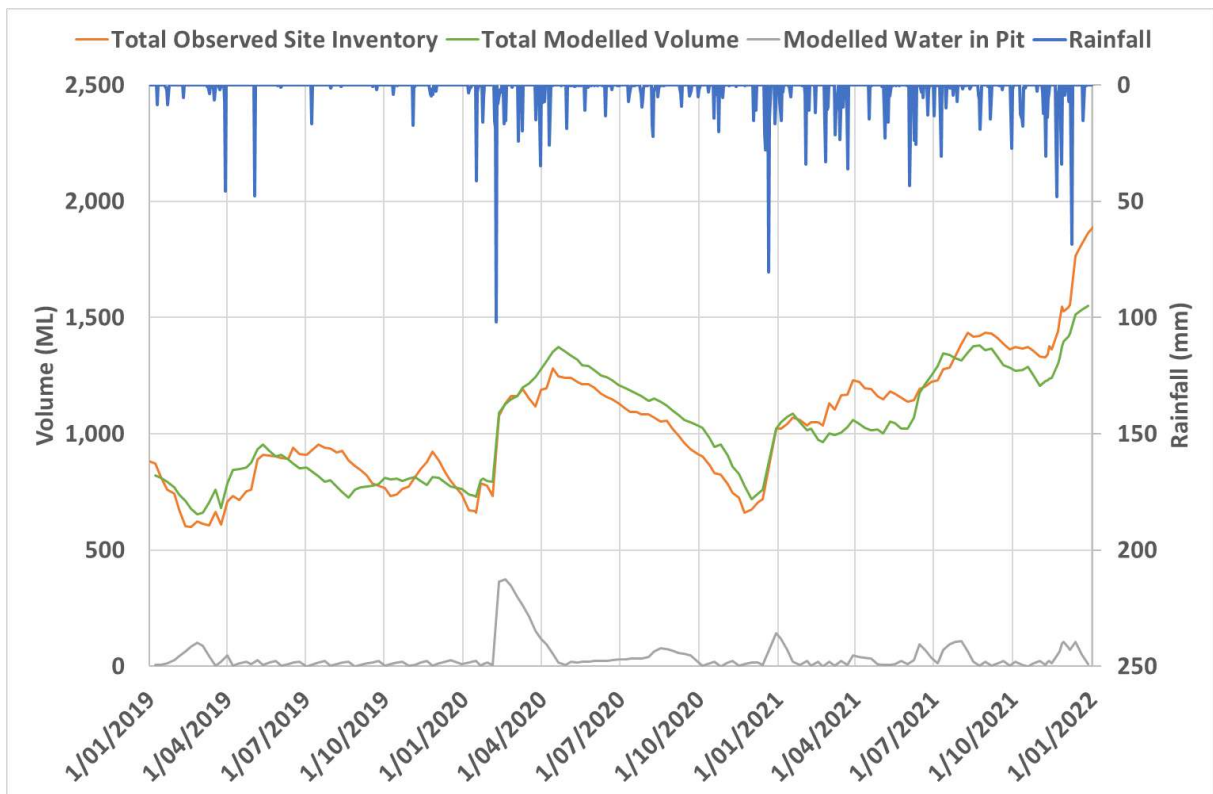
Figure 4-1 Observed vs Modelled Total Site Inventory

Figure 4-1 to Figure 4-3 to show the modelled total inventory and inventory at key storages against the observed values at those storages.

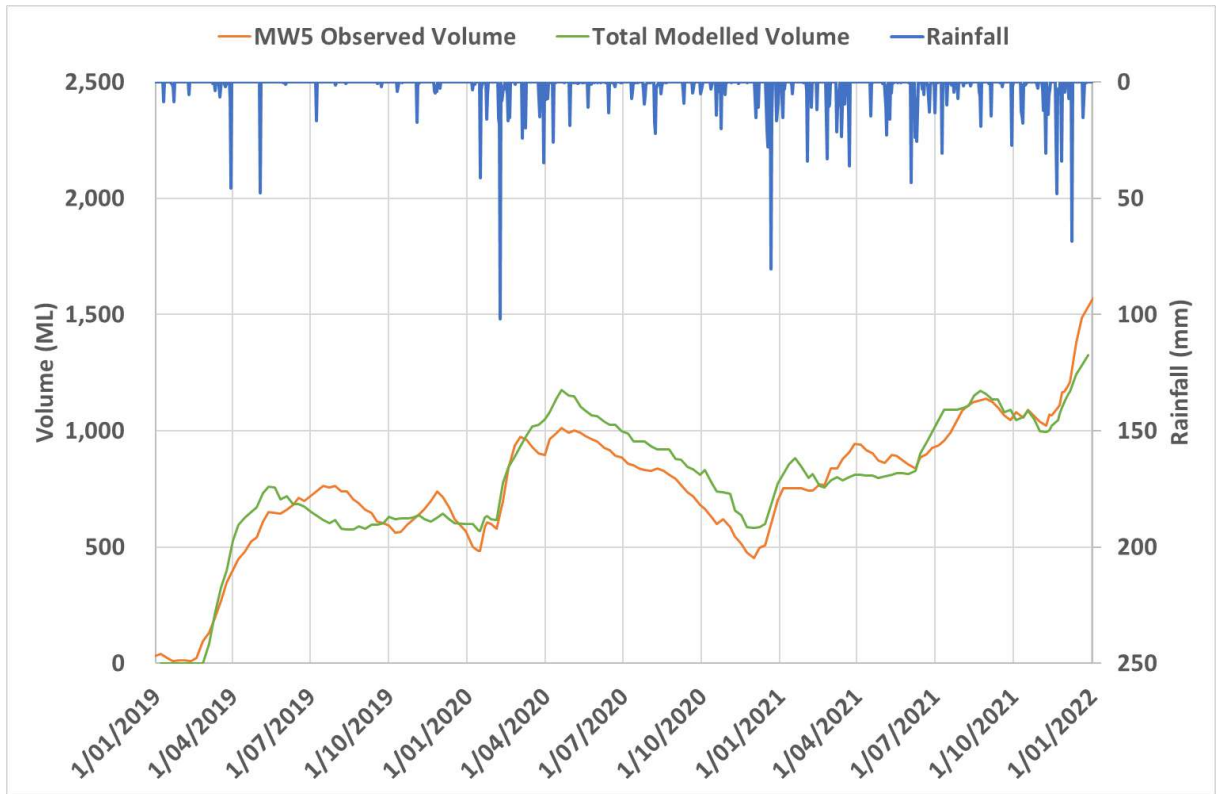
Figure 4-2 Modelled vs Observed Volumes in MW5

During several periods, a significant volume of water (up to 400 ML) was estimated to have accumulated in pit following high rainfall periods. This volume has not been accounted for the in weekly water volume surveys but has been anecdotally confirmed by site and is gradually drawn down over time.

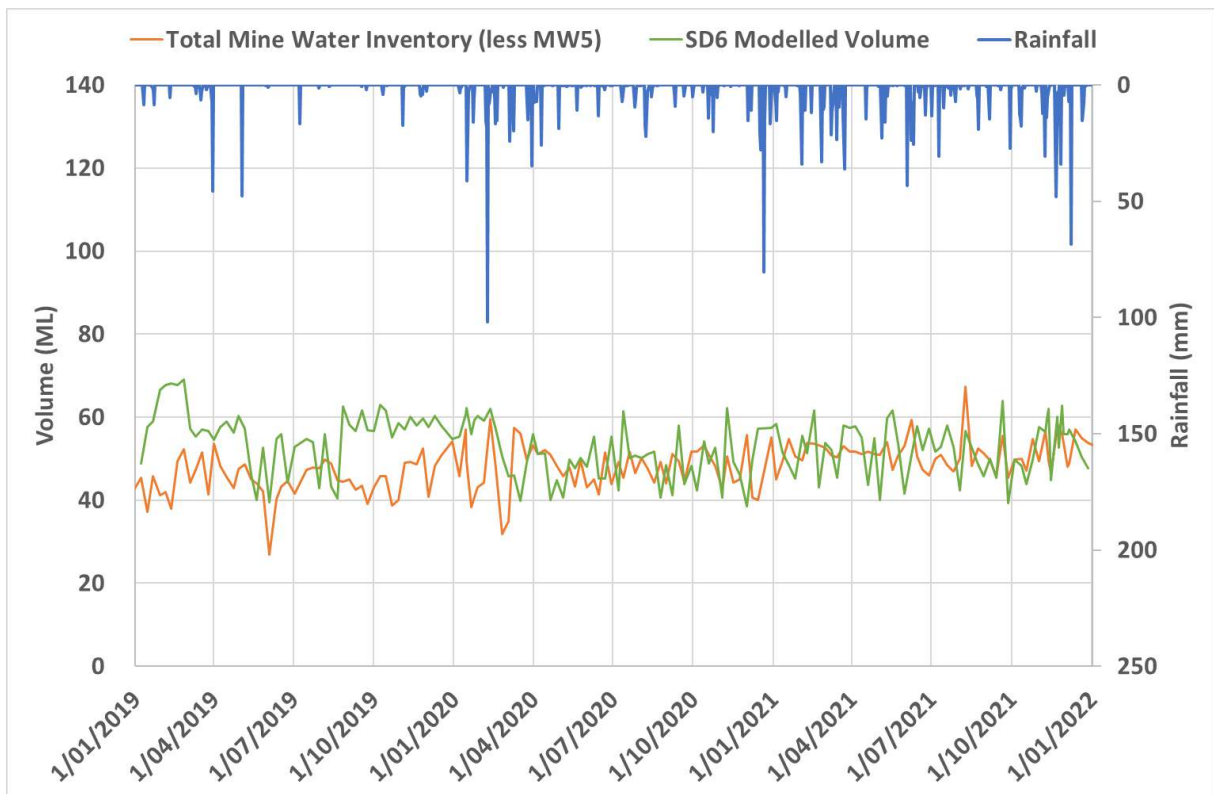
Figure 4-3 Modelled vs Observed SD10 Volumes

SD10 operates as a transfer point for water to and from MW5 as well as supplying water the CHPP. Modelled and observed volumes for SD10 are presented in Figure 4-3. Modelled levels for SD10 are operating within the range of observed levels and it is considered that the modelled operating logic is capturing the operating of SD10 adequately.

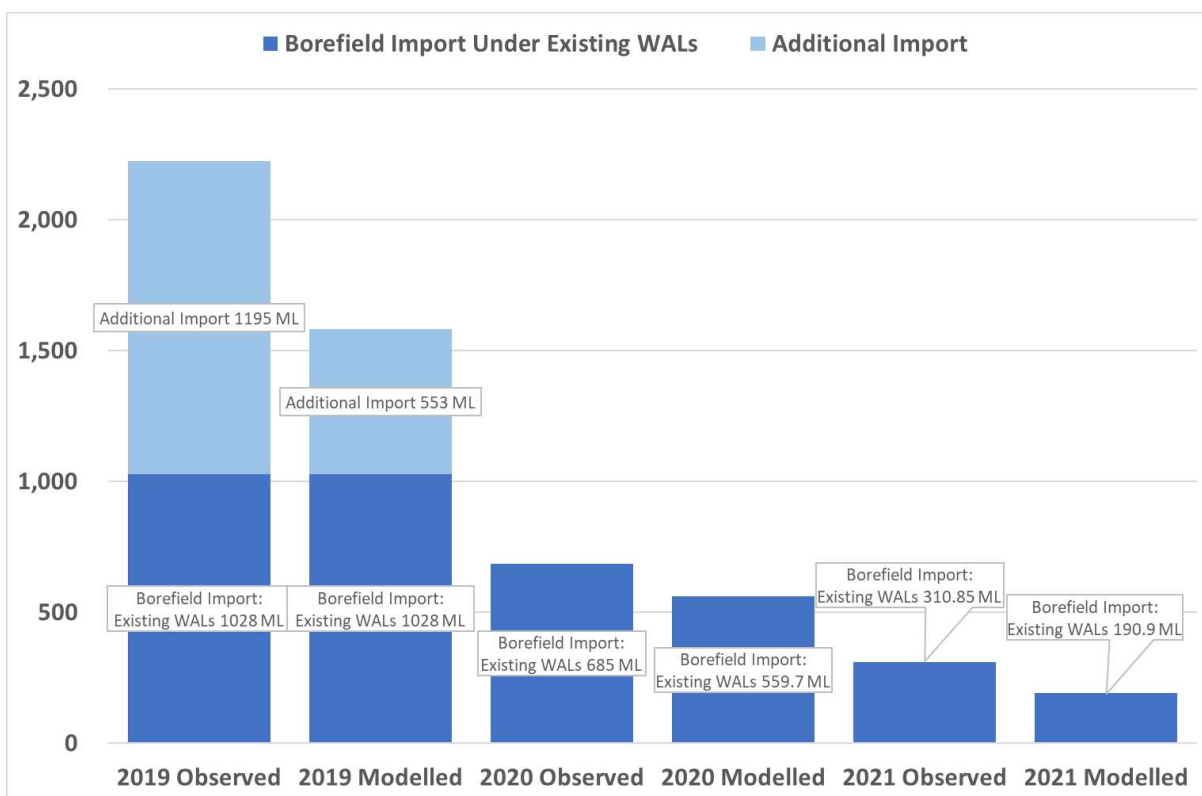
Figure 4-4 Modelled vs Observed Water Import

Figure 4-4 shows the modelled vs observed imports from external sources.

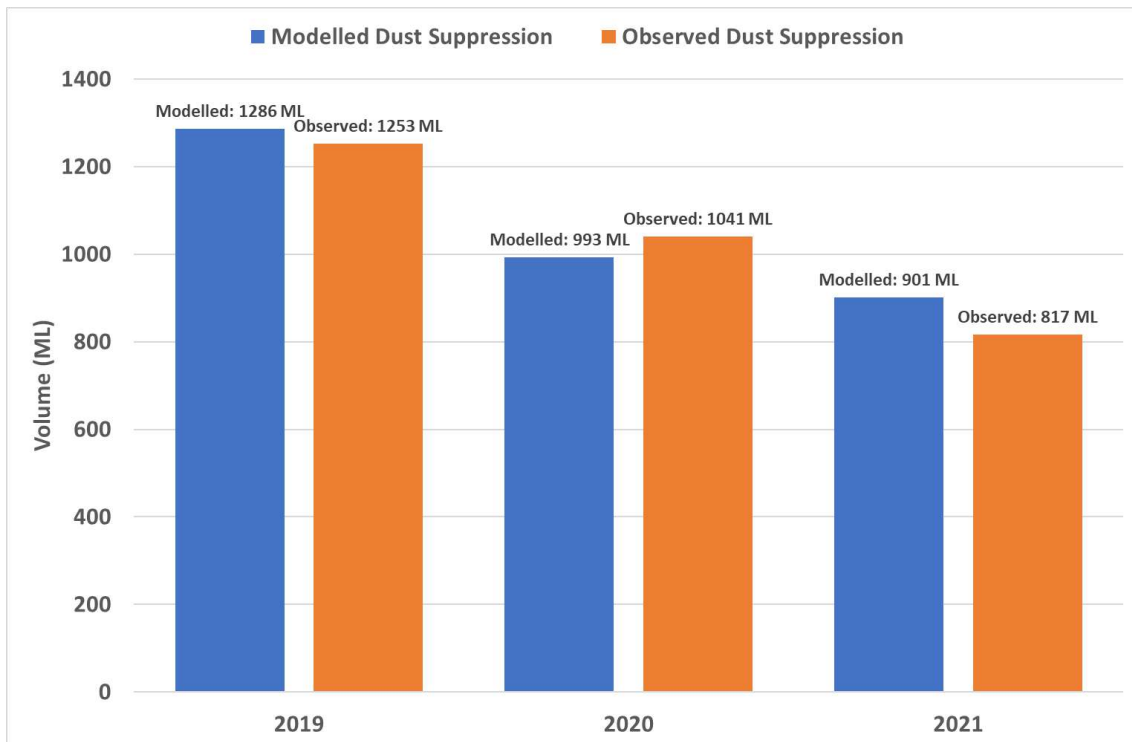
Figure 4-5 Modelled vs Observed Dust Suppression

Modelled dust suppression was compared to observed values for the period from 2019 to 2021. Figure 4-5 shows the comparison between observed and modelled values. The methodology for modelling dust suppression is outlined in Section A.6 of Appendix A.

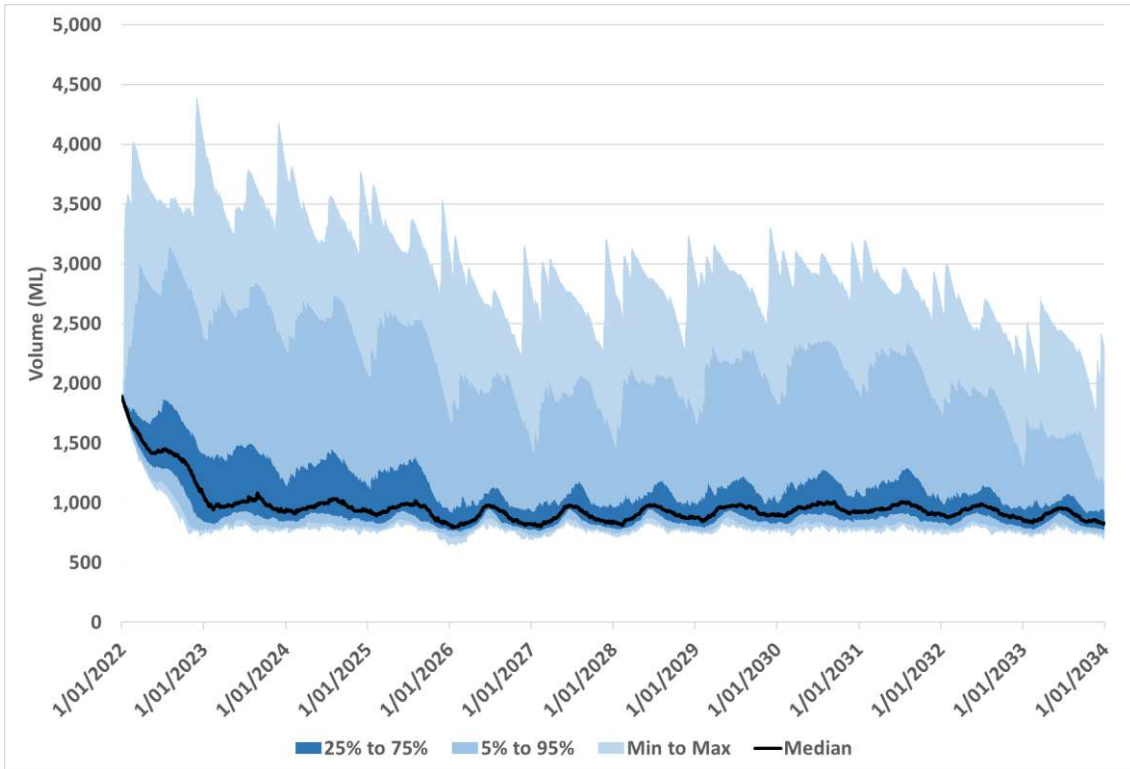
Figure 4-6 Modelled Forecast Total Site Volume

Modelled total site inventory is predicted to remain relatively stable as the mine progresses. Captured runoff remains steady as the pit progresses and rehabilitated areas are released. In the median modelled results, it is predicted that the maximum entitlement of 1028 ML/year will be required to be imported from the borefield. A small amount of additional import may be required in median years, this volume increases in drier years. Figure 4-6 shows the modelled total site volume.

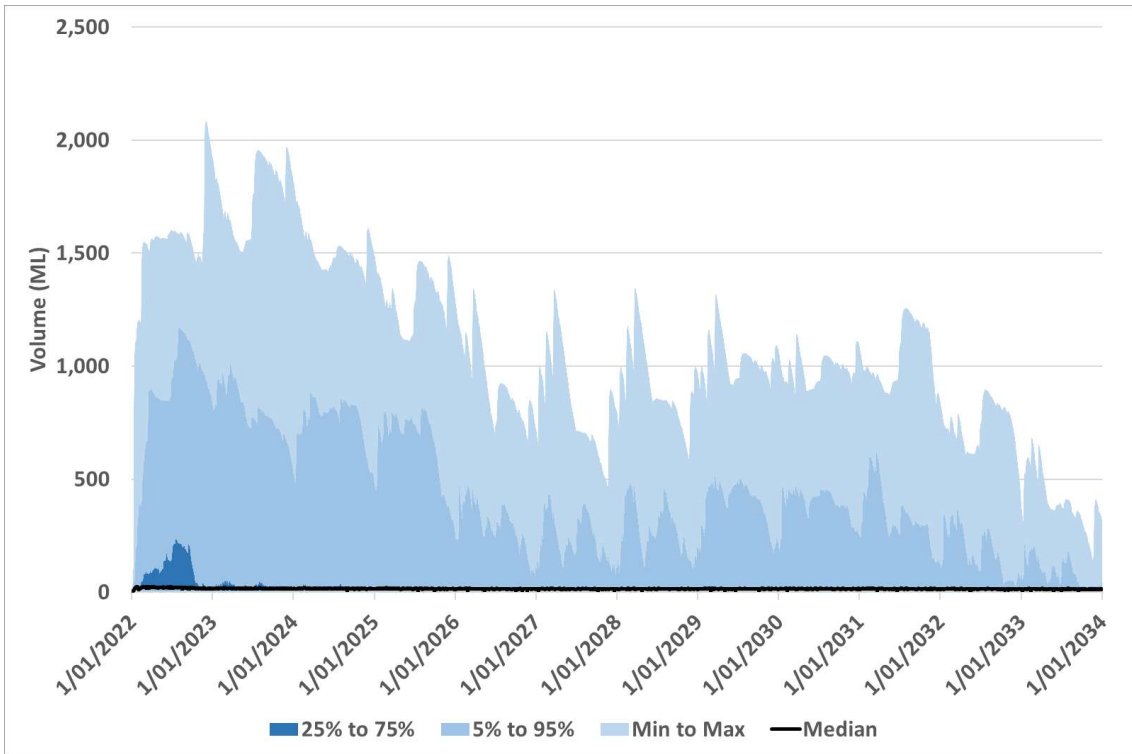
Figure 4-7 Simulated Time Series of Water Stored In-Pit

Summaries of the simulated daily time series of water stored in the mining void (pit sumps) and MW5 over the life of BCM are provided in Figure 4-7 and Figure 4-8, respectively. Note that the percentiles shown in the daily time series plots are daily percentile ranks of the daily results, whereas the percentile shown in Table 4-1 is the percentile ranks of the annual results.

Figure 4-7 shows that the pit void is predicted to be empty most of the time, however, the volume stored at any one time may reach approximately 1,500 ML. This maximum volume may reduce following 2024 as the catchment area reporting to the pit void is reduced.

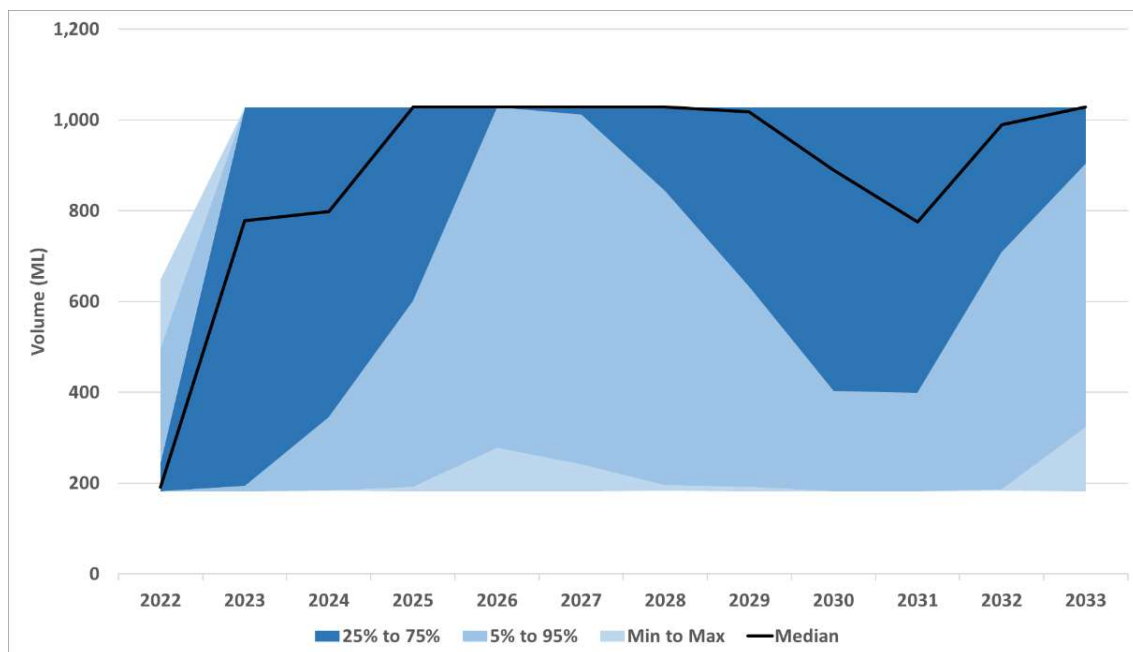
Figure 4-9 Simulated Time Series of Annual Borewater Imported to Site

Predicted import for 2022 and some of 2023 is lower than subsequent years due to the large amount of water currently stored in MW5. The model uses this water in preference to imported borewater (aside from the 0.5 ML/day required in the CHPP). Once this volume has been drawn down, modelled imported water requirements increase.

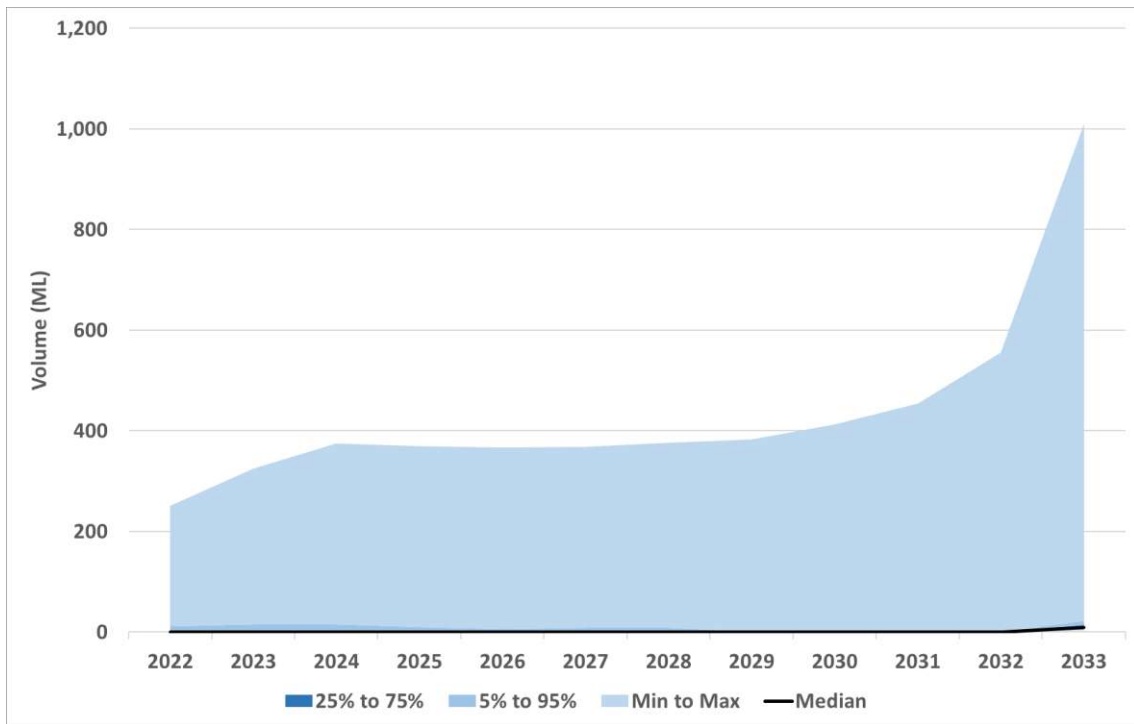
Figure 4-11 Modelled Dirty Water Overflows

Figure 4-11 show the modelled overflows from dirty water sediment dams. There were no modelled overflows in the median modelled results until 2033 where 6.5 ML was discharged. This is largely due to the design capacity of MW5 and the ability to store water there as flood storage in larger rainfall events.

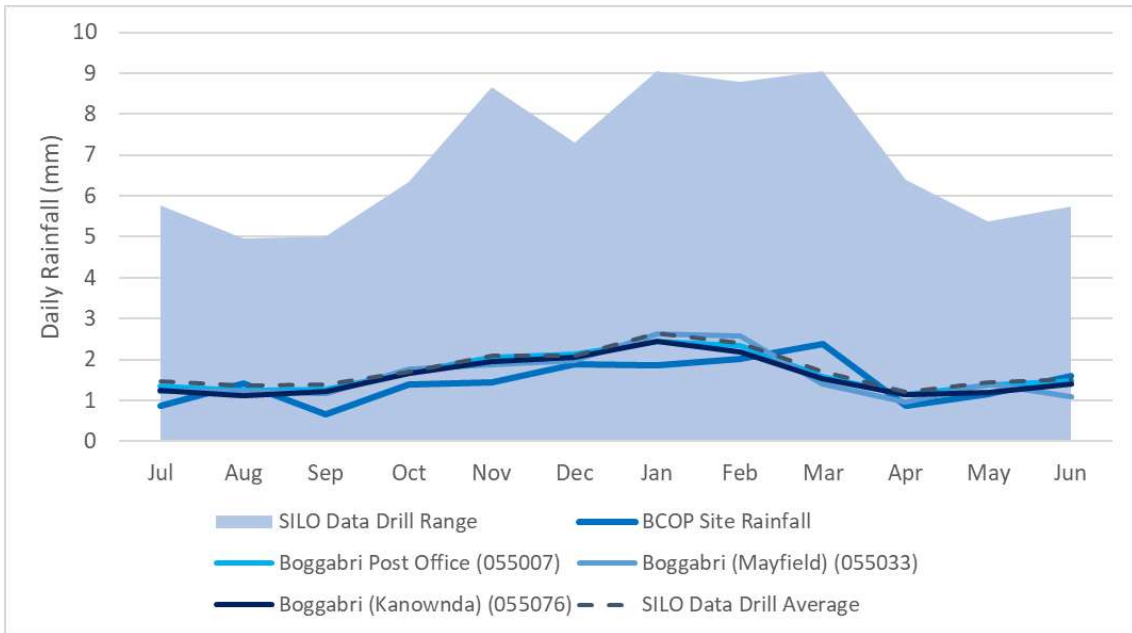
Figure A- 1- Daily Rainfall comparison (range and mean)

Site rainfall data is considered to be the most suitable for use in the model. Prior to the site gauge data becoming available, rainfall data from the Boggabri Post Office gauge was used due to the length of the data record and proximity to site. Where data from the Boggabri Post Office Gauge was not available, SILO Data Drill (1889 to 2022) was used to represent the long term evaporation data set. The SILO data drill is a derived data set from a combination of interpolated recorded data between weather stations and derived long-term average values. A comparison of nearby gauged rainfall mean to the Silo Data Drill mean is presented in Figure A-1.

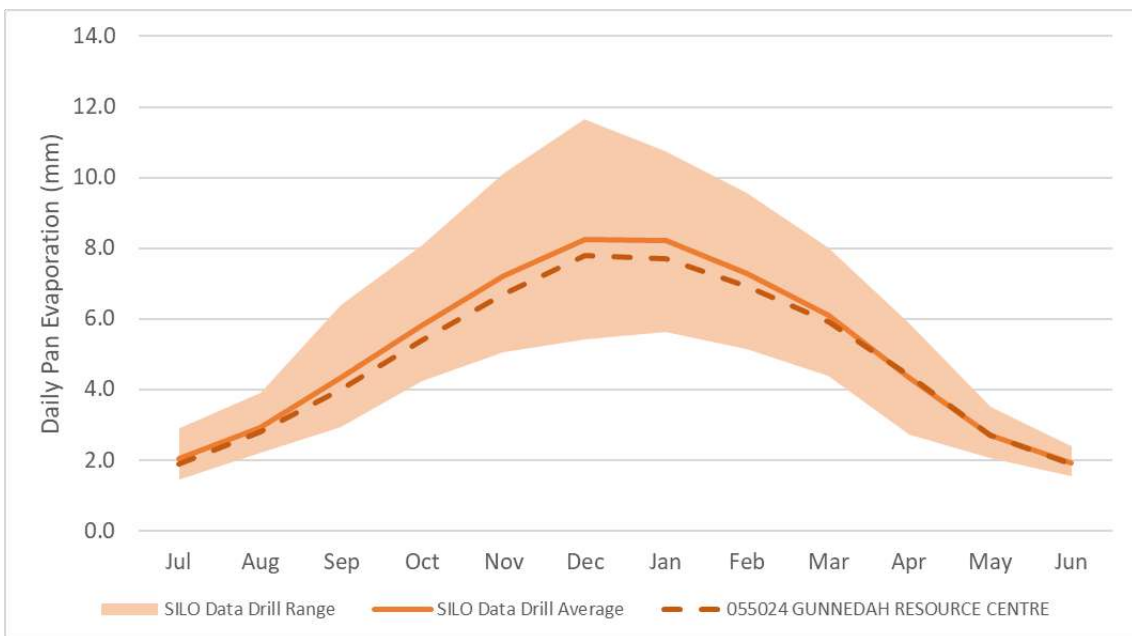
Figure A- 2 - Daily evaporation (range and mean)

Due to the limited distribution of evaporation monitoring stations near the BCM, there is a potential that the interpolated evaporation data at the location of BCM may be inaccurate. To address this the long-term pan evaporation derived from the SILO data drill has been compared against the average daily recorded data from the Gunnedah Research Station (055024) (nearest station available) to validate the SILO data, presented in Figure A-2. The long-term average data from the SILO data drill matches well with the data recorded at Gunnedah Research Station (055024) for the period 1948 to 2019.

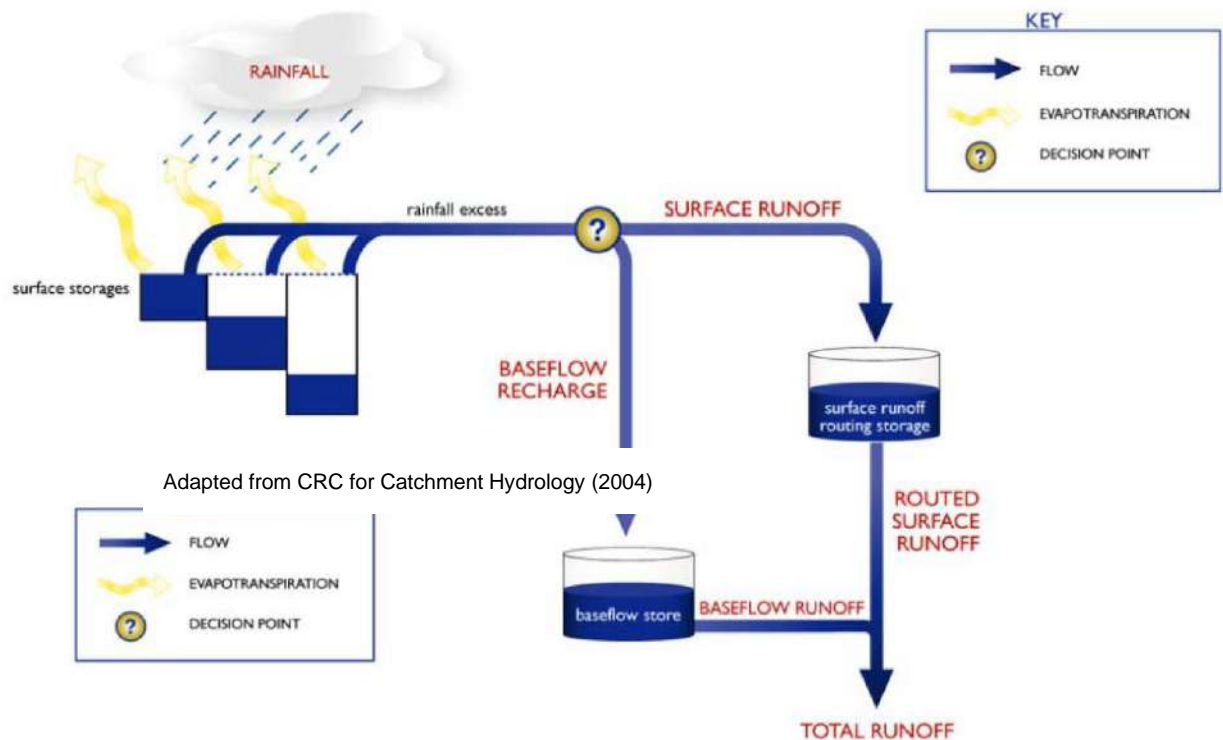
Figure B- 1 - Schematic Layout of the AWBM Rainfall-Runoff Model

The AWBM is a partial area saturation overland flow model. The use of the partial area saturation overland flow approach is simple and provides a good representation of the physical processes occurring in most Australian catchments (Boughton, 1993). This is because daily infiltration capacity is rarely exceeded, and the major source of runoff is from saturated areas. A schematic layout of the AWBM is provided in Figure B-1.
