Boggabri Coal Operations Pty Ltd
Boggabri Coal Mine
2020 Annual Review
3 August 2021

Boggabri Coal Operations Pty Ltd
Site Water Balance
April 2021

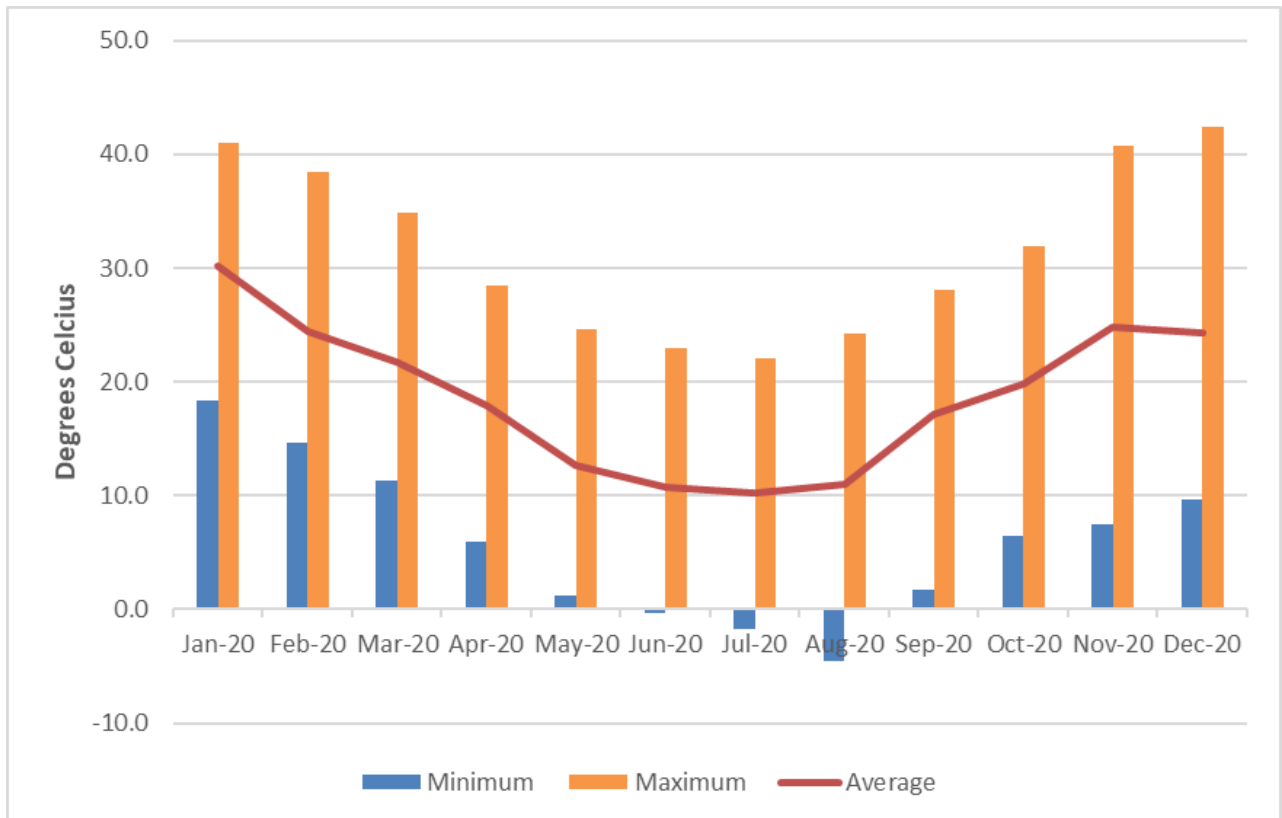
Figure 6-1 2020 Monthly Temperature Records

Maximum, minimum and average temperatures are calculated daily from the 15 min recordings. Figure 6-1 shows average monthly temperature records for the reporting period (2m MET recordings). Compared to the previous reporting period, the average minimum and maximum temperatures are notably higher in summer.

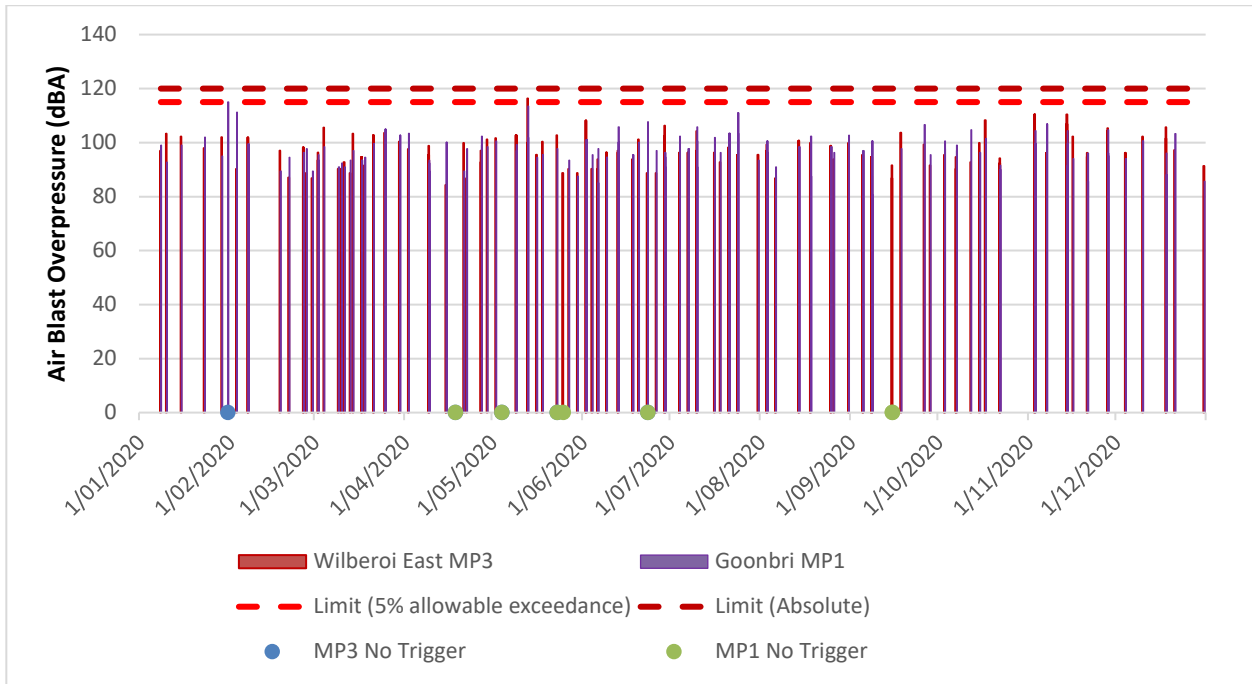
Figure 6-11 Blast Overpressure Results

BCOPL complied with all its blast overpressure criteria during the 2015, 2016, 2017 and 2018 reporting periods with only one exceedance occurring in the previous reporting period (2019).

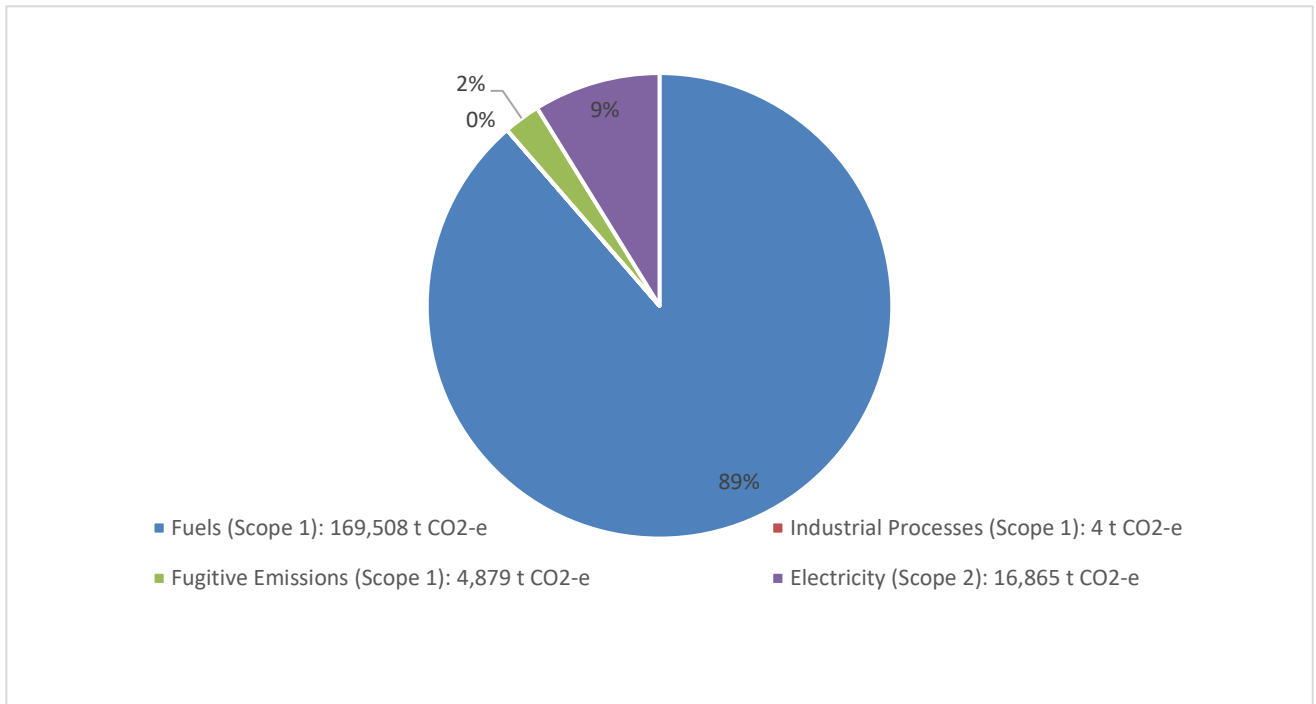
Figure 6-13 Sources of BCM Scope 1 and Scope 2 Emissions

Sources of Scope 1 and Scope 2 emissions for 2019-2020 are illustrated in Figure 6-13. The main contributor to Scope 1 emissions was the combustion of diesel oil. Scope 2 emissions are attributed to the purchase of 20,821,125 kWh of electricity from the state grid.

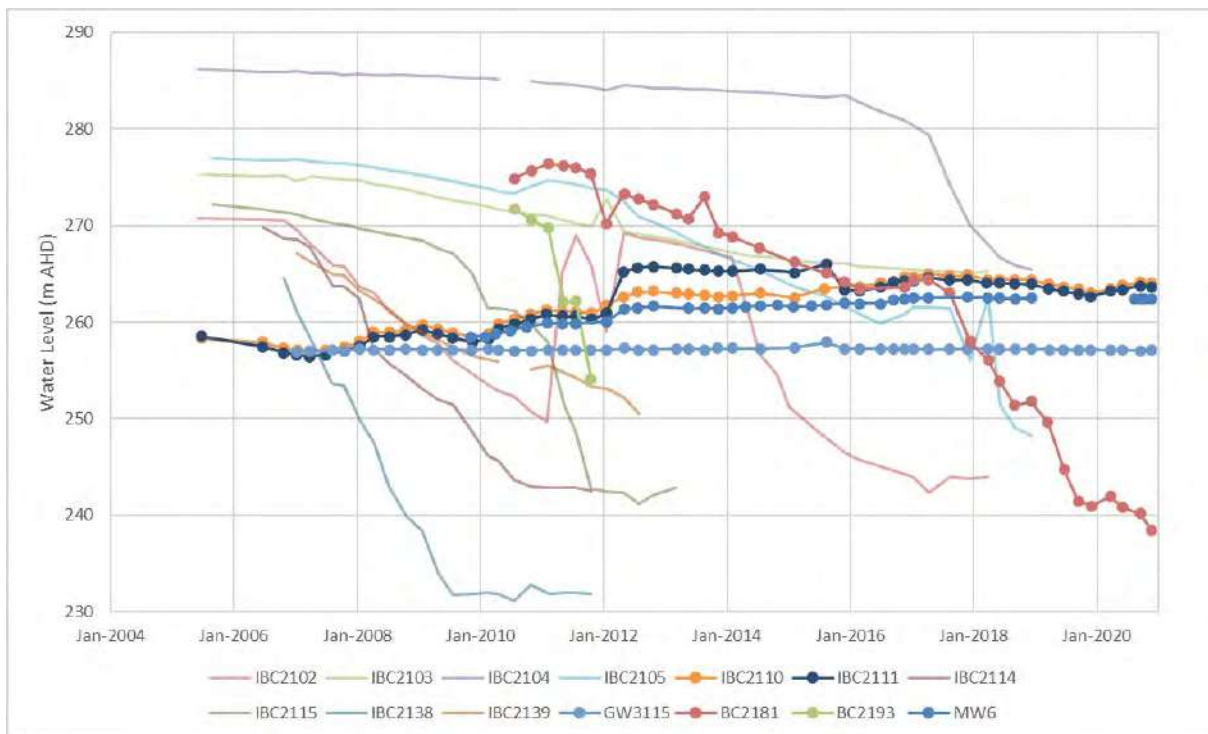
Figure 7-2 Long Term Groundwater Levels for all Bores

The groundwater level monitoring results obtained during the reporting period have been added to the long-term hydrographs presented annually for BCM, as shown in Figure 7-2. Figure 7-2 also includes historical monitoring data from the discontinued bores.

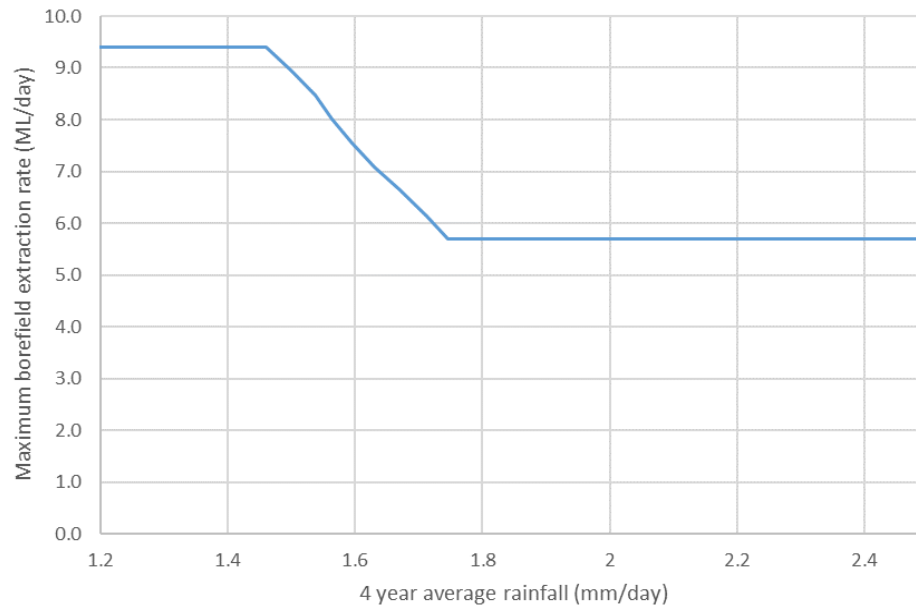
Figure 4-2 Assumed borefield extraction rate varying with 4 year average rainfall

extraction, but it consistent with groundwater modelling described in Parsons Brinkerhoff (2015) and is representative the average of operational conditions.

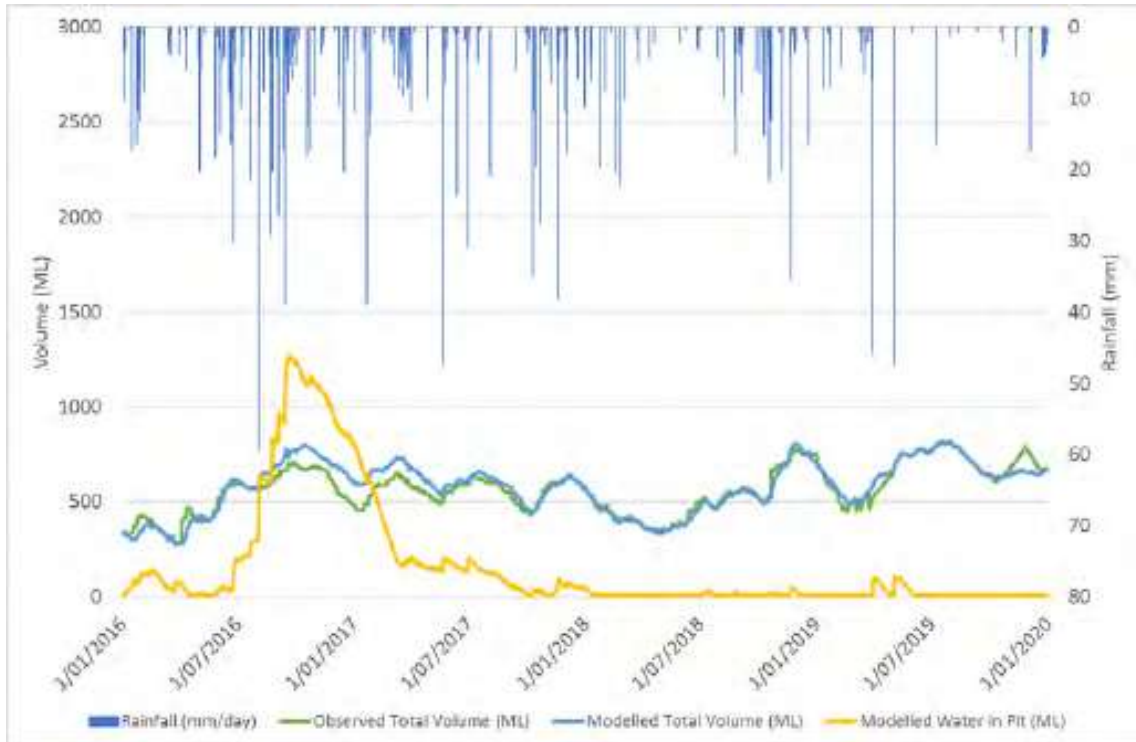
Figure 5-1 Total site water inventory

Observed and modelled total site water volume is compared in Figure 5-1.

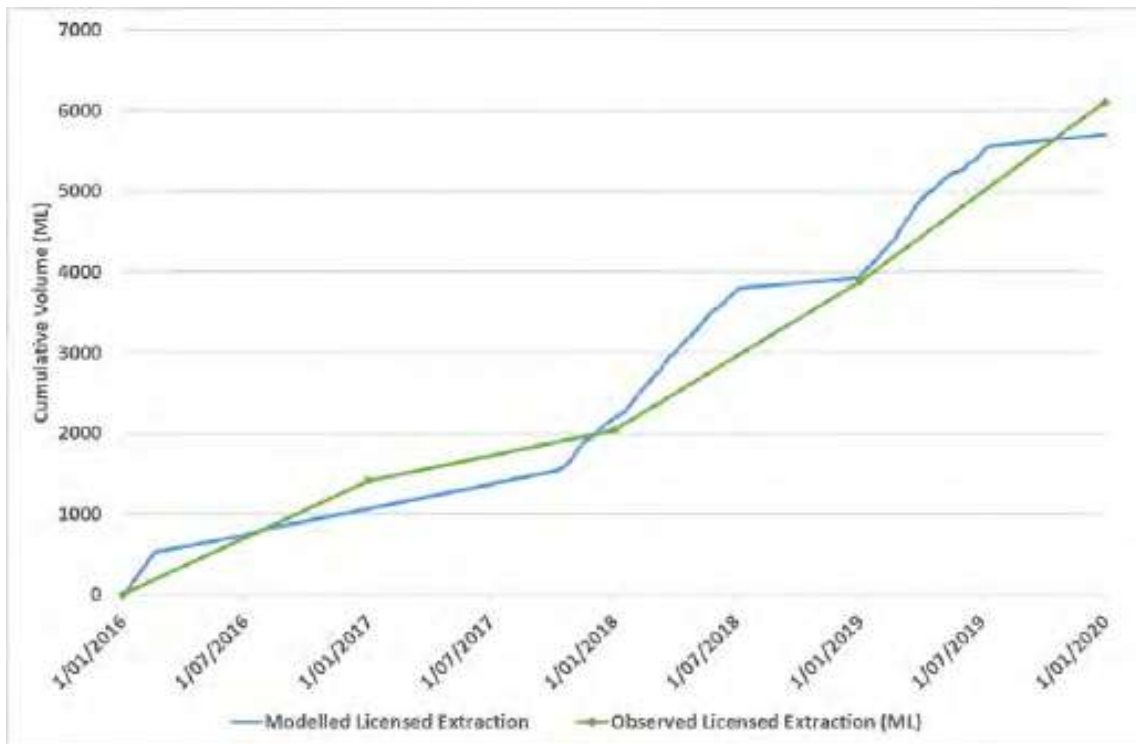
Figure 5-3 Total water extraction

As only annual totals of water extractions and water usage were supplied, the observed annual average was also compared against the modelled daily values for dust suppression (Figure 5-2) and river water extraction (Figure 5-3), to investigate seasonal variations.

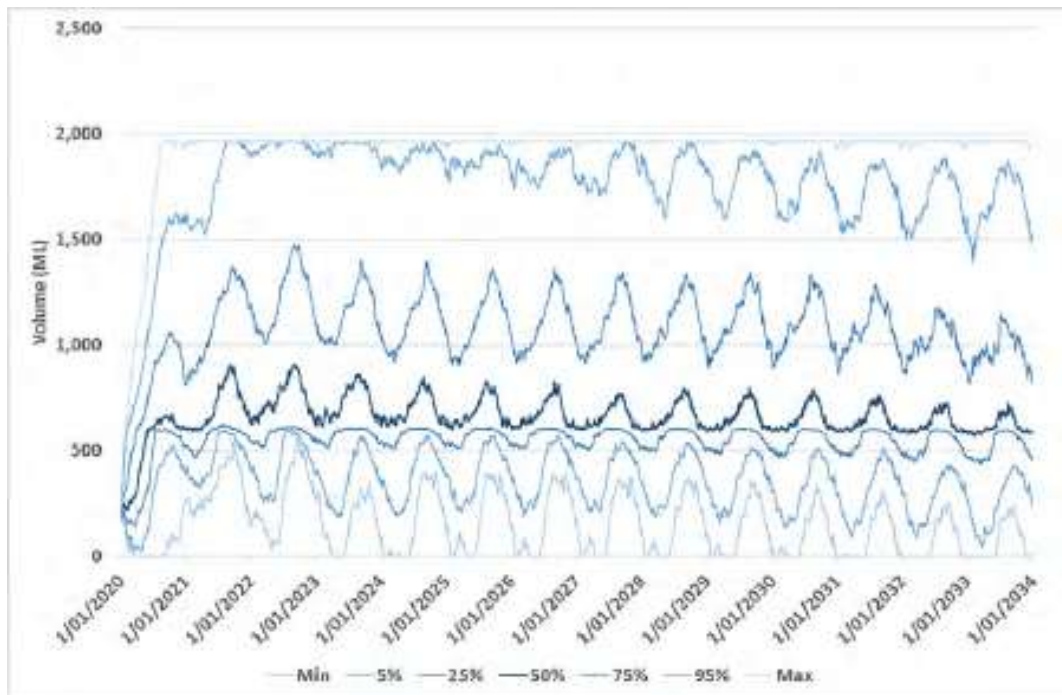
Figure 6-3 Simulated time series of water stored in MW5

Figure 6-3 shows that the volume stored in MW5, after its construction, is predicted to most likely remain close the assumed normal operating volume of 650 ML but may increase to the high operating volume or empty, depending on rainfall conditions.
