**DONALDSON COAL**

# Annual Review

## Abel Underground Coal Mine

1 January 2021 – 31 December 2021

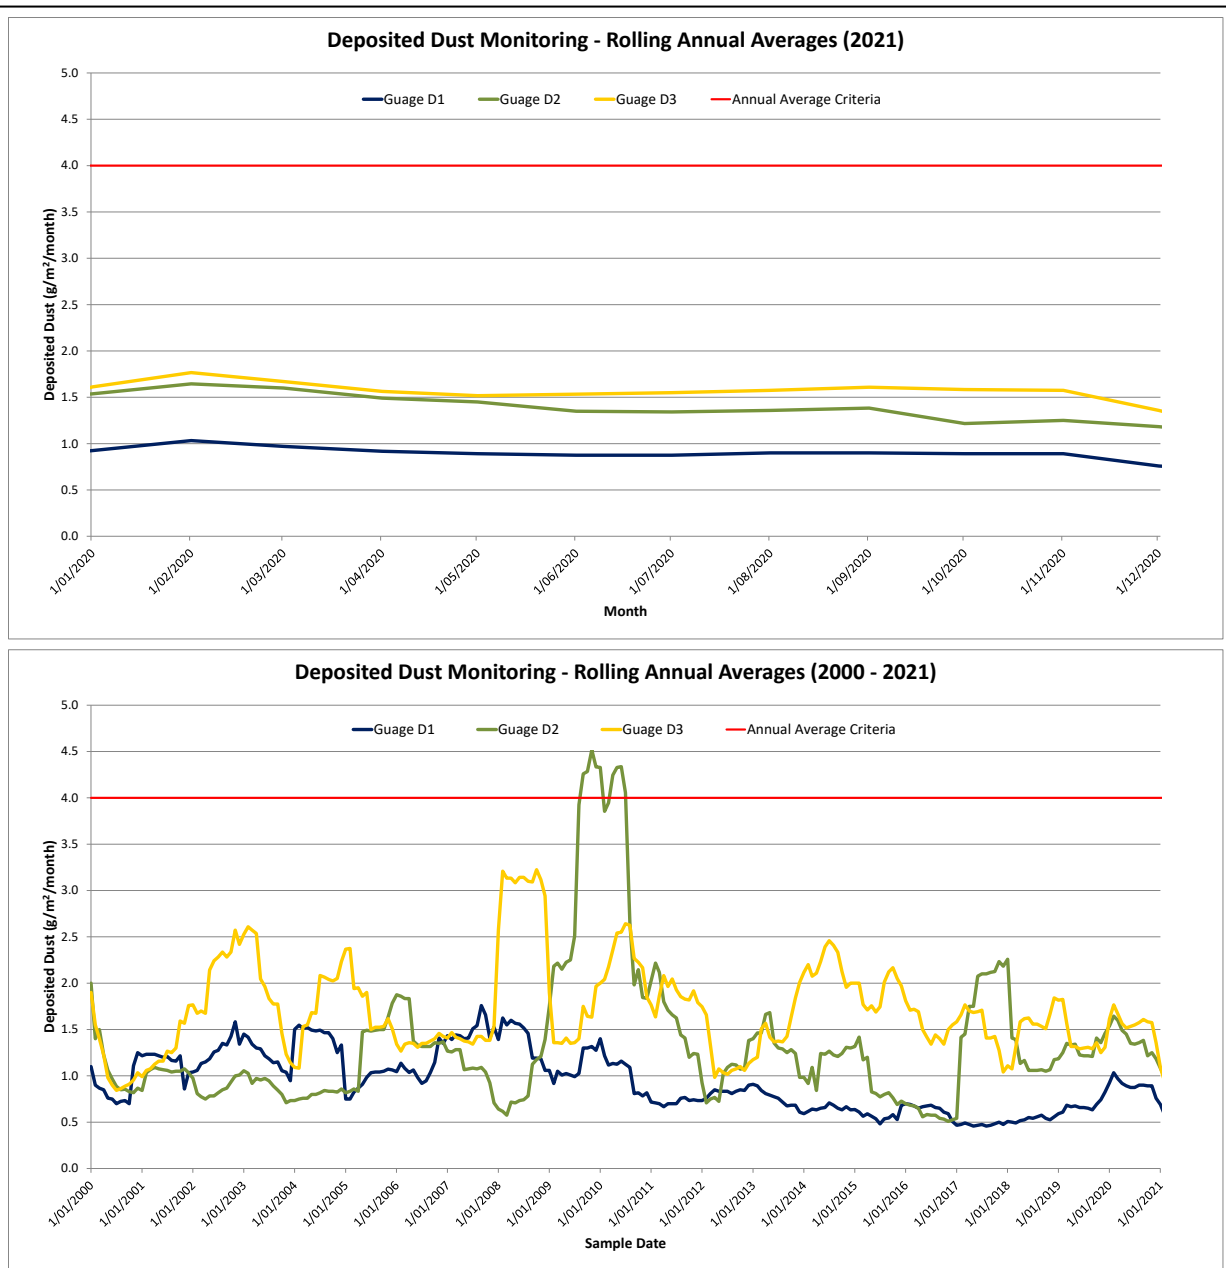
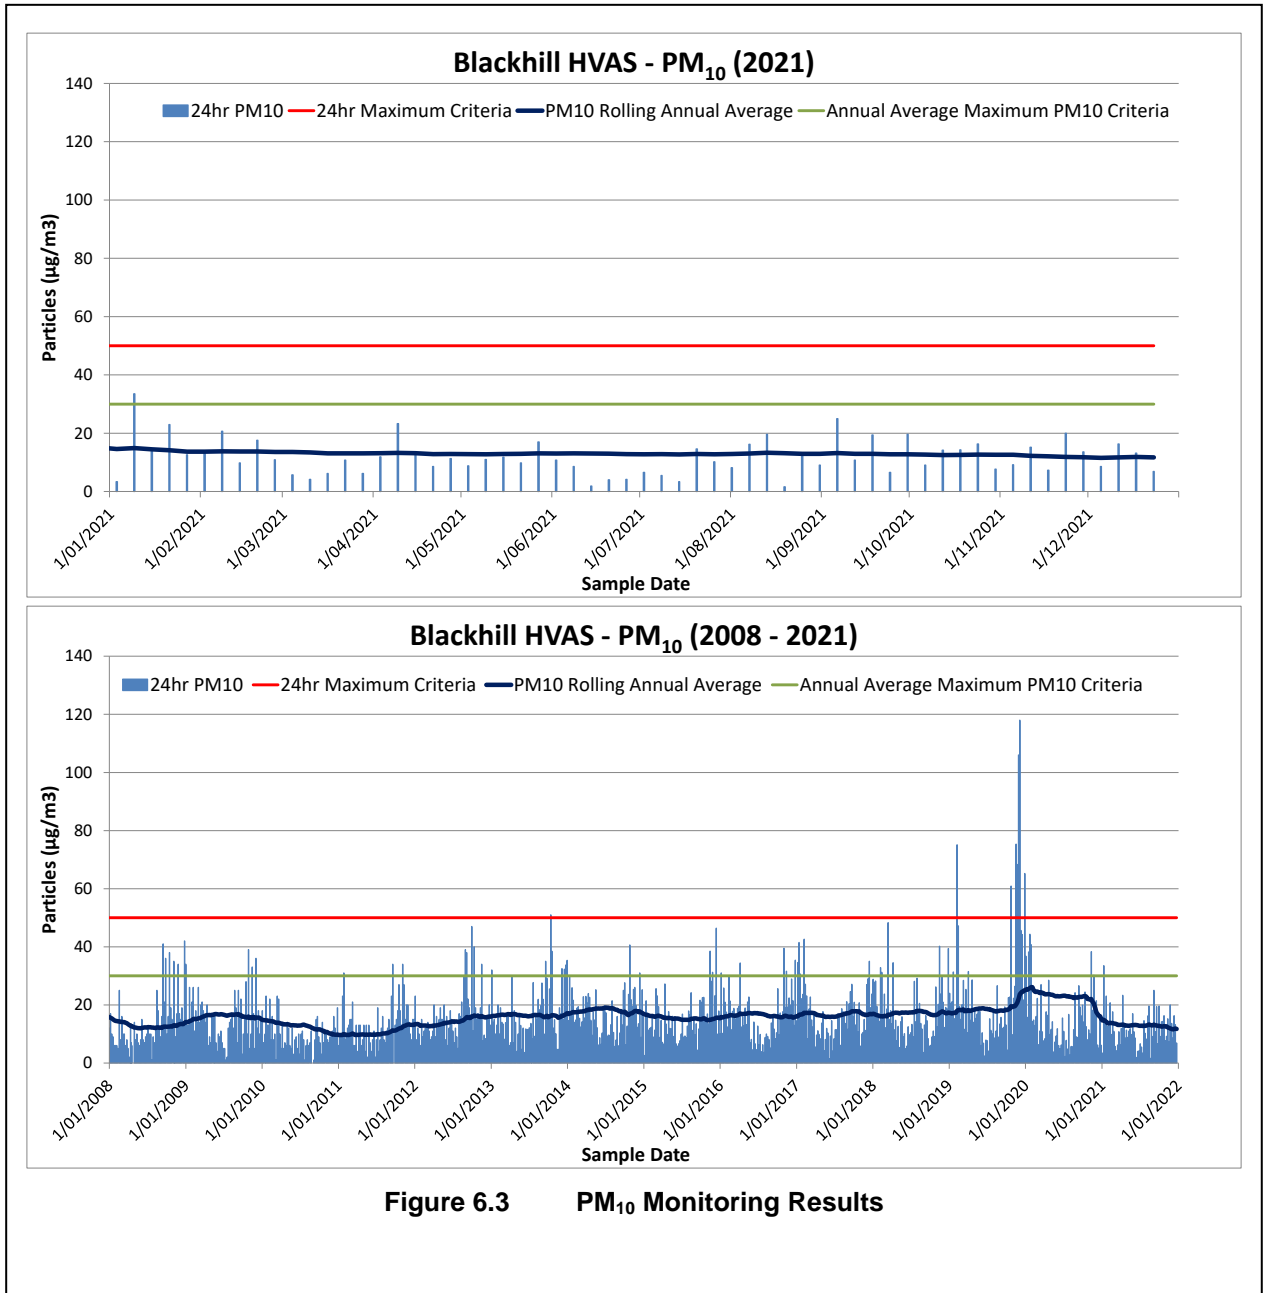
Figure 6.2 Deposited Dust Monitoring Results

The highest uncontaminated monthly dust deposition measurement was 4.4g/m<sup>2</sup>/month recorded during May 2021 at D2 with the annual average monthly deposition rates ranging between 0.5g/m<sup>2</sup>/month and 1.1g/m<sup>2</sup>/month. These values are significantly below the cumulative criteria of 4g/m<sup>2</sup>/month and the incremental criteria of an increase of 2g/m<sup>2</sup>/month, indicating good air quality with respect to dust deposition.

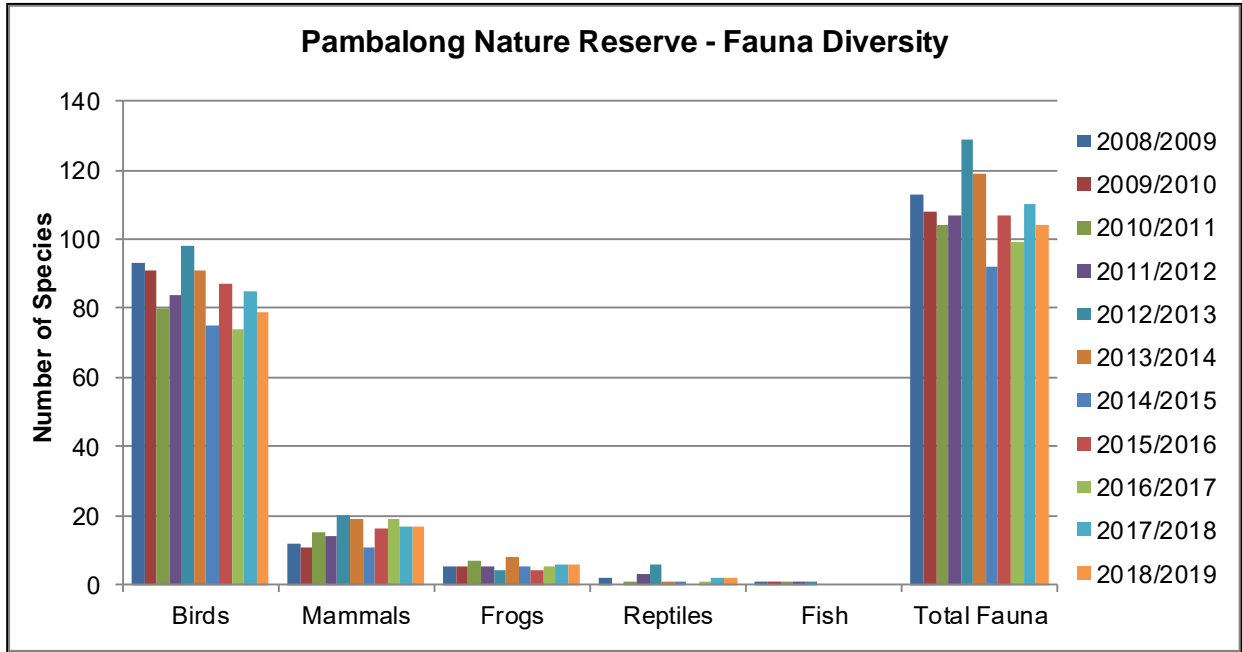
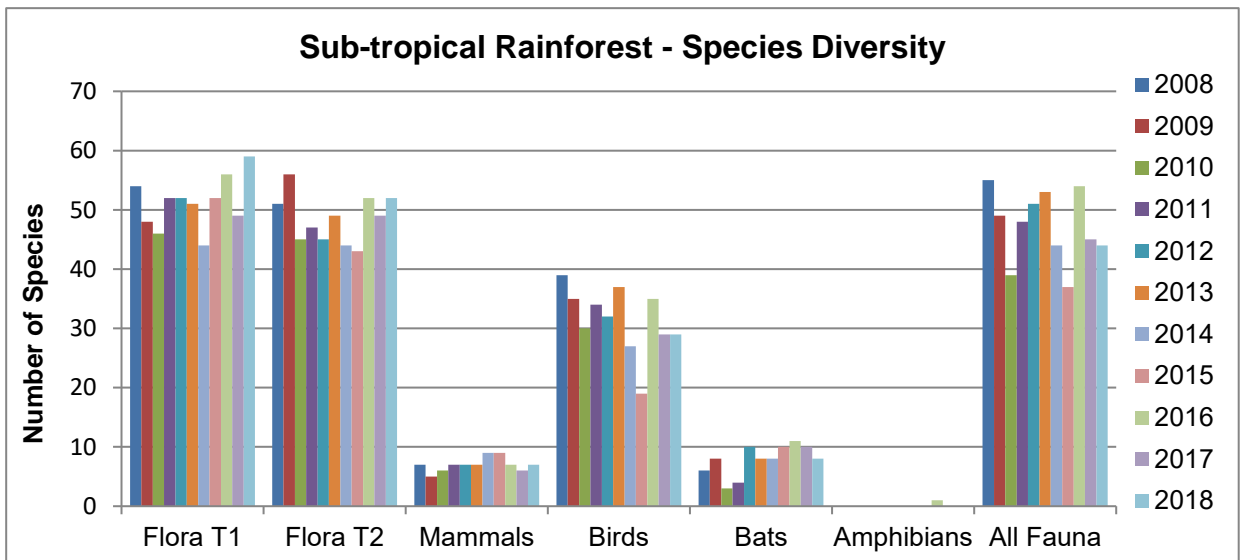
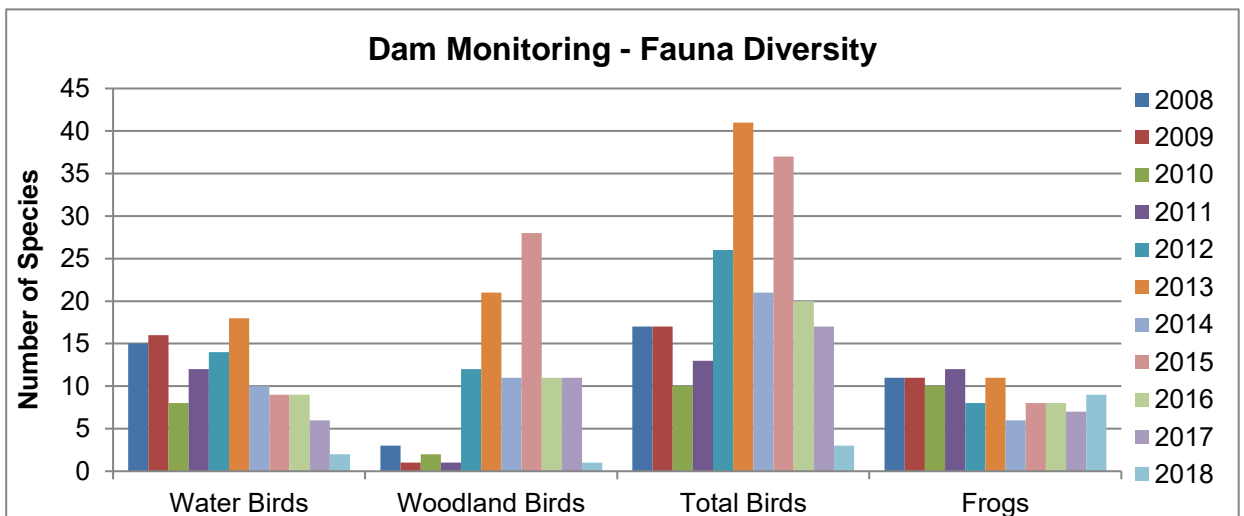
Figure 6.5 Selected Ecological Monitoring Results

A total of 200 flora species have been identified since monitoring commenced in 2008. No significant changes to the spatial extent of vegetation communities were observed. A yearly average of 105 fauna species have been recorded with the yearly breakdown provided in **Figure 6.5**.

A summary of the species diversity recorded over all monitoring periods is provided in **Figure 6.5**. Since commencement of survey in 2008 the area of transition between dry and moist forest at Transect 1 expanded, with the width of the moist forest increasing. Along both Transect 1 and Transect 2, particularly at the end of each transect, there was also an increase in the number of moist species recorded and a decline in the number of dry species within each 5m segment. The reduction in the occurrence of Lantana contributed to the reduction in dry species.

A summary of the species diversity recorded over all monitoring periods is provided in **Figure 6.5**.

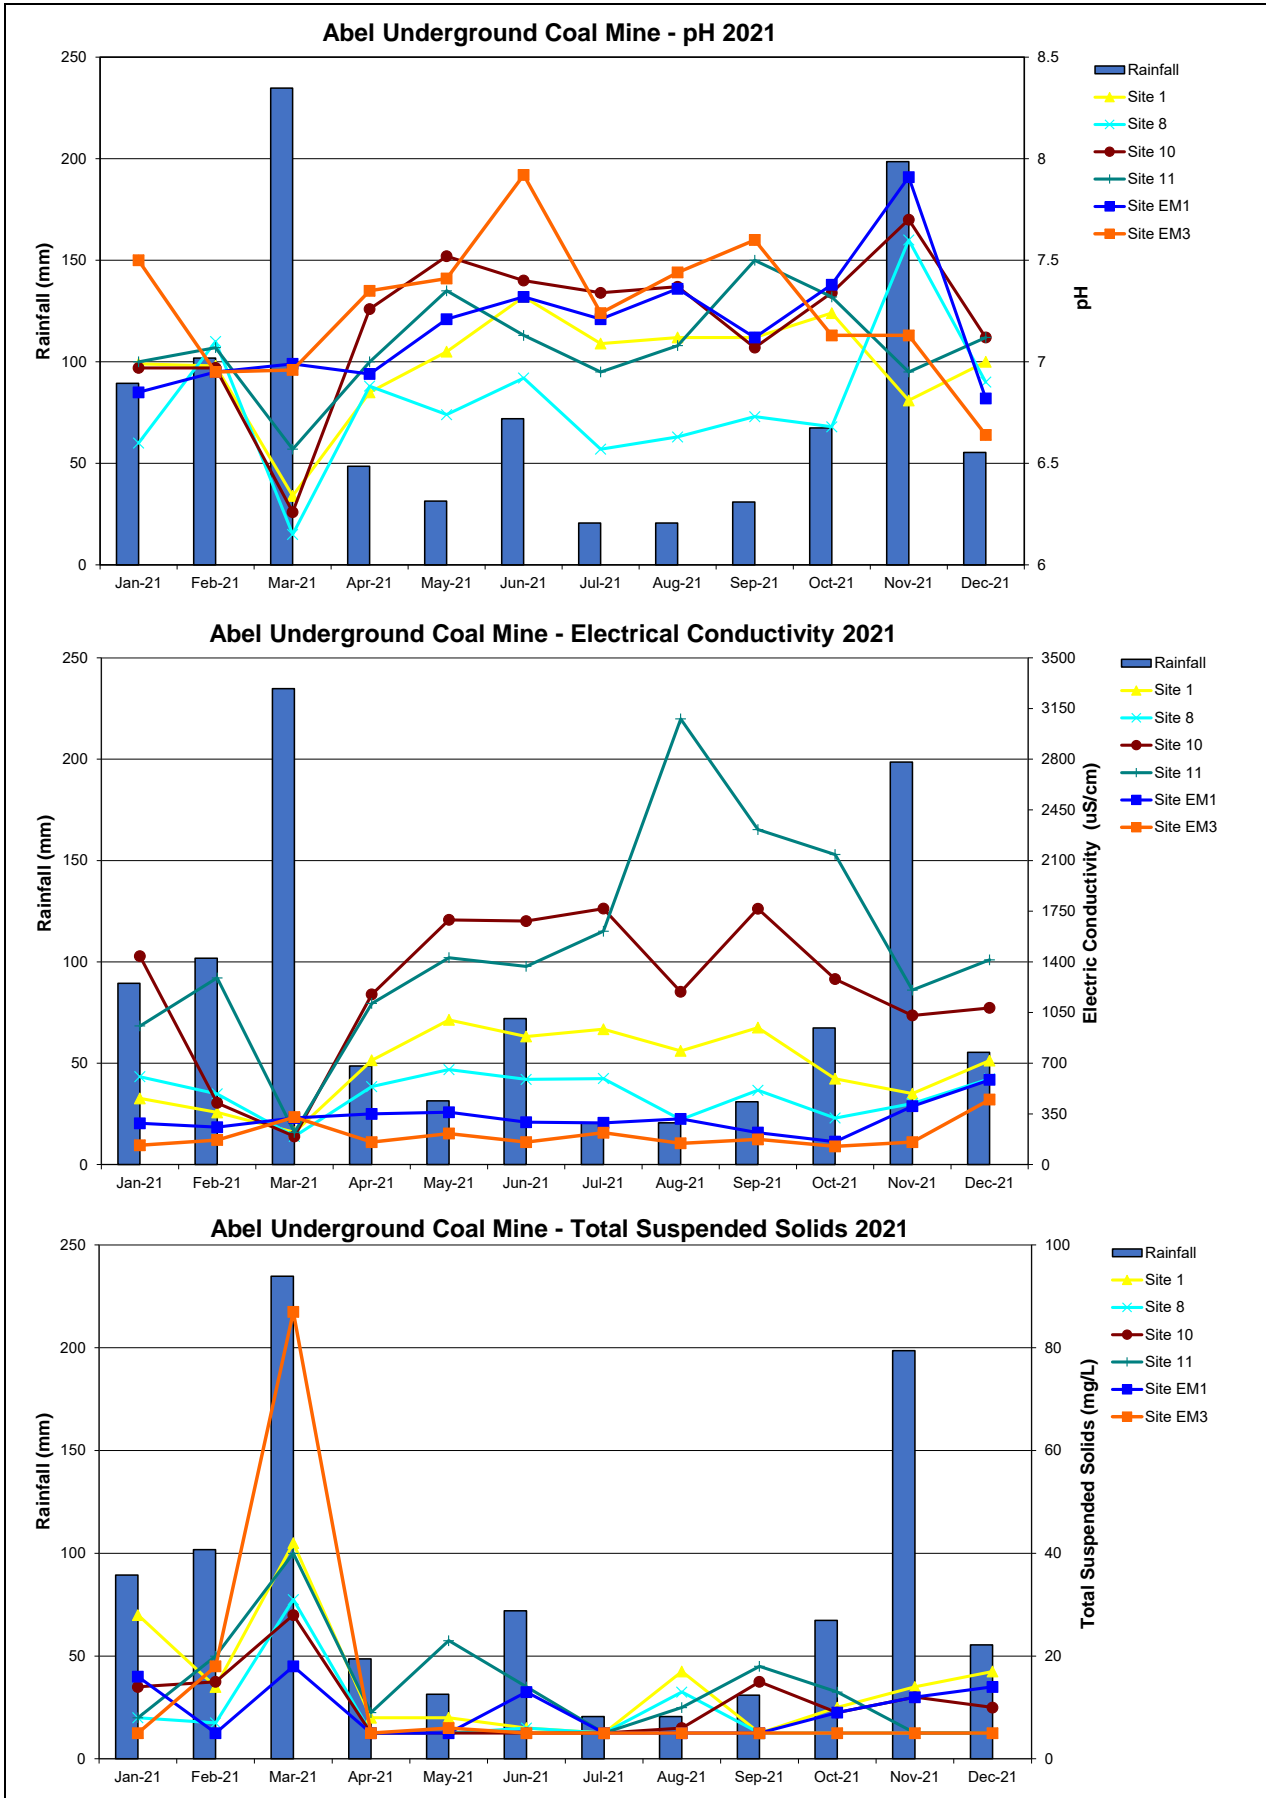
Figure 7.1 Surface Water Quality Monitoring Results – 2021

The electrical conductivity (EC) ranged between 125.5µS/cm and 3078.0µS/cm at all monitoring sites during the reporting period. Lower trigger values were exceeded at Sites 1 and 10 (upstream) and Sites 11, EM1 and EM3 (downstream) during the reporting period. Upper trigger values for EC were exceeded at Site 10 (upstream) and Sites 11 and EM1 (downstream). The average EC levels during the reporting period was generally consistent with the long-term average for all sites excluding Site 11. For Site 11, the average EC during the reporting period was 1512µS/cm compared with the long-term average of 875µS/cm. The highest EC recorded at Site 11 (3078.0µS/cm) is also the highest EC recorded for this site (see **Figure 7.2**).

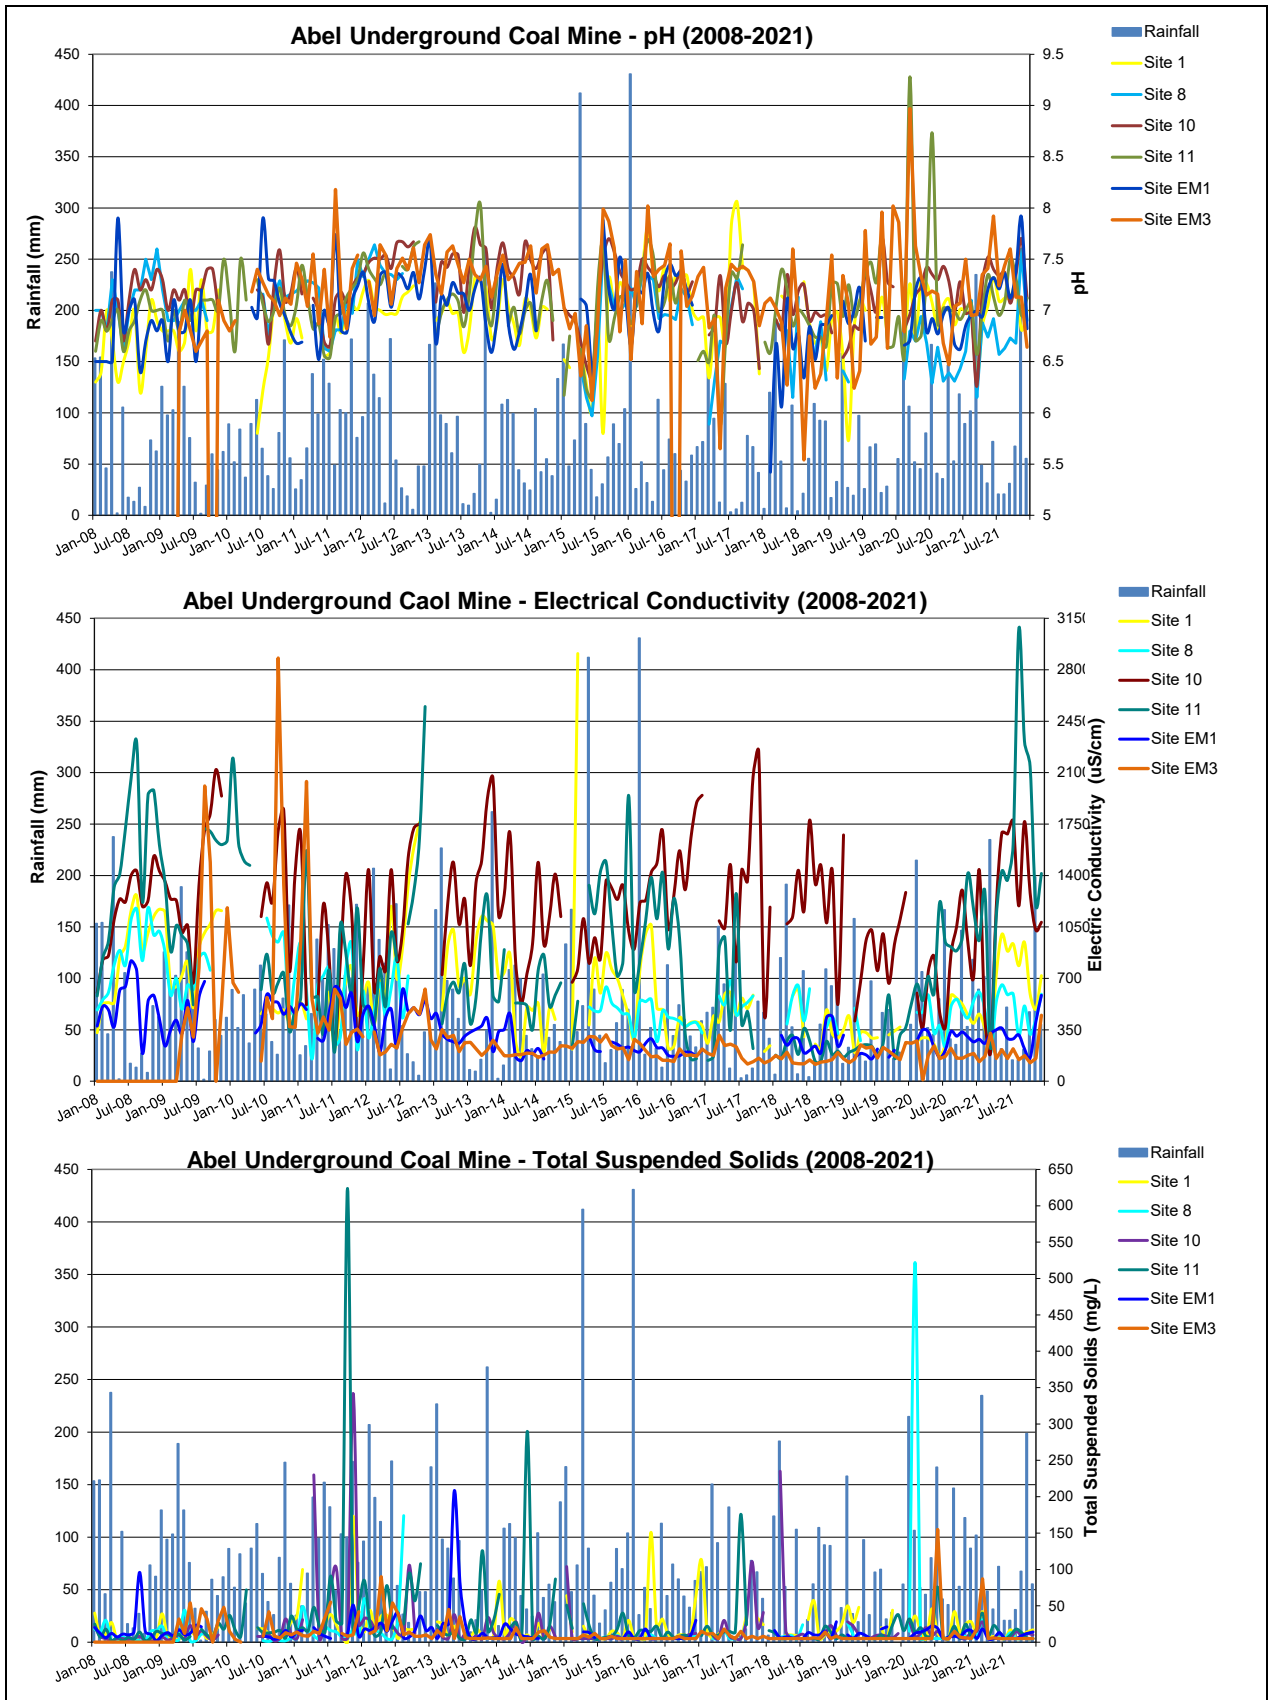
Figure 7.2 Surface Water Quality Monitoring Results – 2008 to 2021

Based on the monitoring data, lower ECs tend to correlate with periods of high rainfall and higher ECs during low rainfall conditions. No significant difference is apparent between upstream and downstream monitoring locations and, despite a short-term spike in EC at Site 11, no long-term trends in EC are apparent (**Figure 7.2**).

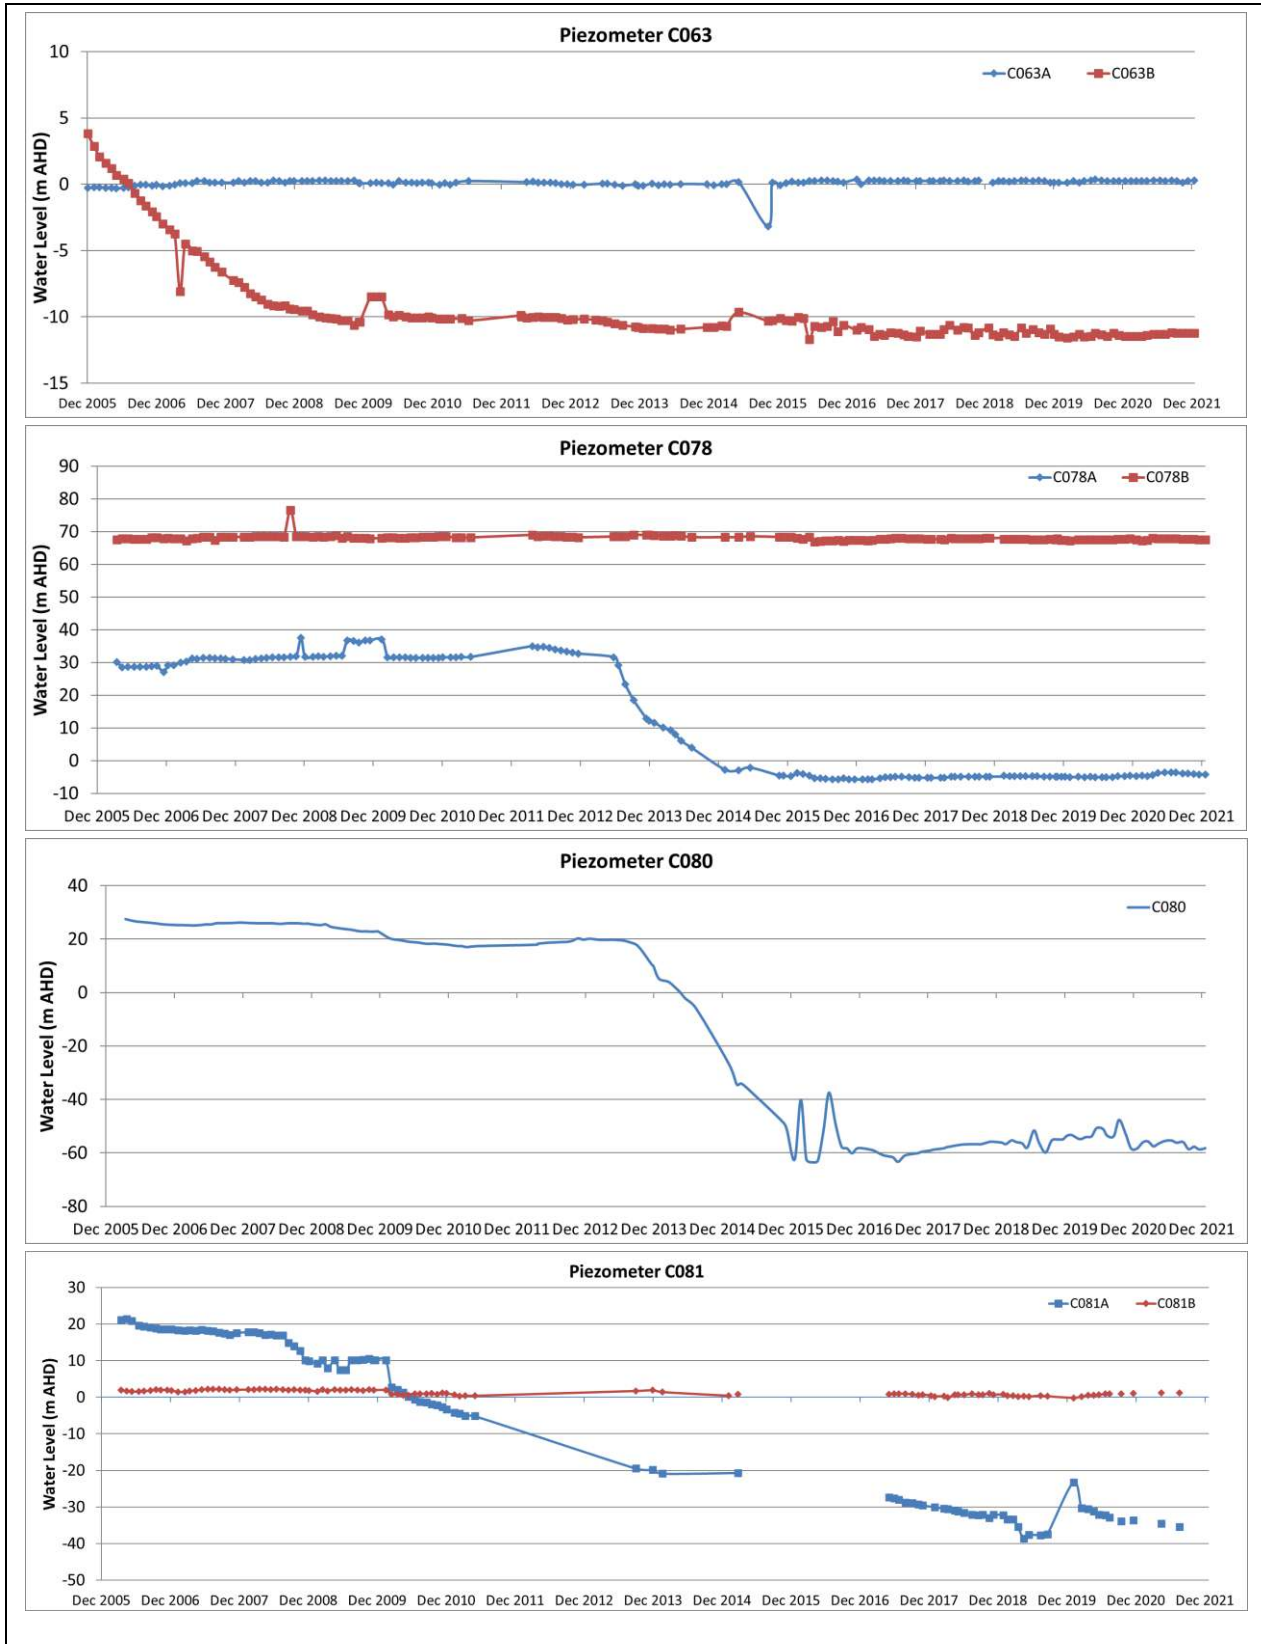
Figure 7.3 Groundwater Level Results – All Data

A graphical summary of groundwater level monitoring results relevant to the Abel Underground Coal Mine is provided in **Figure 7.3** and an interpretation of these results is provided as follows.

Monitoring indicates that there is little evidence of any drawdown response in the alluvium or regolith groundwater. In particular Piezometers 81A and 81B are located adjacent the Pambalong Nature Reserve (see **Figure 6.1**). Monitoring results from 81A (single vibrating wire transducer placed within the Lower Donaldson Seam) showed a drawdown response to mining the Donaldson Seam within the Abel Mine. However, Piezometer 81B is screened within overlying shallow Permian strata with water levels remaining stable or increasing during the reporting period. The lack of response in the shallow piezometer indicates minimal mining impact on the Pambalong Nature Reserve.

Piezometers 63A and 63B are located to the east of the Abel Mine adjacent to the F3 Freeway and near the Hexham Swamp (see **Figure 6.1**). It appears that the shallow Piezometer 63B has failed or the bore has collapsed and therefore this piezometer no longer provides useful data. However, Piezometer 63A is screened in the Lower Donaldson Seam and remains operational. Monitoring results from Piezometer 63A remained consistent throughout the reporting period indicating minimal impact from previous mining activities.

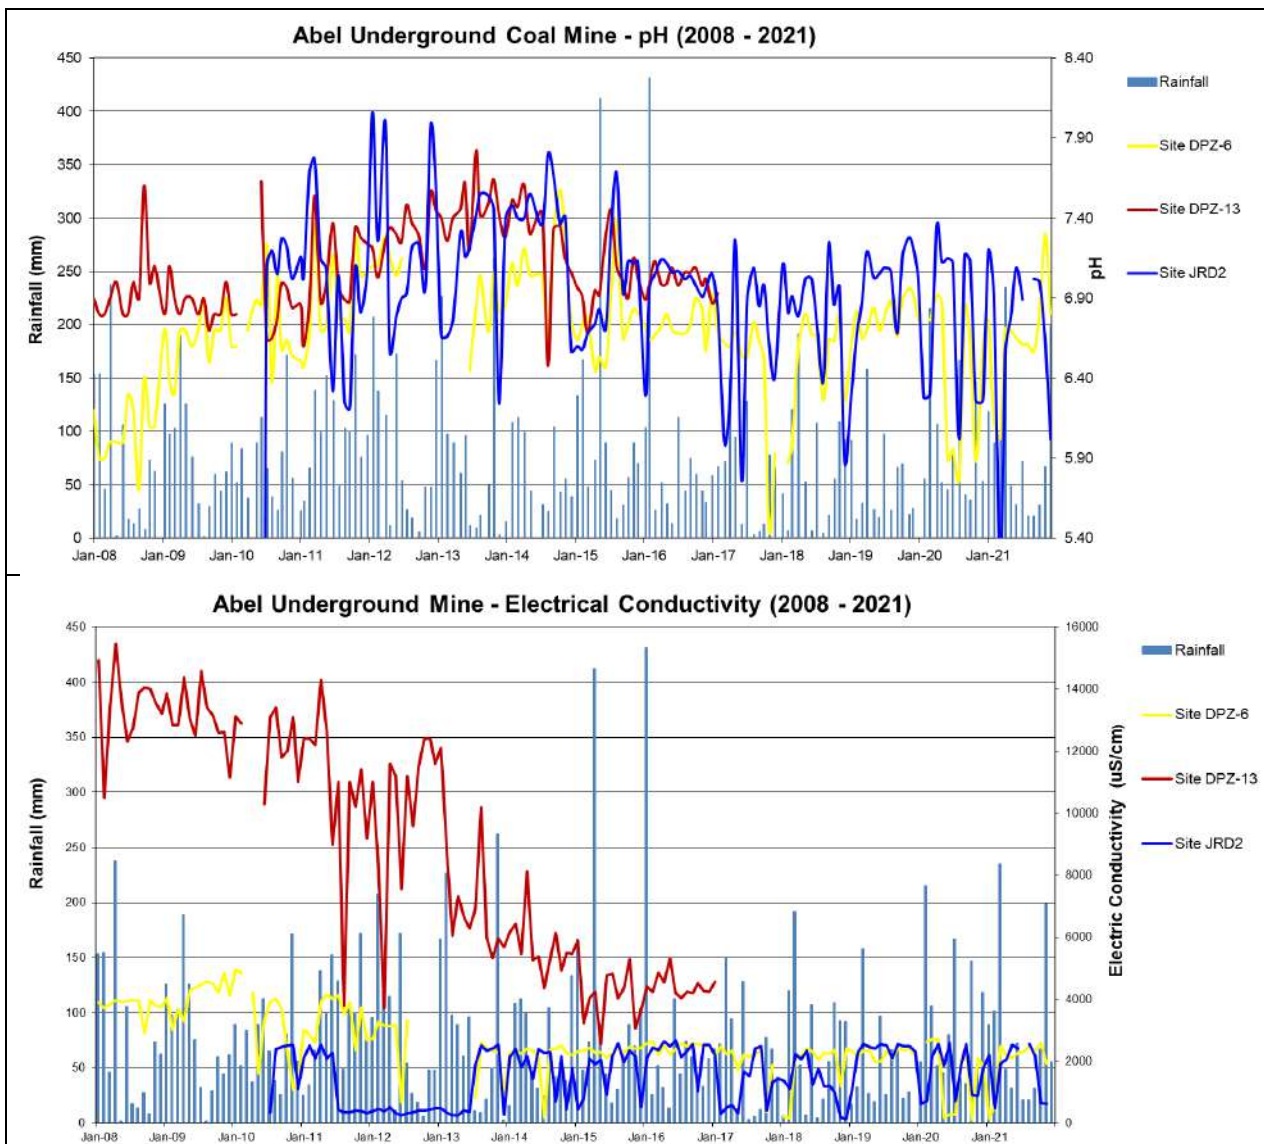
Figure 7.5 Groundwater Quality Monitoring Results – 2008 – 2021

A downward trend in EC has previously been observed at bore DPZ13 (**Figure 7.5**) starting in 2010/2011, which may be due to enhanced recharge following drawdowns in the coal measures as a result of mining. Landholder access was unable to be obtained to enable sampling from DPZ-13 during the reporting period to confirm whether this trend had continued or plateaued. Conversely, EC has been relatively consistent within DPZ-6 and JRD2, with monitoring indicating occasional ‘outliers’ of significantly lower EC. This is likely due to ingress of rainwater temporarily lowering the salinity

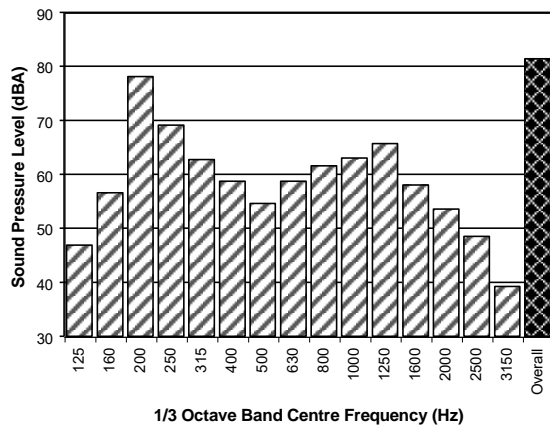
The following figure shows a 1/3 octave band frequency analysis where the noise is dominated by the 200 Hz band. Note that the indicated level of each individual band is less than the overall level, which is the logarithmic sum of the bands.

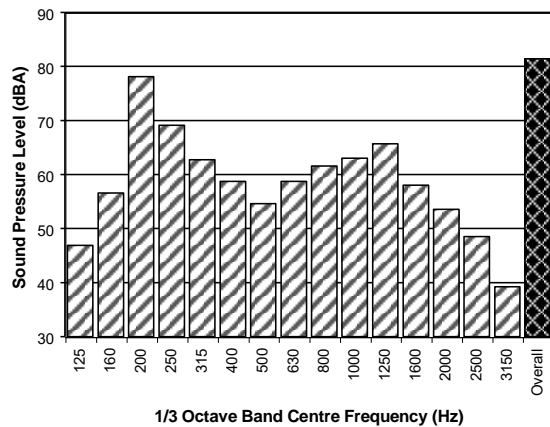
The following figure shows a 1/3 octave band frequency analysis where the noise is dominated by the 200 Hz band. Note that the indicated level of each individual band is less than the overall level, which is the logarithmic sum of the bands.
