Tahmoor Coal Pty Ltd

2022 ANNUAL REVIEW AND ANNUAL ENVIRONMENTAL MANAGEMENT REPORT

March 2023

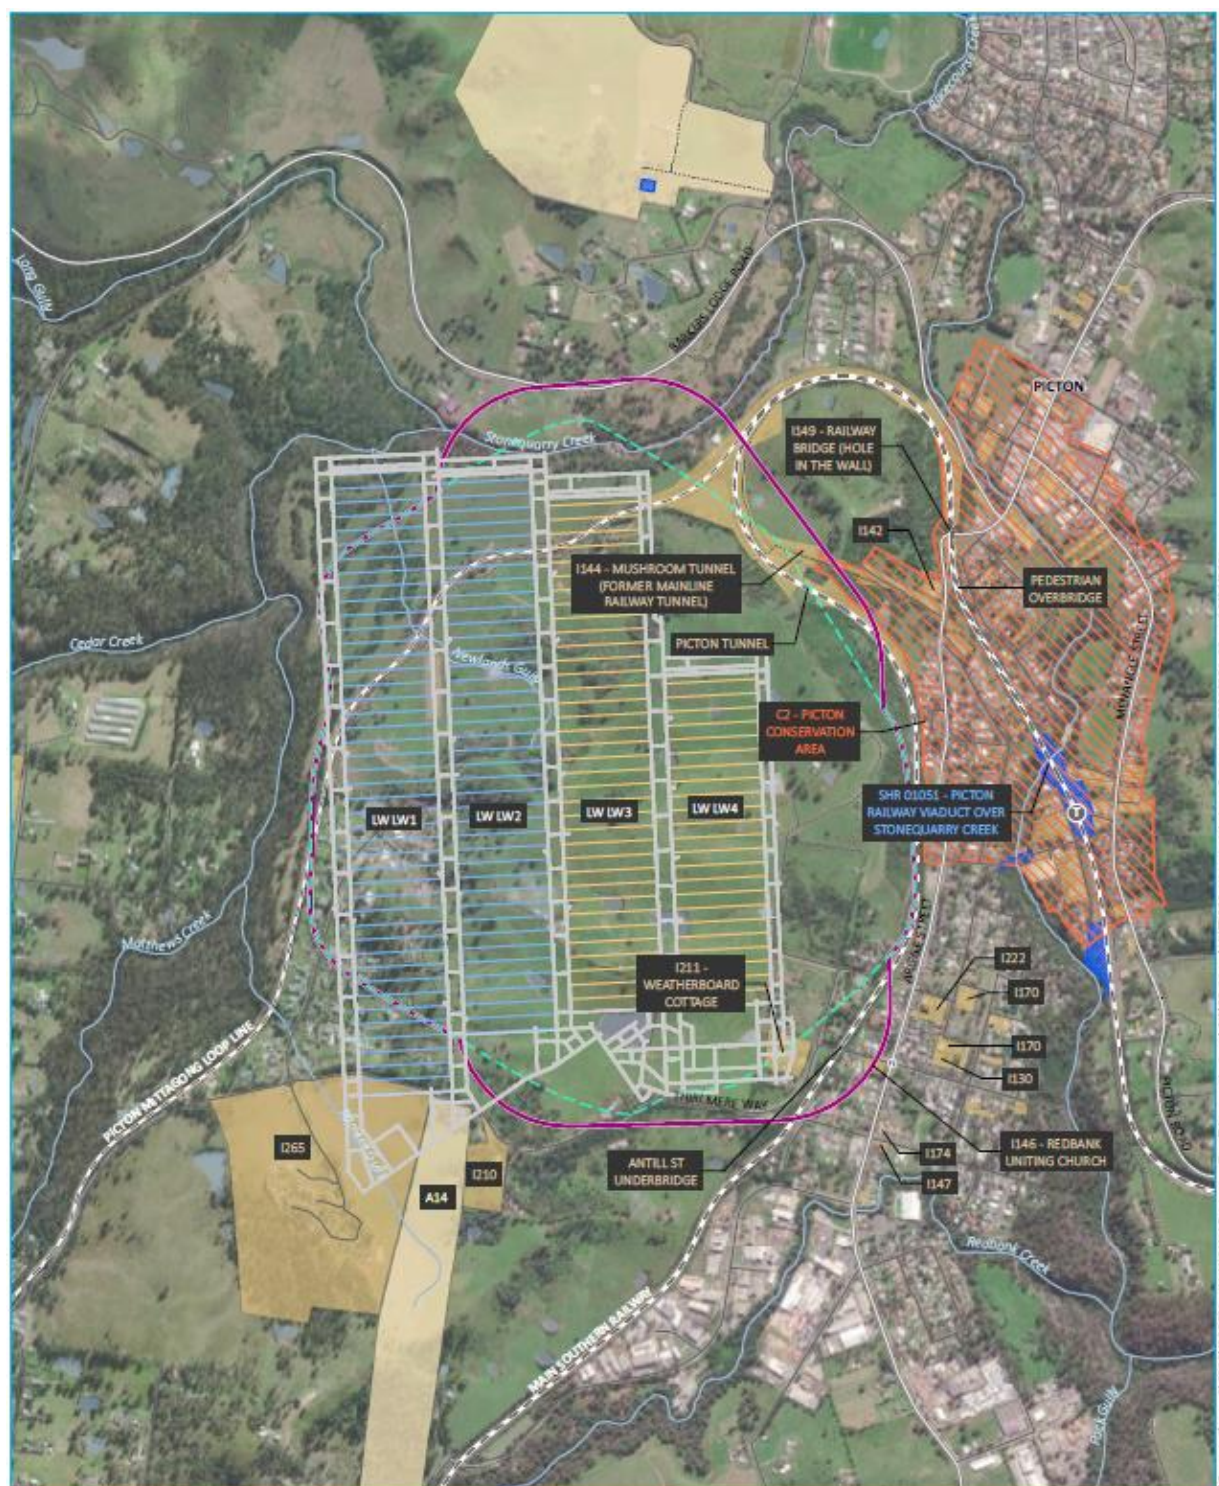
Figure 16 Registered historical heritage sites in the LW W3-W4 Study Area and surrounds

The HHTR provides a subsidence monitoring program for historical heritage sites within the LW W3–W4 project area (**Figure 16 and Figure 17**). The project area is defined by calculating a 35-degree angle of draw from the extents of LW W3 – W4, and the predicted limit of vertical subsidence (20 mm subsidence contour) that may result from their extraction. The HHTR includes a Trigger Action Response Plan (TARP) which provides a description of performance indicators to be implemented to ensure compliance with negligible subsidence impacts or environmental consequences to sites of historical heritage.

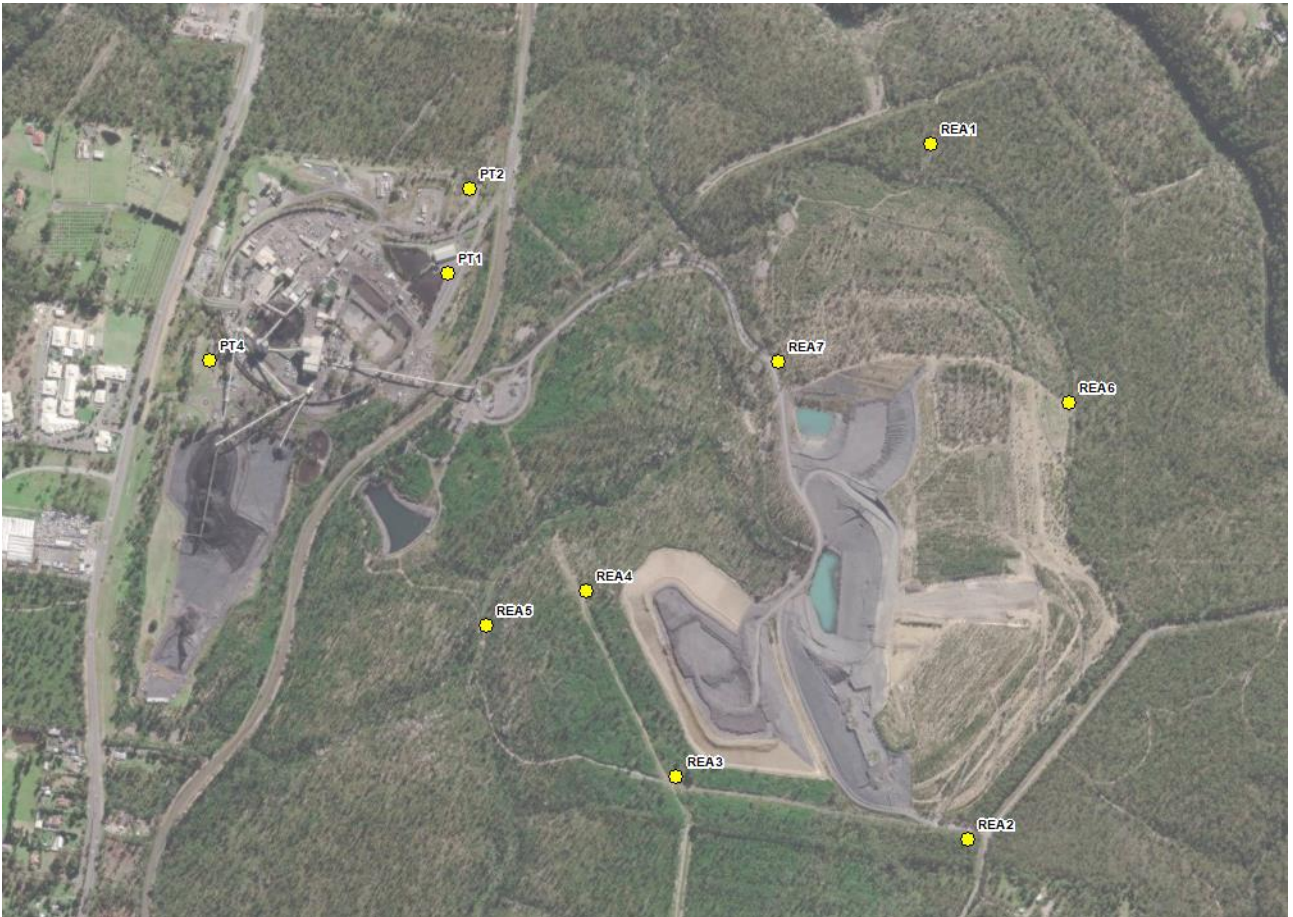
Figure 27 Locations of Piezometers at Pit top and the REA

Groundwater piezometer boreholes located at Tahmoor Mine pit-top and REA are monitored quarterly for water quality and continual water level loggers downloaded by a third party contractor (for piezometer locations refer to **Figure 27**).

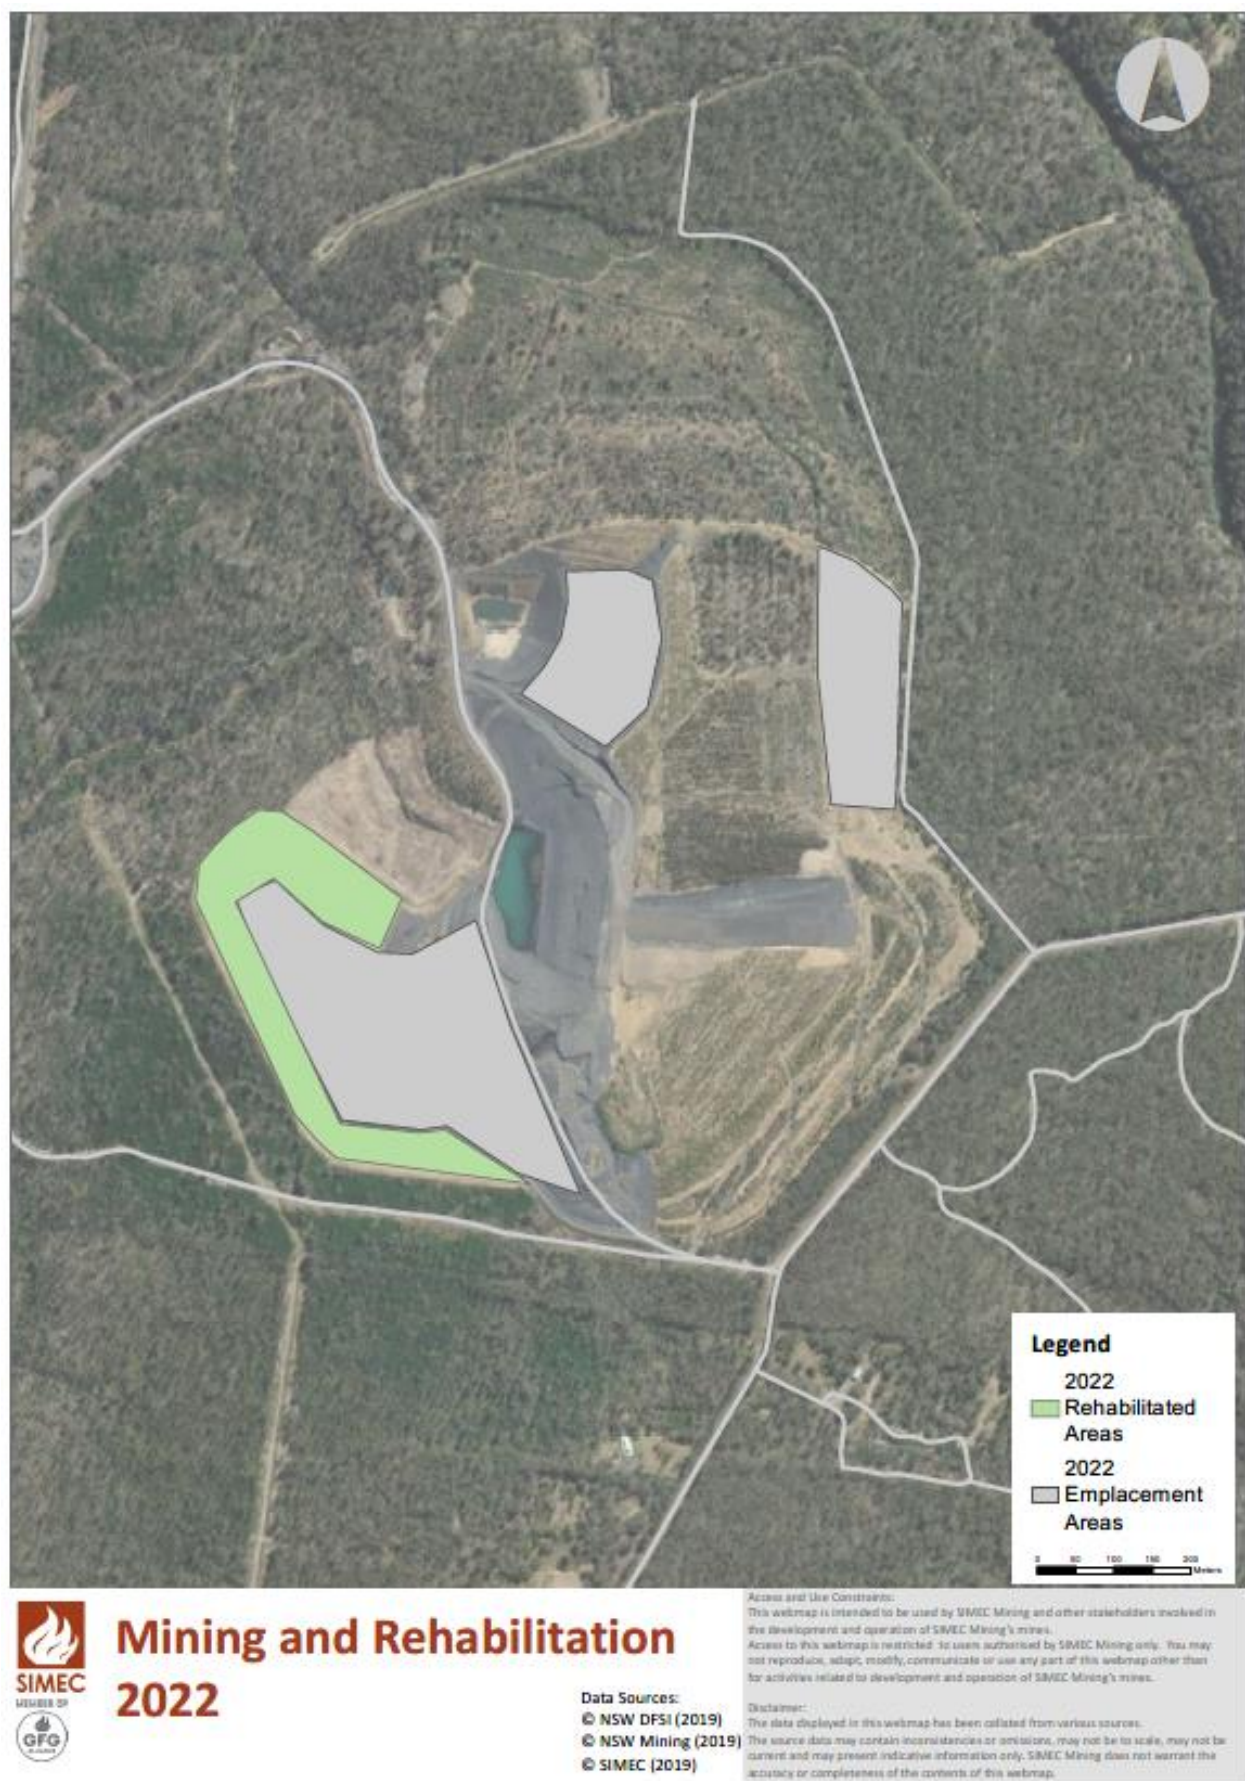
Figure 52 Reject Emplacement Areas and completed Rehabilitation works during 2022.

A summary of Tahmoor Coals' rehabilitation is provided within **Table 20-1** and **Figure 53 and 54**. Approximately four and a half (4.5) hectares of land in the western section of the REA was capped with top soil, contour poughed and rehabilitated with seed mix containing both a cover crop for stability and native seed mix from Tahmoor Coal's native seed list. During the reporting period further emplacement was completed on the eastern batter and has been capped with topsoil. Rock armoured drainage lines will be completed during the next reporting period with contour ploughing and rehabilitation seeding to be completed soon after.

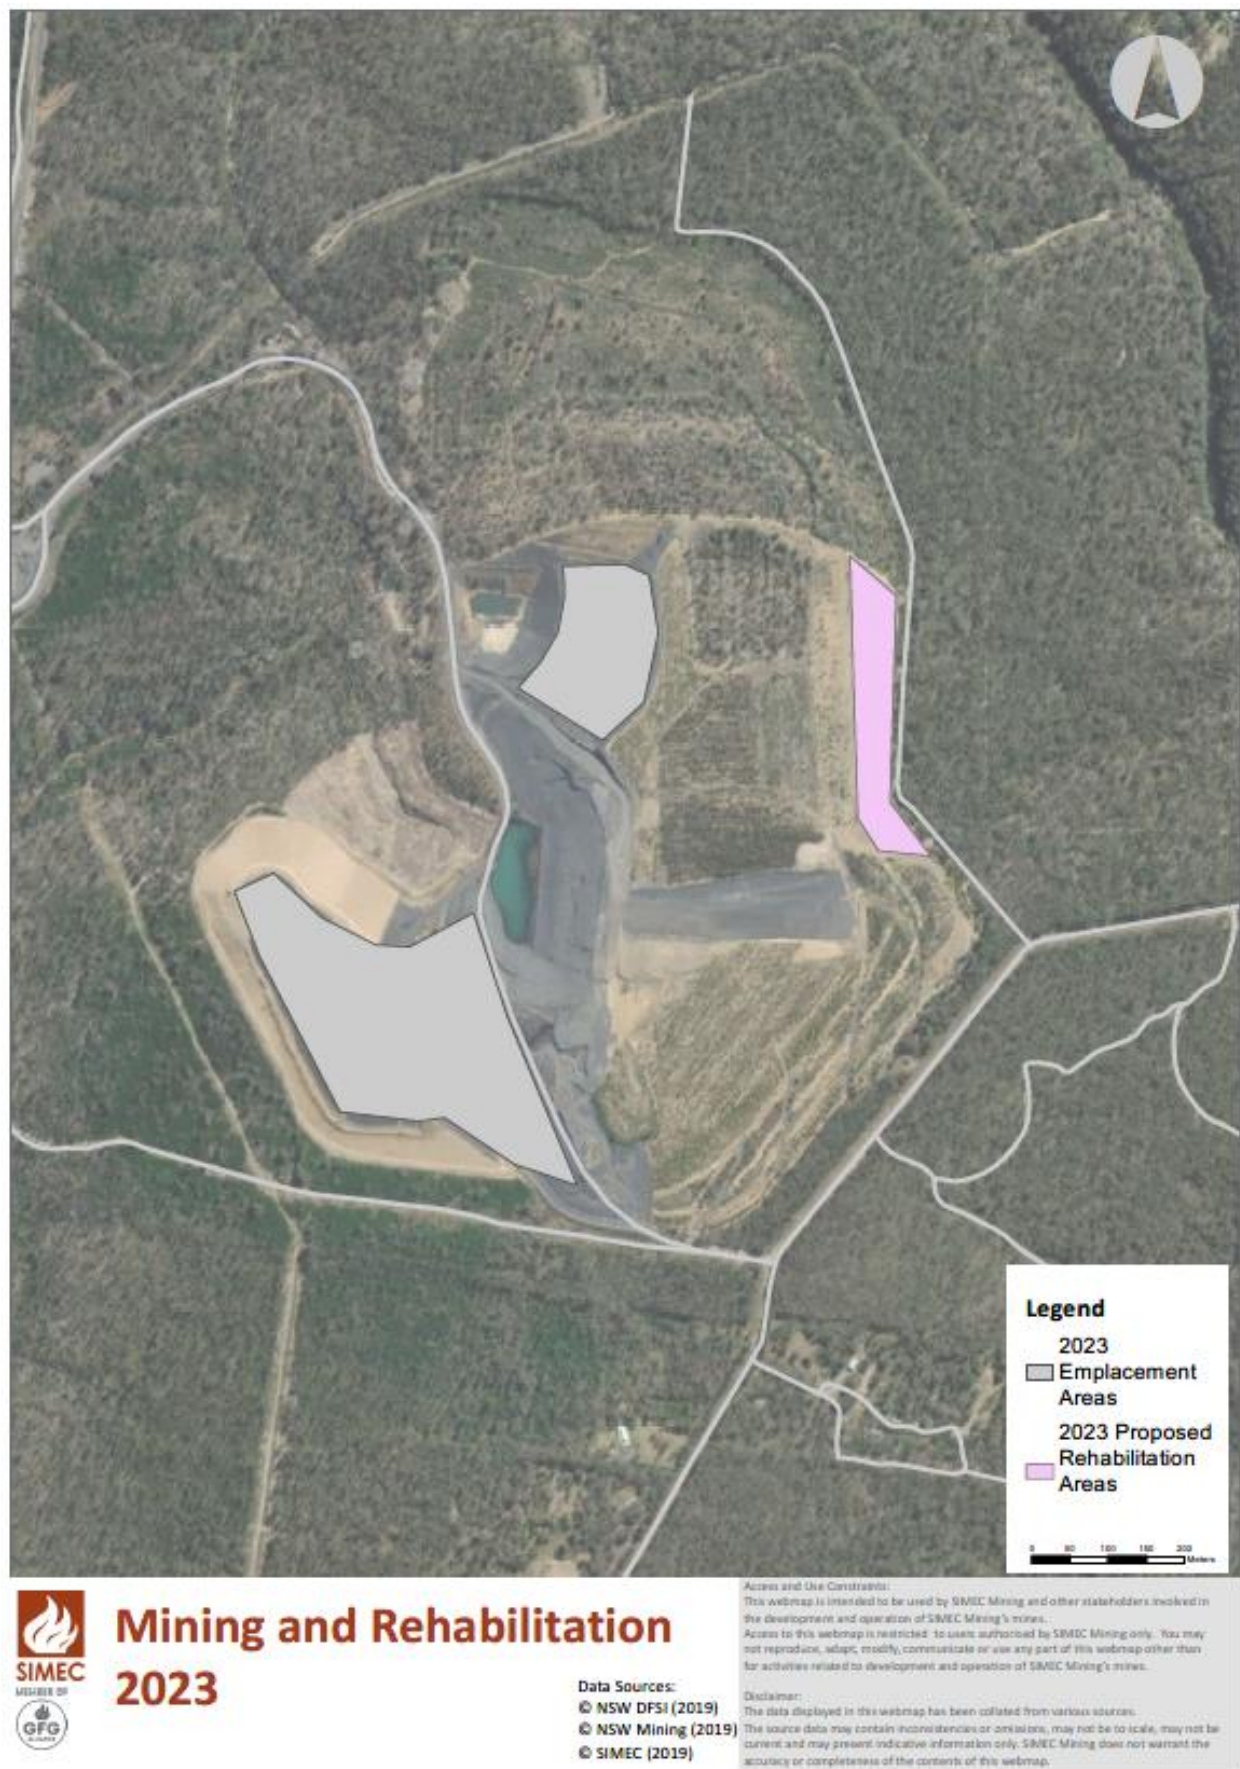
Figure 53. Reject Emplacement Areas and proposed Rehabilitation works for 2023.

Rehabilitation works on the eastern batter of the REA will be commenced with contour ploughing and rehabilitation seeding to be completed during spring 2023. Rehabilitation targets for the next reporting period (1st January 2023 – 31st December 2023) are outlined in **Table 20.4** below.

Tahmoor Coal is currently continuing to emplace refuse within the current approved boundary of the REA as part of normal operations. The emplacement areas utilised during the reporting period were confined to the western lobe and adjoining valley section, an area located east of Dam S7 and the eastern batter which has been re-shaped and capped with topsoil (refer to Figure 34). Future emplacement of refuse material will be confined to the western lobes and adjoining valley section and the area located east of Dam S7 (Refer to **Figure 53**).

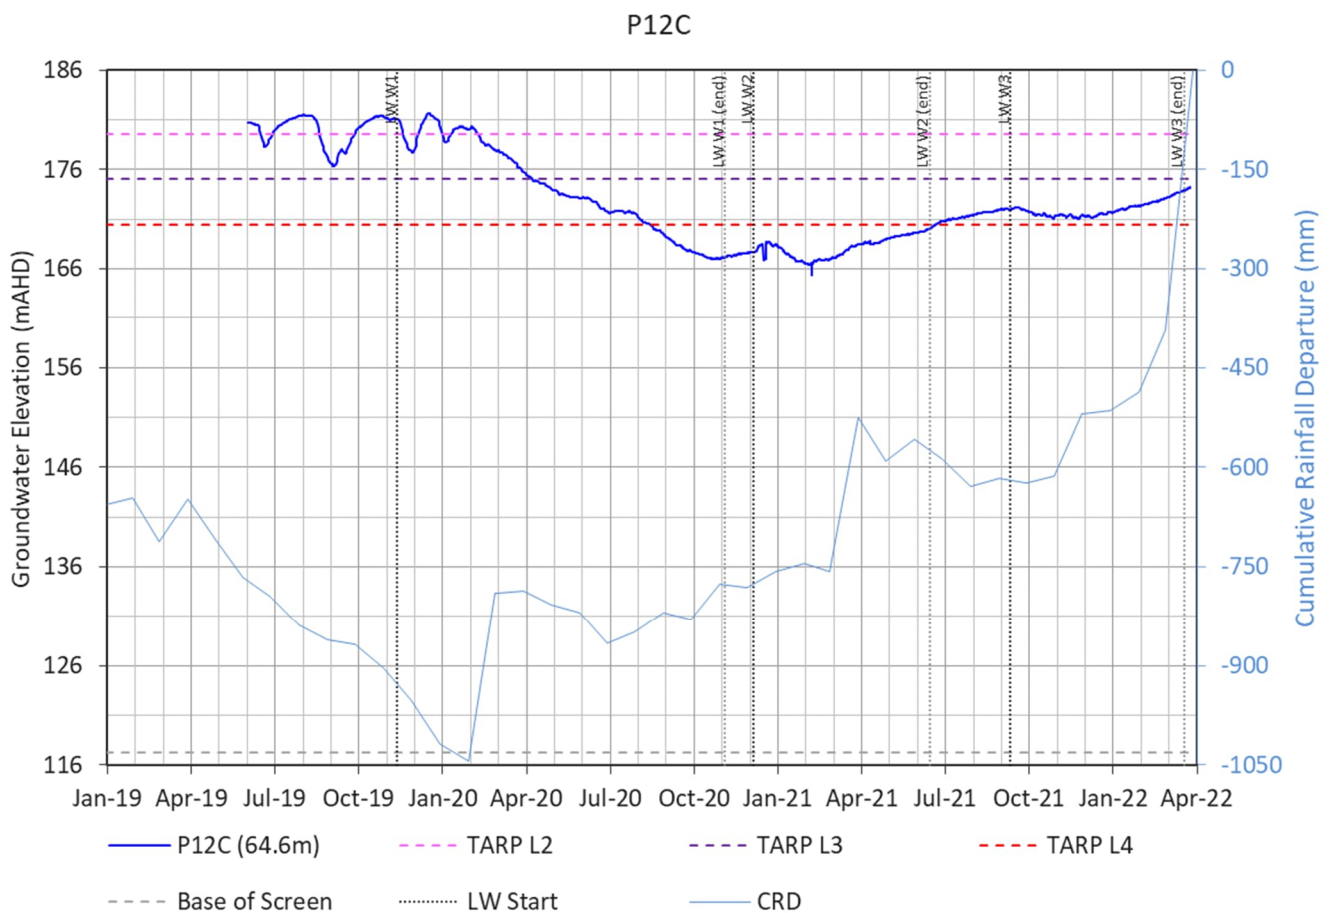
Figure 13 Groundwater Level Exceedance at P12C

During the reporting period, groundwater levels at P12C have increased to a maximum of 174.2 mAHD in March 2022 and are 2.1 m below baseline levels (Table 6). Groundwater levels at P12C have increased by 2.8 m in March 2022 and are approximately 3.1 m above groundwater level observed in the upper piezometer P12A and P12B (Figure A-1). A TARP Level 3 still applies at P12C as the recovered groundwater levels as of March 2022 are below the trigger level 3.

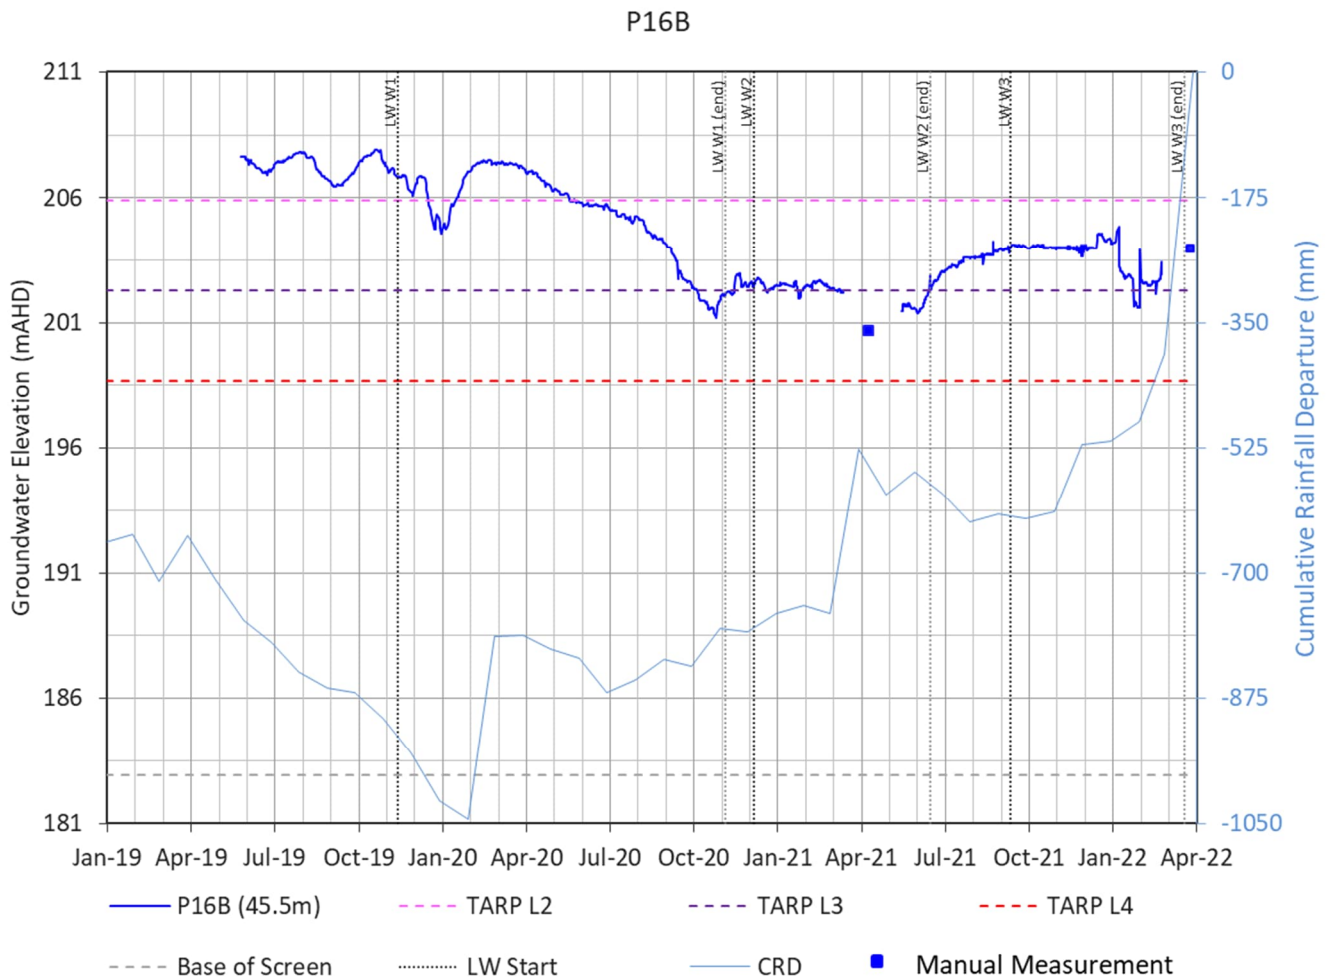
Figure 14 Groundwater Level Exceedance at P16B

At P16B, groundwater levels were observed at 202.8 mAHD in mid-January 2022, below the trigger TARP Level 2 (205.9 mAHD) following a decline of approximately 1.8m (Figure 14). SLR investigated the nature of the sharp decline (SLR, 2022a). The recent decline in groundwater levels could be due to a delayed mining effect from LW W2 and active mining at LW W3. The sudden decline in groundwater levels at P16B could potentially be due to the sudden movement of strata from mining. Similar sudden declines were observed at P15 located adjacent to the northern end of LW W3 after the commencement of that panel (Appendix A, Figure A-3).

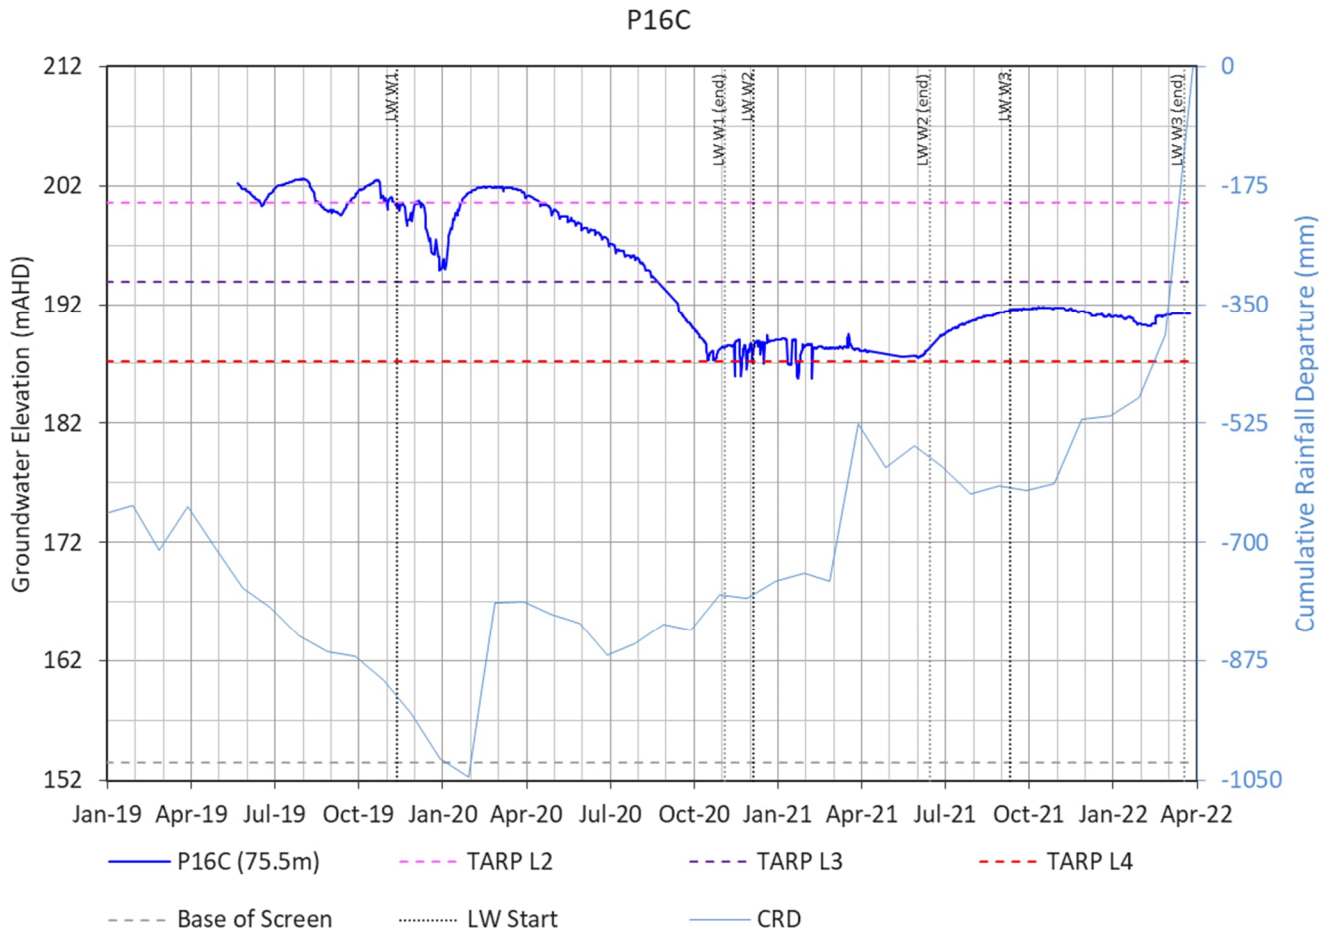
Figure 15 Groundwater Level Exceedance at P16C

Groundwater levels at P16C gradually declined by approximately 0.4 m throughout the reporting period to 190.2 mAHD and are observed at 191.3 mAHD in March 2022. As of March 2022, groundwater levels remain below the trigger TARP Level 3 (193.9 mAHD), hence a TARP Level 3 still applies (Figure 15).

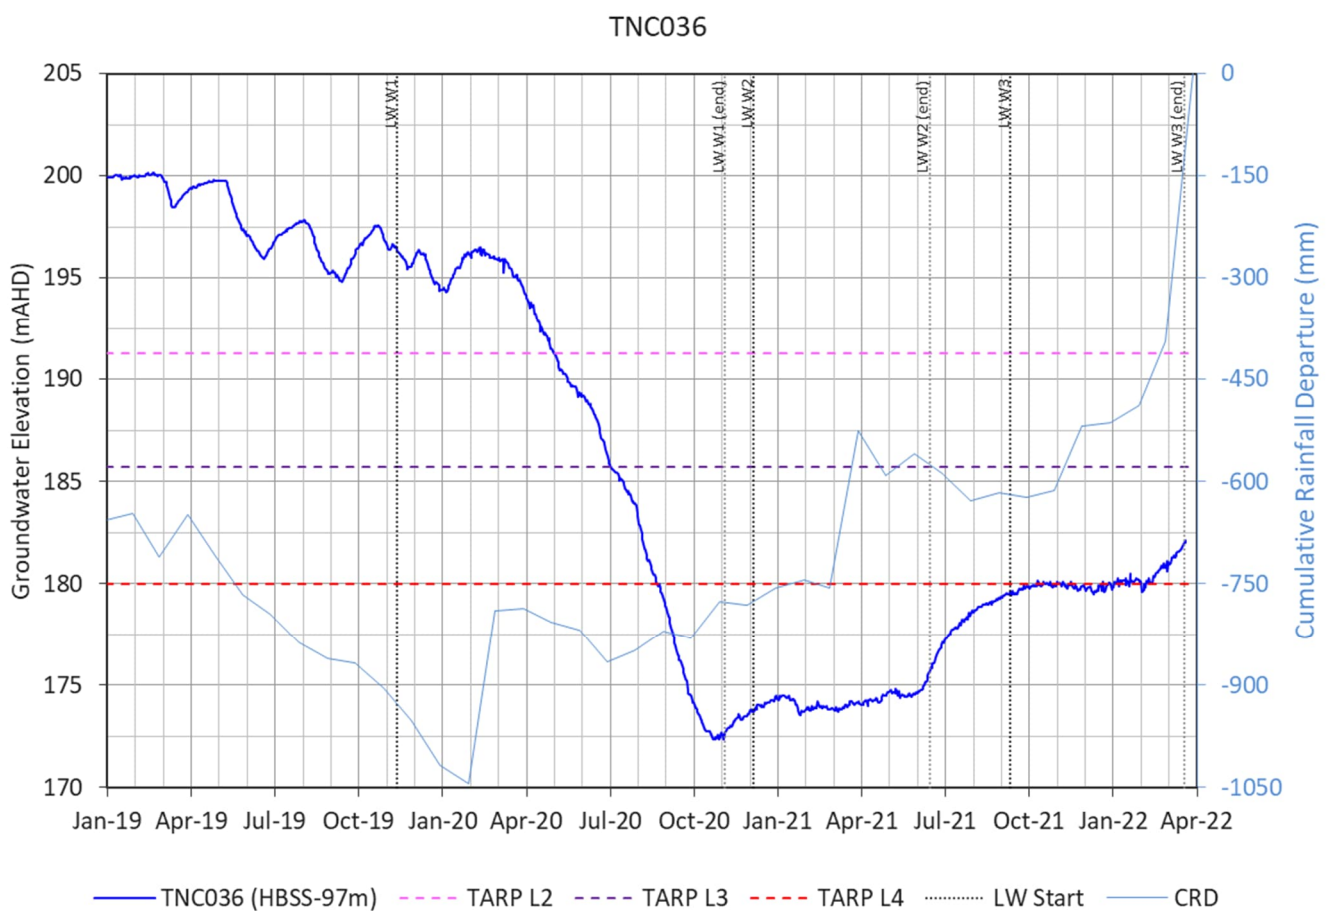
Figure 16 Groundwater Level Exceedance at TNC036-HBSS-97m

At HBSS-97m groundwater levels are observed between 180.7 and 179.6 mAHD between November 2021 and February 2022. Over this period groundwater levels seem to have stabilised with fluctuations up to 1 m. This follows a period of recovery since June 2021 (Figure 16). In February 2022, groundwater levels declined marginally below the trigger TARP Level 4 (180 mAHD) for short periods of time (five days in February 2022). As of March 2022, groundwater levels increased above the trigger TARP Level 4, hence a TARP Level 3 applies.

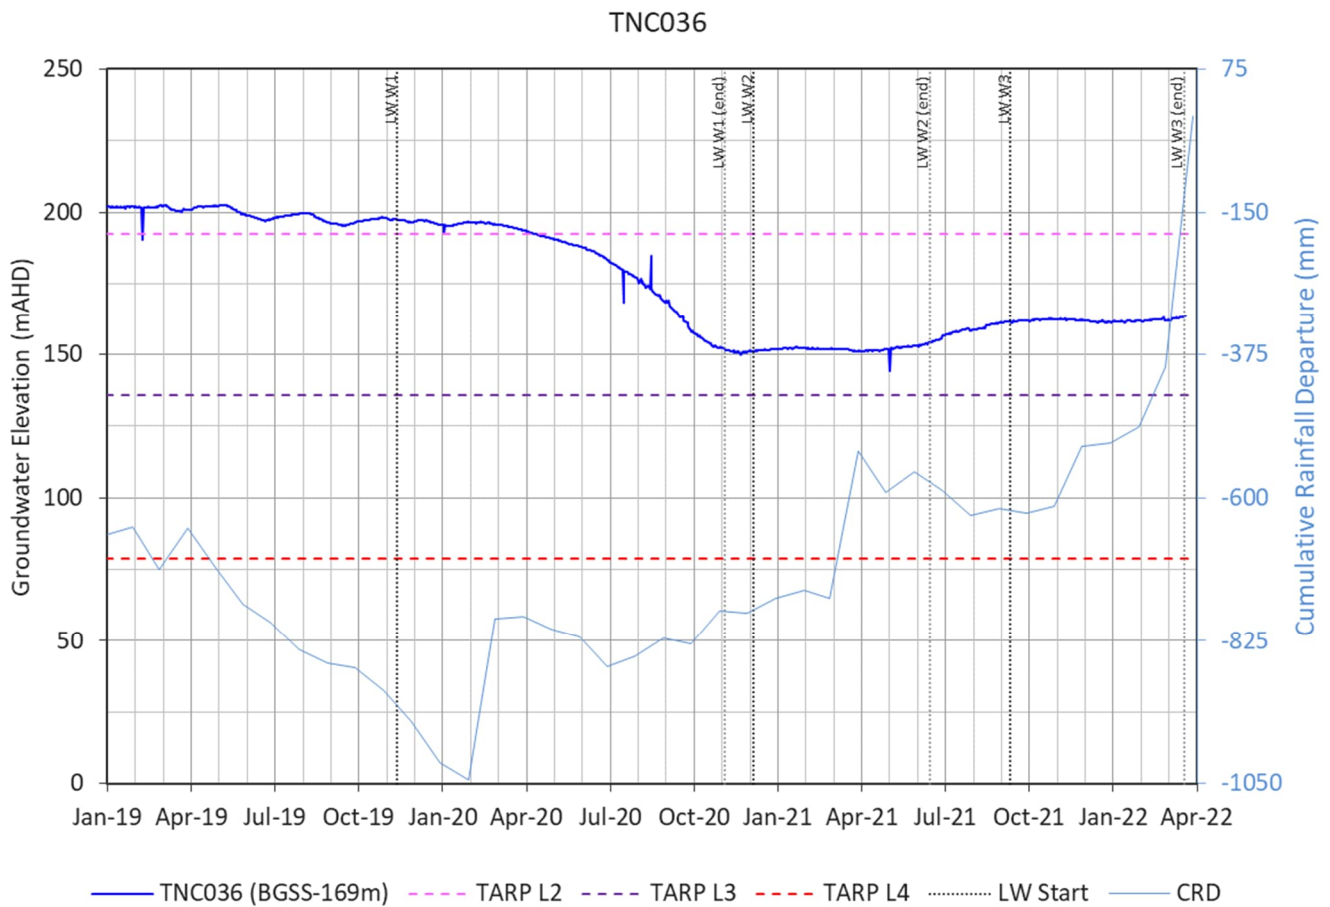
Figure 17 Groundwater Level Exceedance at TNC036-BGSS-169m

In HBSS-169m, the reduction to a TARP Level 2 occurred in September 2021 while groundwater levels continued to recover within the revised TARP Level 2. Groundwater levels are observed between 161.5 and 163.5 mAHD and increase by approximately 2 m during the reporting period (Figure 17). The groundwater trend at TNC36-169m in March 2022 remains consistent with the observations made in the six-monthly review (SLR, 2021a) and previous monthly reporting (SLR, 2022b). As of March 2022, groundwater levels remain below the trigger for TARP Level 2 (192.5 mAHD), hence a TARP Level 2 still applies.

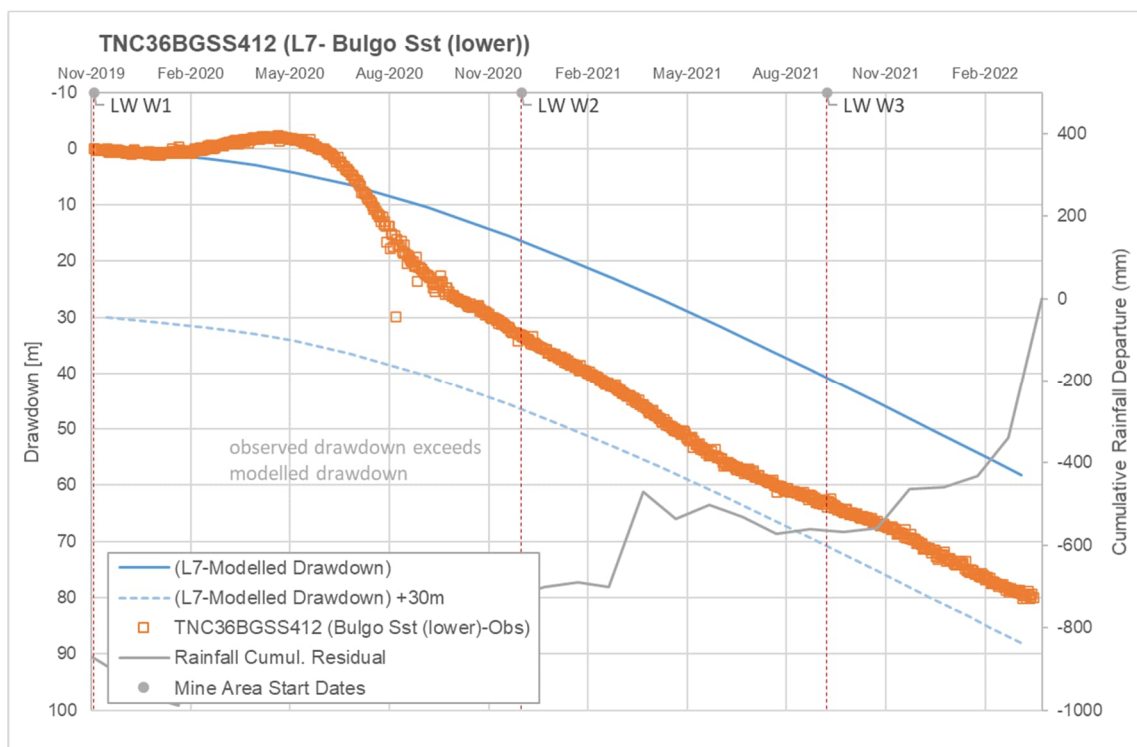
Figure 19 Comparison of Modelled and Observed Drawdown at TNC036 (BGSS-412.5m) with the +30m Threshold Modelled Drawdown

Figure 19 shows that the observed drawdown at TNC036-BGSS-412.5m exceeds the modelled drawdown from August 2020 but remains within the predicted drawdown (+30m) as of March 2022. A Level 2 TARP criteria applies at TNC036-BGSS-412.5m over the reporting period (Table 5).

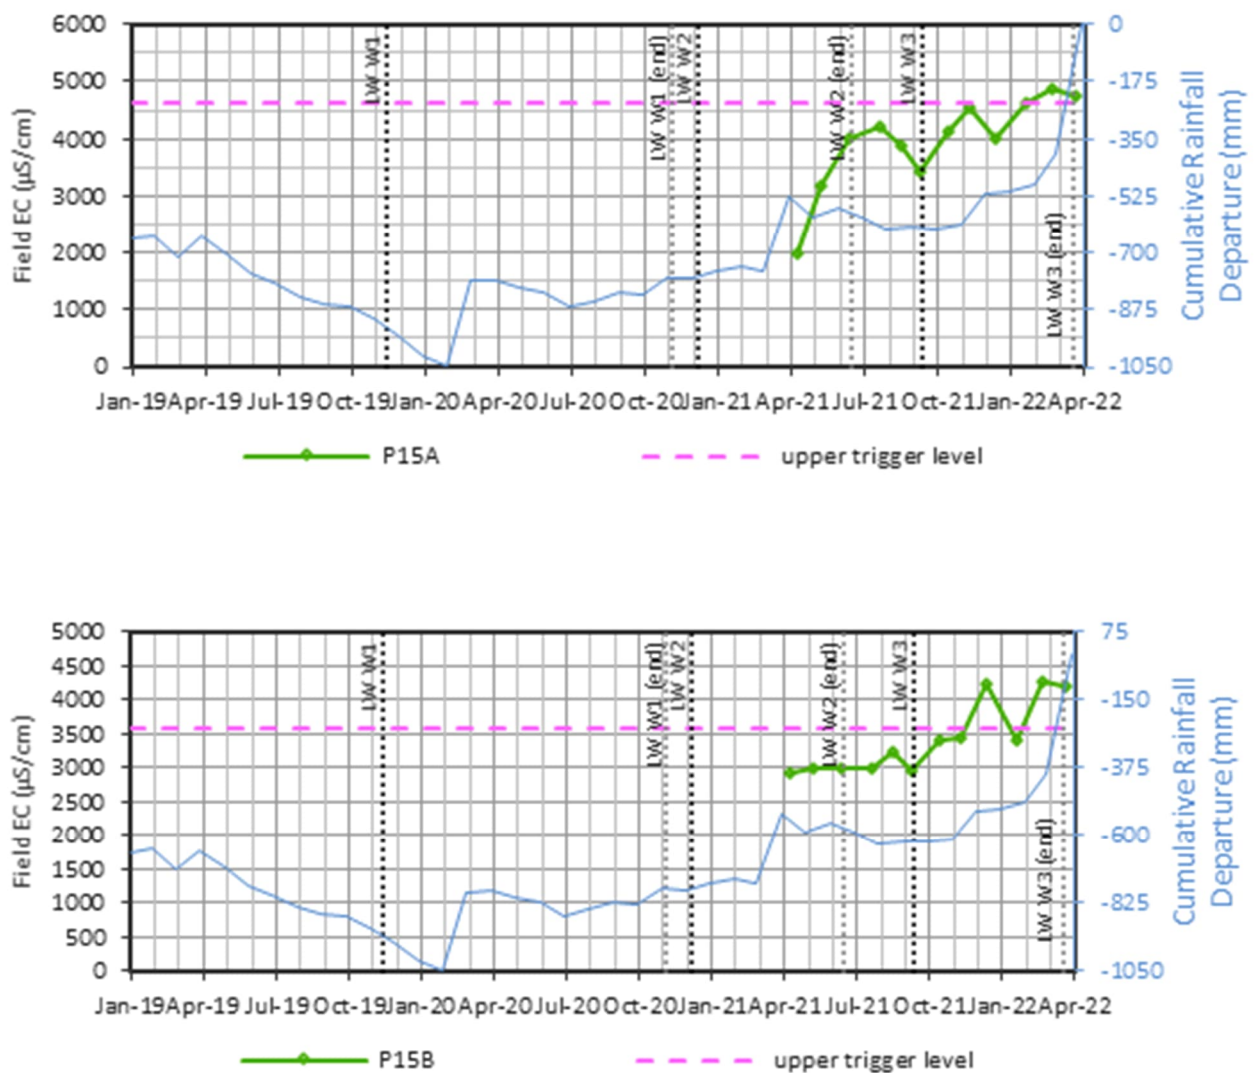
Figure 20 EC Exceedances at P15A and P15B

EC in P15B also shows fluctuating behaviour. At P15B, EC triggered a TARP Level 2 of 3,575 $\mu\text{S}/\text{cm}$ in December 2021 before returning within TARP Level 1 in January 2022. In February 2022, EC increased to 4270 $\mu\text{S}/\text{cm}$ and reduced slightly to 4,210 $\mu\text{S}/\text{cm}$ in March 2022 triggering the TARP Level 2 since February 2022 (Figure 20).

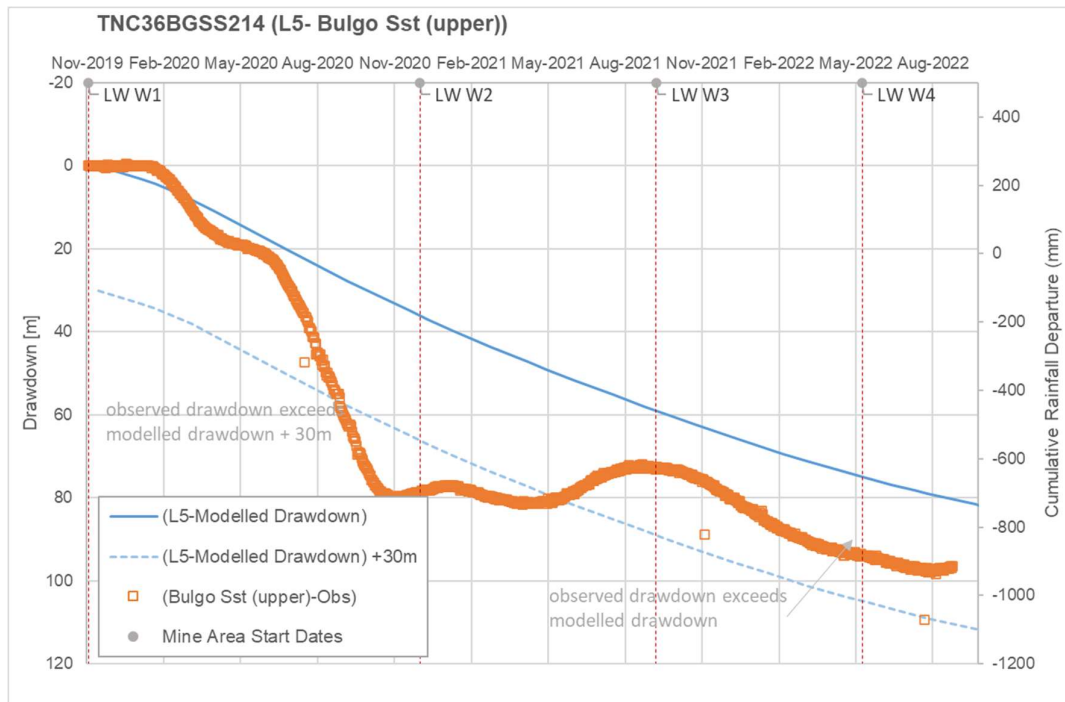
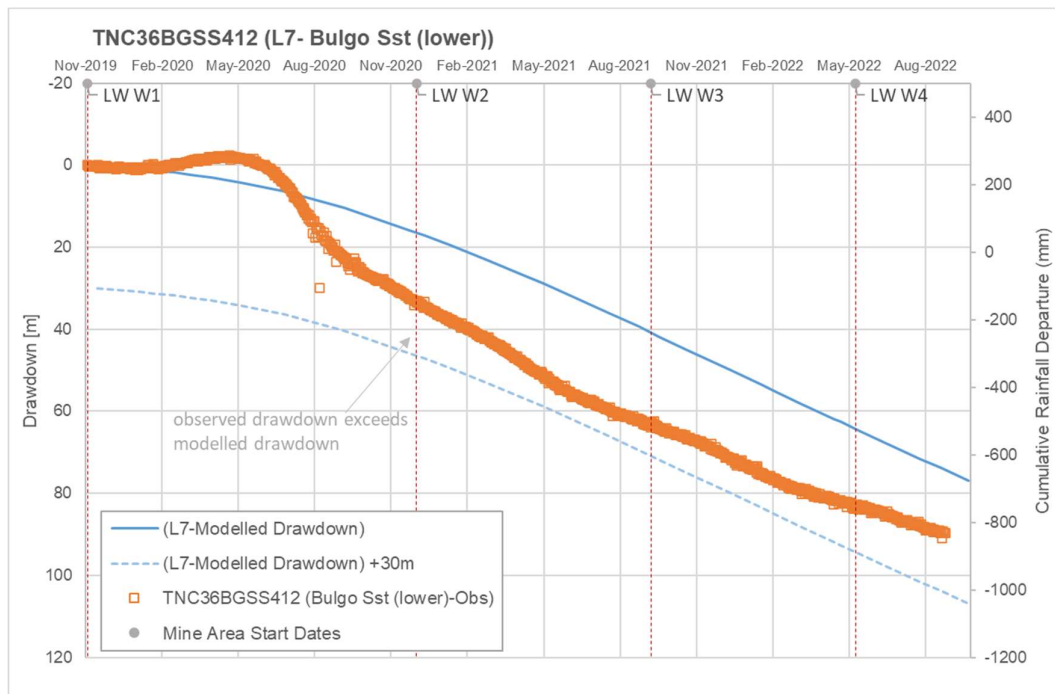
The groundwater level observed at TNC036-BGSS-214m and TNC036-BGSS-412.5m exceeds the modelled drawdown from mid-2020 but remains within the 30 m predicted drawdown as of August 2022 (**Figure 10** and **Figure 11**). A Level 2 TARP criteria (exceeds modelled drawdown but less than 30 m exceedance) still applies at TNC036-BGSS-214m and TNC036-BGSS-412.5m over the reporting period (**Table 8**).

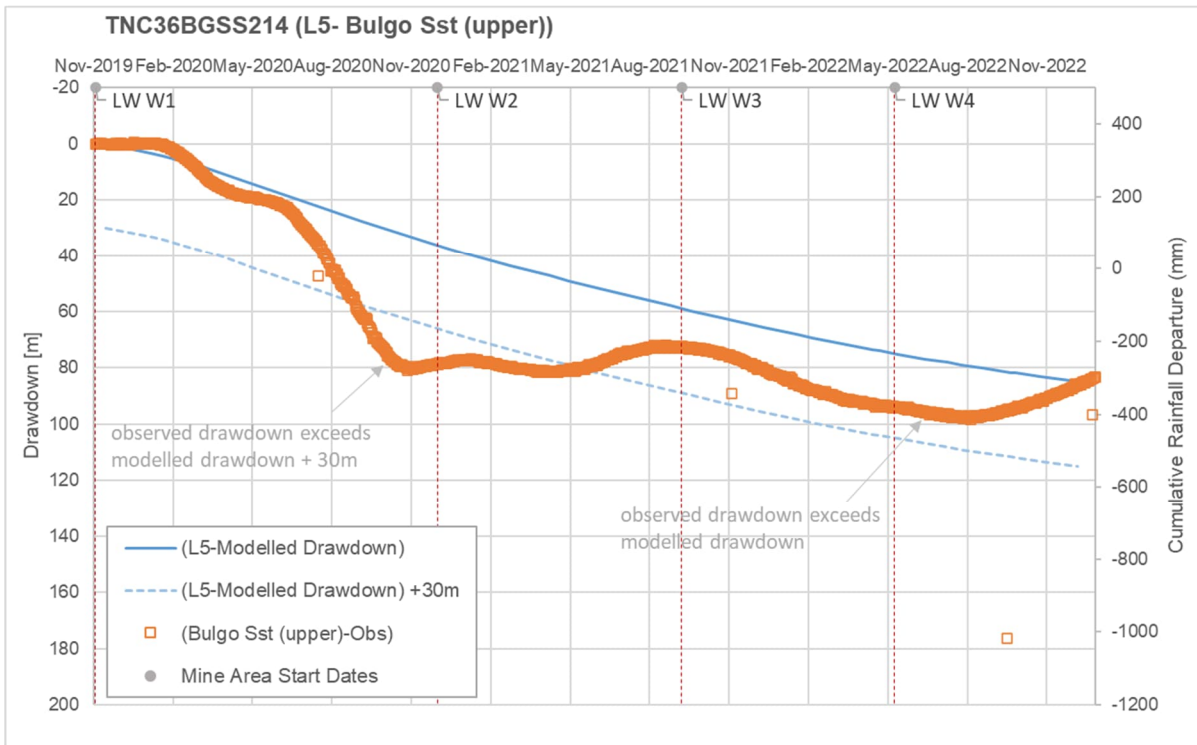
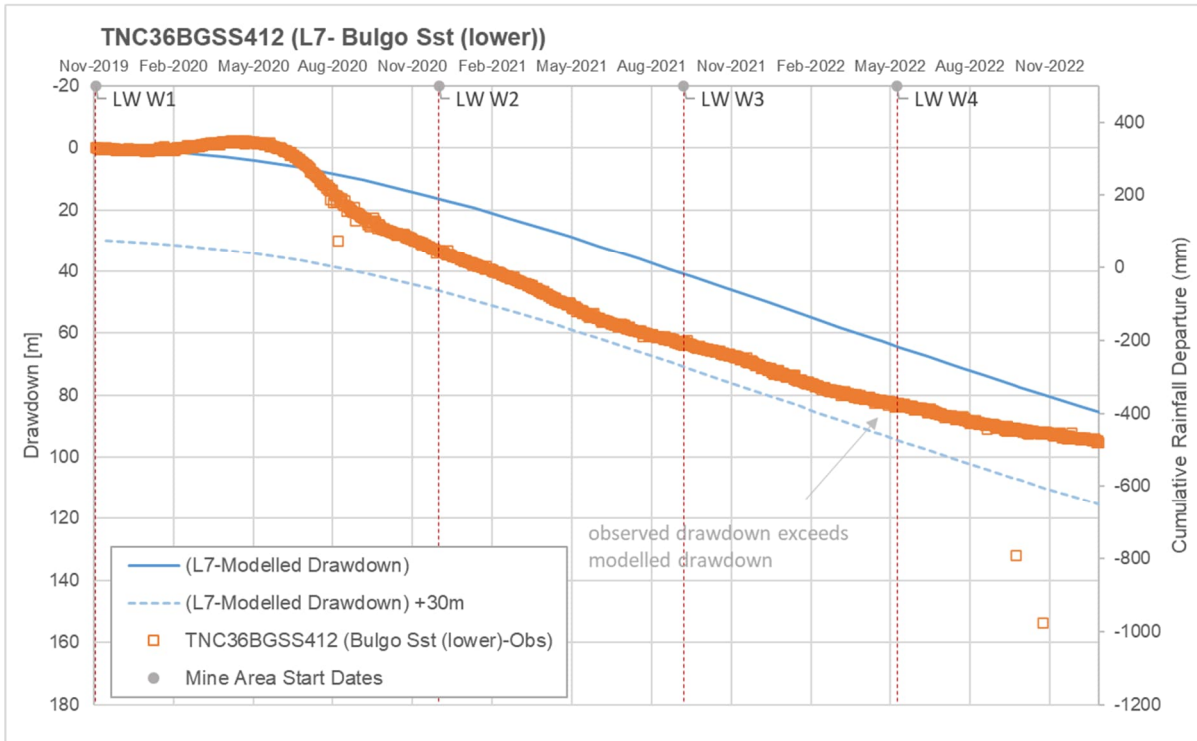
TNC036 (BGSS - 169m)	TARP Level 2 exceedance was observed from October to December 2022. Groundwater levels are observed at 181.6 mAHD in December 2022 and increased by approximately 8.5 m during the reporting period. As of December 2022, groundwater levels remain below the trigger TARP Level 2 (192.5 mAHD), hence a TARP Level 2 still applies.
TNC036 (BGSS - 214m)	A reduction from TARP Level 2 exceedance to TARP Level 1 was observed during the review period. The groundwater level observed at TNC036-BGSS-214m exceeds the modelled drawdown from mid-2020 but remains within the 30 m predicted drawdown in October and November 2022 (Figure 4). As of December 2022, the observed drawdown does not exceed the modelled drawdown resulting in a TARP Level 1.
TNC036 (BGSS – 412.5m)	TARP Level 2 exceedance was observed during the review period. The groundwater level observed at TNC036-BGSS-412.5m exceeds the modelled drawdown from mid-2020 but remains within the 30 m predicted drawdown as of December 2022 (Figure 5). A Level 2 TARP criteria (exceeds modelled drawdown but less than 30 m exceedance) still applies at TNC036-BGSS-412.5m over the reporting period.
