# METROPOLITAN COAL

## 2023 ANNUAL REVIEW

Project No. MET-24-36  
Document No. 01225142

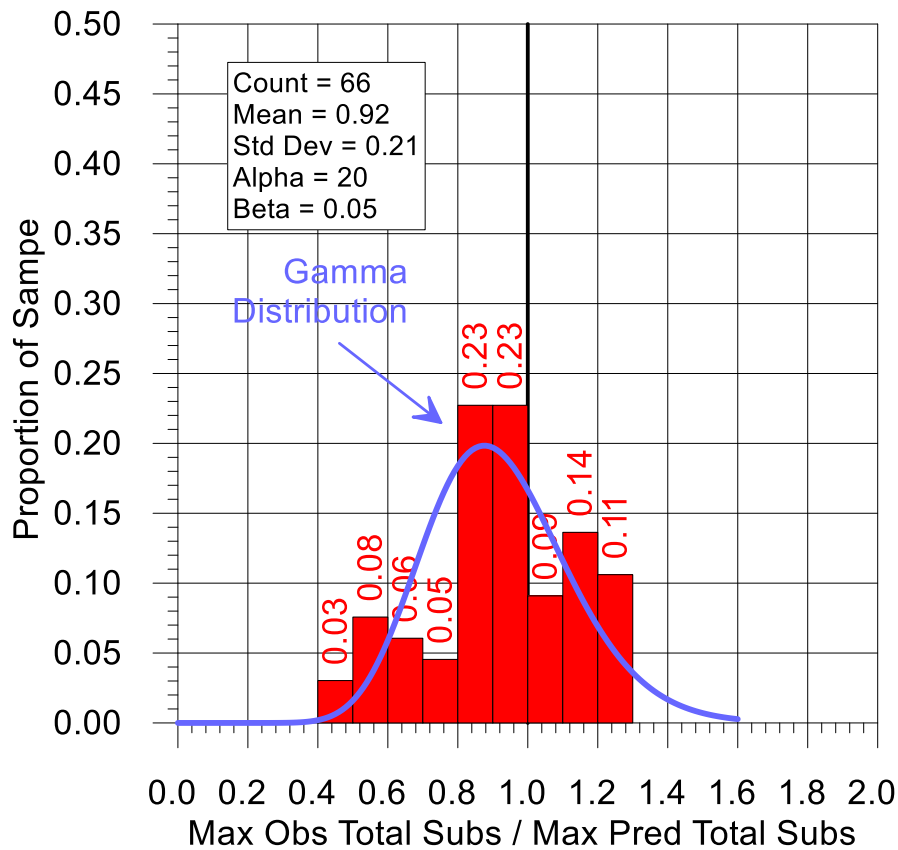
**Chart 2 Histogram of Maximum Observed/Maximum Predicted Total Vertical Subsidence with Gamma Distribution**

An analysis of the maximum observed versus maximum predicted vertical subsidence was undertaken by MSEC (Appendix A). The mean of the maximum observed divided by the maximum predicted vertical subsidence for the project shown in Chart 2 is 0.92, indicating that, on average, observed subsidence is 8 percent (%) less than predicted for the project. Based on the results of survey data to date and comparison with predicted conventional subsidence parameters, the profiles of vertical displacement adequately reflect the predictions. The overall subsidence effects of the project do not exceed predictions by more than 15% (Appendix A).

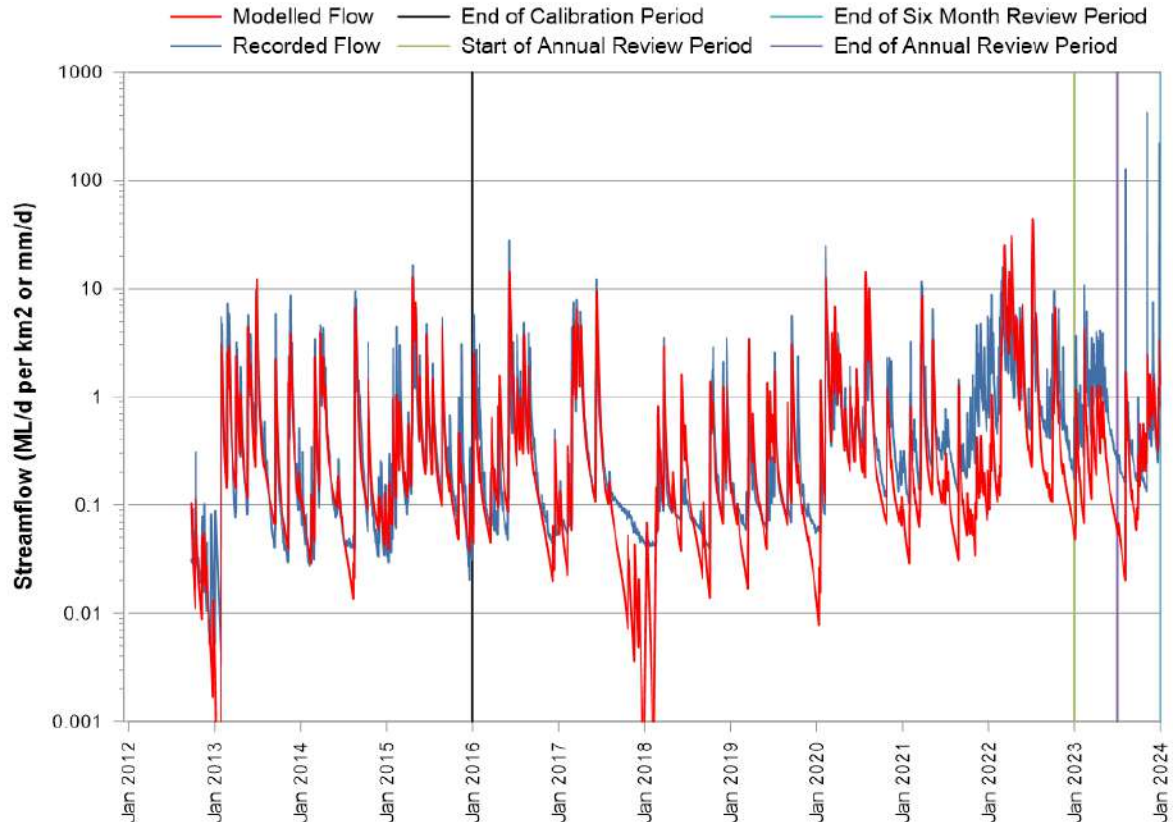
**Chart 4 Monitored and Model Predicted Flows – Eastern Tributary Upstream of Woronora Reservoir**

This indicates that flows reaching the Woronora Reservoir have not been reduced by mining (Appendices B1 and B2).

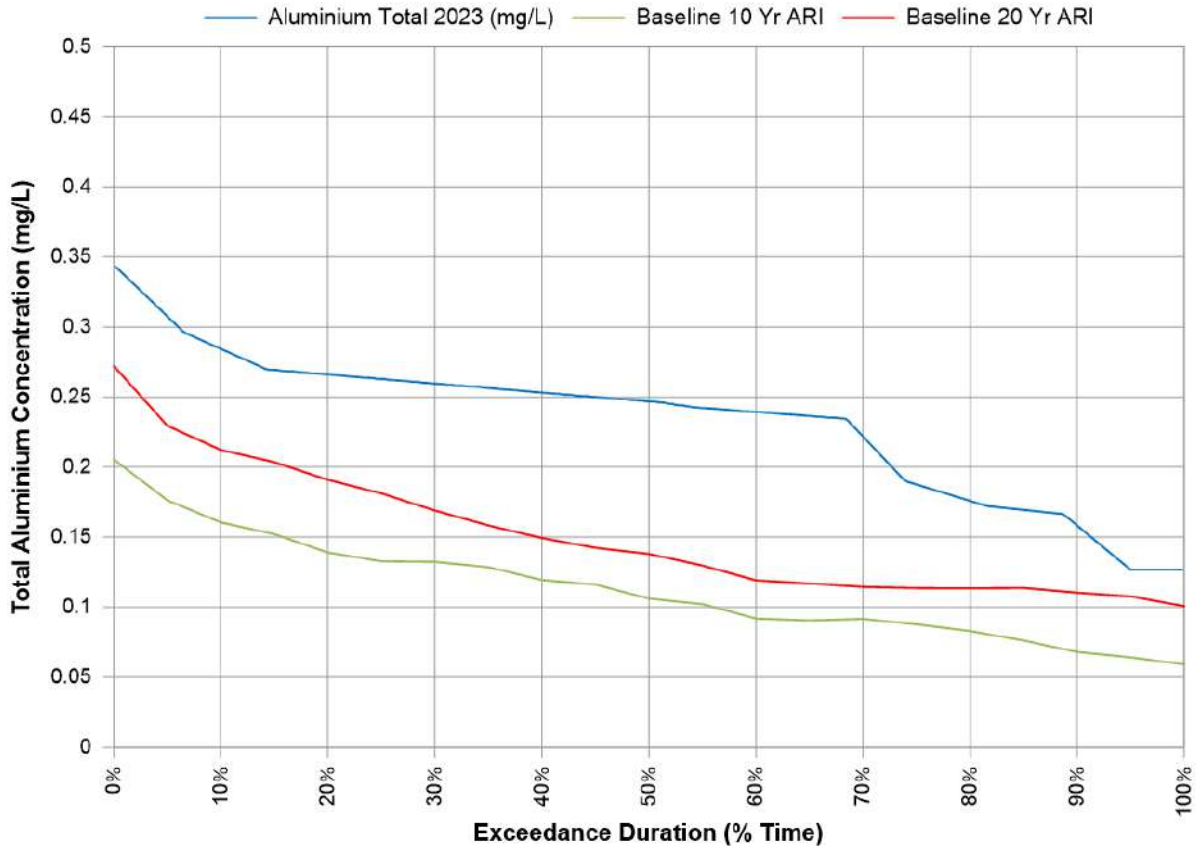
Chart 46 Total Aluminium Performance Indicator Woronora Reservoir 2023

Total iron exceeded the baseline 10 Year ARI exceedance curve for 100% of the reporting period and exceeded the baseline 20 Year ARI exceedance curve for approximately 95% of the reporting period (Chart 45). Total aluminium exceeded the baseline 10 Year and 20 Year ARI exceedance curves for 100% of the review period (Chart 46). Total manganese exceeded the baseline 10 Year exceedance curve for 100% of the review period and marginally exceeded the baseline 20 Year ARI exceedance curve for approximately 5% of the review period (Chart 47). The results for total iron and total aluminium equate to a Level 3 significance and for total manganese equate to Level 2 significance.

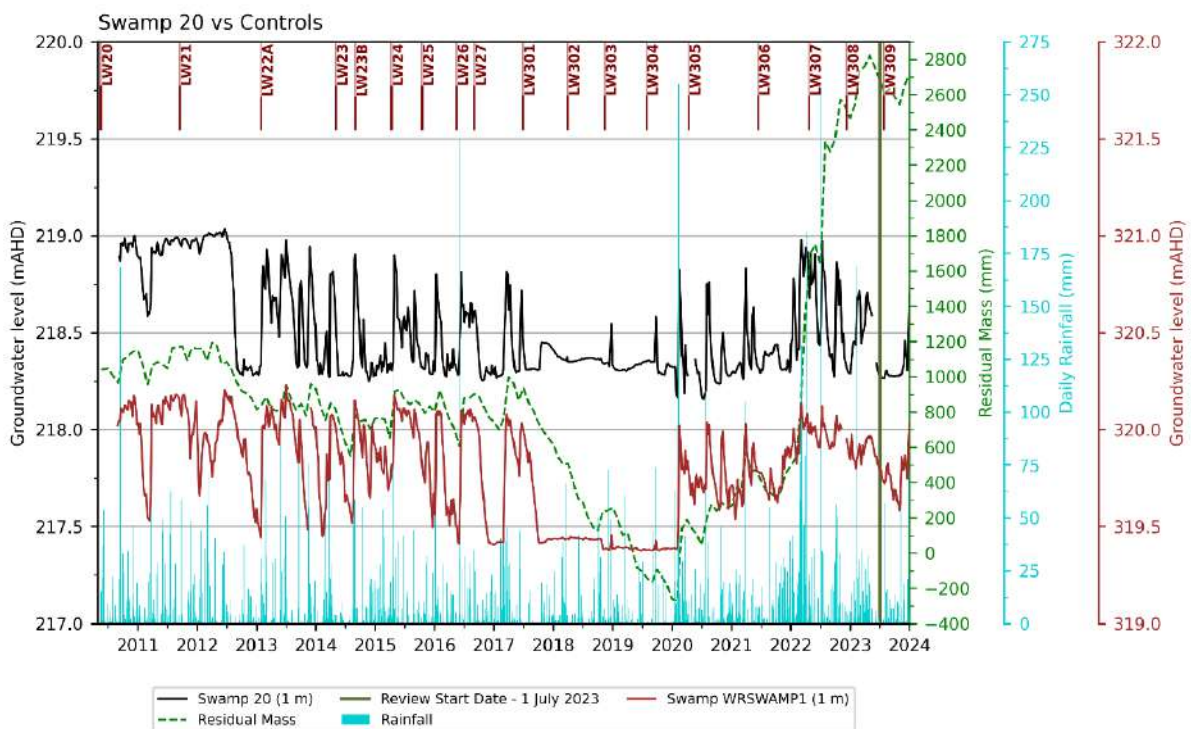
**Chart 48 Comparison of Piezometer Responses at Swamp 20 and Woronora River 1 Control Swamp**

The upland swamp groundwater performance indicator has been exceeded at Swamp 20 since 2012. Swamp 20 substrate water levels changed from being permanently saturated to being periodically saturated as a result of the passing of Longwall 21 (Chart 48, and Appendices C1 and C2). There is a very strong correlation with rainfall trend at Swamp 20 and control swamp Woronora River Swamp 1 over the period of record. As the rate of decline in the two piezometers is similar between 2013 and 2016, but different in 2012, it is likely that Longwall 21 caused a mining effect at Swamp 20, but the effects have not been exacerbated by Longwalls 22-27 or Longwalls 301-306 (Appendices C1 and C2). In 2018 and 2019, both swamps reported water levels at the base of the substrate dataloggers for the full period apart from the short period of saturation recorded in Swamp 20 in September 2019. Both swamps increased in water levels after the large rain event in February 2020. However, following rainfall events throughout 2020, 2021 and 2022, Swamp 20 exhibited a decrease in groundwater levels whereas the WRSWAMP1 water levels remained at near-saturated levels. During the current reporting period both swamps water levels were concordant with rainfall, both experiencing upward trends due to October 2023 rainfall, with downward trends during the dryer months (Chart 48, and Appendices C1 and C2).

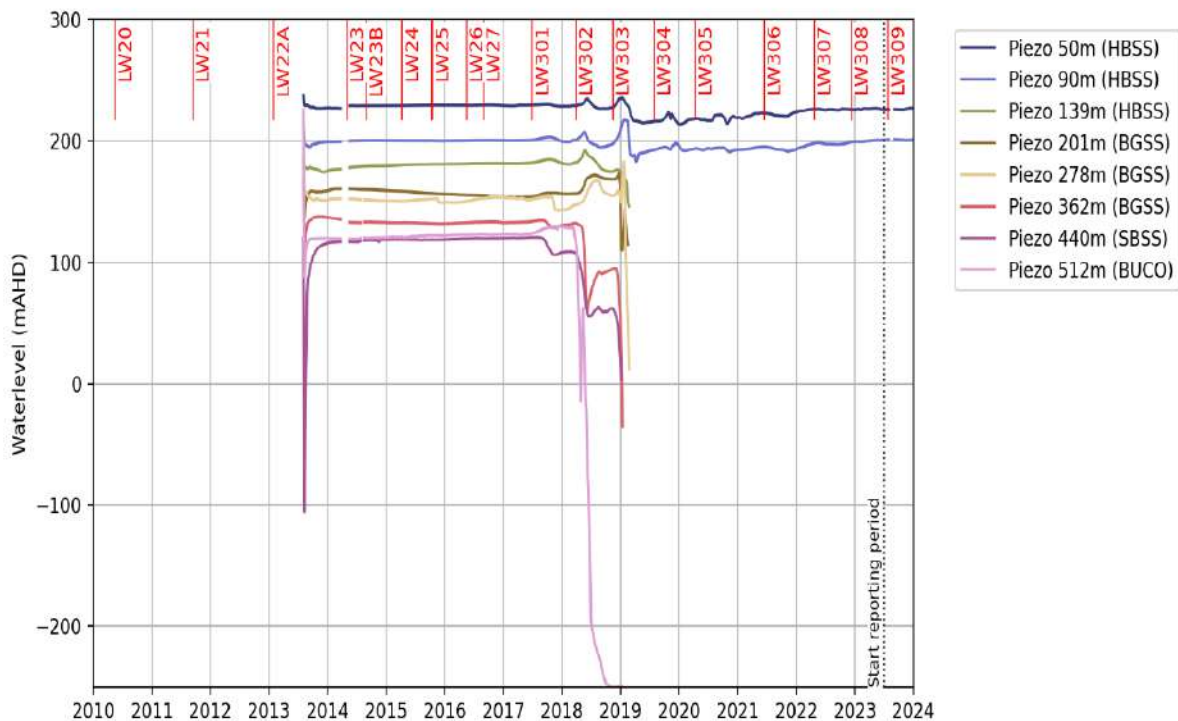
Chart 55 Time Variations in Potentiometric Heads at F6GW4A

Bore F6GW4A overlies the chain pillars between Longwalls 303 and 304. The time-series record for bore F6GW4A is shown on Chart 55. This bore is two panel widths from Longwall 301 and one panel width from Longwall 302. The respective mining faces came closest to the bore in late-September 2017 and late-May 2018, at which times distinct features are evident on all hydrographs. The passage of Longwall 301 caused mild responses, generally short-term increases in head, while the passage of Longwall 302 caused sharp cusp-like features on the Hawkesbury Sandstone hydrographs, sustained rises in the upper and mid Bulgo Sandstone, and strong declines in the three deepest piezometers. In January 2019, F6GW4A was undermined by Longwall 303 causing the depressurisation and disabling of the six lower sensors (i.e. 139 metres below ground level [mbgl], 201 mbgl, 278 mbgl, 362 mbgl, 440 mbgl and 512 mbgl). The upper and mid Hawkesbury Sandstone piezometers (50 mbgl and 90 mbgl) also displayed a lowering of groundwater head following the passage of Longwall 303, however, they showed no significant decline after the passage of Longwall 304, 305, 306, 307, 308 or 309. Both piezometers showed stable water levels during the reporting period.

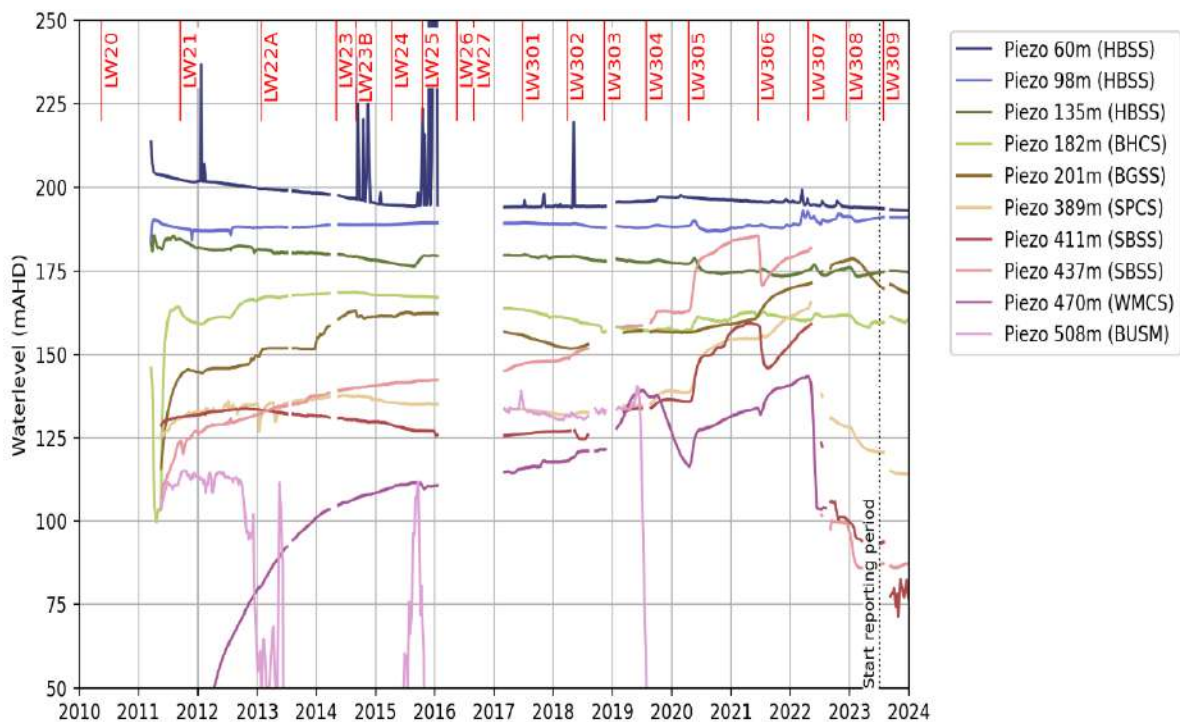
**Chart 56 Time Variations in Potentiometric Heads at PHGW2A**

By early September 2022, three piezometers (piezometers at 389 mbgl, 411 mbgl, and 437 mbgl) experienced depressurisation after a period of non-recording, coinciding with the start of Longwall 307. In the last reporting period, only four of the 10 piezometers (piezometers at 60 mbgl, 97.5 mbgl, 135 mbgl, 181.5 mbgl) were recording during this reporting period, all four show a decrease in groundwater pressure, before increasing in mid-2023. Additionally, lost monitoring data from early 2023 for piezometers 389 mbgl, 411 mbgl, and 437 mbgl were recovered and updated. In this reporting period, most piezometers (piezometers at 60 mbgl, 98 mbgl, 135 mbgl, 201 mbgl, 182 mbgl, 389 mbgl, and 437 mbgl) showed stable readings, with a brief interruption in data recording in August 2023. This is seemingly independent of the climate. During this period, the Hawkesbury piezometers maintained relatively stable water levels, while the deeper piezometers indicated potential depressurisation, likely resulting from the activity of Longwall 309.

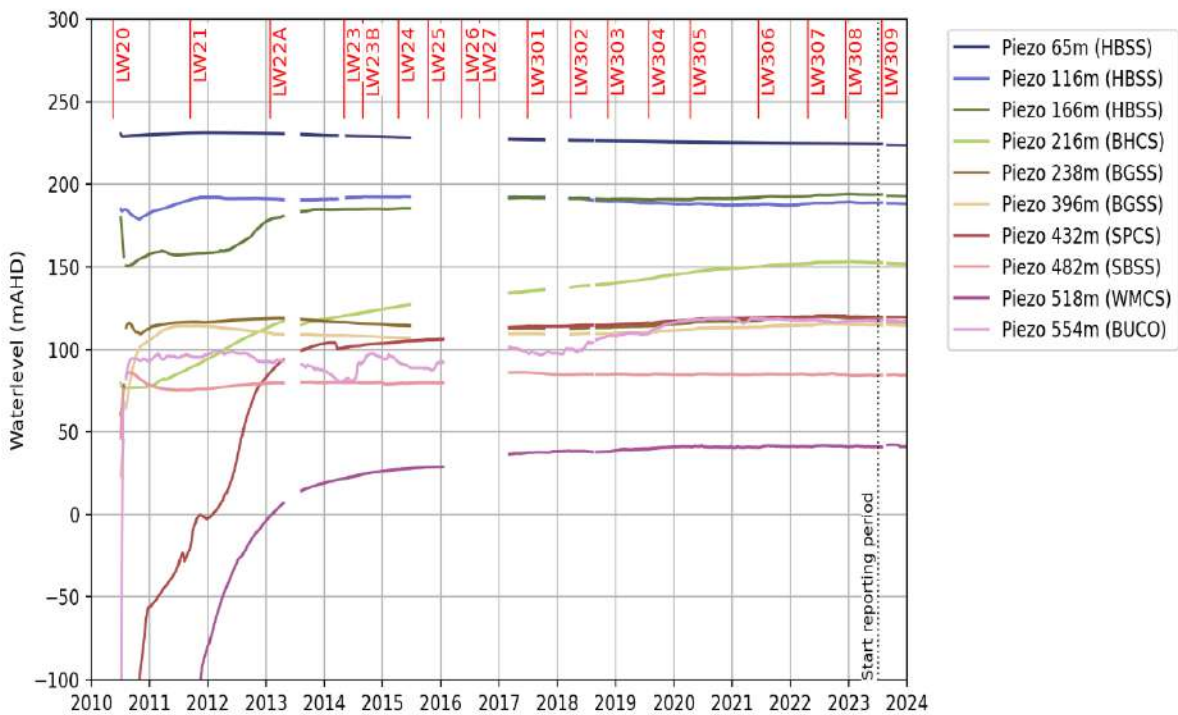
**Chart 58 Time Variations in Potentiometric Heads at PHGW1B**

Chart 58 shows the water levels at bore PHGW1B. The piezometers are located approximately 700 m north of Longwall 308. A connection failure prevented the upload of data for sensors in PHGW1B in 2016. Sensors have now been reinstated. During the reporting period, all piezometers showed steady water pressures and no response to the mining of Longwall 308.

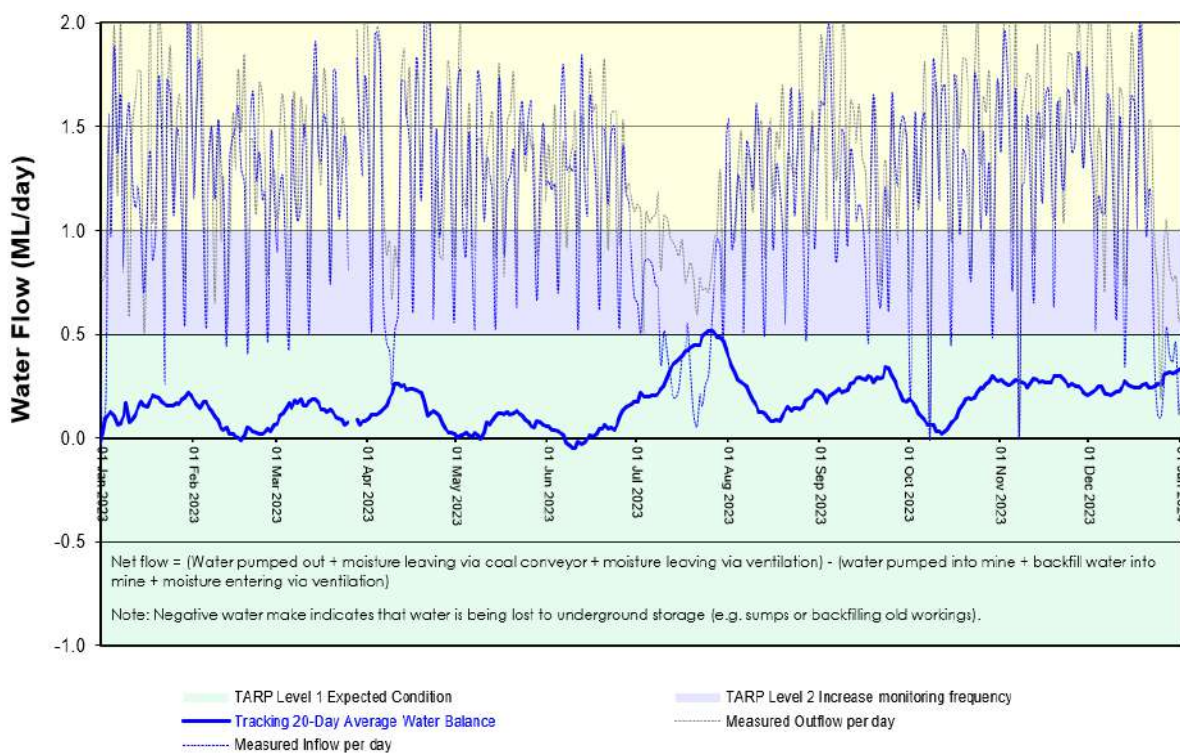
**Chart 67 Estimated Daily Mine Water Make**

The 20 day average daily mine water make was approximately 0.18 ML/day during the reporting period (i.e. well below the 0.5 ML/day Level 2 TARP trigger) (Chart 67).

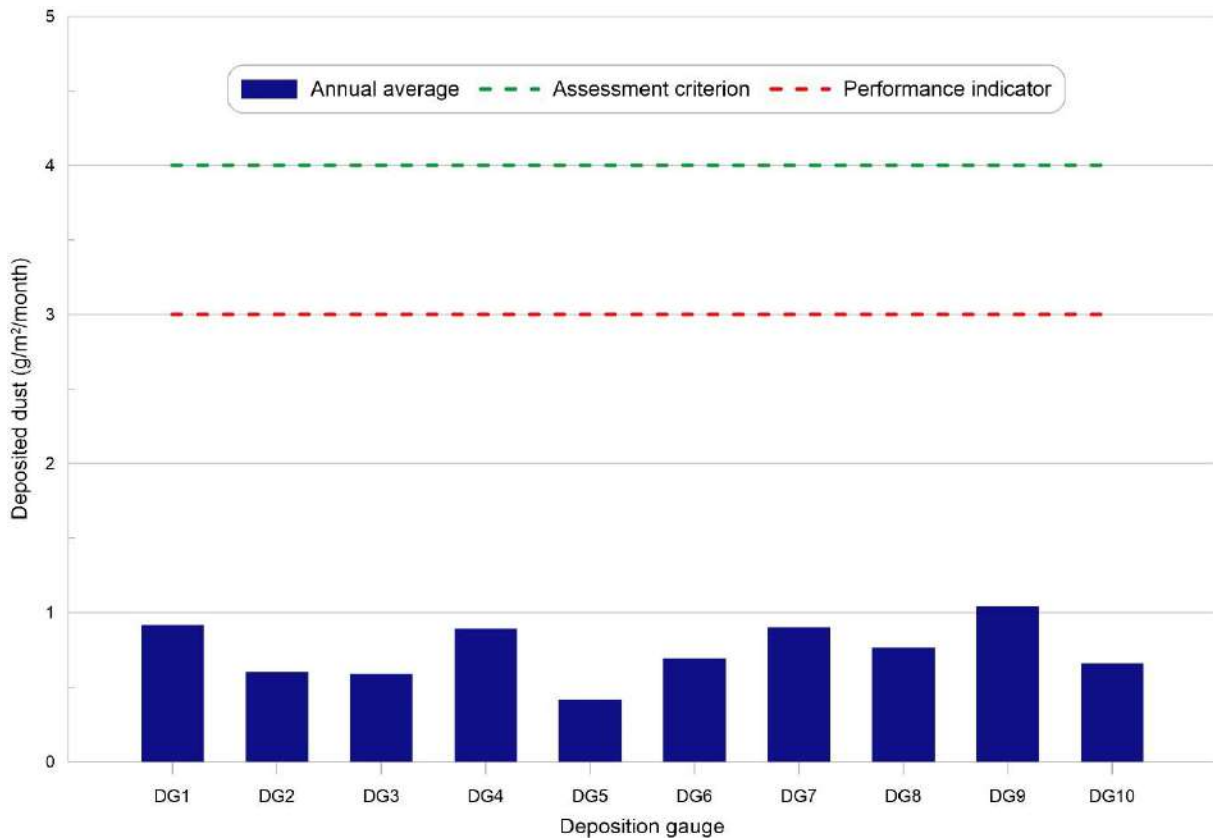
**Chart 70 Annual Average Dust Deposition Rates Measured at Dust Gauges (DG1 to DG10)**

The annual average dust deposition rate at all dust gauges did not exceed  $4 \text{ g}/\text{m}^2/\text{month}$ . Compliance was thus achieved with the annual average performance criterion for dust deposition during the reporting period (Chart 70).
